# MEAN BED LEVEL TRENDS IN THE MANUTAHİ AND MANGAHAREI STREAMS; RUATORIA

1979 to 2015

PEACOCK D H LTD & MARDEN ENVIRONMENTAL SERVICES

December 2017

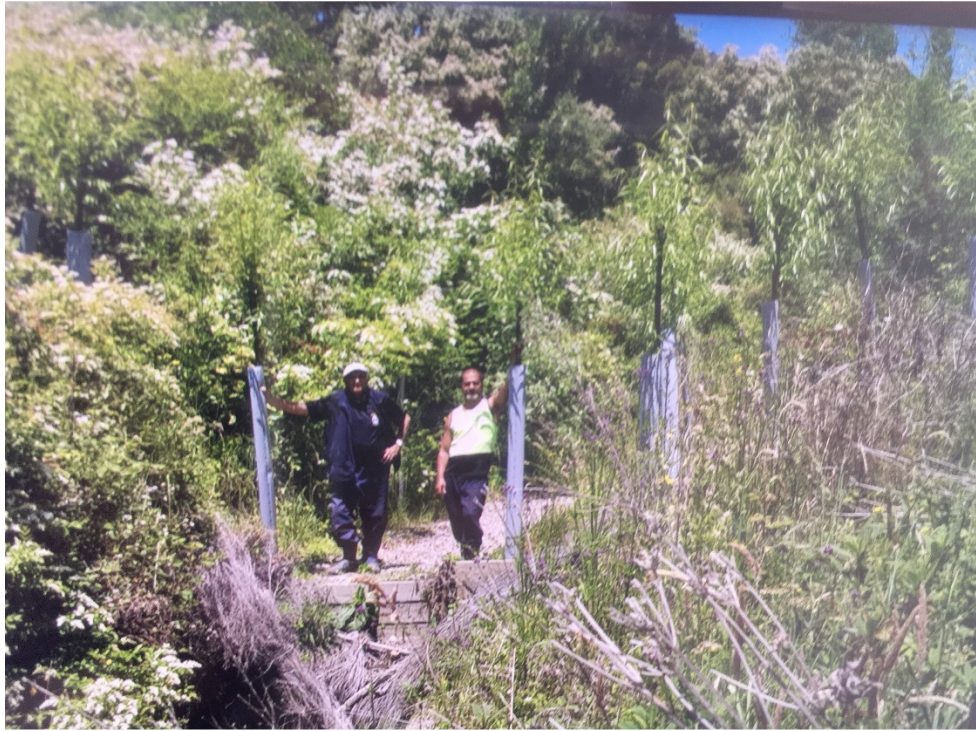
**Fig. 3:** Alex Reedy, supervisor, at left; and Selwyn Temaro; at dam No. 1; *November 2017.*

cross sections, (Appendix 4). Figures 3 and 4 show two of these erosion control dams. Willow poles (with plastic sleeves) have been planted adjacent to the dams, but rubber aprons have yet to be added to the downstream sides.

More recently, (January 2017), seven small timber debris dams have been erected in the Manutahi Stream bed; two of them opposite Ngata College, and the other five upstream of the

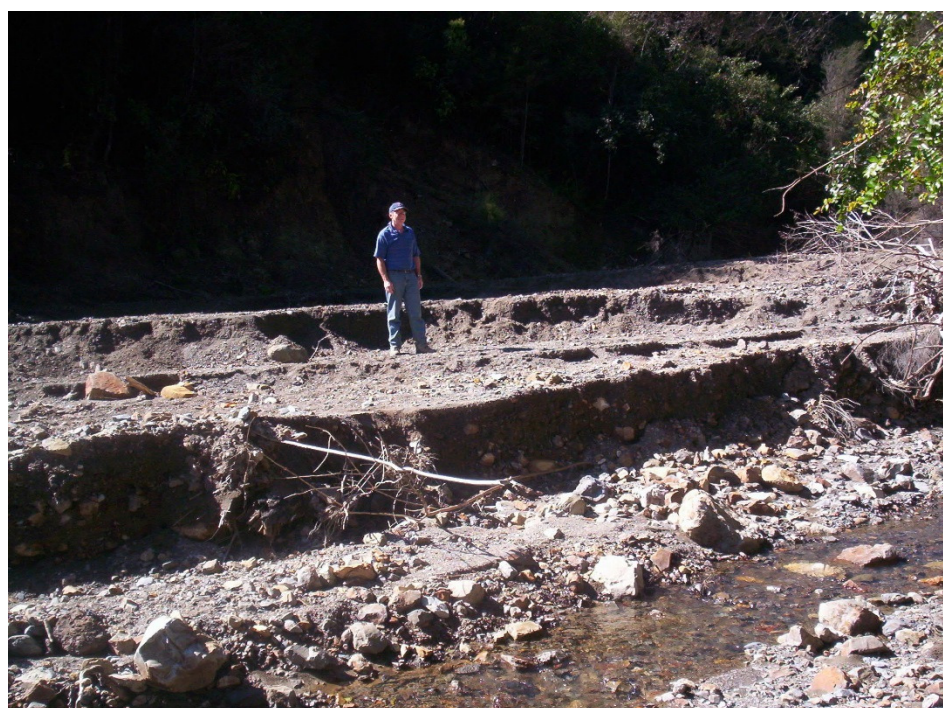
Figure 6 shows that the stream bed at the two upstream cross sections at 1887m and 1703m has been degrading since the first survey in 1979 at an average rate of 67 and 77 mm/year respectively. The terraces left by the degrading stream in 2006 are clearly visible in Figure 7.

**Fig 7: Terracing in the upper Mangahareei Stream.**  
*Photo: D Peacock, 31<sup>st</sup> August 2006.*

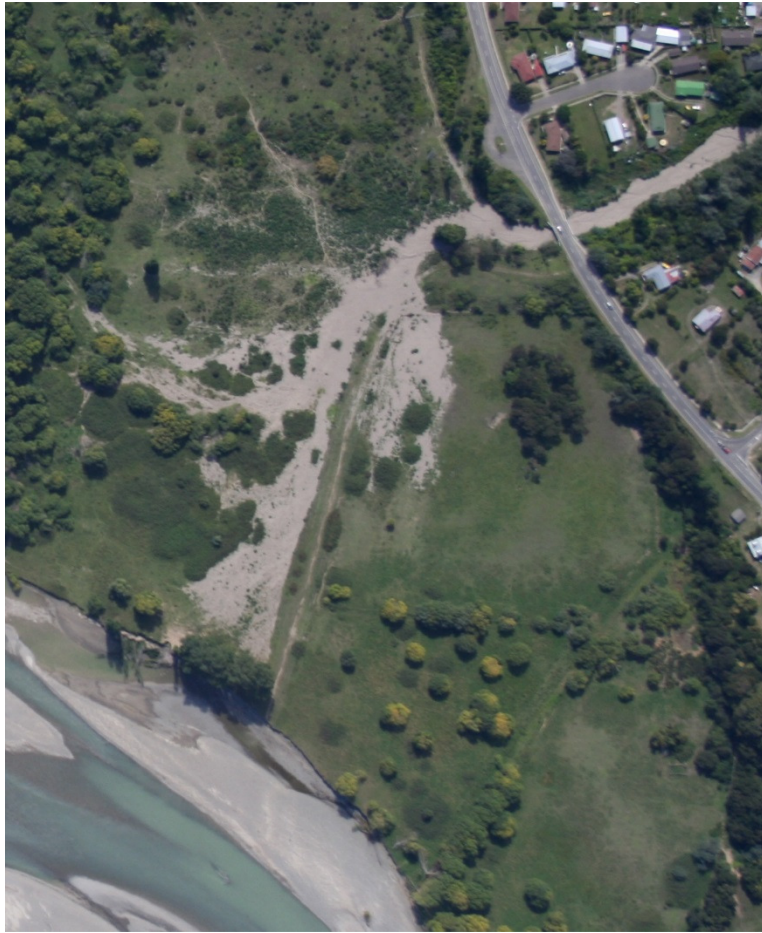
A log/rail wall was constructed downstream of the bridge by the East Cape Catchment Board in 1985 to deflect the stream to the north-east, however this was not successful as the area is a natural shingle fan and inherently will always deposit bed load material because of the flattening of the grade. While the Mangaharei Stream appears to be flowing in a north-easterly direction in Figure 1, this is not always the case as shown in Figure 8; where fan material is mainly depositing in a south-westerly direction towards the Waiapu River.

**Fig. 8:** *Mangaharei Stream fan downstream of Waiomatatini Road.*  
*Photo: P F Olsen; 1<sup>st</sup> February 2007.*
