Analysis of Rainfall for the storm events of 11th-12th June. East Coast Tairāwhiti

27 November 2018

Dr Murry Cave

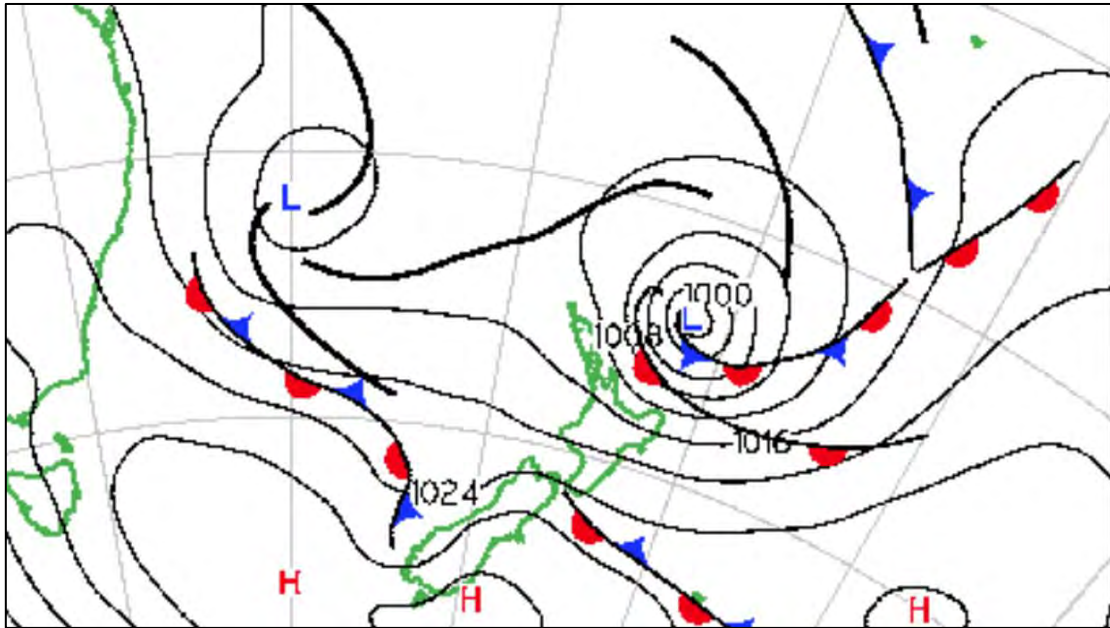
Figure Two. Synoptic map for the 11th -12th June storm showing a low moving south approaching East Cape on the 11th.

The 11th-12th June 2018 storm appears to be a more typical storm than the Queens Birthday storm. The MetService synoptic map for the 11th of June suggests that a sub tropical low situated to the north of Bay of Plenty-East Cape would move south over the intervening 24 hours (**Figure Two**). A severe weather outlook issued on the 10th of June indicated that heavy rain was predicted with a high level of confidence for all of Tairāwhiti (**Figure Three**).

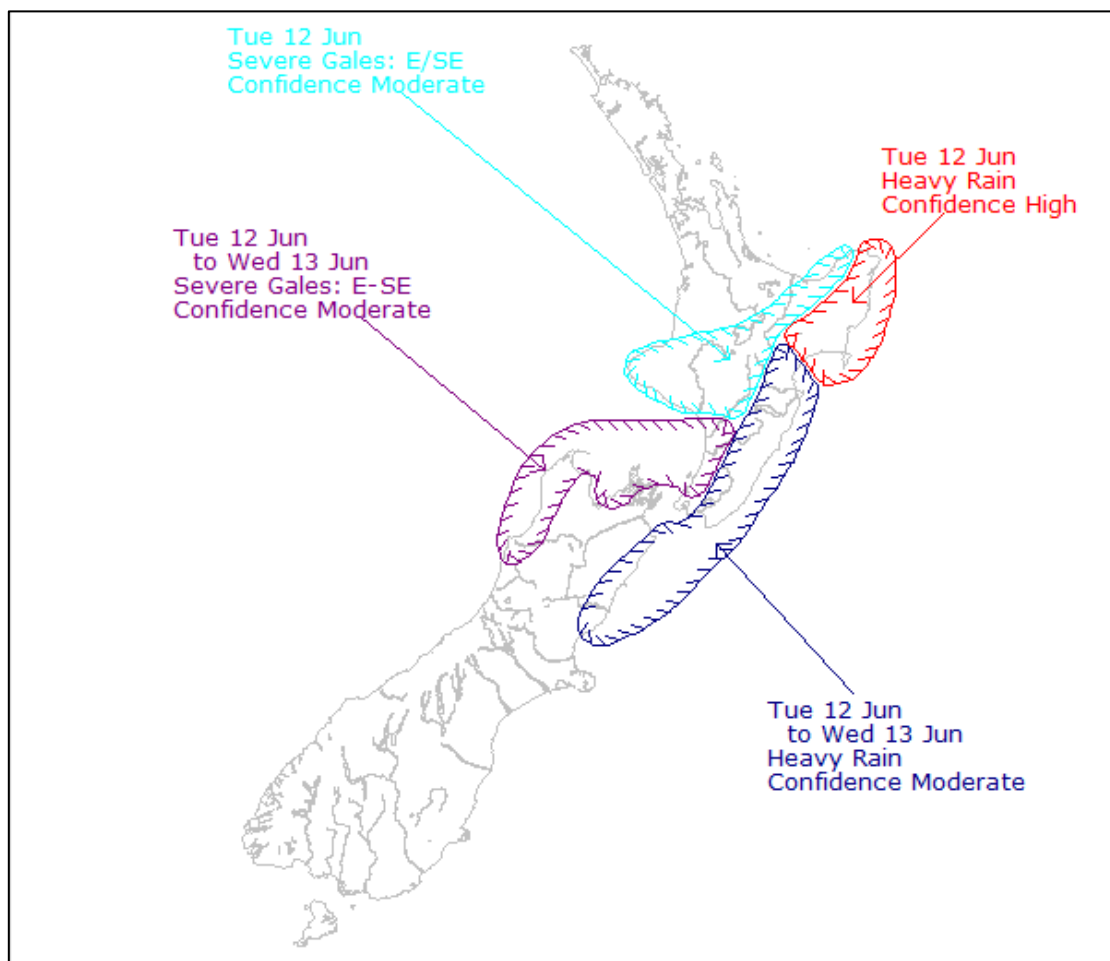
Figure Three. MetService outlook map dated 2:14pm 10th June 2018 which showed heavy rain with a high level of confidence for the region.

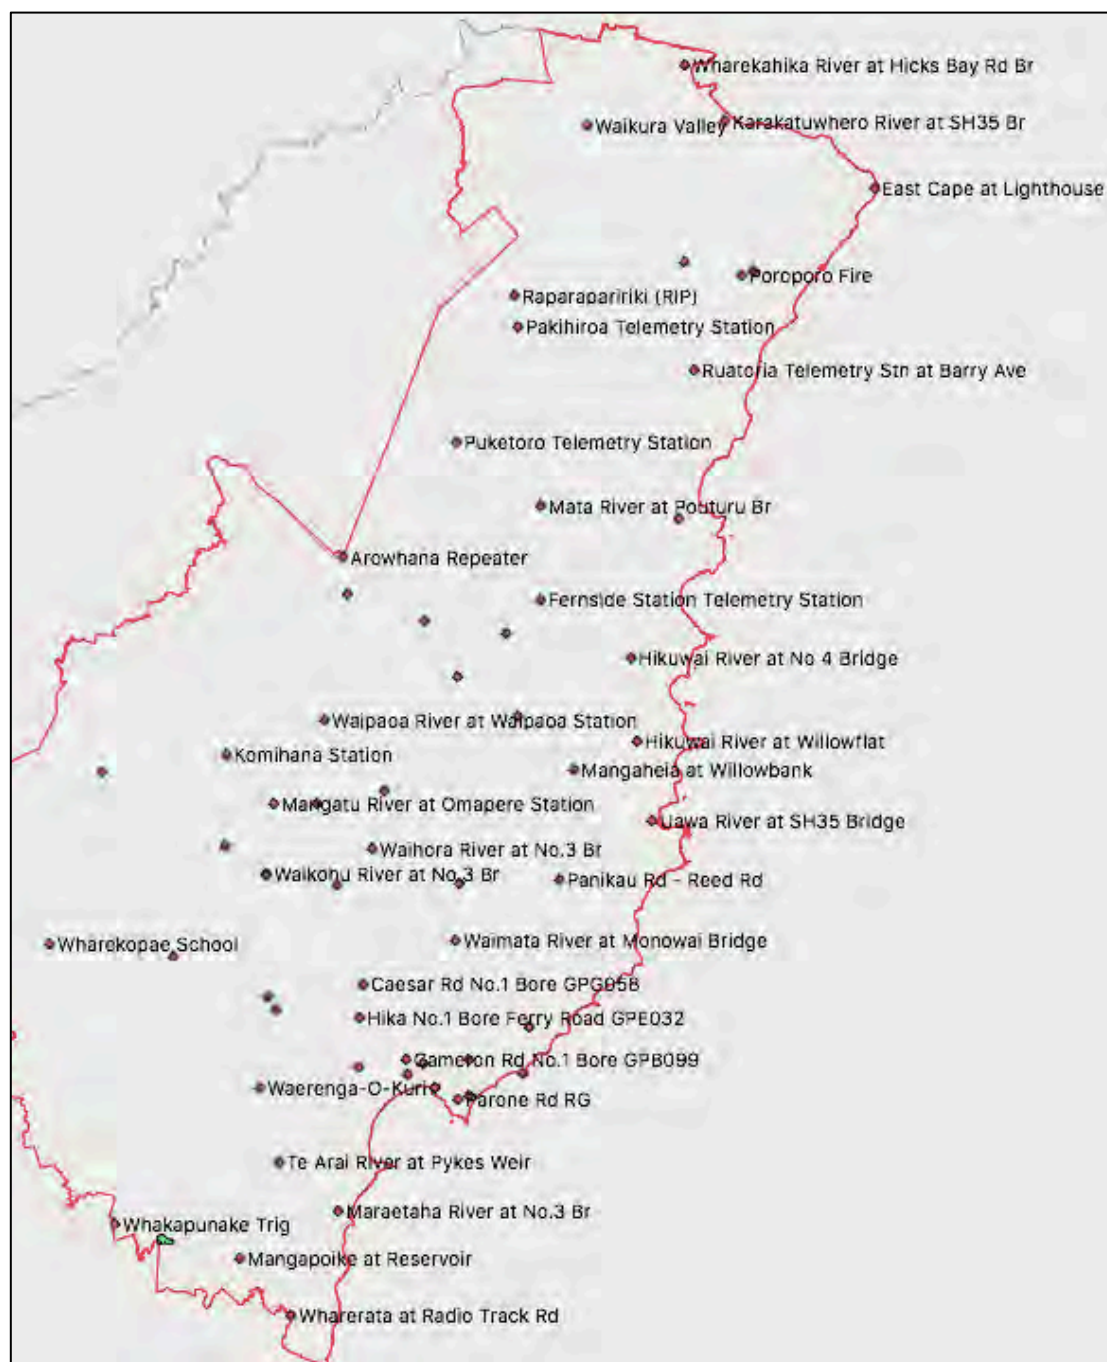
Figure Four. Location of rain gauges within East Coast/Tairāwhiti.

This analysis of rainfall data for the East Coast Tairāwhiti Region is based on 59 rain gauges distributed across the area from Hicks Bay in the north to the top of the Wharerata in the south. There is a gap in coverage in the west while coverage to the north may be too coarse to adequately define rainfall distribution across the area (**Figure Four**). Raw rainfall data is presented as **Appendix One**.

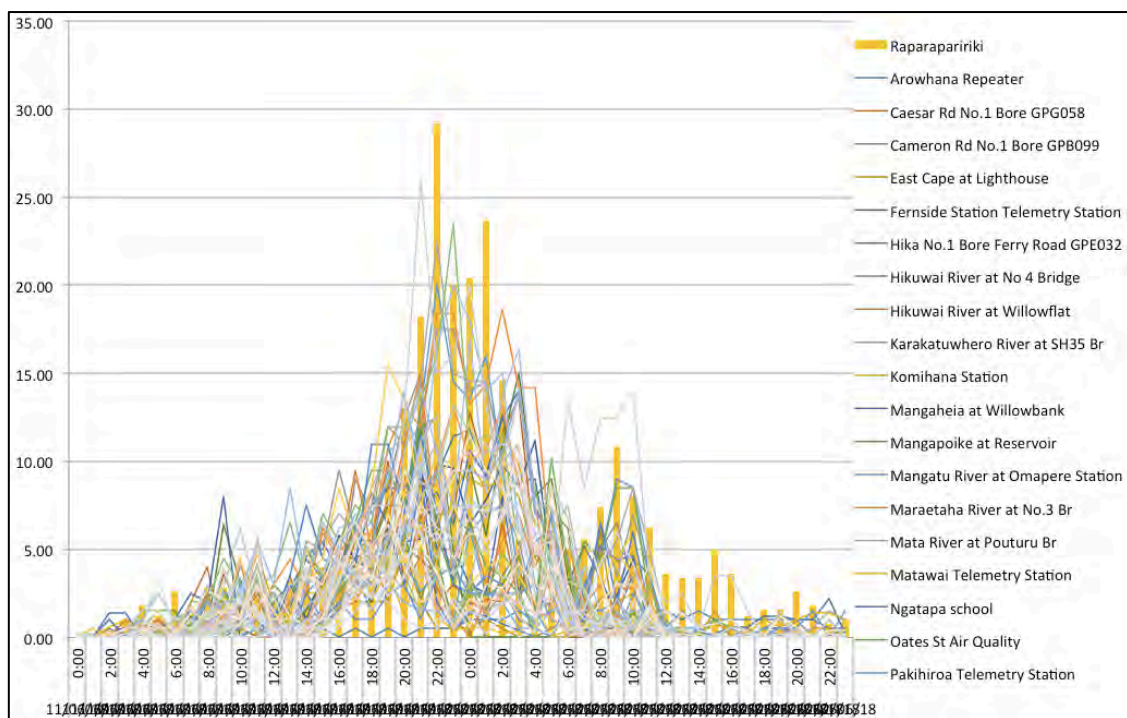
Figure Five. Aggregate of all rain gauges for the storm of 11th and 12th June 2018 which generally suggests a simple bell curve rainfall distribution over time with a minor peak (8mm/hr) prior to the main event and a 10 to 14mm peak soon after the main event.

When the aggregated rain gauge data is plotted which suggests a simple bell curve with the storm initiation around 1pm on the 11th June and ending by midday on the 12th June (**Figure Five**). There are a couple of minor peaks before and particularly after the main event but these do not seem significant (see **Figure Five**).

Because much of the detail is lost in **Figure Five**, the hourly maximum rainfall was calculated for each hour. This plot does not suggest a picture of the storm that is much different from the aggregated data although it indicates that the precursor and post main storm tails would have contributed to the event (**Figure Six**).

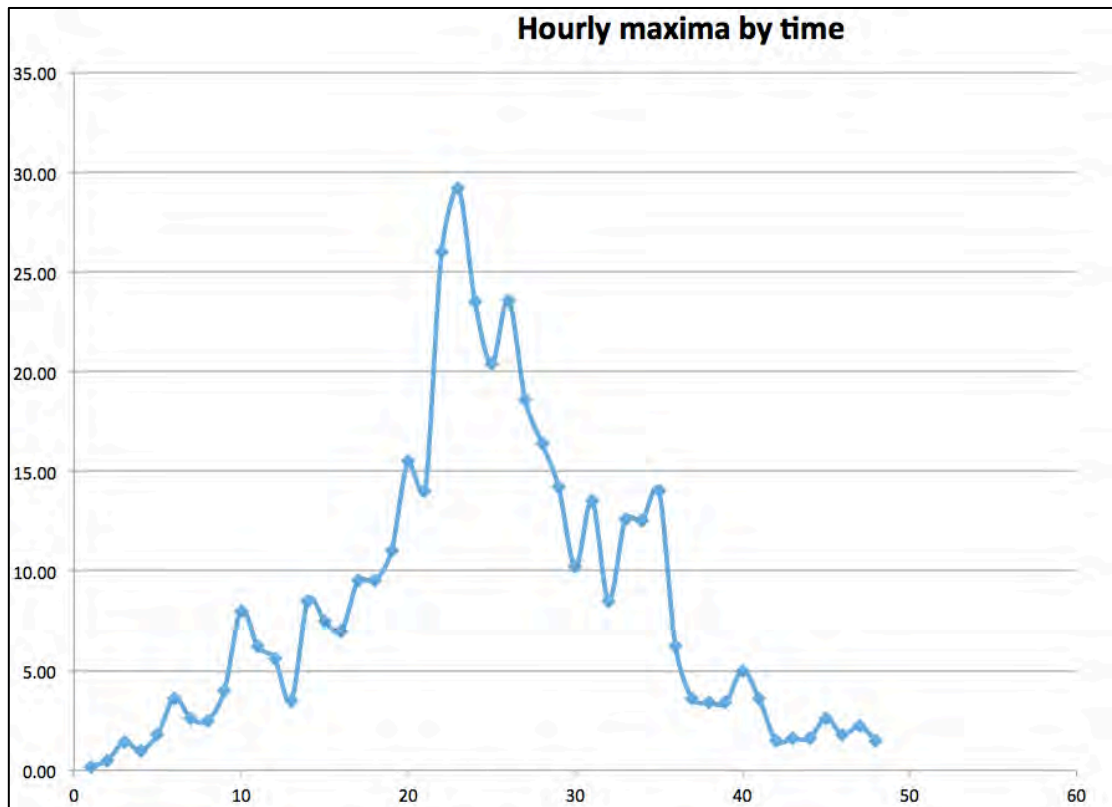
Figure Six. Hourly maxima rainfall accumulations for the 11th-12th June 2018 event. This suggests a fairly simple storm profile. While the main storm event is around 24 hours long there were significant tails resulting in a total rainfall accumulation covering around 30 hours.

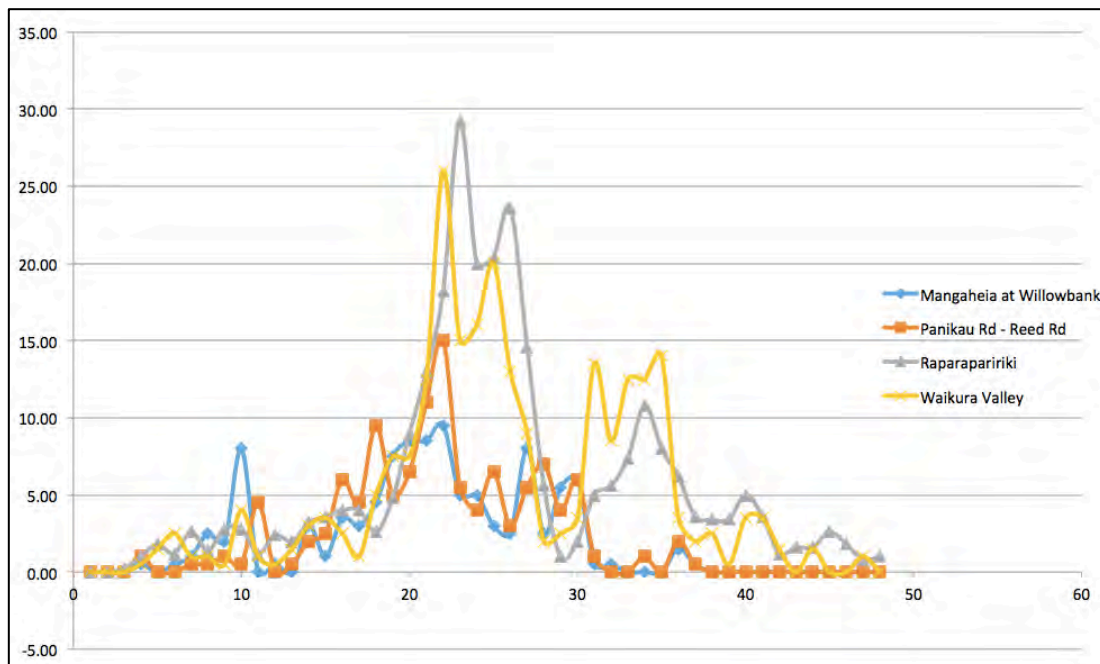
Figure Seven. Plot of the hourly rainfall accumulations for the two heaviest rainfall gauges (Raparapaririki-RIP) and Waikura Valley compared with Panikau-Reed Road and Mangaheia at Willowbank. The Panikau-Reed Road gauge had a short peak of 15mm in one hour while the Mangaheia gauge did not go above 10mm.

When it is further unpacked by plotting 4 key sensitive gauges over the duration of the storm, it indicates that peak rainfall accumulations occurred at two rain gauge sites, Raparapaririki (RIP) and Waikura (**Figure Seven**).

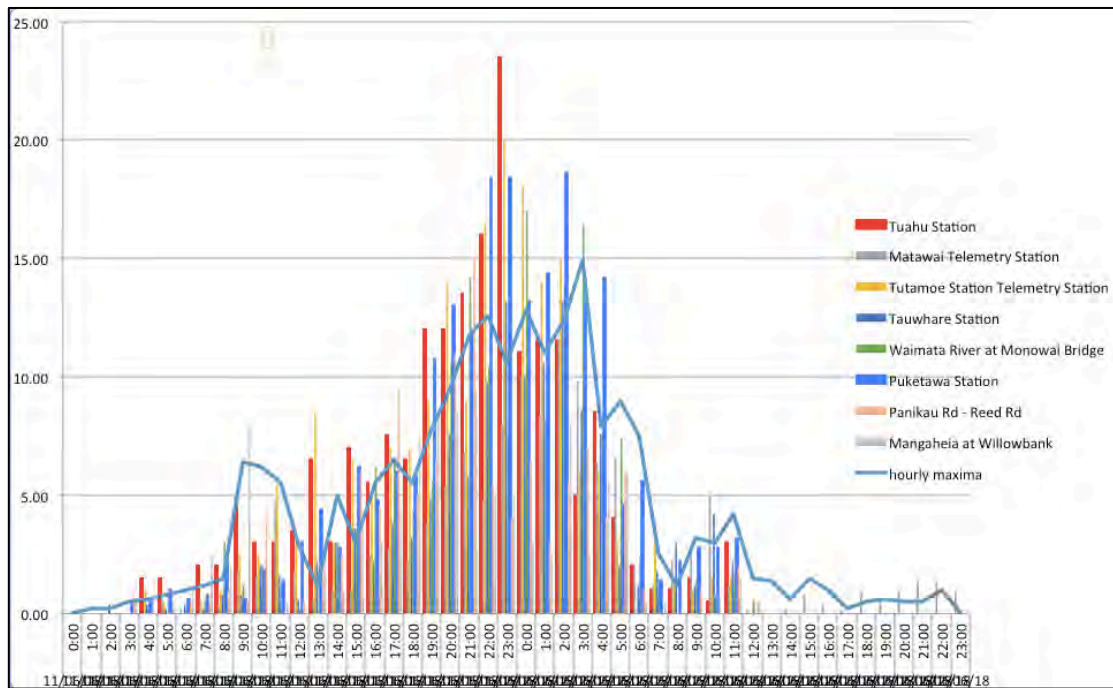
Figure Ten. Plot of all Waipaoa catchment rain gauge accumulations plotted as an aggregated hourly maxima compared with bordering gauges in adjacent catchments.

Both Hika and Caesar Road are on the eastern side of the catchment and suggested that elevated rainfall accumulation may have been from the east. Hence the hourly maxima for the Waipaoa gauges have been compared with adjacent gauges from the Waimata, Pouawa, Pakarae Uawa and Waipuu catchments (**Figure Ten**).

This indicates that, indeed, rainfall accumulations were higher in the bordering catchments in the north and east with Tuahu Station having a maxima of just under 25mm while Tutamoe, Tauwhare, and Puketawa Stations, and Waimata at Monowai all had peak hourly accumulations approaching 20mm (**Figure Eleven**). The 1 hour, 12 hour and 24 hour rain gauge accumulations for all gauges are shown in **Table One**.

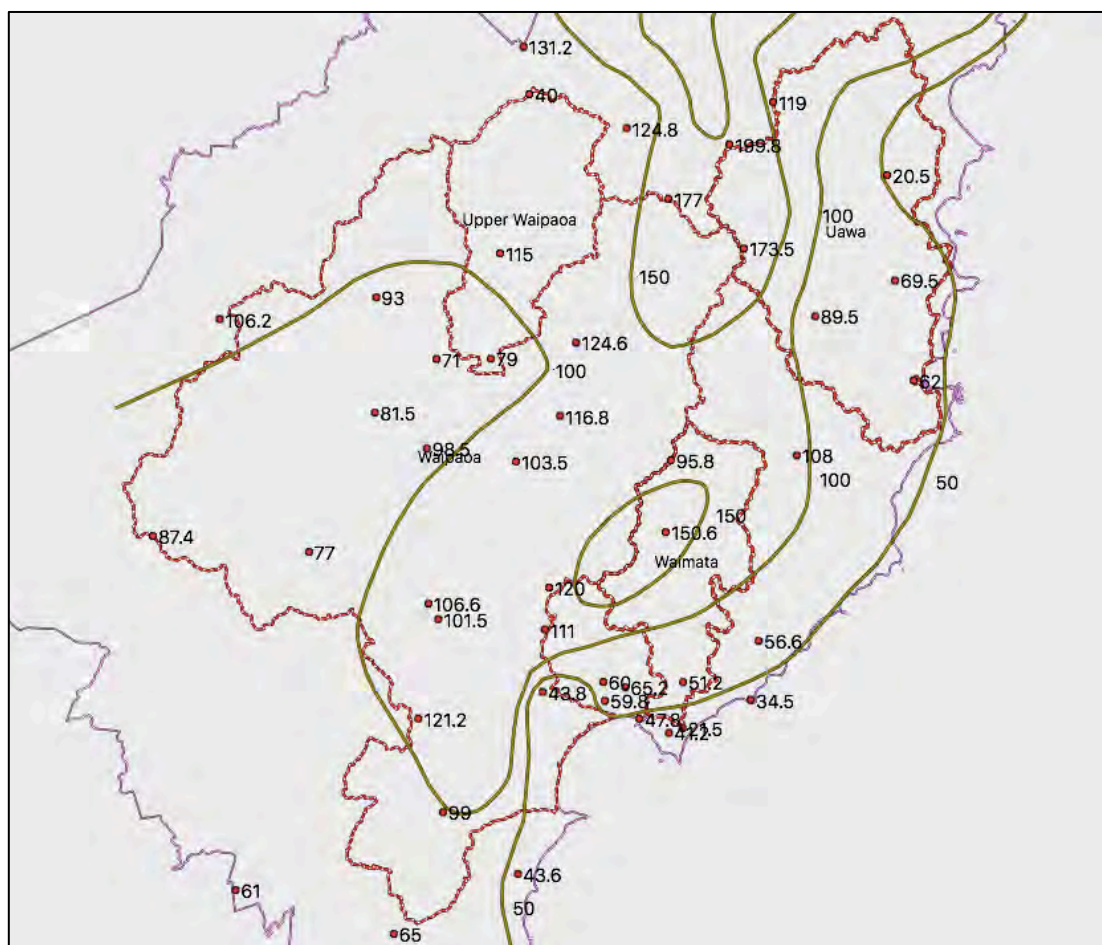
Figure Eleven. Rainfall isopleth of southern Tairāwhiti showing the Waipaoa, Waimata, and Uawa Catchments.

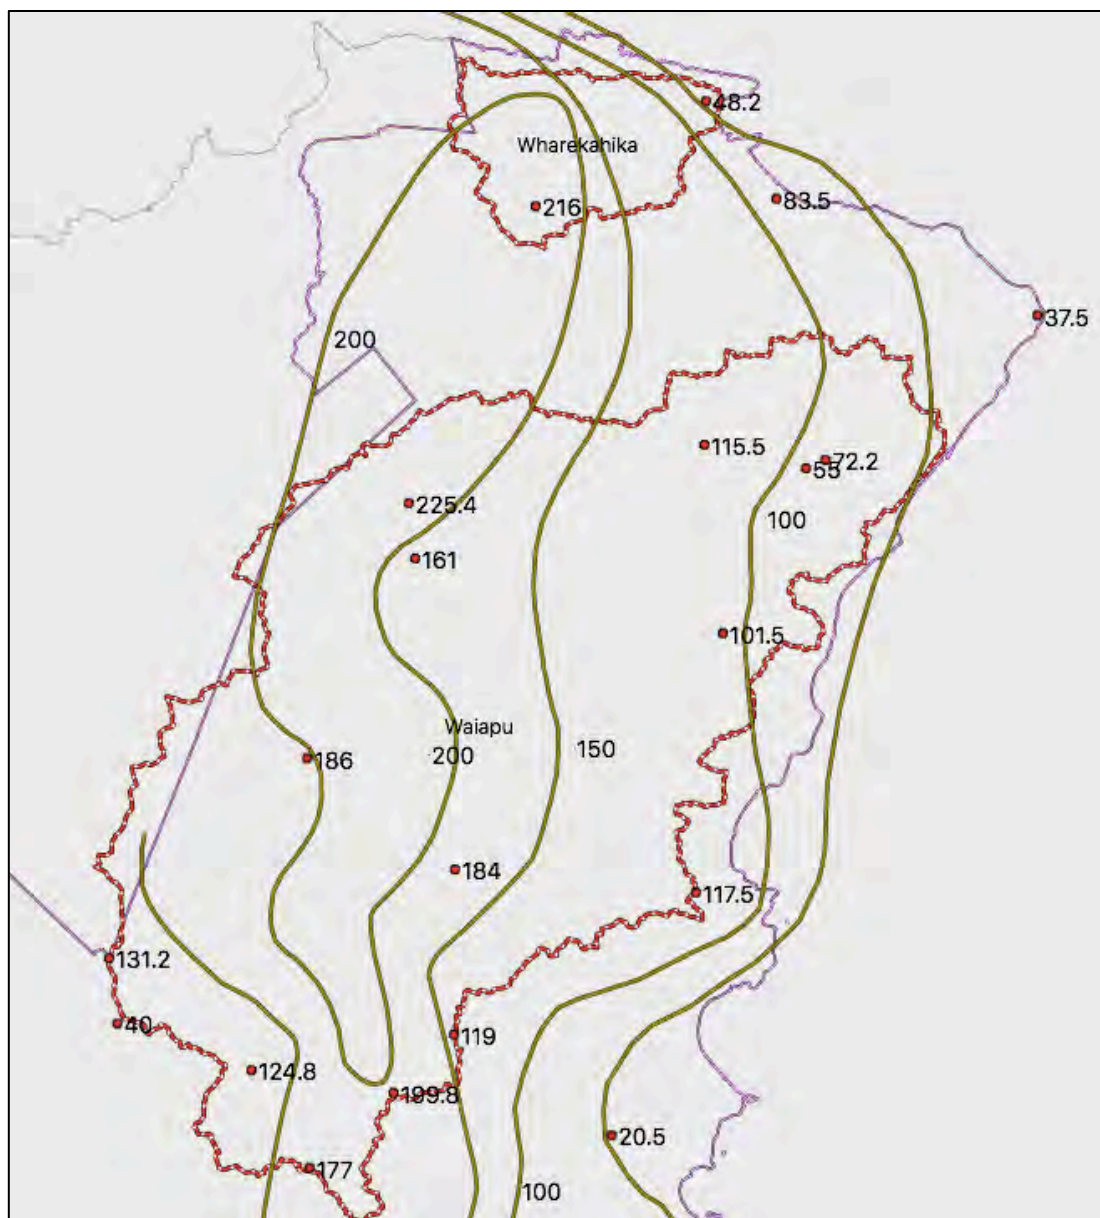
Figure Eleven. Rainfall isopleth of northern Tairāwhiti showing the Waiapu and Wharekahika Catchments [Note that heavy rain also accumulated in the Waikura and Whangaparaoa Catchments which discharge west into the Bay of Plenty].

As noted above, the northern catchments received considerably more rainfall than in the south with the Waiapu and Wharekahika catchments experiencing heavy rain (see **Figure Seven above** and **Figure Eleven below**). The Raparapaririki (RIP) rain gauge in the headwaters of the Waiapu Catchment had the highest rainfall accumulation with 225.4mm of rain falling over the 24 hours of the storm. The Waikura rain gauge had a 24 hour accumulation of 216mm (**Table One**).

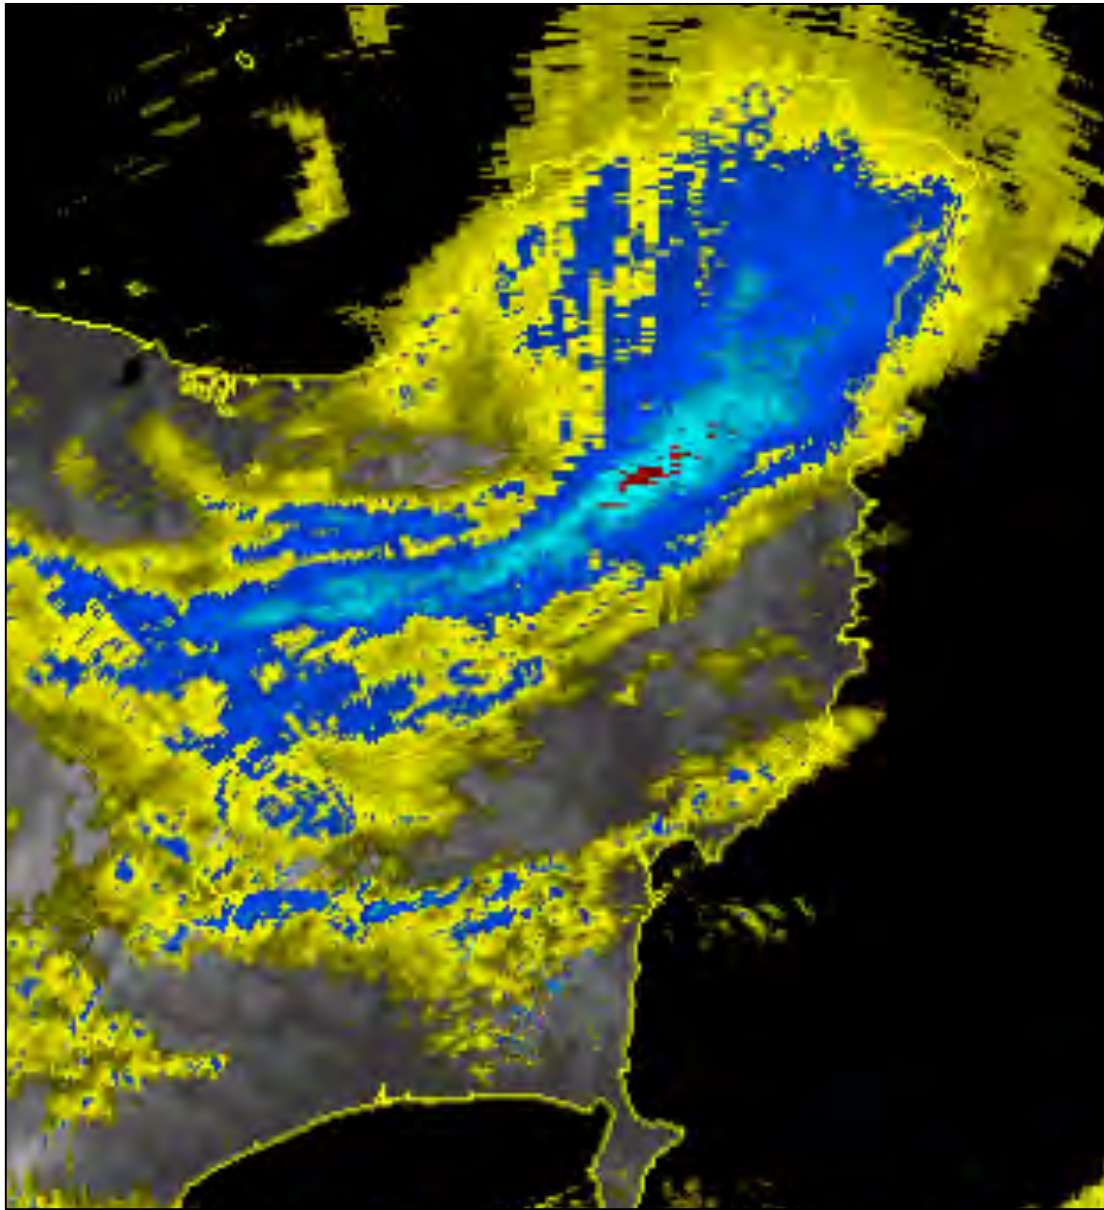
Figure Twelve. Rain radar image showing the storm sweeping south east across the Raukumara Ranges with the bright spots associated with intense rain in the head of the Waiapu. A narrower band of heavy rain is event in the headwaters of the Waipaoa and adjacent catchments.

Also evident on this image are the bright (red) cells located in the vicinity of the Raparapaririki (RIP) rain gauge (**Figure Twelve**). A narrow band also extends to the south at the headwaters of the Waipaoa while a second narrow band across the Wharerata. The majority of the Uawa Catchment appears largely clear of significant rain.

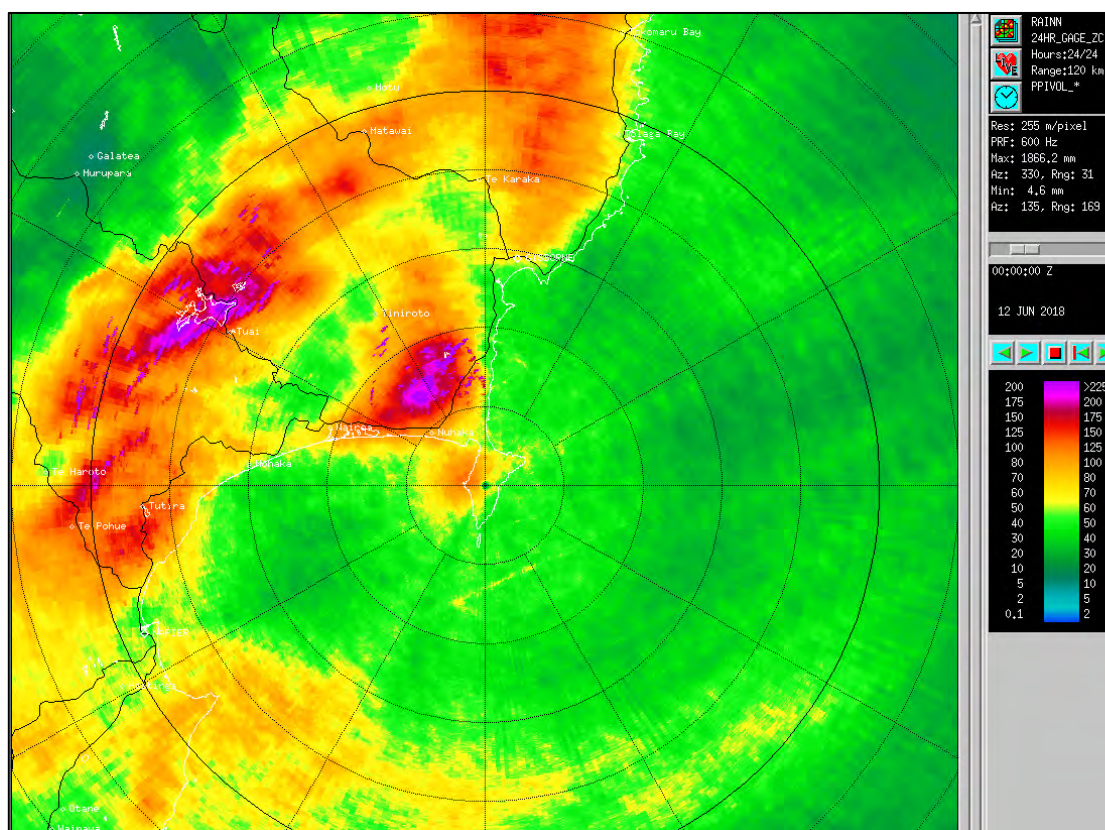
Figure Thirteen. Rain radar image showing the 24 hour rainfall accumulation for the region for the period before midday on the 12th June (NZ time). This shows a significant accumulation over the Wharerata east of Mangapoike, north of the Waipaoa catchment and with a small cell south of Matawai.

A second image dated at 00.00 hours on the 12th UTC time (midday 12th NZ time) shows the 24 hour accumulation for the entire storm (**Figure Thirteen**). This that a band of relatively heavy rain covered the entire region north of Te Karaka and particularly over the Wharerata where pixel densities suggest rainfall accumulations of between 150 and 200mm over 24 hours. This image does not extend into the Waiapu and has not been geo-corrected.

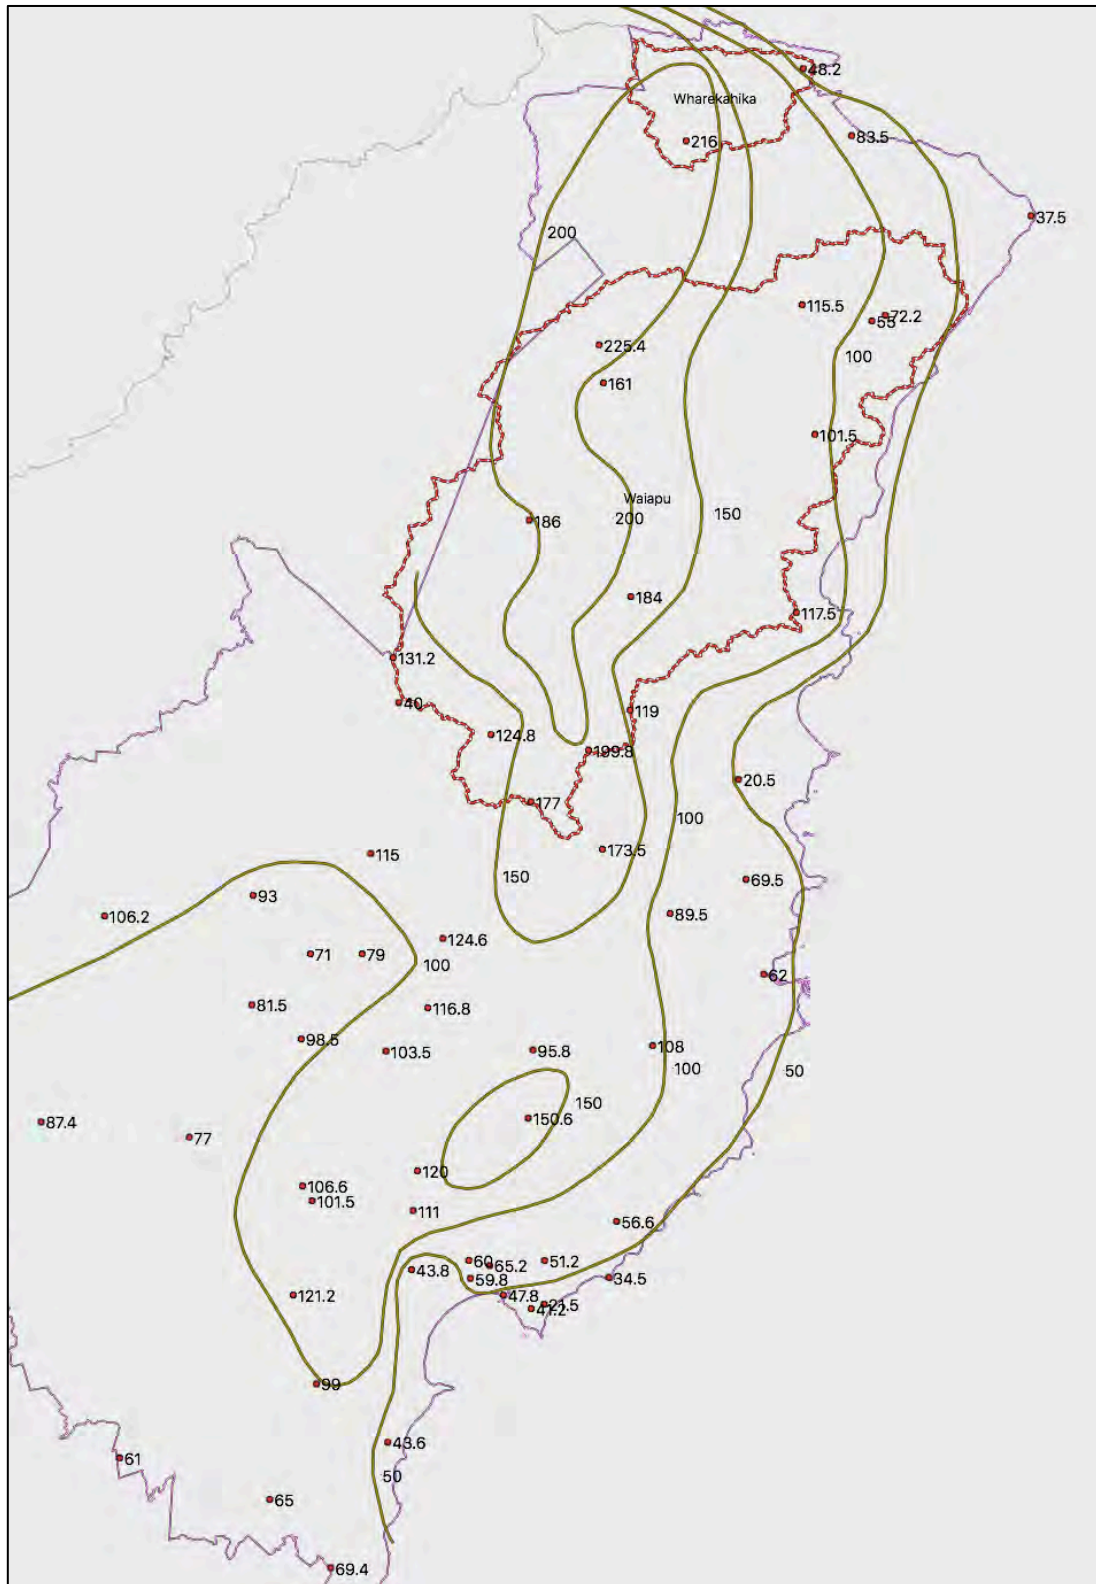
Figure Thirteen. Twenty four hour rainfall accumulations for the Tairāwhiti region from 1pm on the 11th June to Midday on the 12th June.

As noted above, the heaviest rainfall accumulations were in the Waiapu and catchments further north. In the far north rainfall of 216mm at Waikura dropped off to 48.2mm at Hicks Bay. The highest rainfall for the storm occurred at the northwestern edge of the Waiapu Catchment at Raparapaririki rain gauge. Rainfall dropped off to 101mm at Ruatoria and 55mm at the Poroporo Fire gauge. This band of rain extends to the southern eastern end of the Waiapu Catchment with the Puketawa rain gauge recording 199.8mm, Tutamoe 177mm, and Fernside 199mm over 24 hours. East of these gauges, the Mata gauge at Pouturu recorded 184mm while 117.5mm fell at Te Puia.

At the western edge of the Uawa Catchment, the Tauhu rain gauge recorded 173.5mm over 24 hours while the Mangaheia and Willowbank rain gauge recorded 89.5mm. The Hikuwai River at Willowflat recorded 89.5mm while Uawa River at SH 35 bridge recorded 60mm over 24 hours.

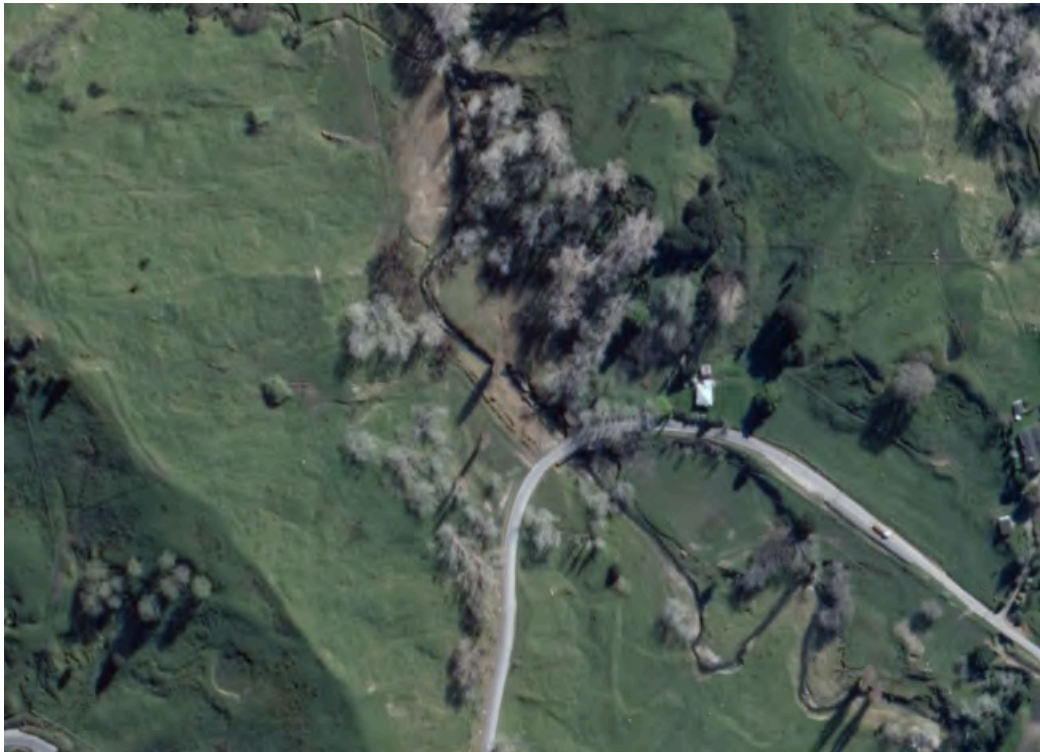
Figure Fourteen. Google imagery of Uttings bridge dated 17th August 2017 showing the pre-event condition of the stream. The bright areas above the bridge are where flooding during ex-Cyclone Cook at Easter 2017 caused some sediment mobilisation in the stream.

Google Earth imagery of Uttings Bridge dated 17th of August 2017 and 25th August 2018 are shown in **Figures Fourteen** and **Fifteen** below. These indicate the extent of sediment deposited at Uttings Bridge during the storm. There are bright areas above the bridge in the August 2017 arising from flooding during ex-Cyclone Cook at Easter 2017 which caused some sediment mobilisation in the stream.

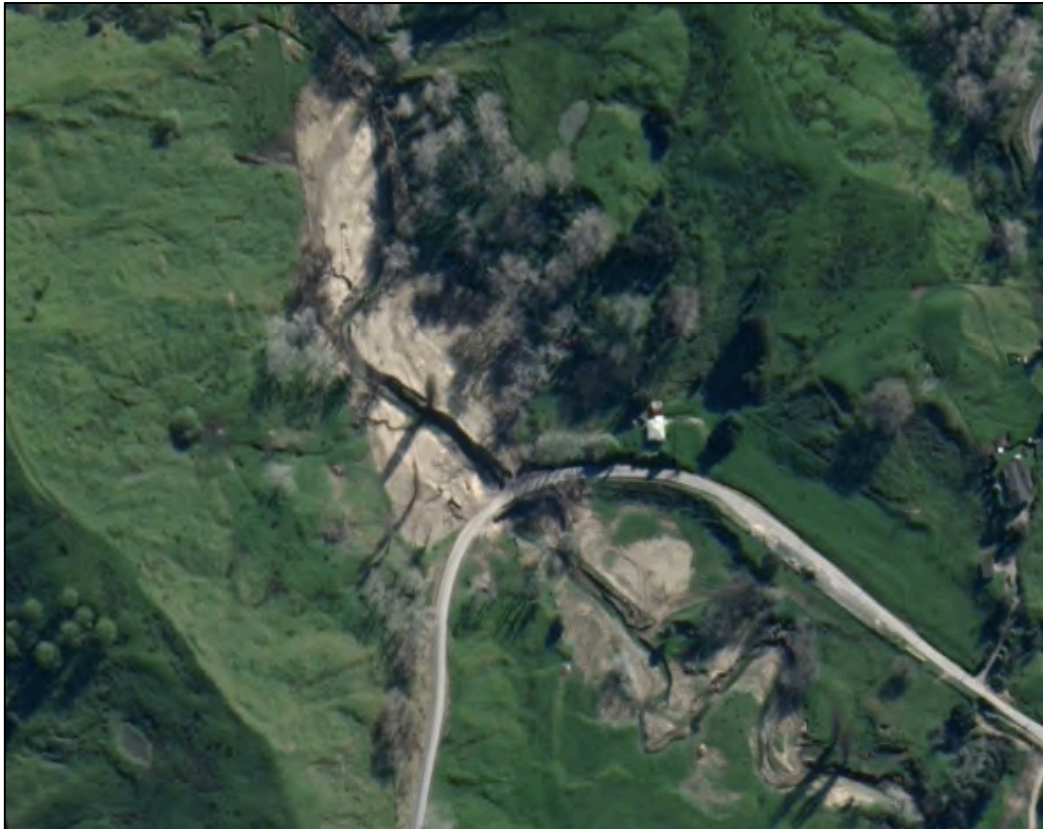
Figure Fifteen. Google imagery of Uttings bridge dated 25th August 2018 showing the extend of sediment deposited during the 11th-12th June 2018 event.

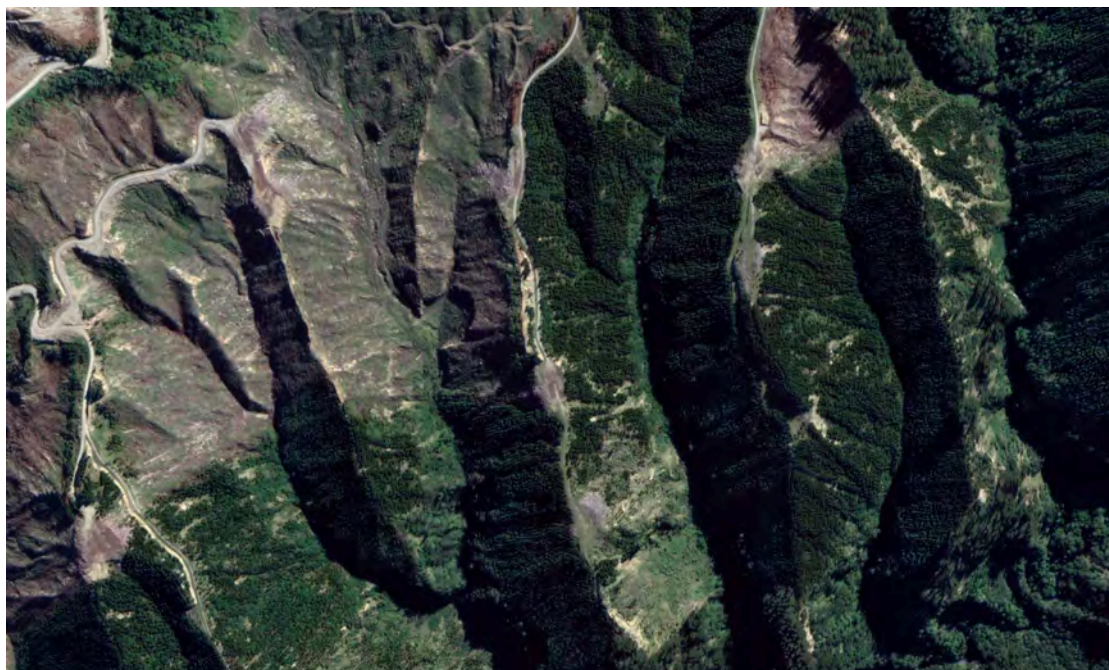
Figure Sixteen. Google Earth image of the middle of Wakaroa Forest dated 17th August 2017 showing no significant slope stability issues. In particular the skid site at bottom left and top right.

Google Earth images for part of Wakaroa Forest (Hikurangi Forest Farms) dated 17th August 2017 and the 25th August 2018 have been examined to assess the impact of the storm in the forest and these have also been compared with the aerial photography Gisborne District Council acquired over the 2017-2018 summer.

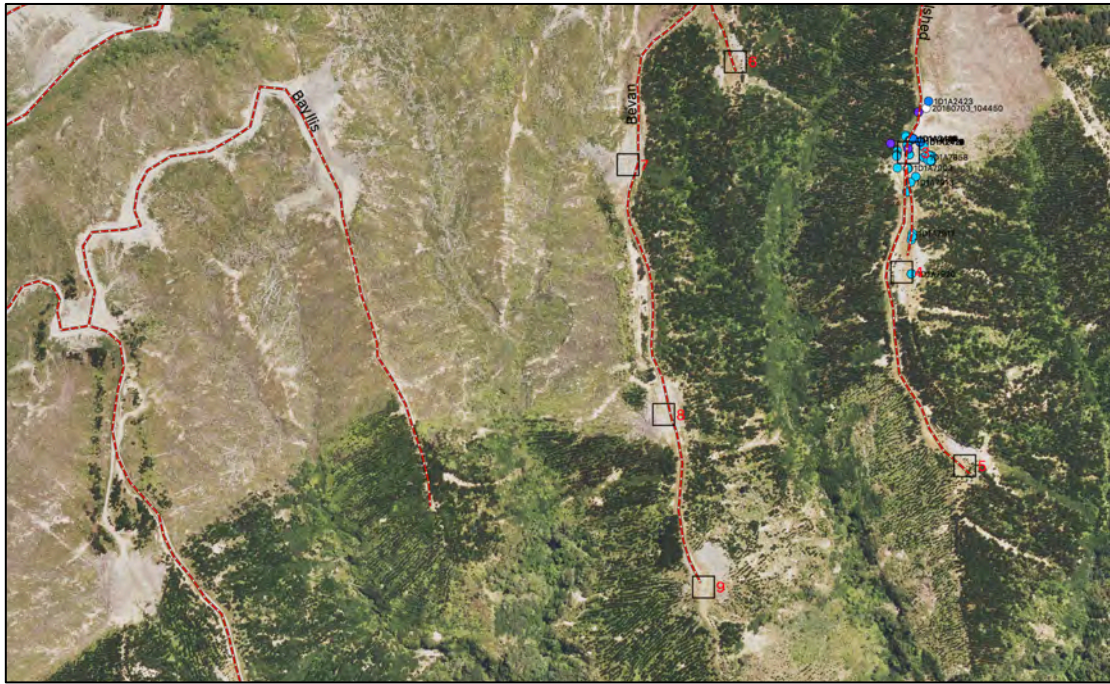
Figure Seventeen. Aerial image of the same area as Figure Sixteen (image acquired summer of 2017-2018) showing the skid site bottom left with no landslide activity and no evidence of fresh slipping elsewhere.

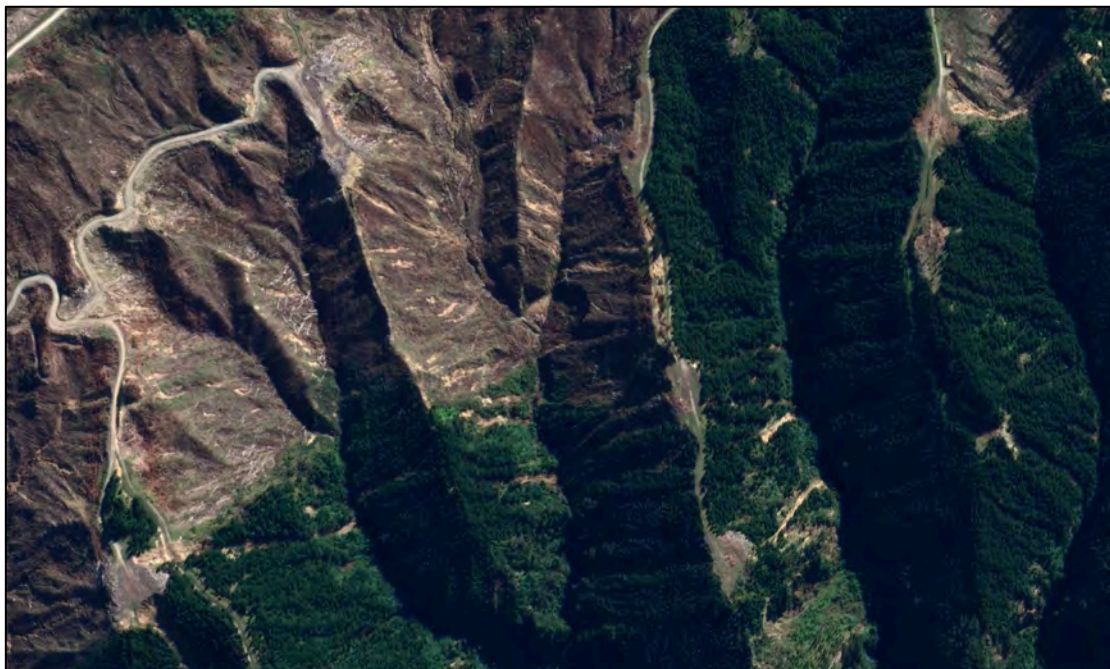
Figure Eighteen. Google Earth image of the Wakaroa Forest dated 25th of August 2018 showing the bright areas where collapses have occurred. A collapse from the western side of the landing at top right is not well evident due to being in shadow. It is notable that only a few “mid slope” type landslides have occurred.

Particularly evident from the 25th August 2018 image are the presence of landslides originating from skid sites, spur lines or roadways. This is consistent with the on-the-ground observations of damage and the probable causes of the slope failures.

A key feature of the image is that there is little damage within closed canopy forests or 10 year-old trees. The exception has been where landing collapses have caused debris flows which have migrated down slope to the stream bed and from there downstream. The presence of birds-nests or harvest waste evident in Figures Sixteen and Seventeen would have exacerbated the force of the debris flows.

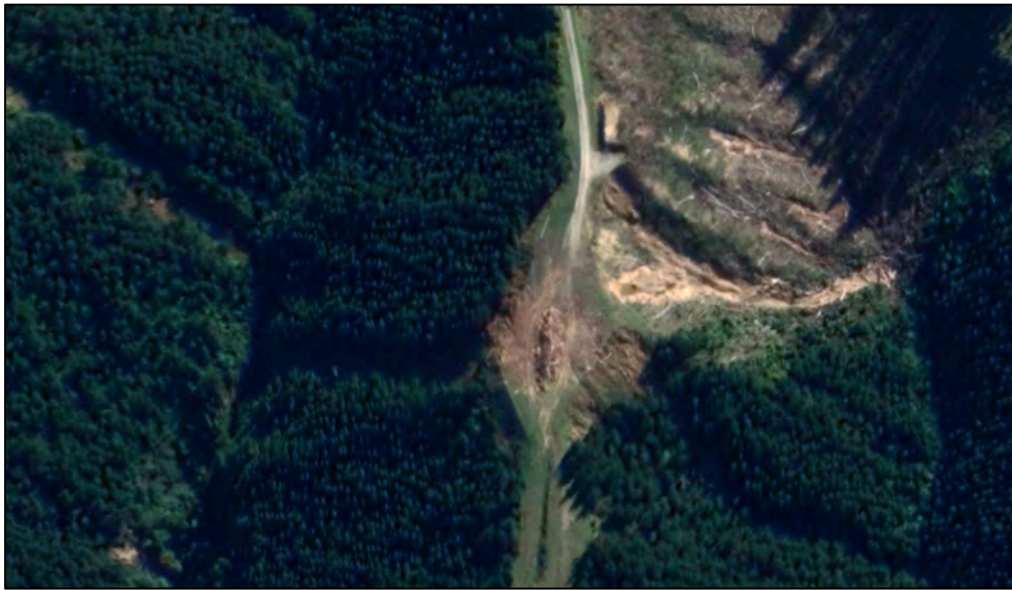
Figure Nineteen. Detail of Figure Eighteen showing the debris flow from the top right landing (in shadow) on the lefthand side of the landing. Also more evident in the image are the slope failures generated on the righthand side of the landing.

Figures Nineteen and **Twenty** below show details of the top right and bottom left landing sites described above respectively.

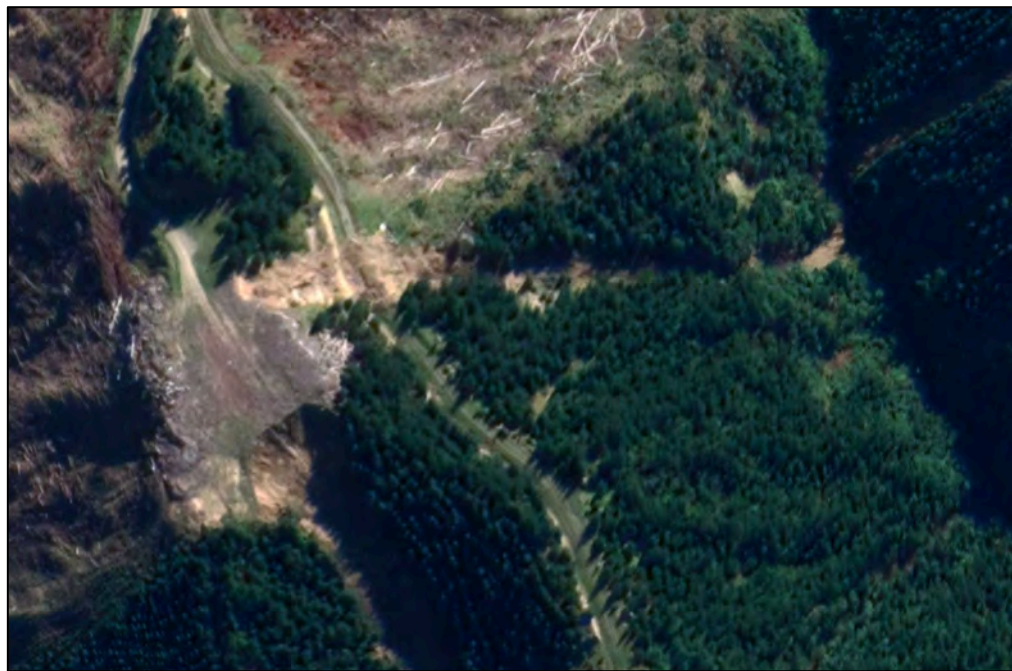
Figure Twenty. Detail of Figure Eighteen showing the multiple collapses of the bottom left landing.

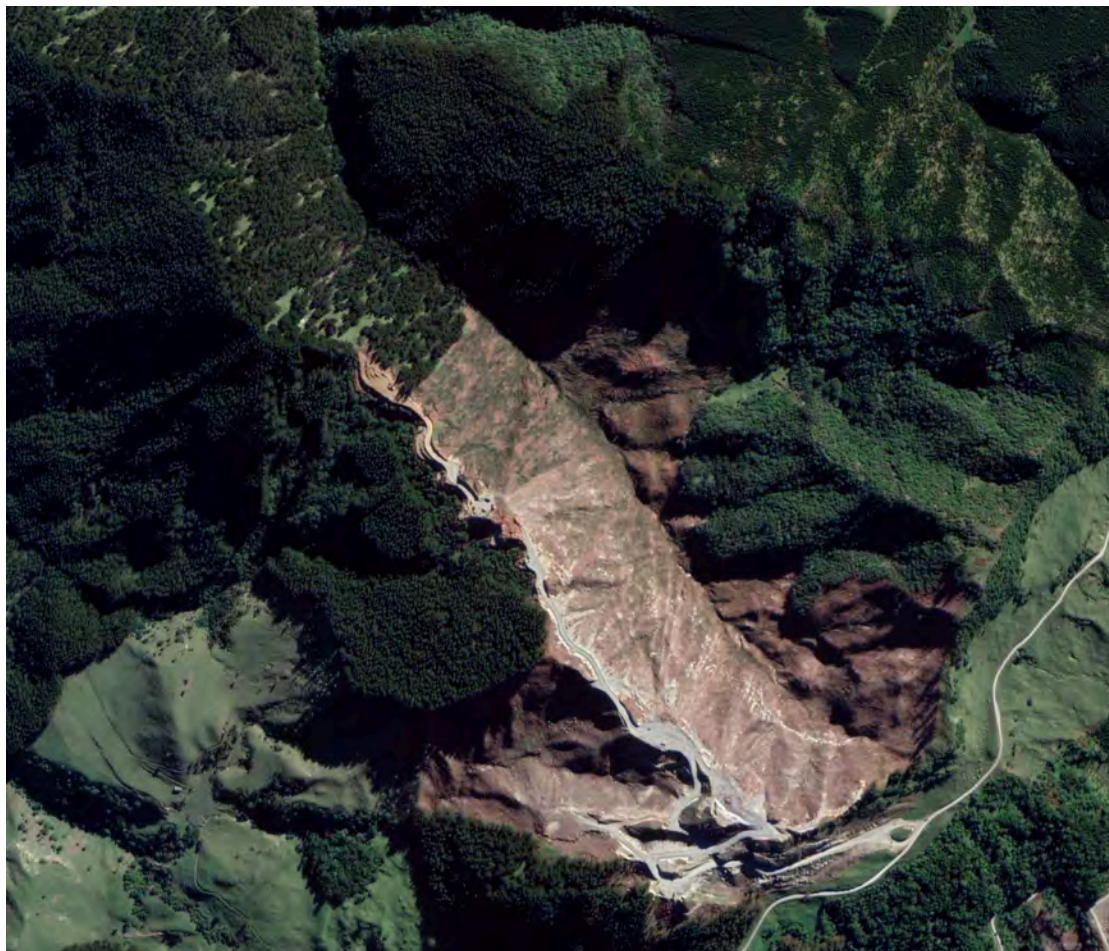
Figure Twenty One. Satellite image of Makiri Forest dated 17th August 2017 showing prestorm condition of the forest. Striations evident on the harvested slope are the result of dragging by cable haulers.

The Makiri Forest is immediately north of Wakaraoa Forest and is immediately north of the Wakaraoa rain gauge which reported 95.8 mm over 24 hours during the storm of 11th 12th June 2018. The condition of Makiri Forest dated 17th August 2017 is shown in **Figure Twenty One** and shows the landscape in

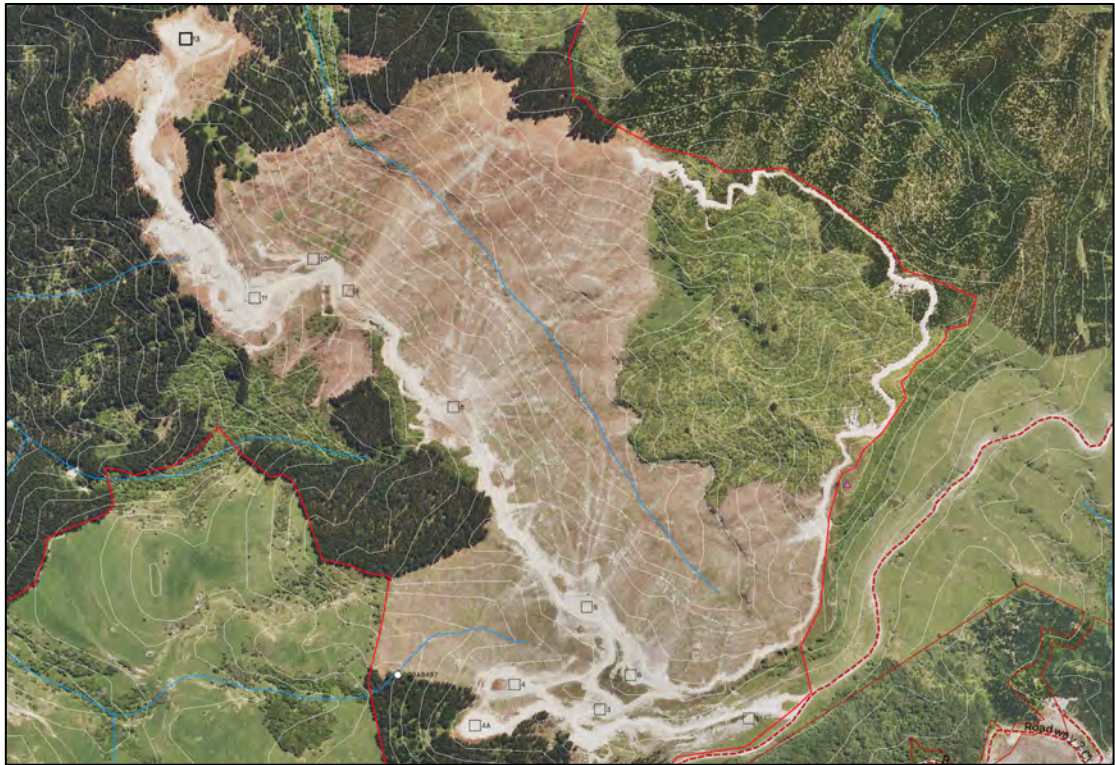
Figure Twenty Two. Aerial Imagery acquired over the summer of 2017-2018 showing the extension of the main forestry road to the Northwest but also shows no sign of landsliding activity.

good condition, albeit with scarring from cable hauler activity. Gisborne District Council aerial imagery acquired over the summer of 2017-2018 shows the development that has occurred after August 2017. This shows that roadway development had continued but also shows that there's been no landsliding up until summer 2017-2018 (**Figure Twenty Two**).
