Analysis of Rainfall for the storm events of 11th-12th June. East Coast Tairāwhiti

27 November 2018

Dr Murry Cave

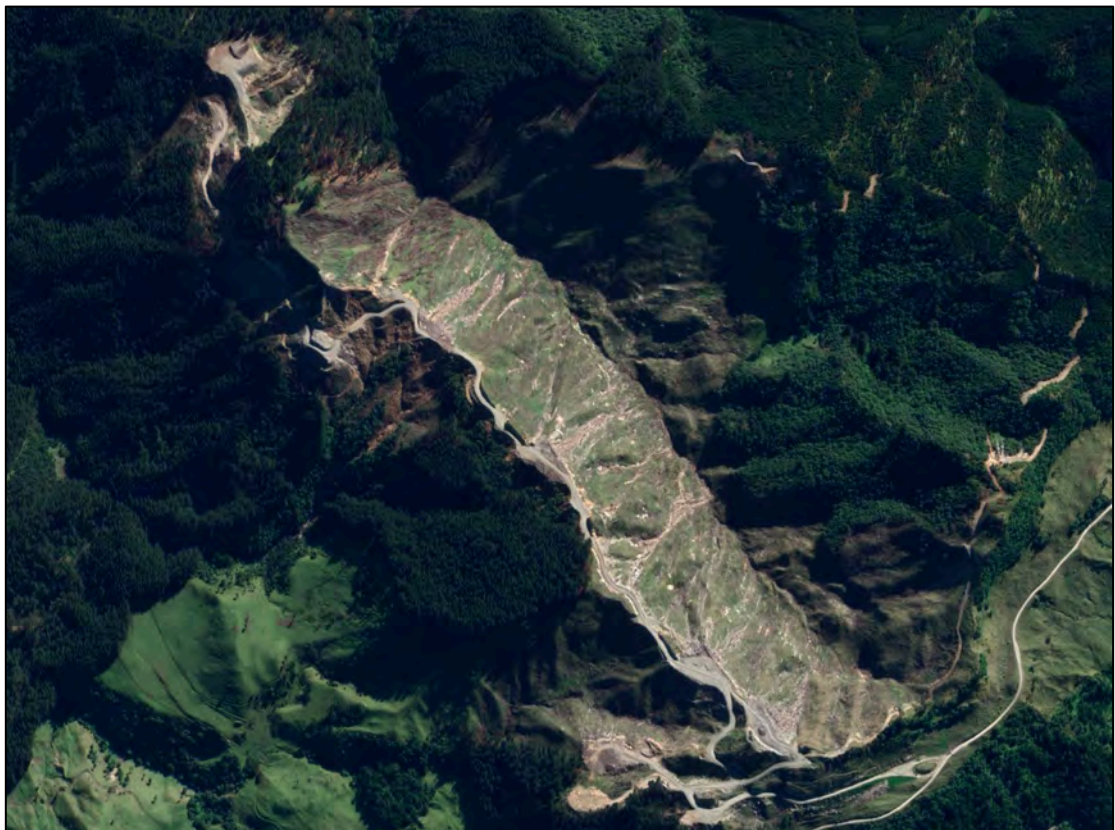
Figure Twenty Three. Satellite Imagery dated 25th August 2018 showing extensive landsliding activity since the summer of 2017-2018 imagery.

Satellite imagery dated 25th August 2018, however, shows that significant landsliding has occurred since the summer of 2017-2018 (**Figure Twenty Three**). Notably there has been no slope failures from intact forest except for two failures from a forestry road in the north of the image. A detail of **Figure Twenty Three** is shown in **Figure Twenty Four** and shows that the landslide originated from the forestry road or from landing collapses which has caused the downslope mobilisation of harvest residues.

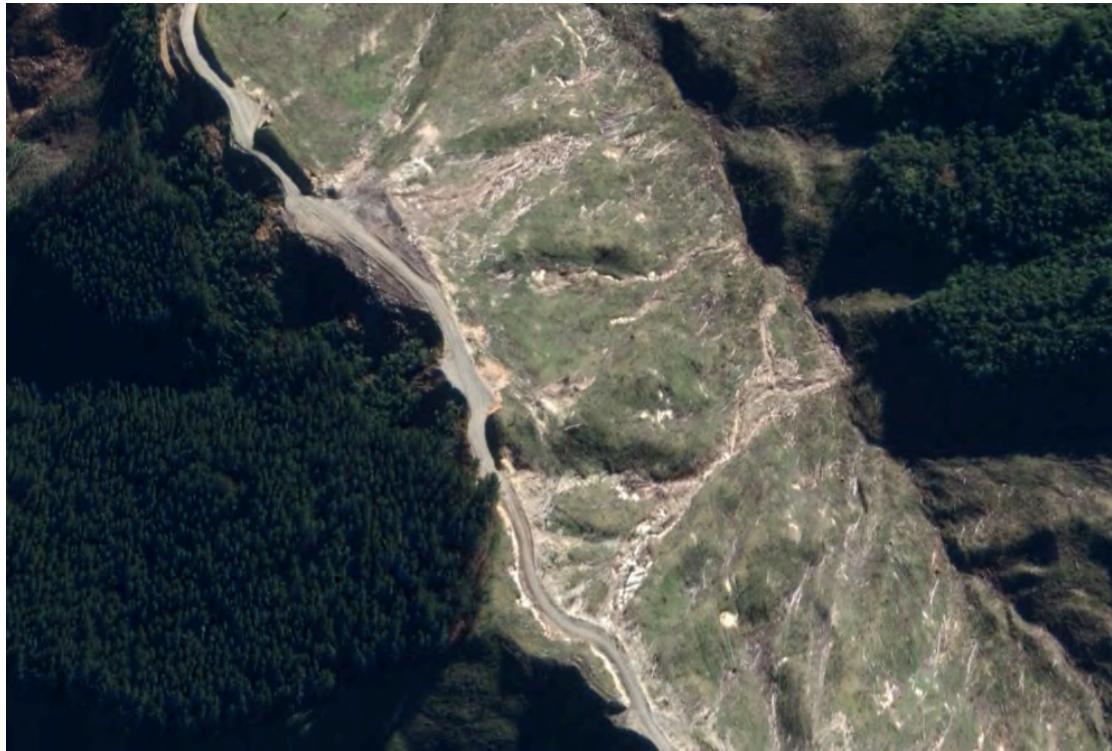
Figure Twenty Four. Detail of figure Twenty Three showing the main forestry road in Makiri Forest with significant slope failures originating from the roadway and in the top of the image from a landing with harvest waste discharged downslope to the waterway.

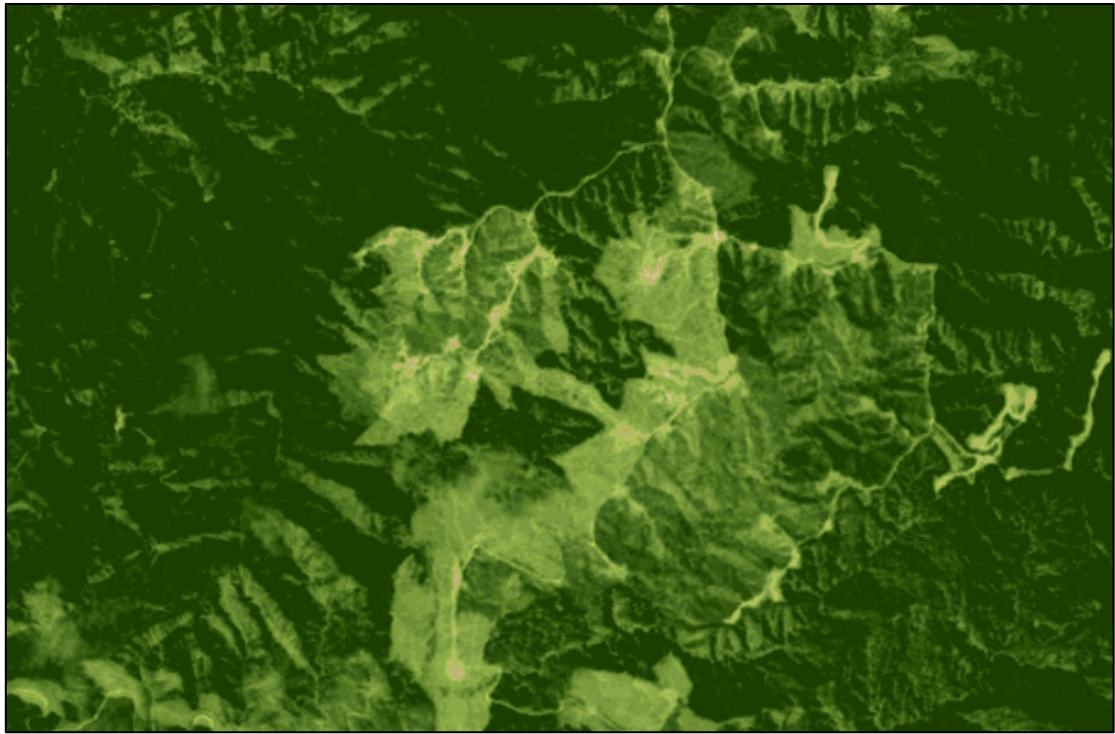
Figure Twenty Five. Sentinel 2 NDVI image of Waituna forest dated 24th of April 2018 prior to the Queens Birthday and 11th-12th June storms. Dark areas are intact forest, bright areas are roadways and skid sites, pale green are recent harvest areas while areas in between the pale and dark green are earlier harvest areas.

The first image used was taken on the 23rd of April UTC time which is 24th of April 2018. The image, although low quality shows only limited a small number of slope failures in the recent harvest area (**Figure Twenty Five**). The second image is dated 6th June NZ time and shows an increase in reflectance indicating that significant damage occurred in the 3rd-4th June Queens Birthday Storm (**Figure Twenty Six**). Since, however, JNL only reported an event after the 11th-12th June event, it is presumed that material was mobilised but no significant harvest was discharged out of the forest until the 11th-12th June event.

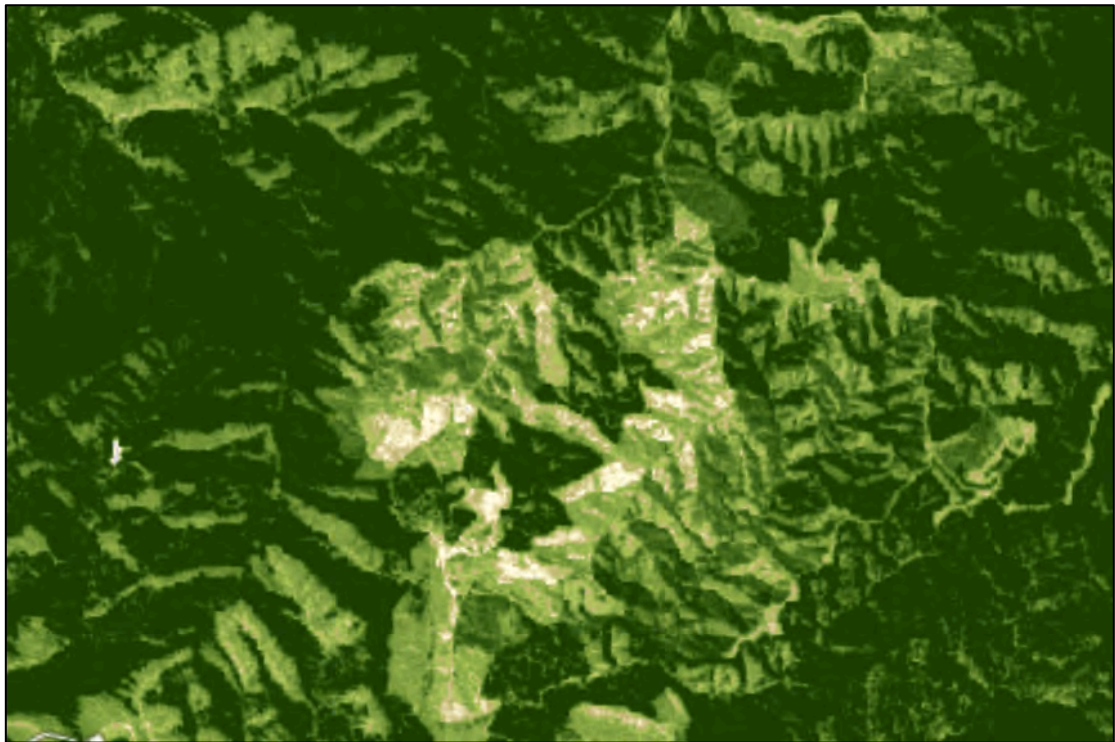
Figure Twenty Six. Sentinel 2 NDVI image of Waituna forest dated 6th of June 2018 immediately following the Queens Birthday storm. Evident are the new highly reflective areas indicating areas of bare earth after slips.

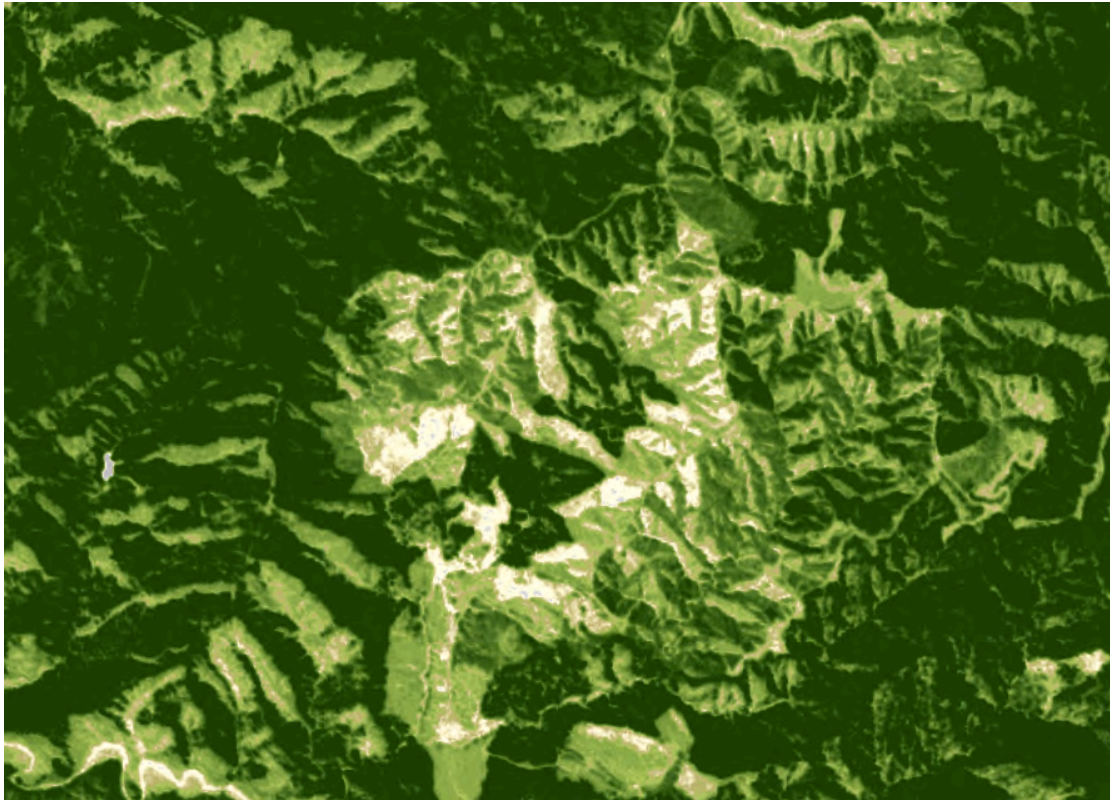
Figure Twenty Seven. Sentinel 2 NDVI image of Waituna forest dated 16th of June 2018 NZ time showing the enlargement of highly reflective areas as well as additional areas of reflectance, particularly at top middle-left.

An image dated 16th June New Zealand time shows a further change in the area of reflectance over the 6th of June largely through enlargement of reflective areas evident on the 6th of June. Some new areas of high reflectance are evident in the top middle-left of the image.
