Project Reference: 13364 Review  
25 August 2021

## **TE PANUKU TU**

### **PHASE I AND II ENVIRONMENTAL SITE MANAGEMENT REVIEW**

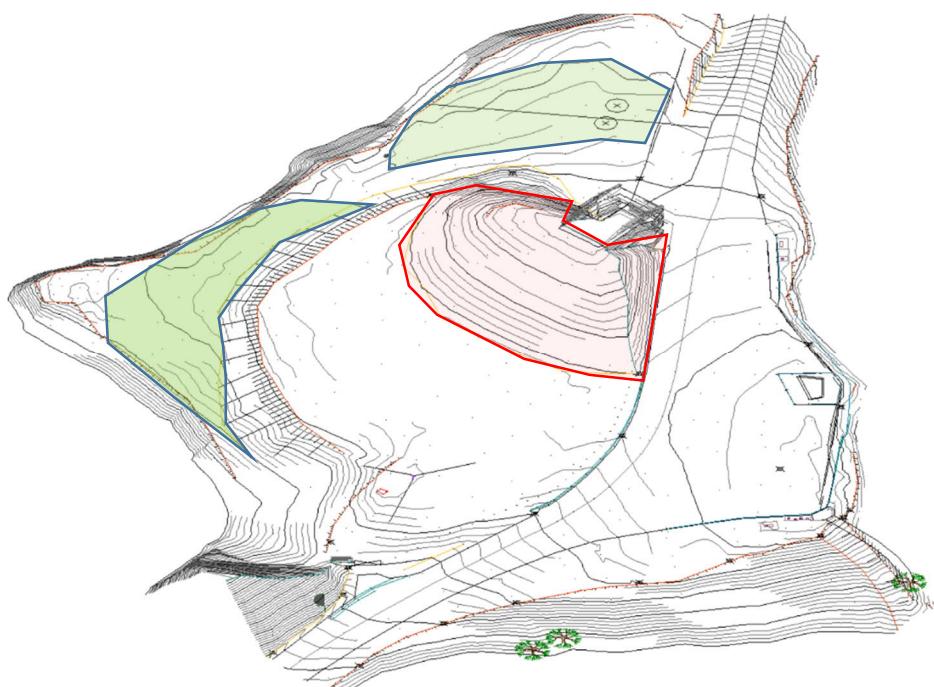
Additionally, we understand that in addition to landscaping works, further cut-to-fill earthworks are planned with remaining fill material (adjacent to the gun embankment) removed and placed in 2 areas that require infill (see fig 1 below). DSI sampling (up to 2.2m bgl) of this material shows that it meets NES SCS for a recreational scenario and are below the Hawkes Bay Region Background Soil Concentrations, therefore may be re-utilised onsite as planned, and any offsite disposal may be as cleanfill however, it is likely the cleanfill facility will require additional testing to ensure that it complies with their acceptance criteria.

Figure 1: Future cut (red) to fill (green) earthworks.

It is possible that either >25m<sup>3</sup>/500m<sup>2</sup> of soil disturbance, or >5m<sup>3</sup>/500m<sup>2</sup> of soil removal offsite will occur therefore it is recommended that these works proceed under a controlled activity consent obtained from GDC.

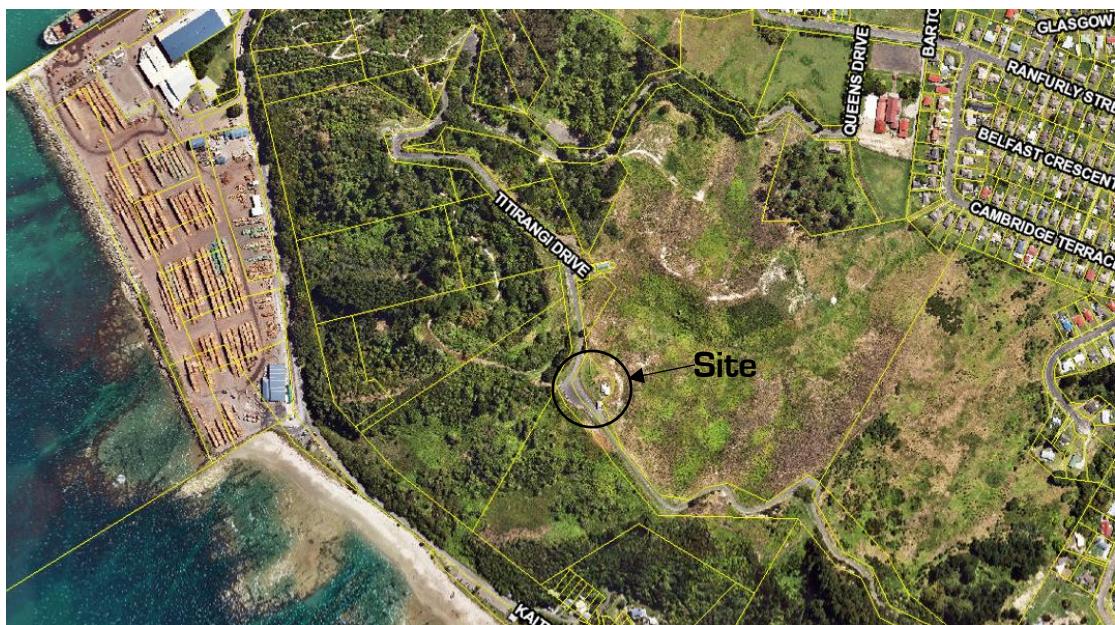
Figure 2: Site location and area of investigation. The legal lot boundaries are shown in yellow. Source Tairawhiti Maps [annotated image].

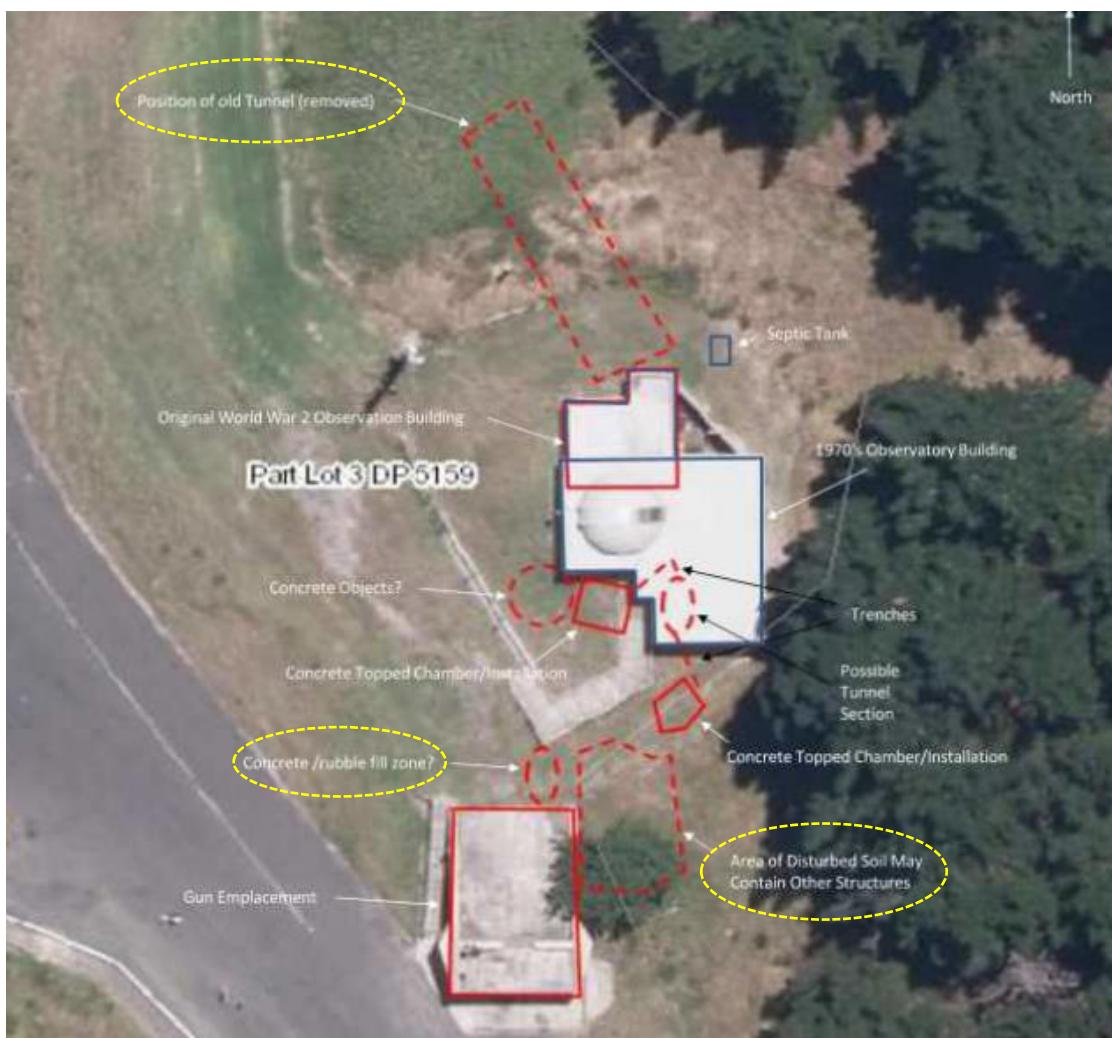
*It appears that a large excavation into the slope was made to construct the gun emplacement which was then backfilled up against its rear, sides (up to 4m thick), and over the top (soil on top now removed). A series of trenches, in-ground chambers and pits were also installed in the ground between the emplacement and the original observation building. Our investigations indicate that newer 1971 section of the observatory extends out to and over ground, which was over ground, which was and in some respects, is still occupied by these features."*

Figure 5: Extract from LDE Geotechnical report (annotated in yellow) showing an interpretation of in-ground features observed from the 1943 image over recent site plan. Note that the image predates forestry clearance on the eastern and northern sides of the buildings.

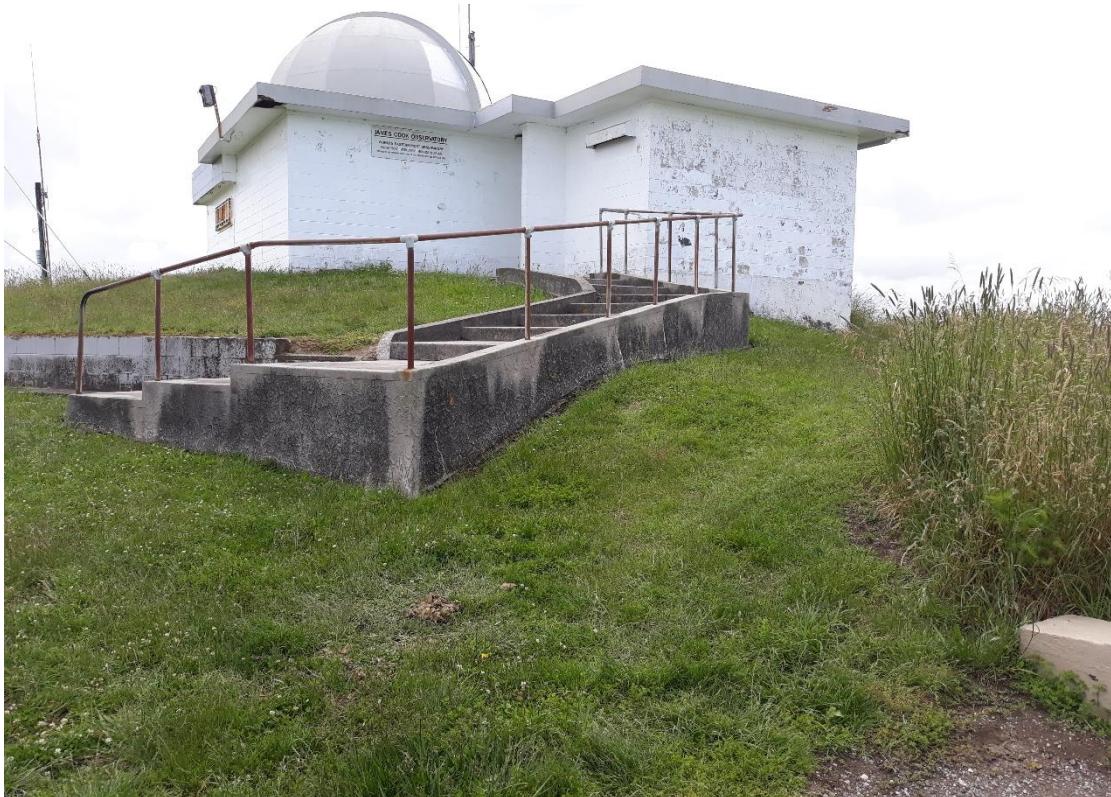
The observatory building is located at the summit of the site (Figure 6), with the gun emplacement located south and below the observatory (Figure 7). The benched grassed area located at the west and northwest of the site has been mowed (Figure 8).

Figure 6: Observatory building located at the summit of Titirangi.

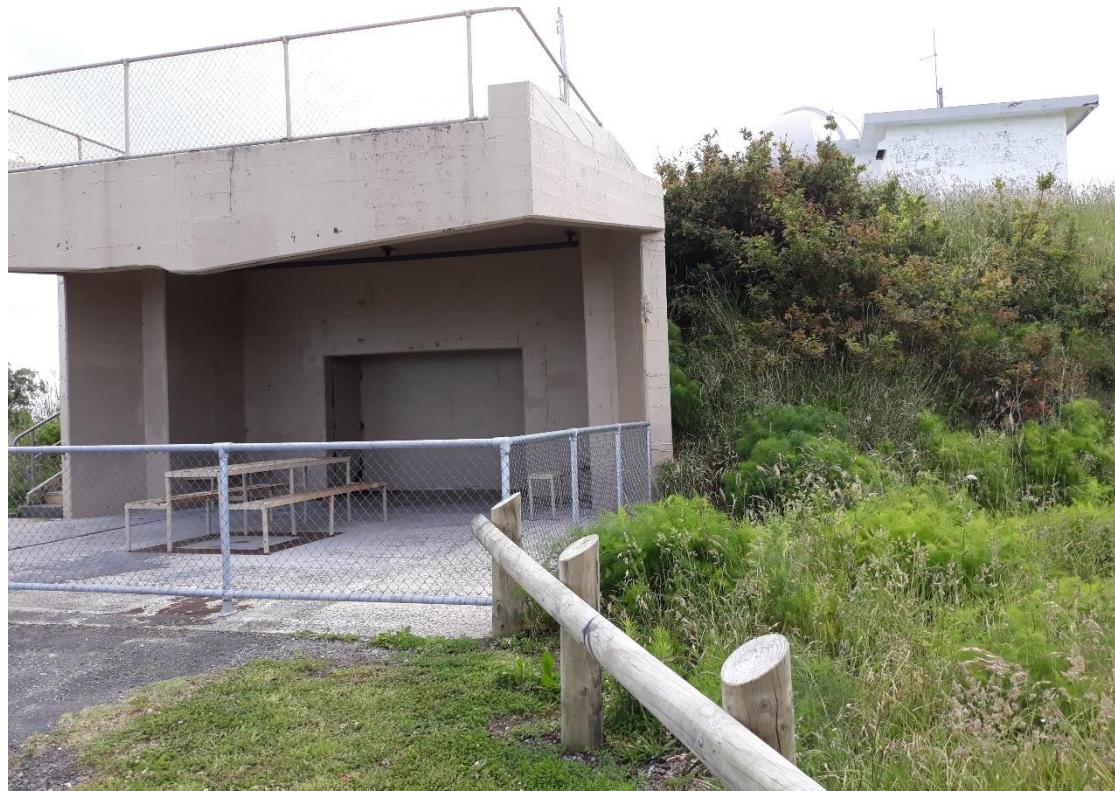
Figure 7: Gun emplacement building.

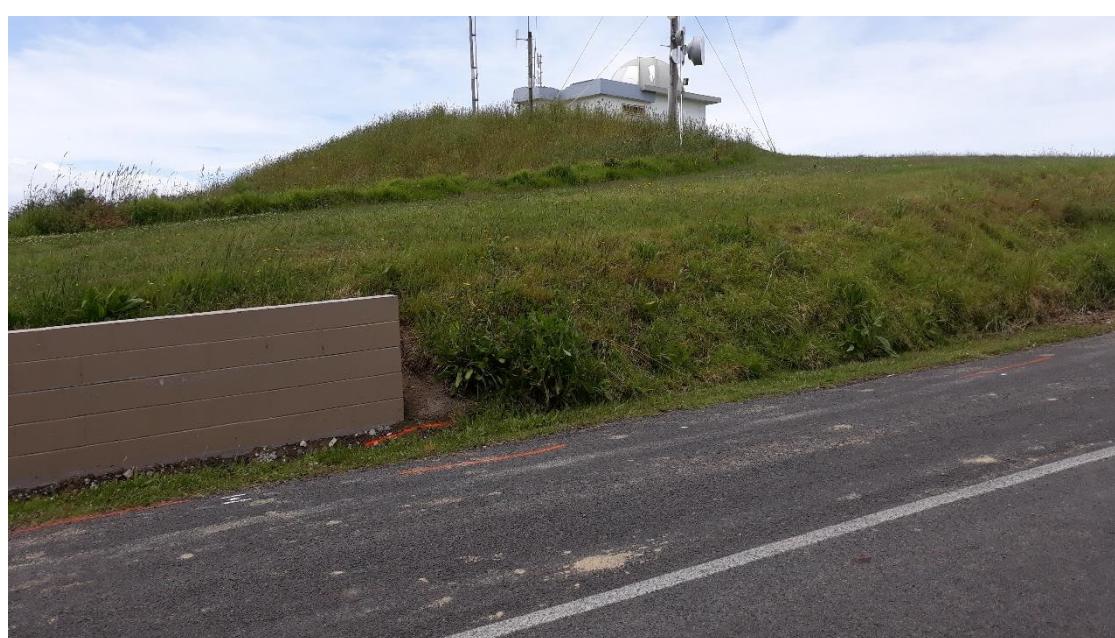
Figure 8: View of site from Titirangi Drive level, facing southeast towards the carpark area

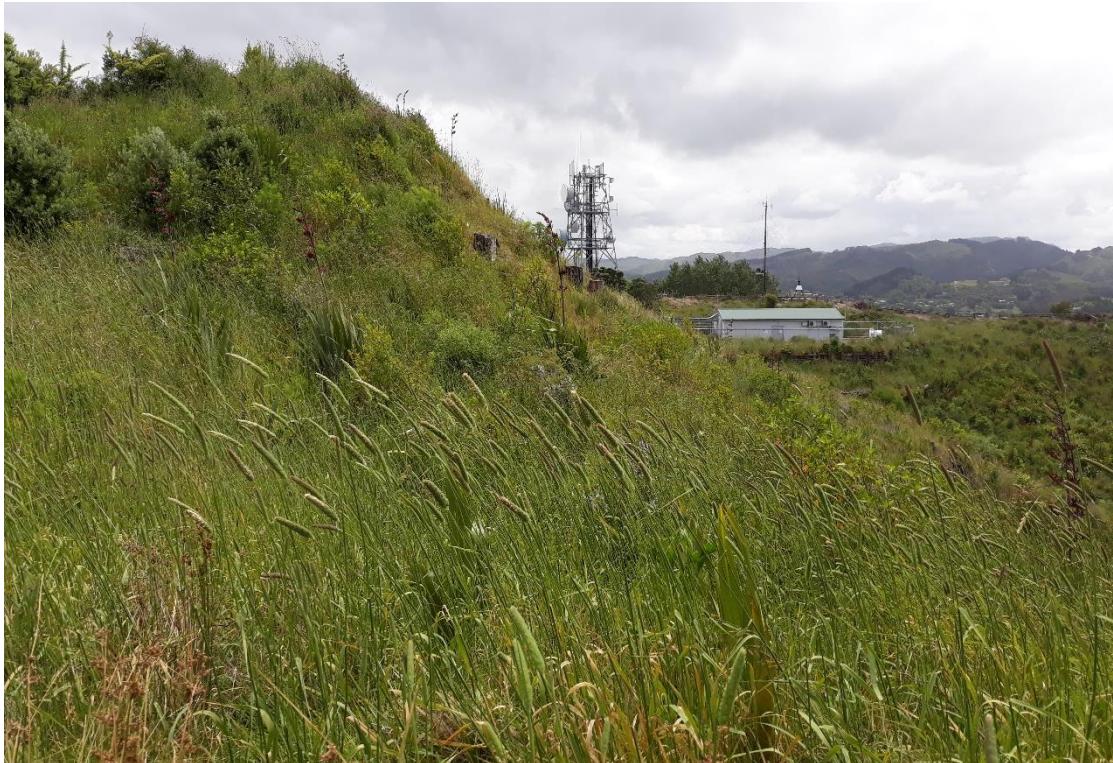
Further out from the edges of the building, the site comprises very long grass/vegetation and steep slopes (Figure 9. As such any remnant building foundations from the now removed building (evident in the 1943 image) were unable to be identified.

We note that it appeared that the level of the former building was below the proposed soil disturbance level/area, thus reducing the risk of contact from any potential contaminants associated with the former building.

Figure 9: Photograph taken from approximate location of former building looking north towards the chorus site.

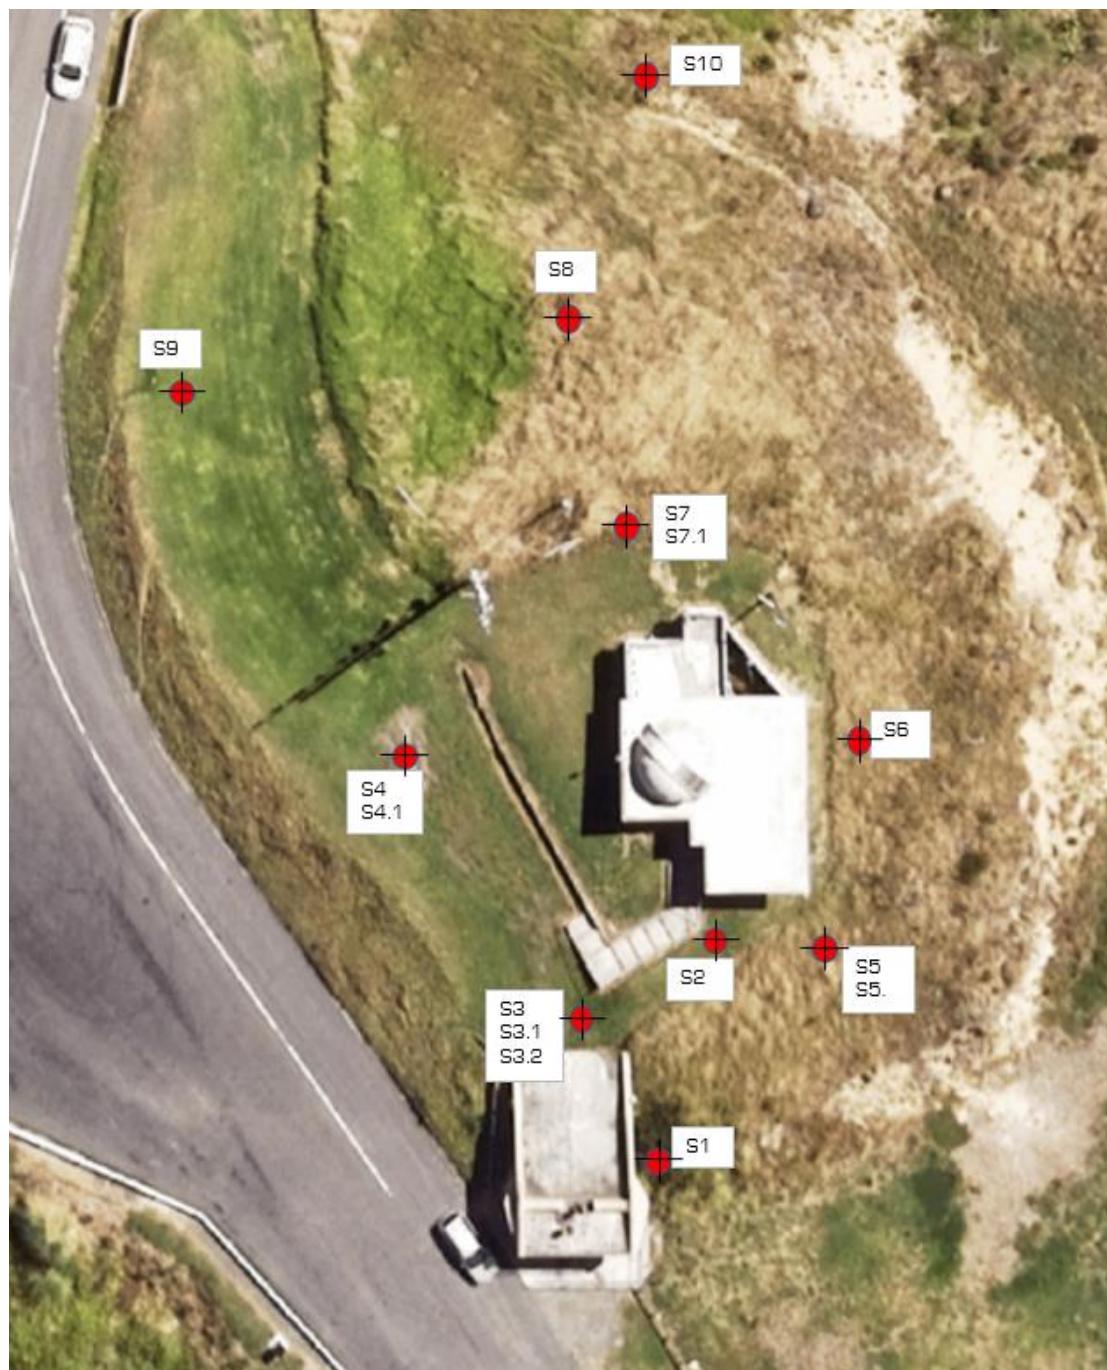
Name	Description	Depth	Lab Analysis
S1	Dark brown silt topsoil.	0-0.2m	Heavy Metals, Asbestos and PCP.
S2	Dark brown, silt fill with rare brick fragments, dry and friable soil.  Note that a deeper sample was sought, however, after several attempts we were unable to advance the hand auger deeper due to an obstruction [possibly from the building foundations].	0-0.2m	Heavy Metals and Asbestos
S3	Dark grey silt with angular gravel [no brick or deleterious materials identified].	0-0.2m	Heavy Metals, Asbestos and PCP.
S3.1	Orange brown reworked clay with layers of buried topsoil, rage gravel and minor orange mottling.	1-1.2m	Heavy Metals and Asbestos
S3.2	Orange brown reworked clay, rage gravel and minor orange mottling.	2-2.2m	Heavy Metals and Asbestos
S4	Brown silt topsoil fill to 0.3m.	0-0.2m	Heavy Metals and Asbestos
S4.1	Light greyish brown reworked clay.	0.5-0.7m	Heavy Metals and Asbestos
S5	Dark brown silt topsoil to 0.4m.	0-0.2m	Heavy Metals and Asbestos

S5.1	Light brown clay.	0.5-0.7m	Heavy Metals and Asbestos
S6	Brown silt topsoil.	0-0.2m	Heavy Metals and Asbestos
S7	Brown silt topsoil.	0-0.2m	Heavy Metals and Asbestos
S7.1	Reworked silt fill. Some rare brick fragments noted at 0.6m, clay soil identified at 1m depth.	0.5-0.7m	Heavy Metals and Asbestos
S8	Brown silt topsoil.	0-0.2m	Heavy Metals and Asbestos
S9	Brown silt topsoil.	0-0.2m	Heavy Metals and Asbestos
S10	Brown silt topsoil.	0-0.2m	Heavy Metals, Asbestos and PCP.

Figure 11: Soil sampling site plan [approximate].

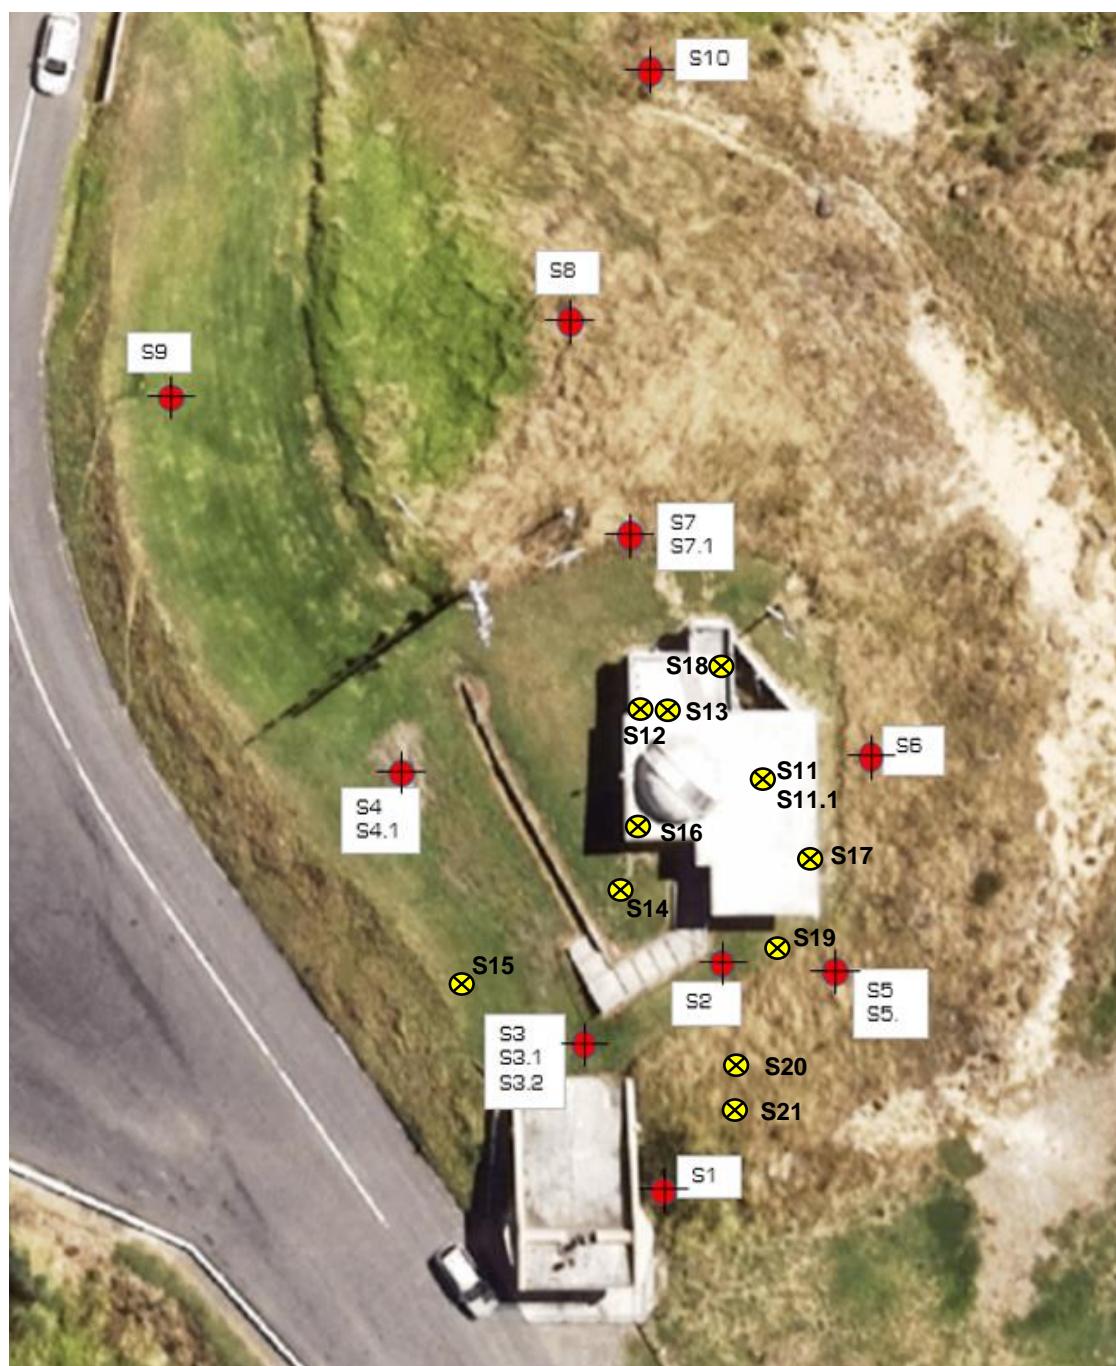
Figure 2: Approximate soil sample locations. The samples shown in red were undertaken in 2018, whilst the more recent soils samples taken in 2019 are shown in yellow.

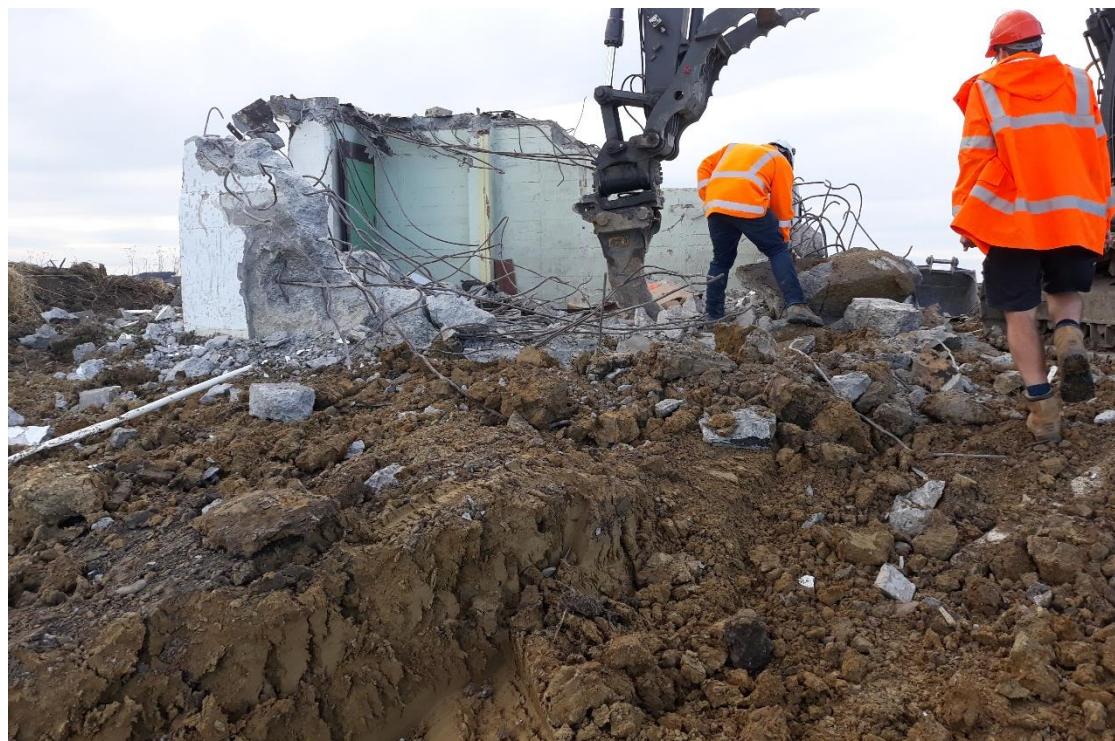
Figure 3: Photo taken during demolition of the observatory building on 31 July 2019 (AM).

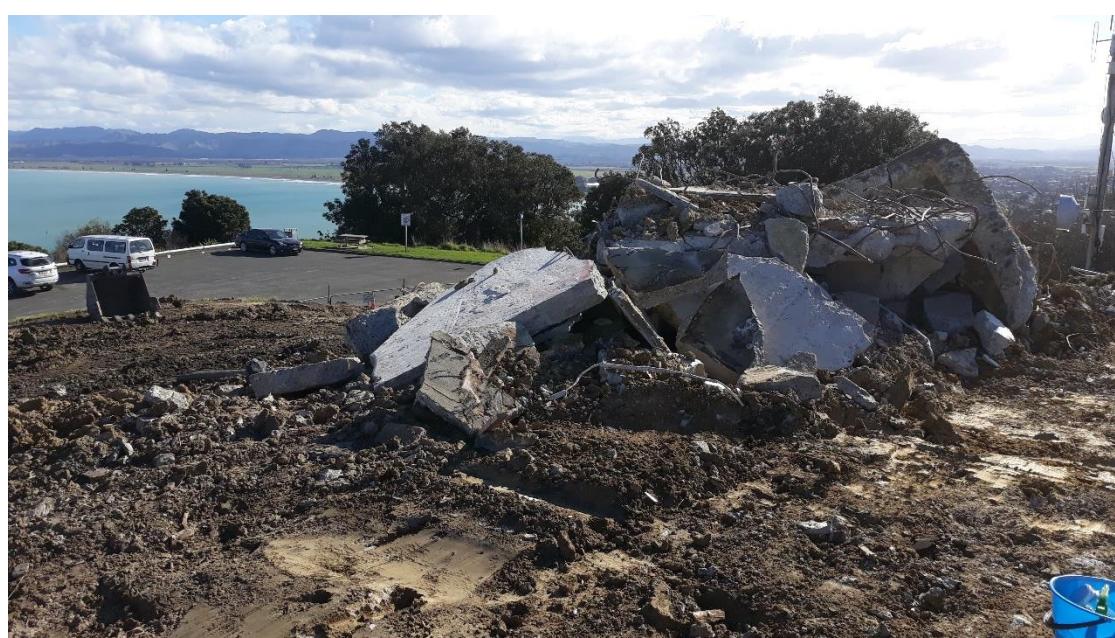
Figure 4: The observatory building has been demolished by 31 July 2019 (PM) with the suspected asbestos (black material) identified between the concrete floor and subfloor kept separate from the other building waste.

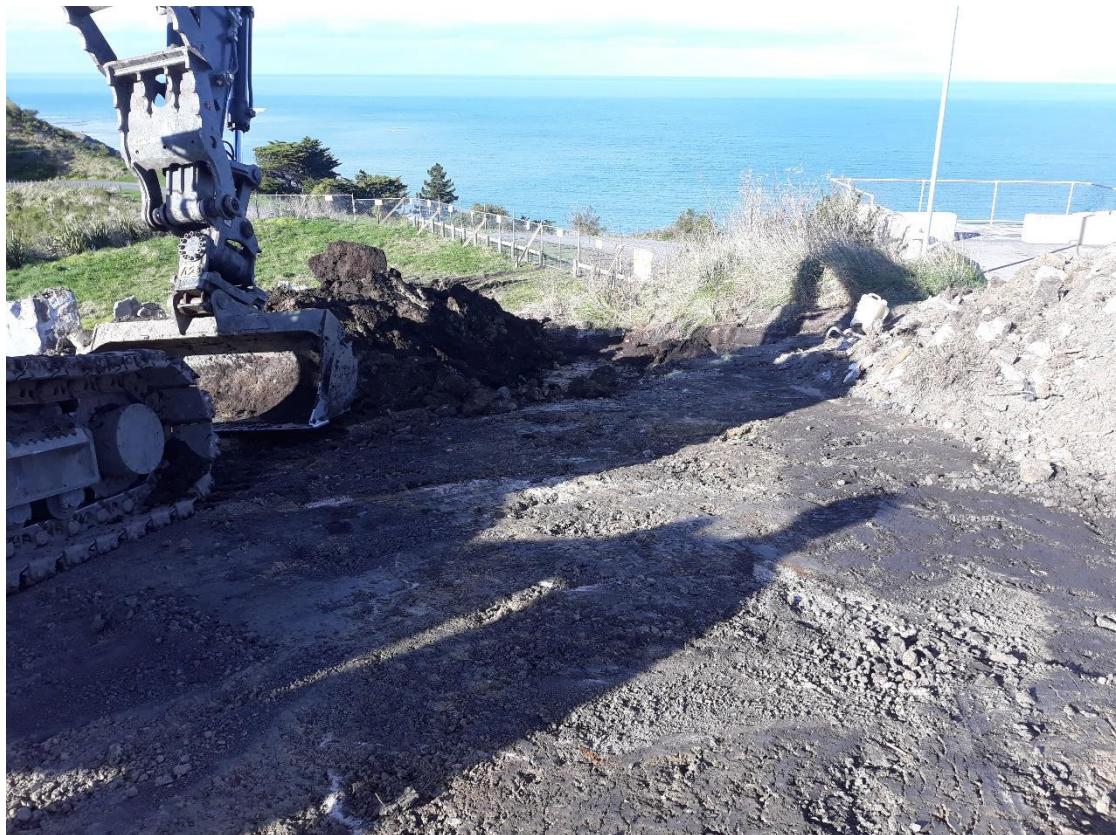
Figure 5: The area where the observatory was located was fully cleared by 1 August 2019 (AM) and soil samples were collected.

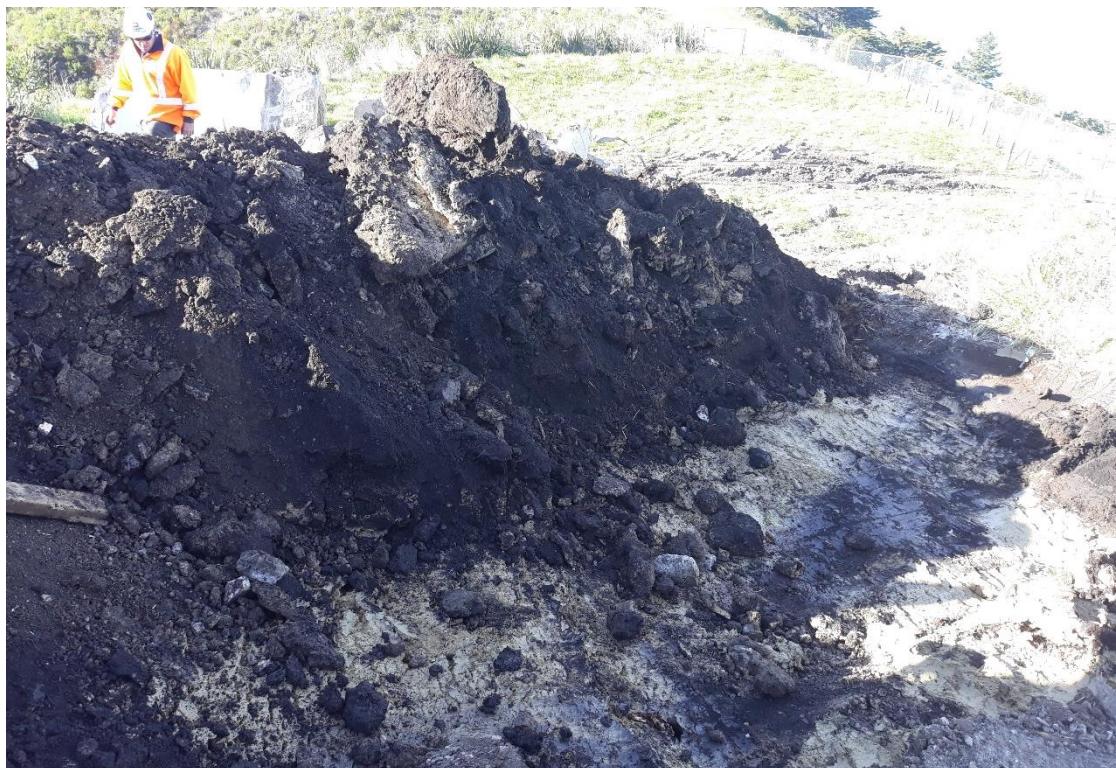
Figure 6: The back filled trench is evident in this image taken on 1 August 2019 (AM). Filling material including brick, concrete and a steel drum lid was identified within the backfilled trench fill.

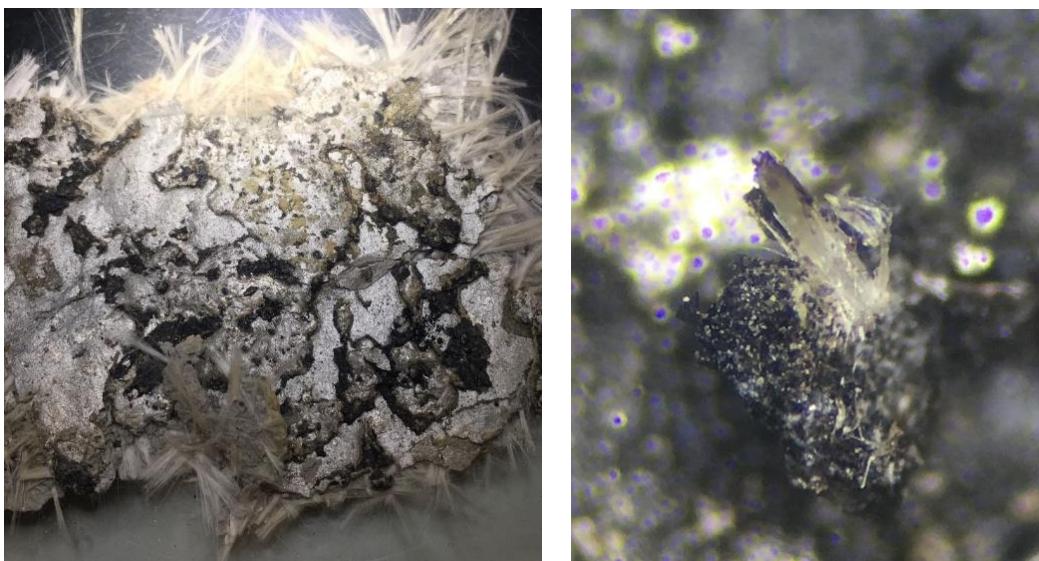
There was no detection of asbestos within the soil, however, a piece of material found on site which had the appearance of fibres glass tested positive for chrysotile (white asbestos) fibres. The lab confirmed that one bundle of asbestos fibres was stuck onto the bitumastic layer (black material) of the sheet material. Refer to Figure 7 showing a photograph of the material containing the asbestos (after lab analysis).

Figure 7: Photograph of Sample 14. The image on the left shows the material mostly intact with the asbestos detected within the bitumastic material (black material), whilst the image on the right shows the chrysotile bundle.

Remnant building waste found on the ground surface in small quantities which appeared to be fibreglass did contain asbestos fibres within the bitumastic layer of the material. The asbestos fibres were bound within the sheets of the material. We consider this finding a relatively low risk to human health due to the fact that it was found in small quantities on site and bound within the sheeting material.

Any other material found on site similar in appearance (to what was confirmed as asbestos) also needs to be disposed of to a licenced landfill approved to accept asbestos containing material.

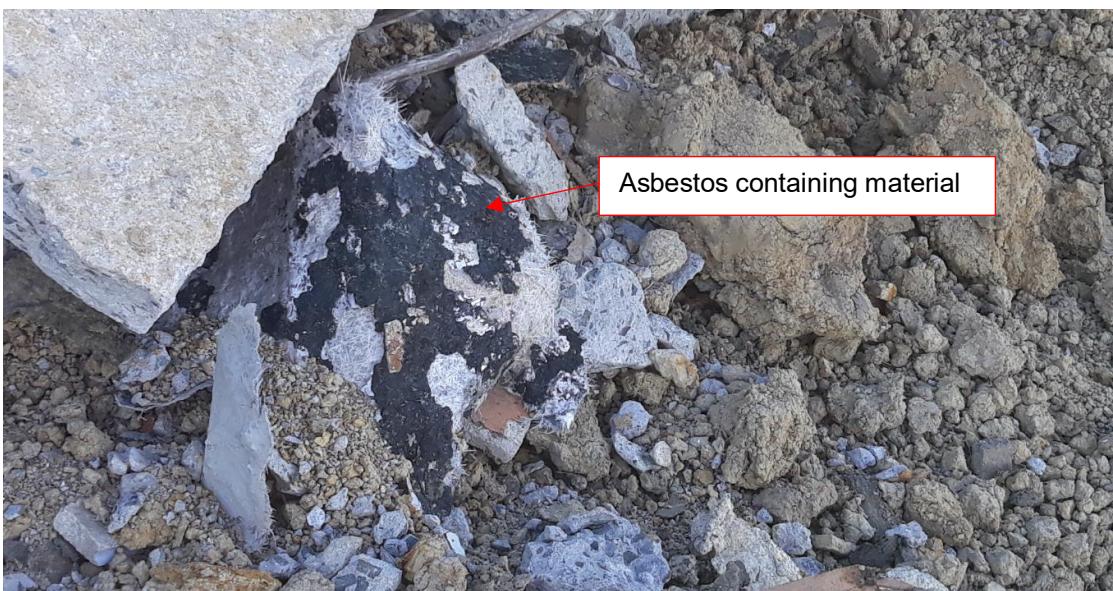
During our site inspections, potential asbestos sheeting material was identified within the building demolition material. Testing confirmed that asbestos was present within the black bitumastic layer of the sheeting (refer to Figure 1). It appeared that this material was adhered to the concrete roof of the observatory building which had been mostly demolished. Given that asbestos was bound to the bitumastic layer, the potential for free fibre release was considered low however precautions were taken to ensure the health and safety of site workers and future site users.

Figure 1: Sheeting material identified to contain asbestos within the black bitumastic layer within the material.

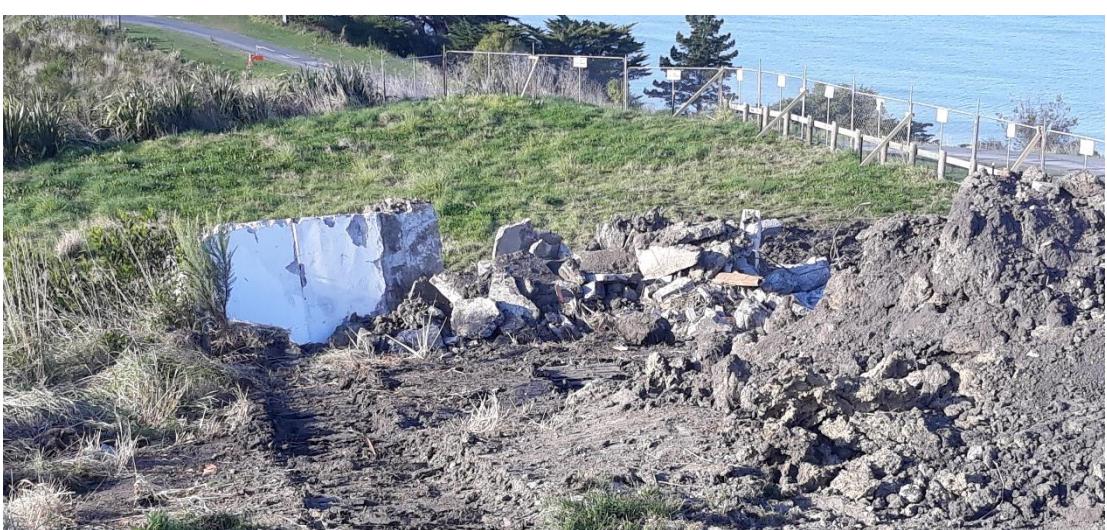
The concrete waste was stockpiled at the 'skid site' located at the bottom of the east side of the slope (Figure 2) and at the top of the slope near the building platform (Figure 3). We also identified the same asbestos sheeting within a mixed soil/fill pile (containing smaller pieces of concrete) which was also located near to the building platform (Figure 4).

Figure 2: Skid site containing concrete with asbestos sheeting.

Due to the discovery of the asbestos containing material LDE recommended that the concrete/asbestos/fill stockpiles be removed off site and taken to a licenced landfill, with validation soil sampling to be undertaken in the areas of the identified asbestos stockpiles.

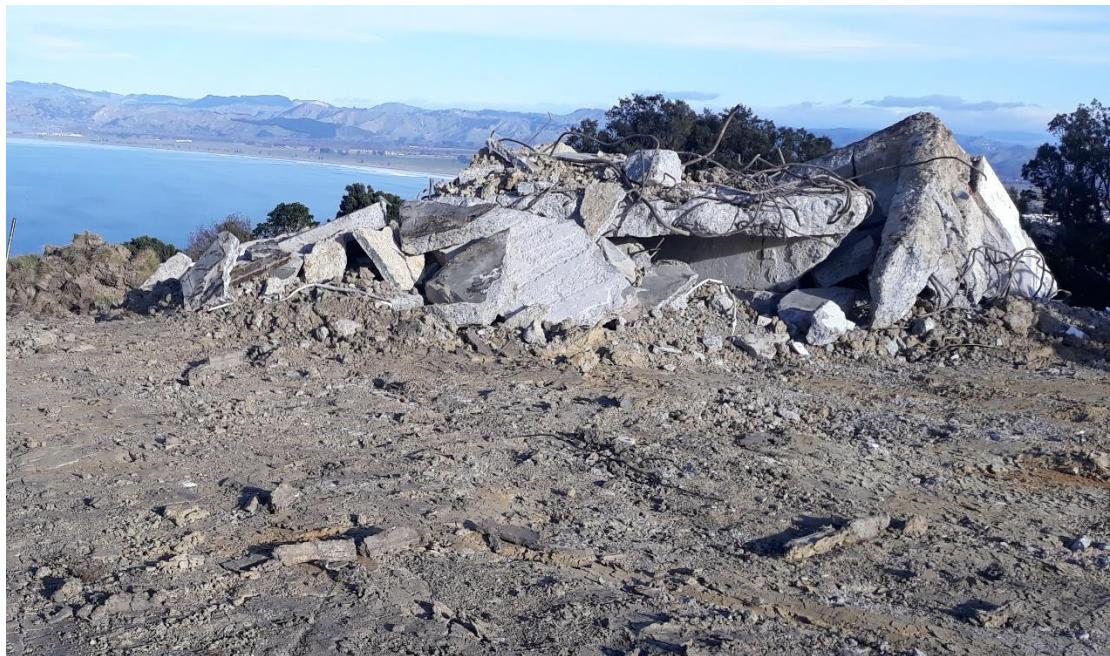
Figure 3: Concrete stockpile containing asbestos sheeting

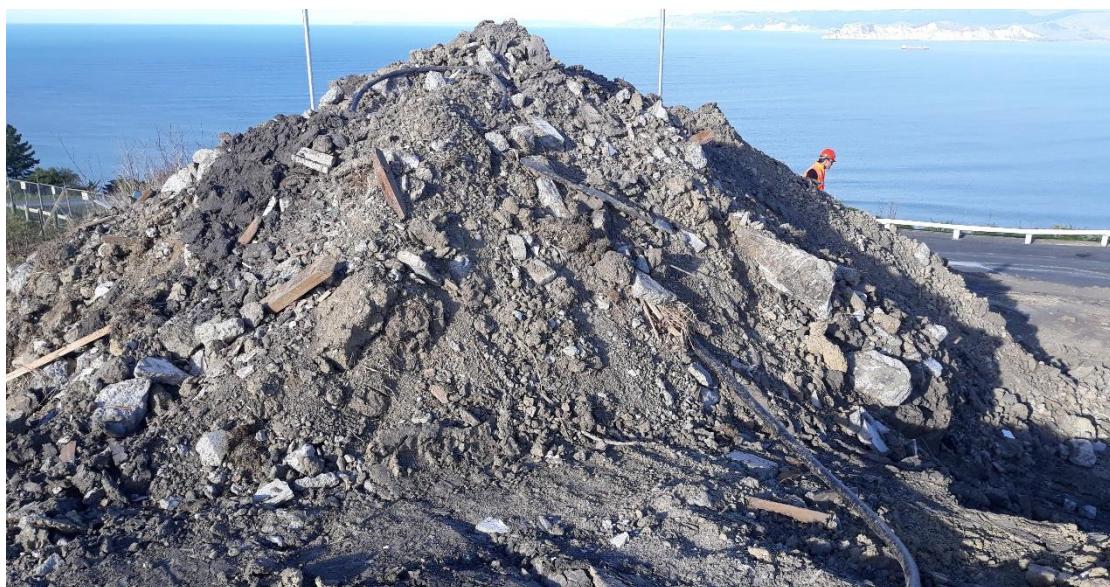
Figure 4: Mixed fill/concrete stockpile containing asbestos sheeting.

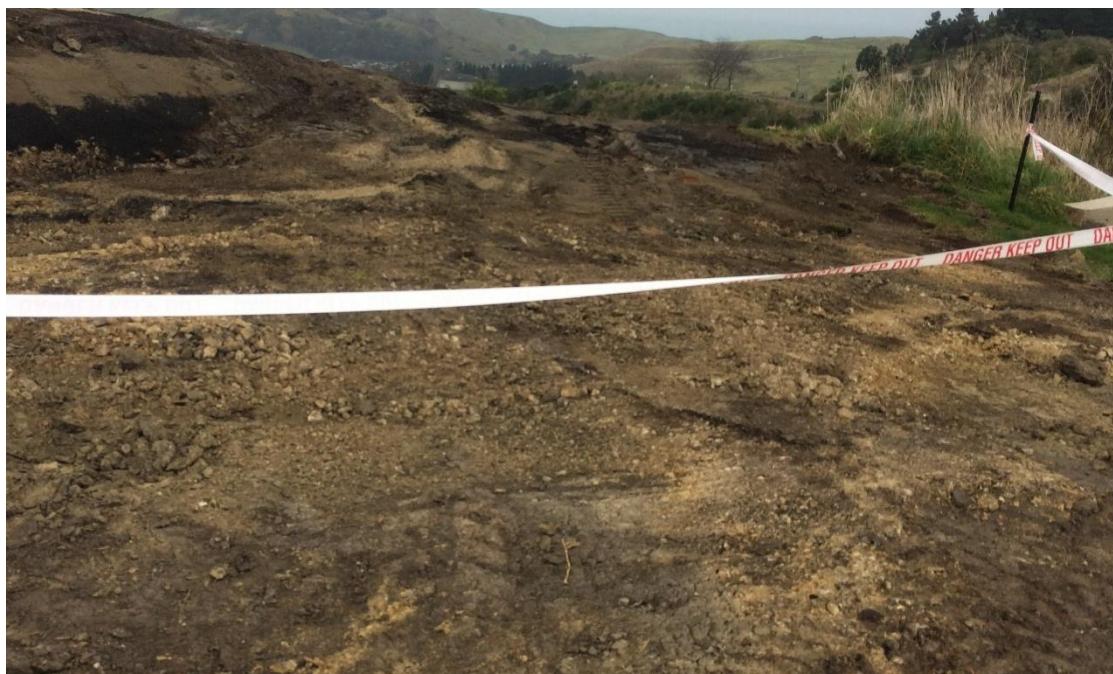
Our site inspections undertaken after the discovery of the asbestos material noted that that the concrete had been removed off site and the soil where the stockpiles were located (including the face of the slope) were also scraped back with the turf/upper soil layer removed. Refer to Figures 5 and 6.

Figure 5: Top of slope now cleared of asbestos containing concrete. Photograph taken on 9 August 2019.

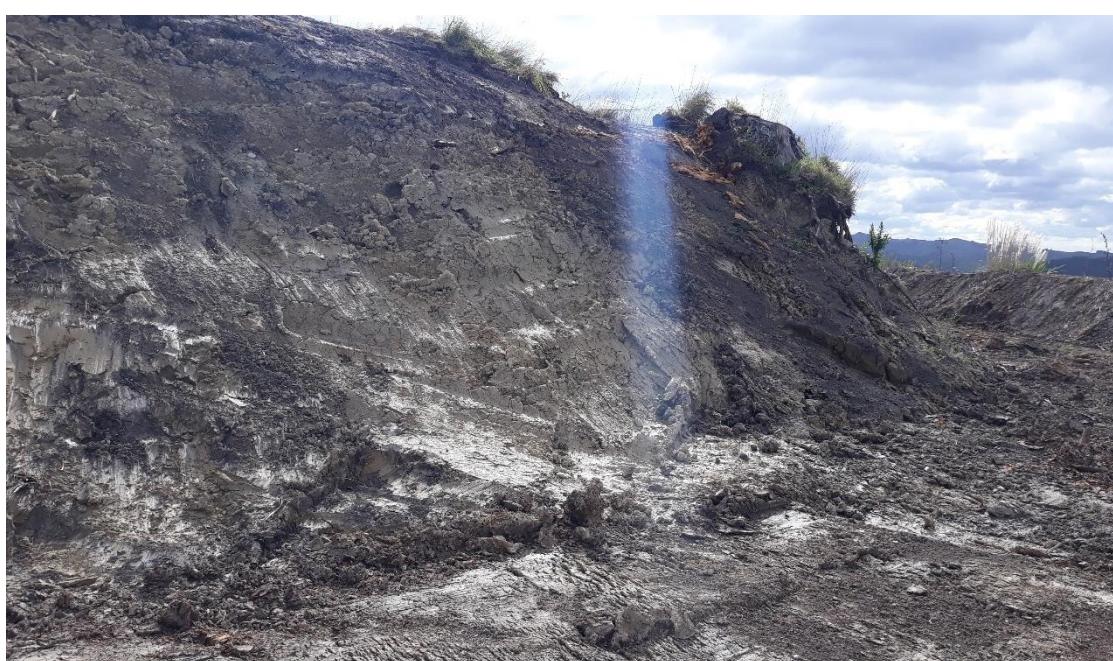
Figure 6: Scraped back face of skid site. Photograph taken on 14 August 2019.

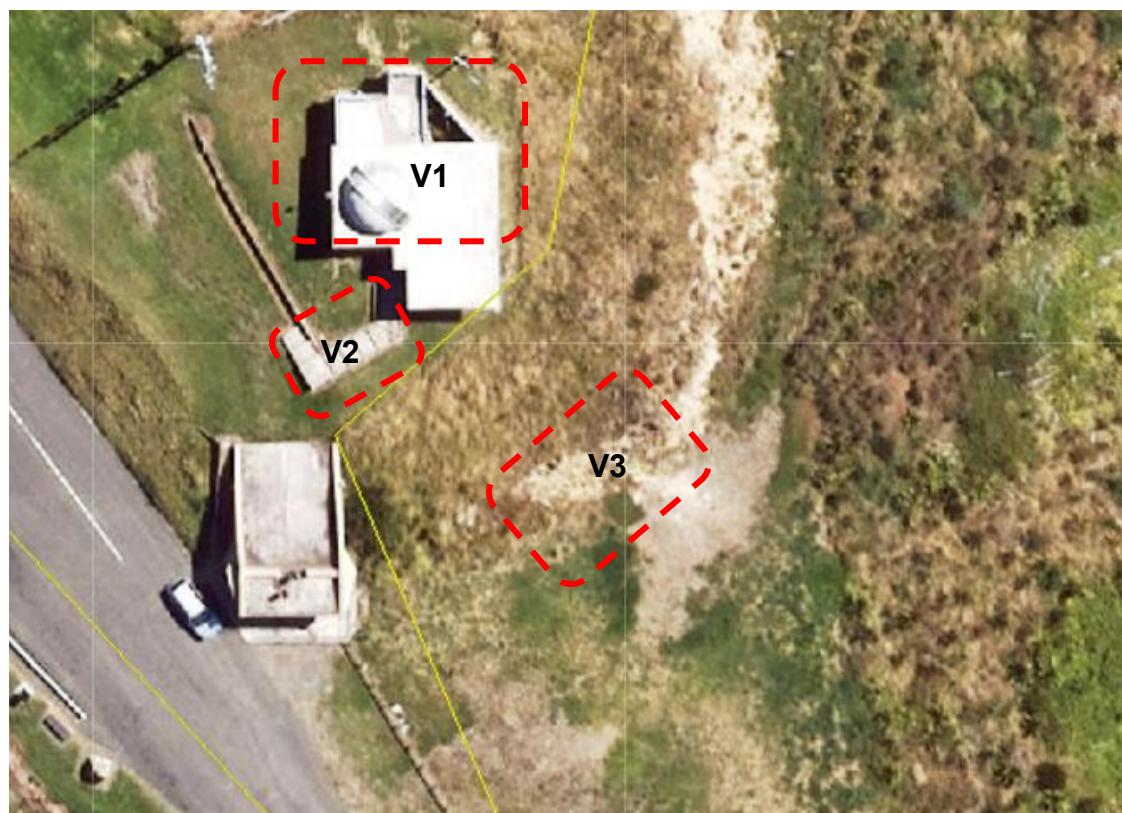
Soil sampling was undertaken to validate that the soil directly beneath the stockpiles (and nearby) did not contain asbestos. Soil grab samples were collected from within each validation area between 0-100mm below ground level. The grab samples were composited in the field, with one sample per validation area tested by the lab (three in total). Figure 1 shows the location of the soil samples collected as part of the site validation.

Figure 7: Surface soil grabs were collected from within the validation areas shown within the red boundaries and composited in the field prior to lab testing.

The results showed that no asbestos was detected within the validation soil samples. Refer to Table 1 for the summarised results, and Appendix B and C for the chain of custody and full lab results record.
