AGENDA

OPERATIONS - INFRASTRUCTURE/NGĀ WHAKAMAHI - TE HANGANGA Committee

| 9.1. 23-39 Tonkin & Taylor Flood Investigation Report - 2022 | 4 |
| 9.2. 23-40 Tokomaru Bay Transfer Station Update..... | 98 |

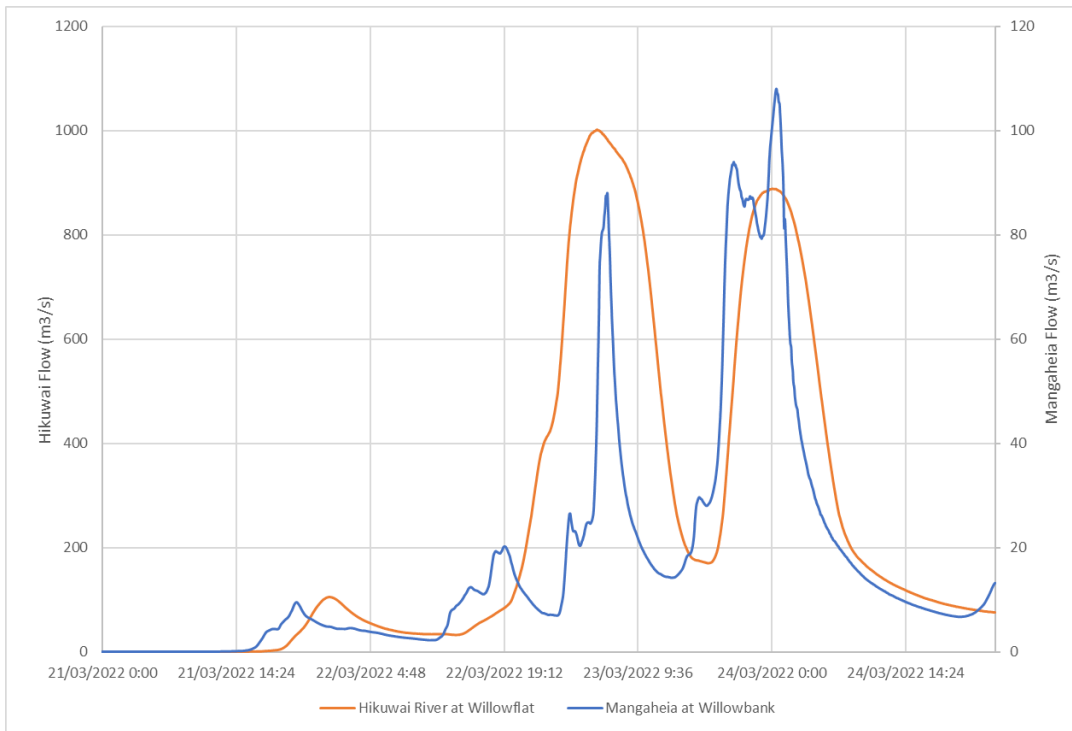
Figure 5.2: Hikuwai at Willow Flat (orange) and Mangaheia at Willow Bank (blue) stream flow responses to the 22 to 23 March 2022 rainfall (Data source GDC)

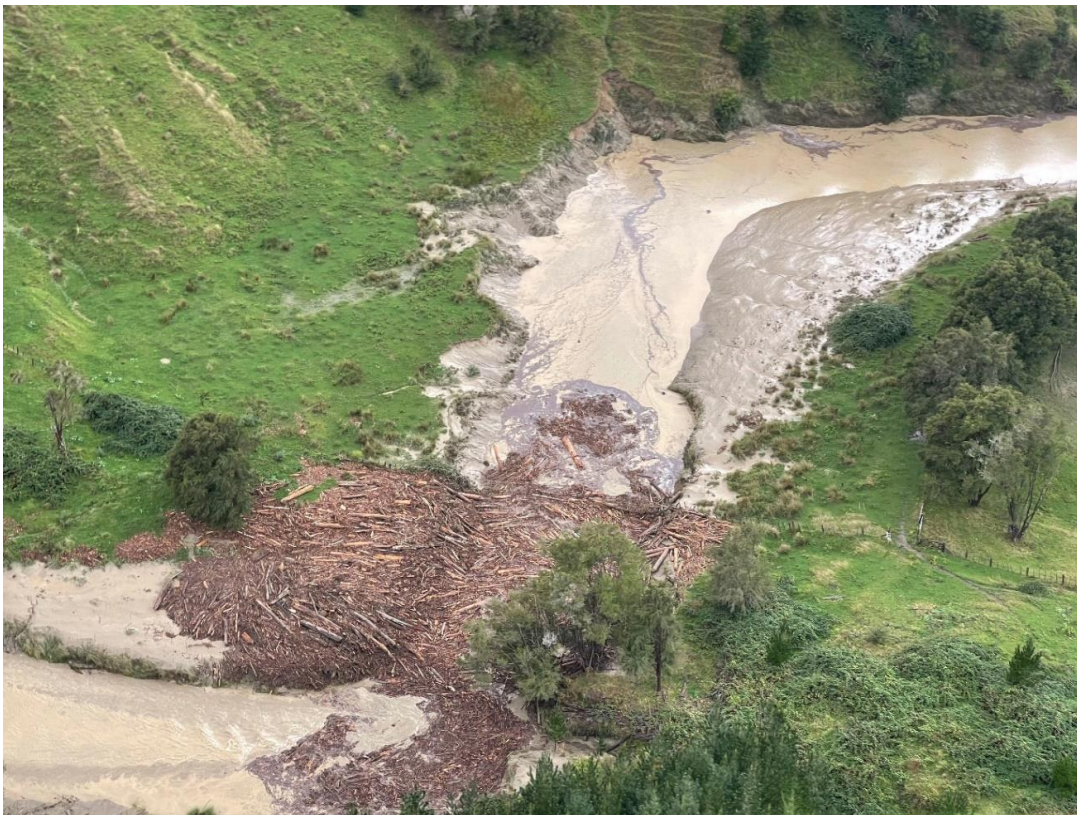
Figure 5.3: Photo of wood debris on the Waitoroko Stream showing the river damming impact of large amounts of wood debris.

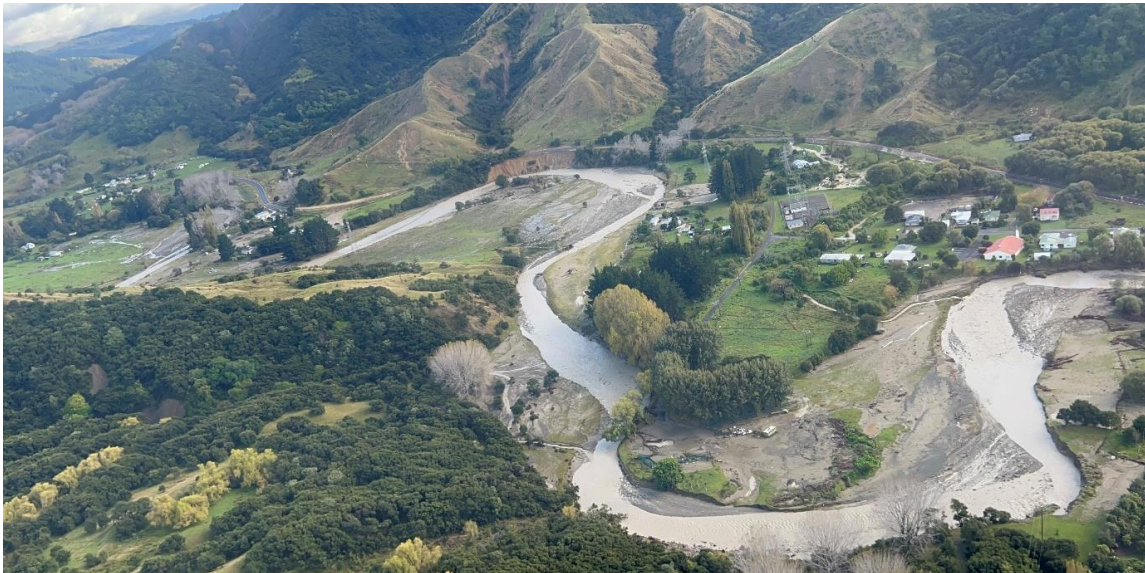
It is noted that there is a legacy landfill located next to the Mangahauini River, which sustained damage in June 2021 floods and again in March 2022. While this has not been reviewed as part of this assessment, while the historic landfill remains in the floodplain, each future flood event will increase the landfill's vulnerability to future flooding and erosion.

Figure 5.5: Aerial view of the Mangahauini River and the north end of Taro Street, with the transfer station at the bend in river (at the bottom of the photo). Lateral slips can faintly be seen in the middle of the photo at the foot of the hills (Photo source GDC).

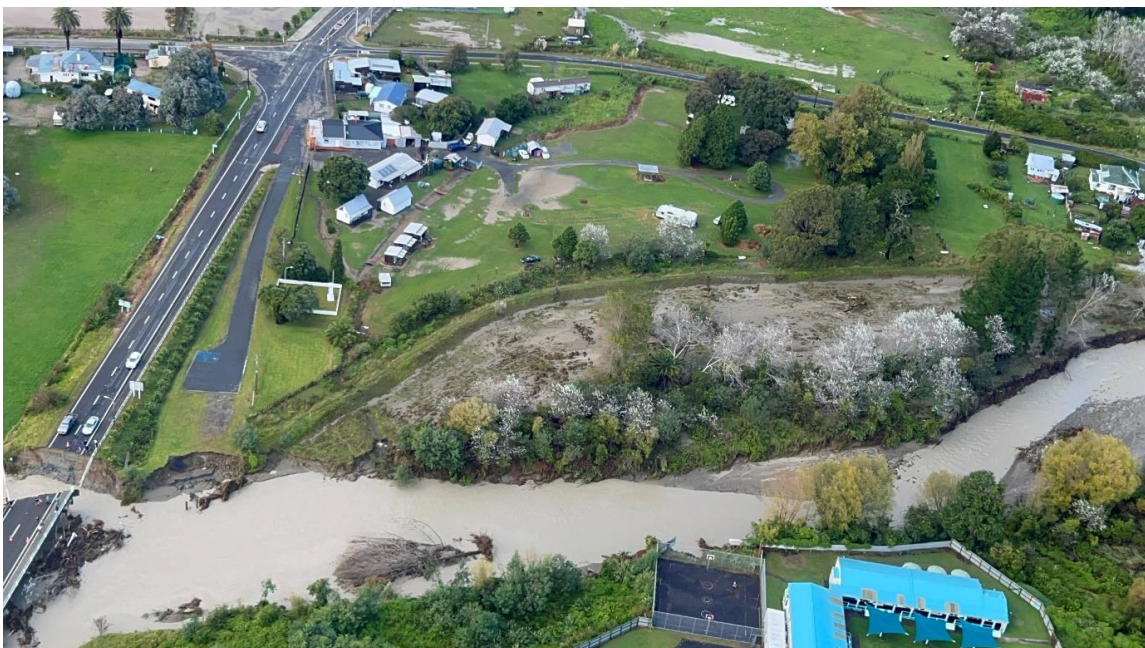
Figure 5.6: Mangahauini River SH35 bridge washout, with the stopbank on the true right bank (Photo source GDC).

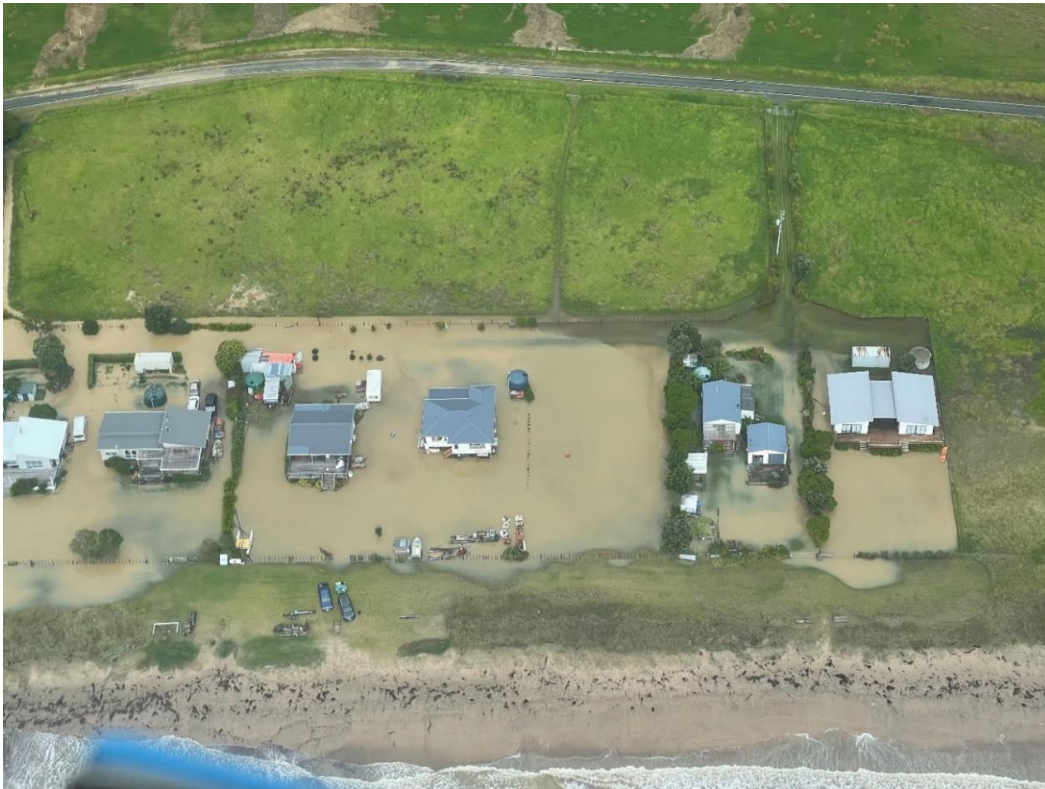
Figure 5.8: Aerial photo of Anaura Road properties in the middle of Anaura Bay (source GDC)

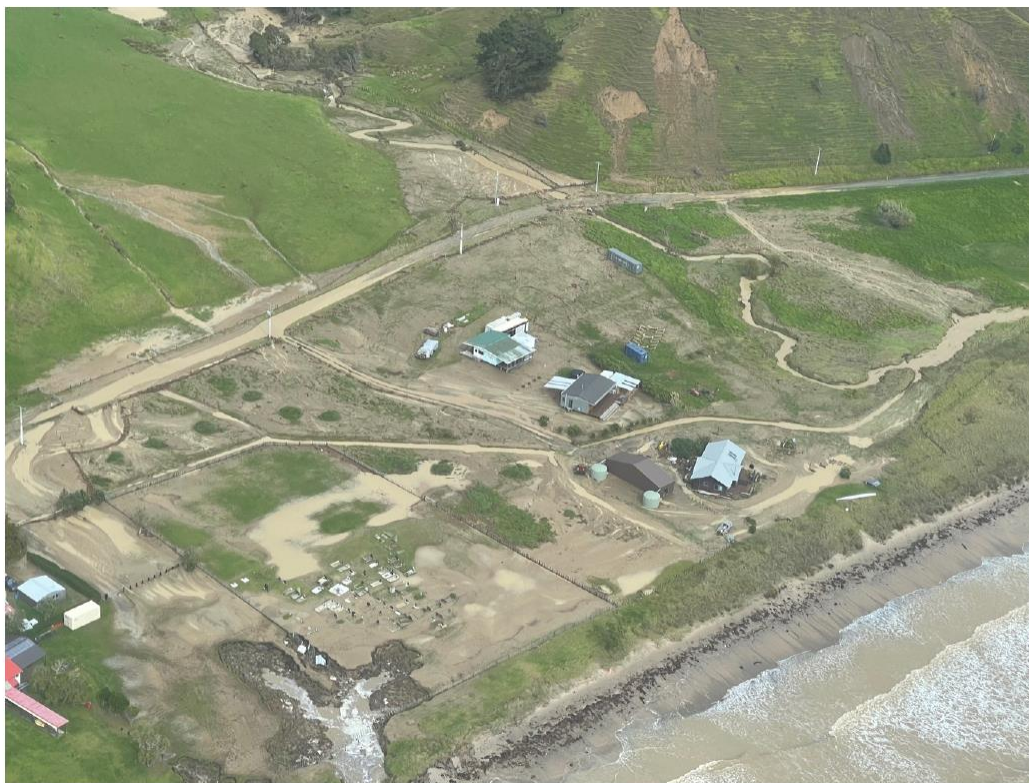
Figure 5.9: Aerial photo of Lockwood Road, the Hawaii Stream and urupa erosion at the south end of Anaura Bay (source GDC)

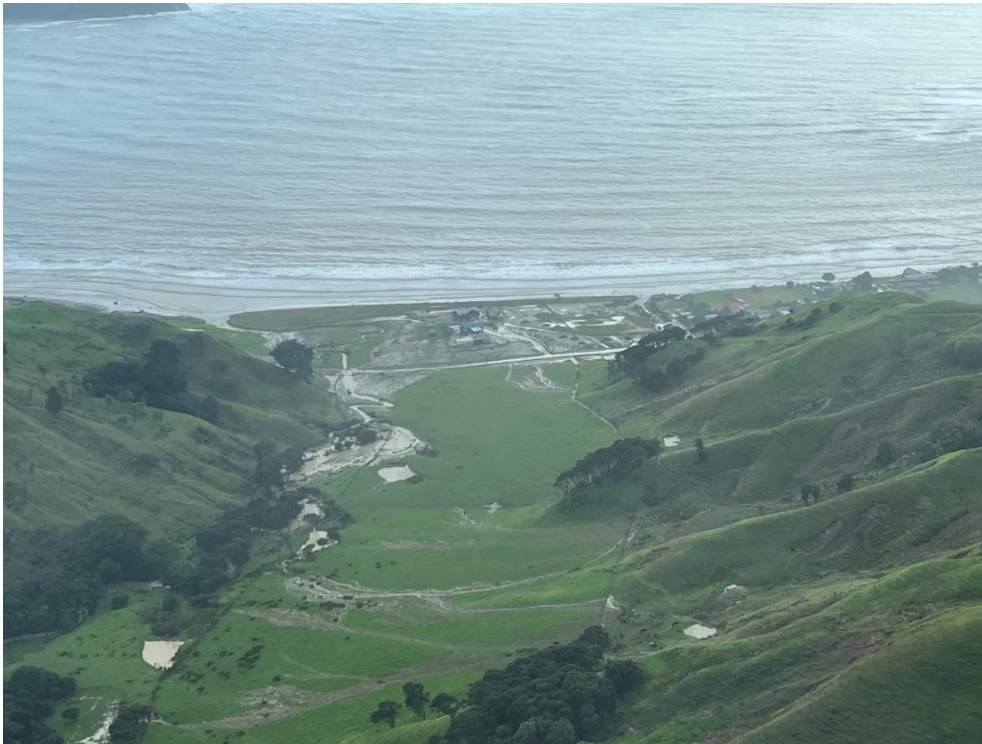
Figure 5.10: Aerial photo of the Hawai Stream catchment looking east. Note the landslides throughout the hills and overland stream flow along the Hawai Stream (source GDC)

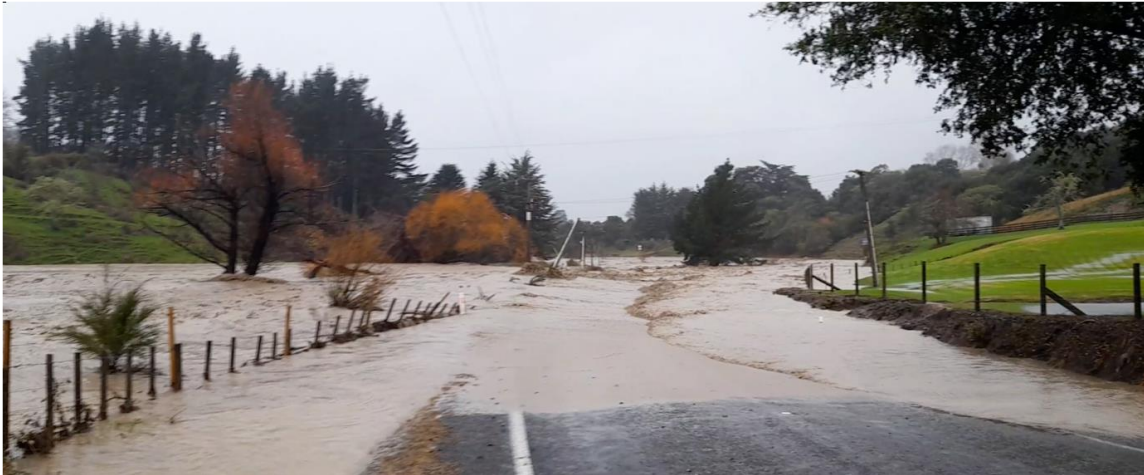
The Waiotu Stream overflowing onto SH35 southern approach to Tokomaru Bay early morning 20 June 2021.

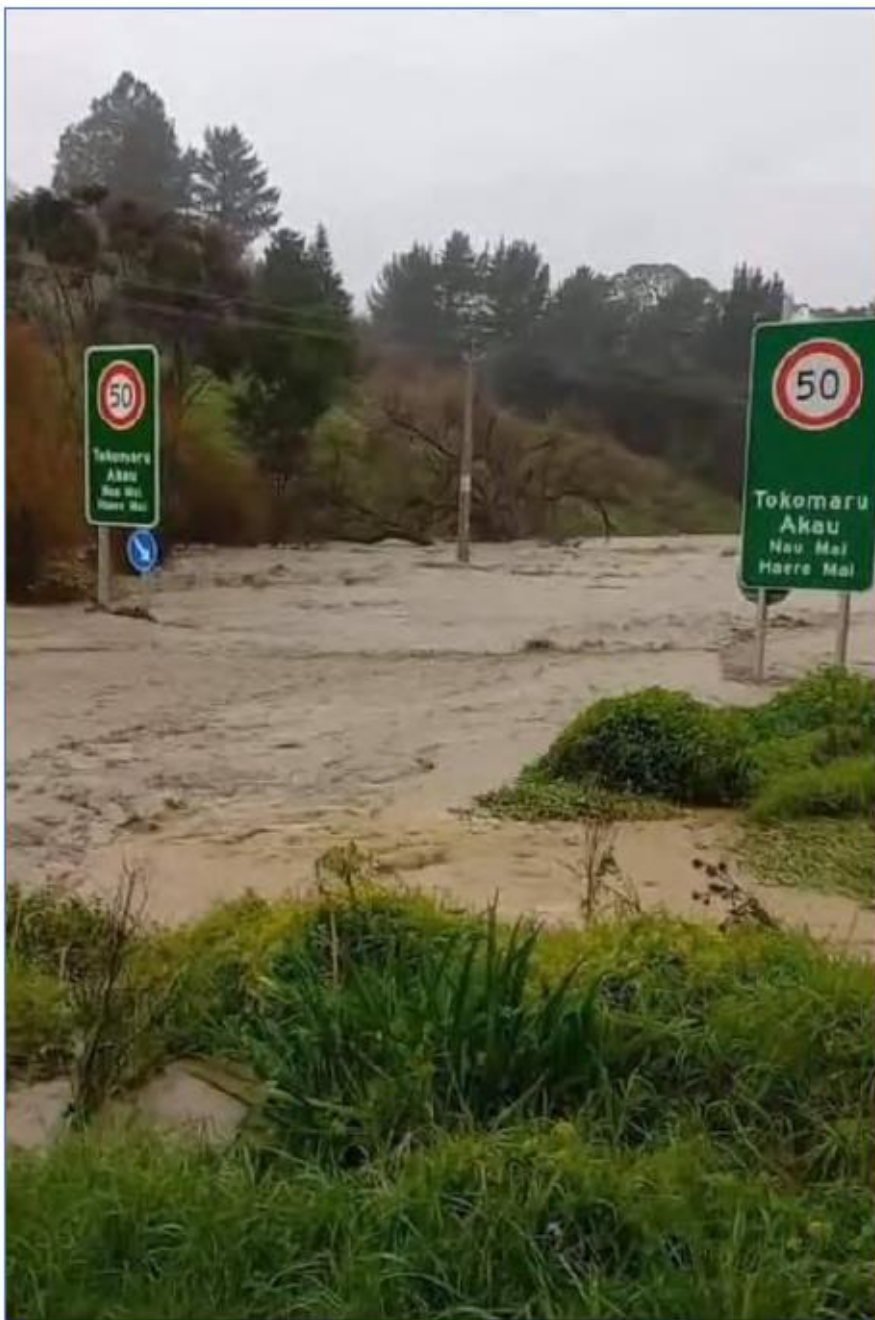
Figure Fifteen. Photograph hosted on the Uawa Live Facebook page credited to Kuipo Saulala and described as taken at approximately 8am.

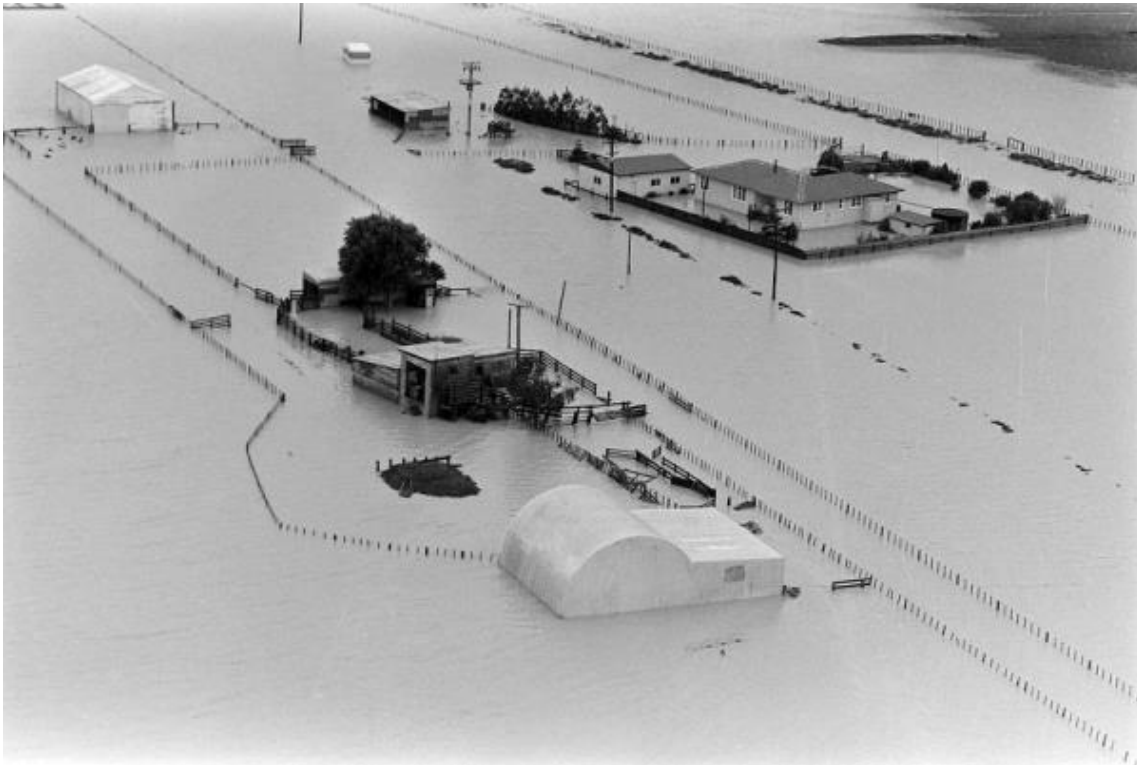
Aerial view of Tolaga Bay Cyclone Bola. Source Gisborne Herald [Remembering Cyclone Bola – The Gisborne Herald](#)

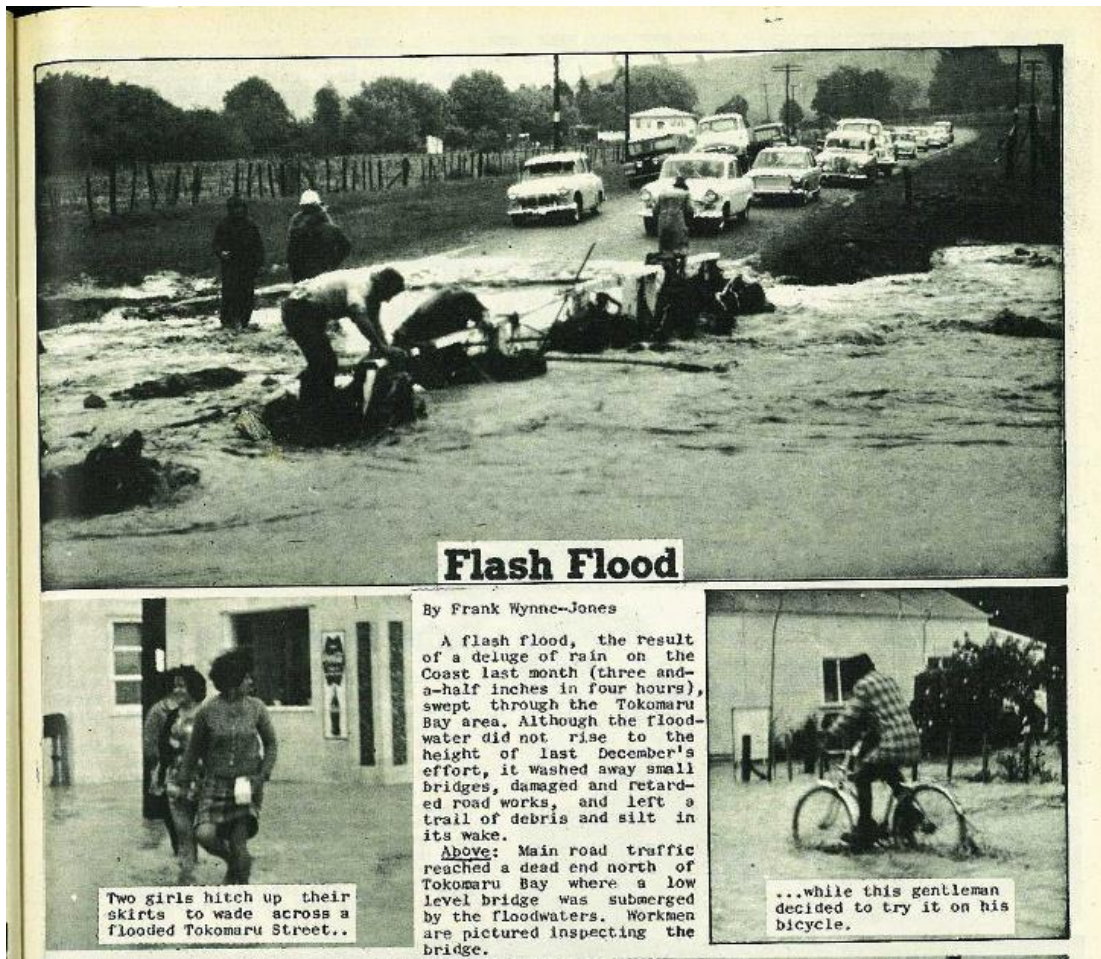
A flash flood, the result of a deluge of rain on the Coast last month (three and-a-half inches in four hours), swept through the Tokomaru Bay area. Although the floodwater did not rise to the height of last December's effort, it washed away small bridges, damaged and retarded road works, and left a trail of debris and silt in its wake. Main road traffic reached a dead end north of Tokomaru Bay where a low level bridge was submerged by the floodwaters. Workmen are pictured inspecting the bridge.

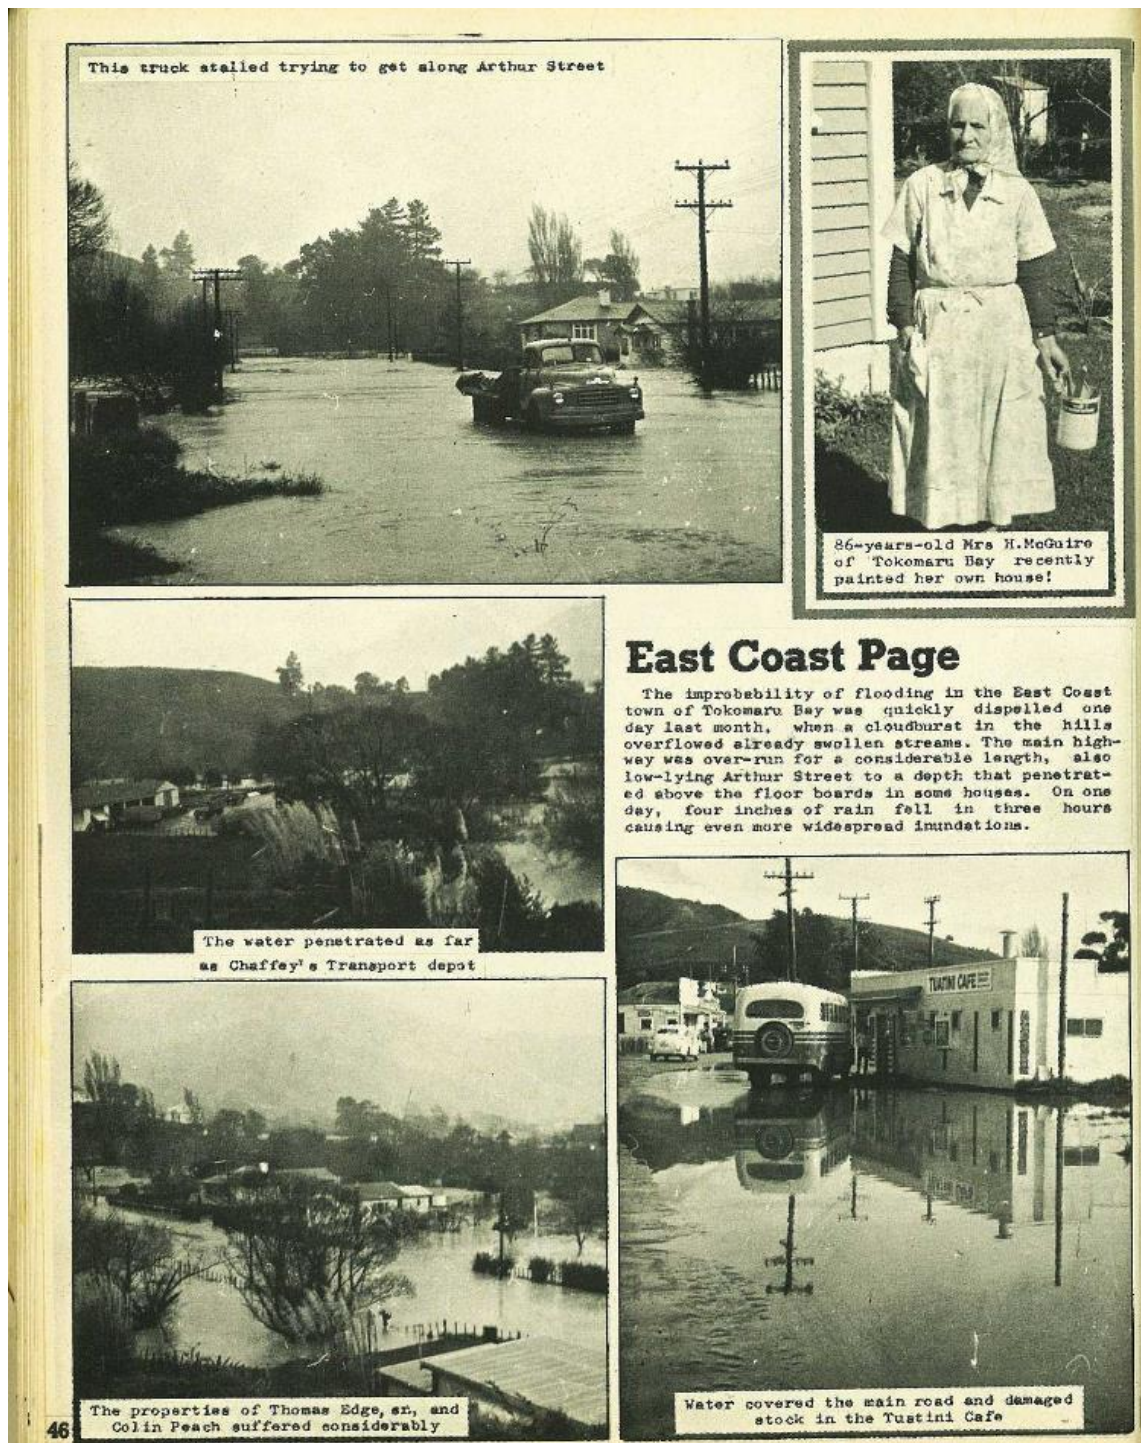
"The improbability of flooding in the East Coast town of Tokomaru Bay were quickly dispelled one day last month, when a cloudburst in the hills overflowed already swollen Streams. The main highway was overrun for a considerable length, also low lying Arthur Street to a depth that penetrated above the floor boards in some houses. On one day four inches of rain fell in three hours causing even more widespread inundations."

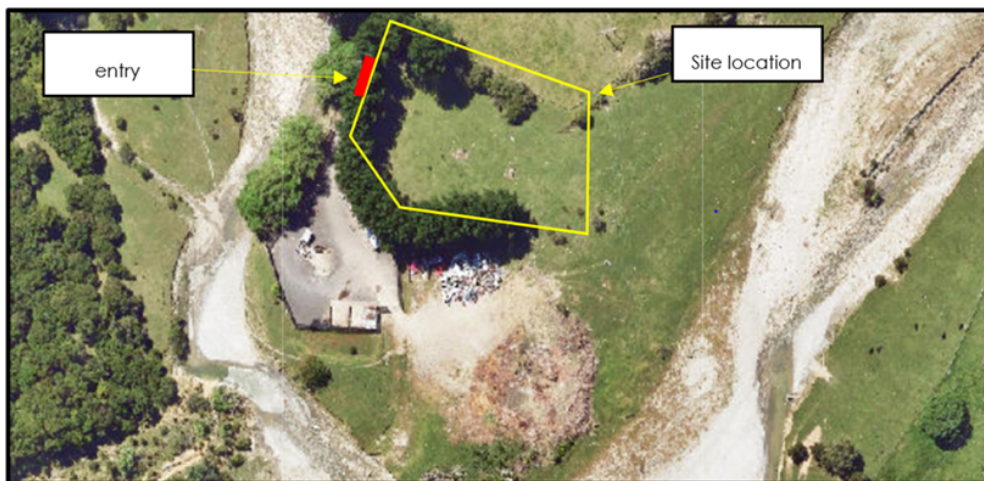
Figure 4 - Site Entry and Location

17. Two locations were considered when assessing a site relocation (reference **Attachment 3** - Tokomaru Relocation of Transfer Station). This option is the most cost-effective option and addresses the difficulties presented by the current location. The proposed site for the transfer station is the land located immediately north of the existing transfer station indicated in *Figure 4 - Site Location*. The site is currently consented to operate a transfer station. This consent was granted when the transfer station was primarily constructed. This proposed site suffered minimal damage during the 20 July 2021 flood event and is positioned outside the assessed flood zone. To mitigate and decrease the risk of future flood events affecting the operational ability and reduce the impact on the environment, it is recommended the land be built up in height to approximately 2.5m with river run material and the new transfer station positioned on top, with the entry located on the left-hand side of the paddock adjoining the current road indicated by *Figure 4 - Site Location (Entry)*.

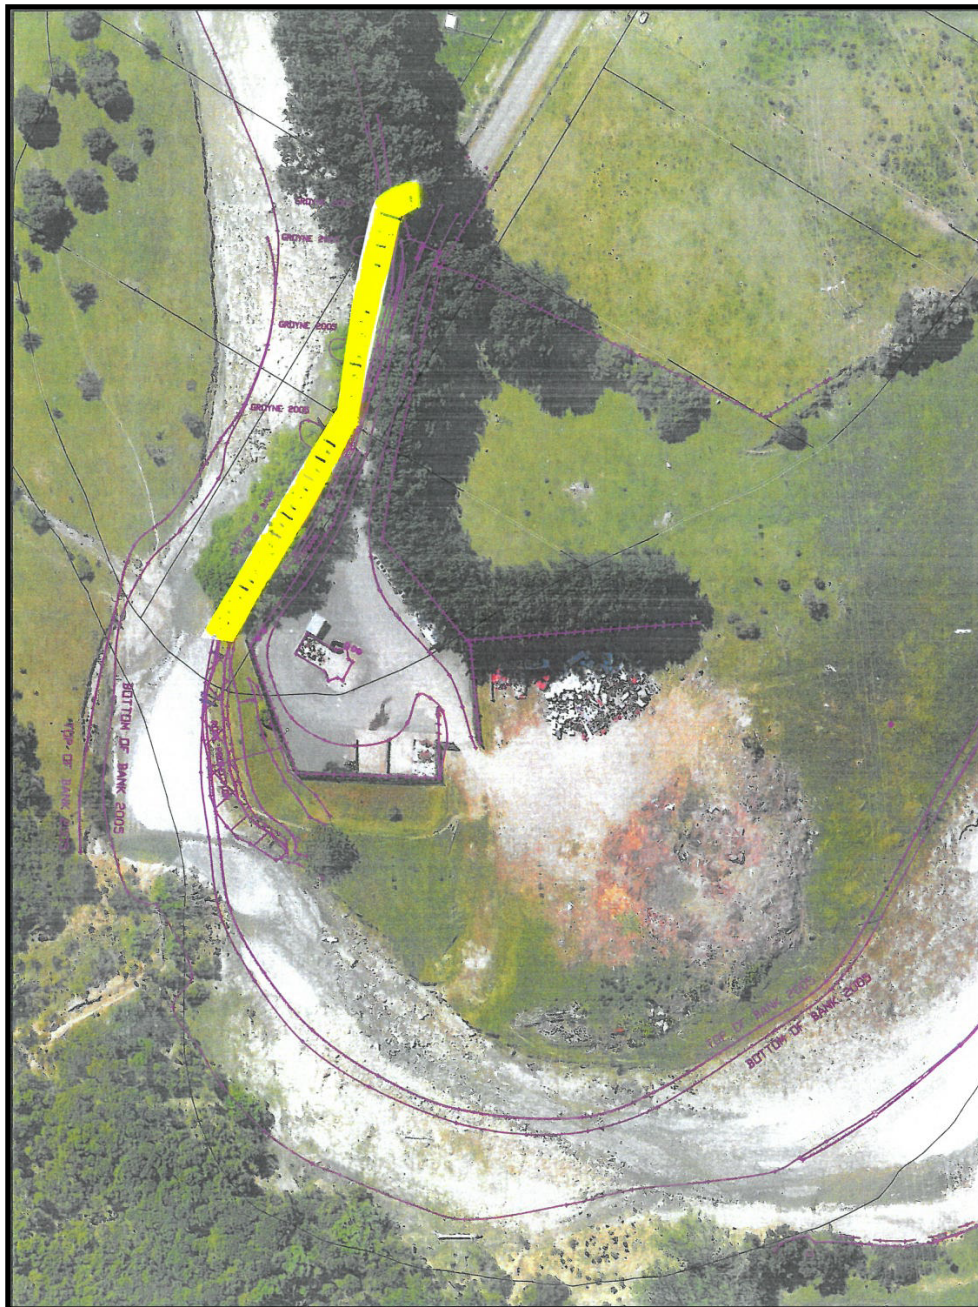
Figure 5 - Revetment Location and Length

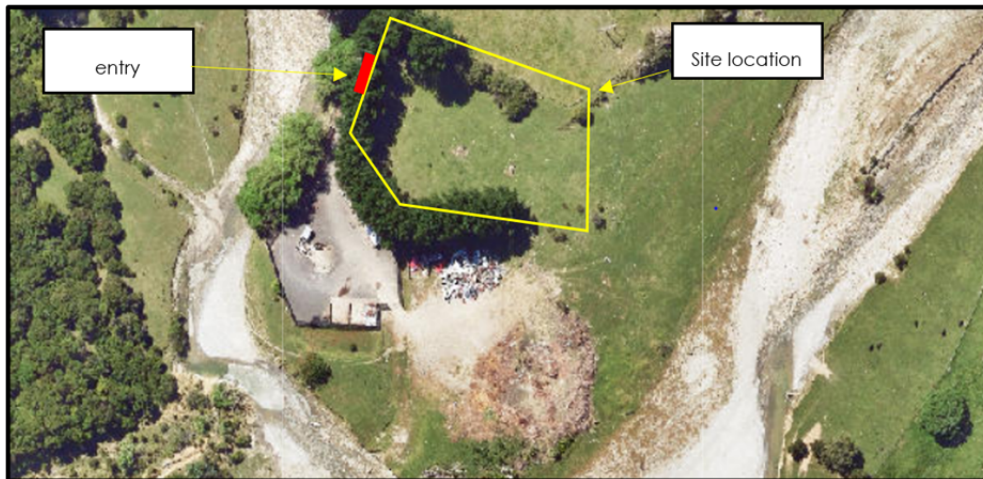
Figure 6 – Site Location

21. This option proposes the closure of the Tokomaru Bay Transfer Station and the primary use of the Te Puia Springs Transfer Station. Residents from Tokomaru Bay will be required to travel 12km to dispose of their household rubbish. The combined population of Tokomaru Bay and Te Puia Springs is 844. The Te Puia Springs Transfer Station will need to be emptied more than once a week and further planning will be needed for this. Good traffic management will need to be established by the caretakers to ensure the process of recycling and dumping of rubbish is safe.

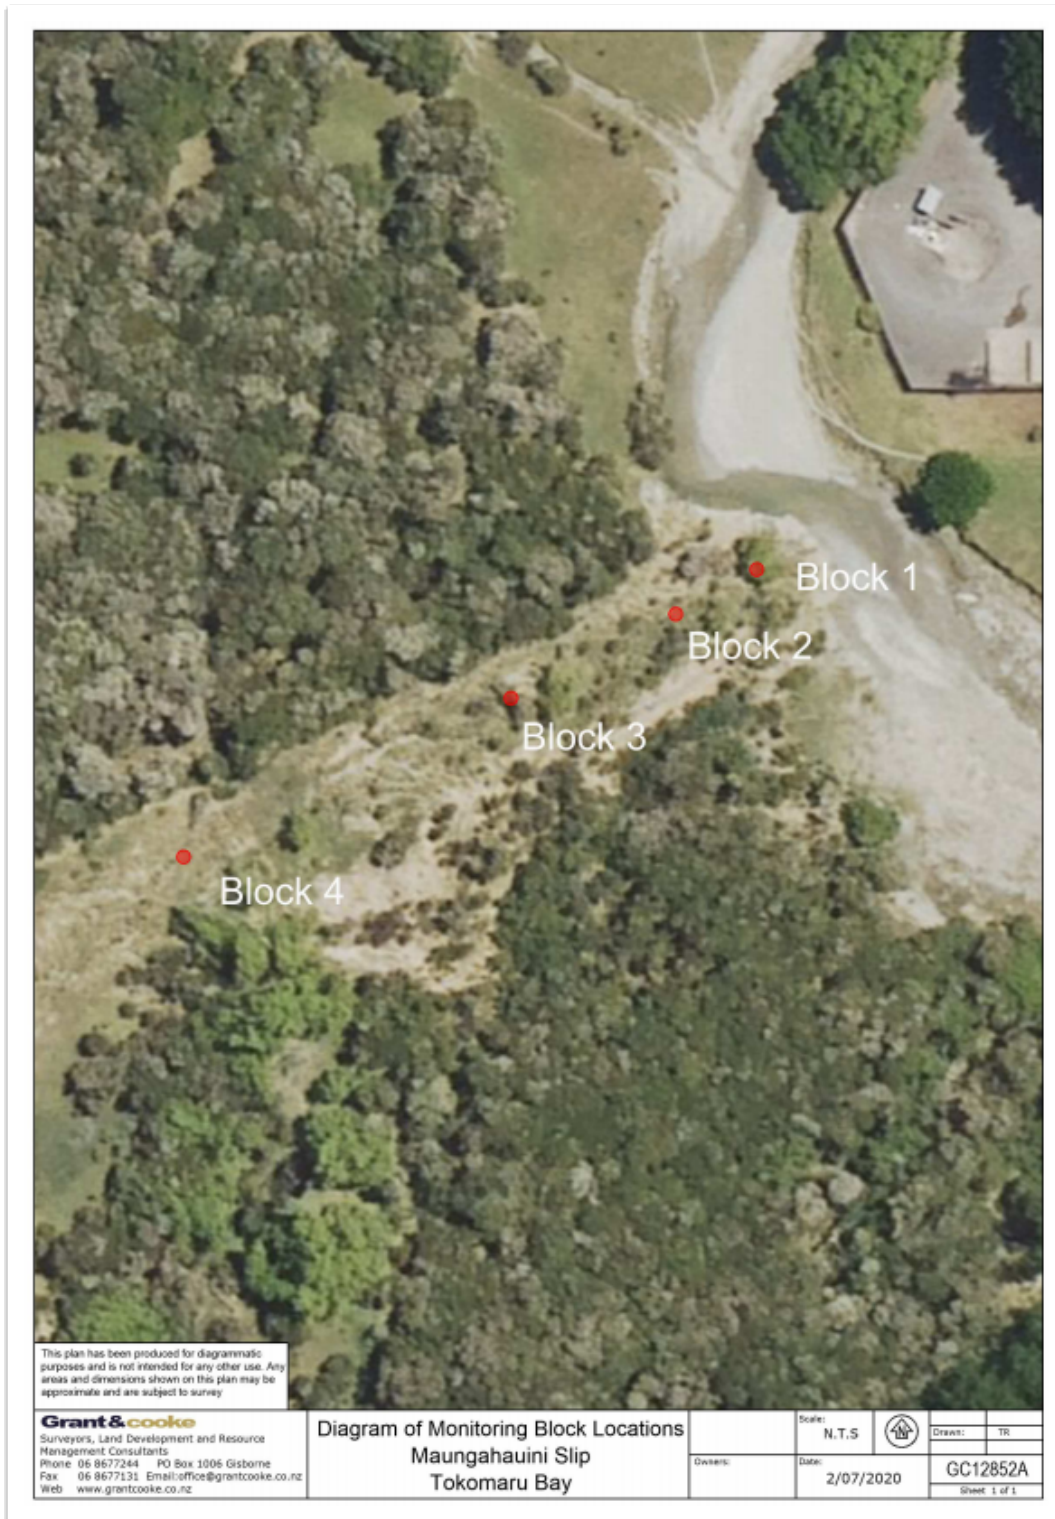
Figure 1: Slip into the Mangahauini River forcing erosion on the left bank when the river is high.

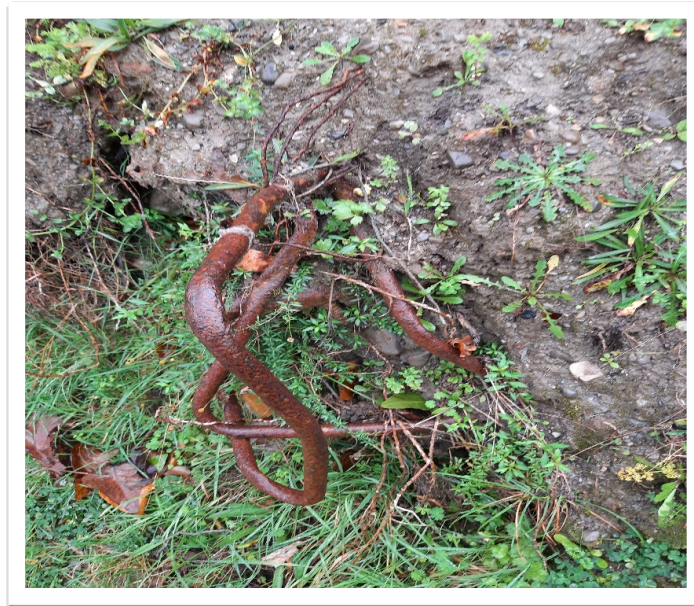
Figure 2: Metal protruding from the landfill. The Mangahauini River located to the immediate front.

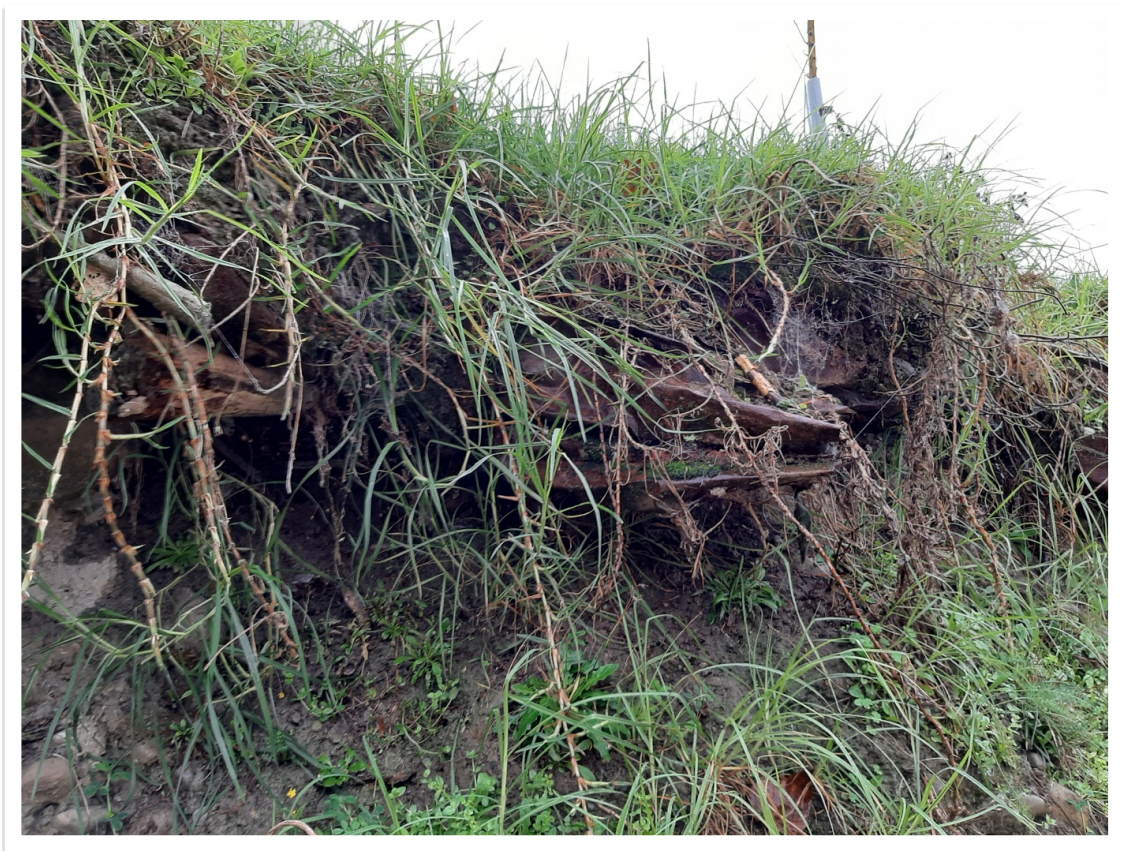
Figure 3: Further metal protruding from the landfill. The Mangahauini River located to the immediate front.

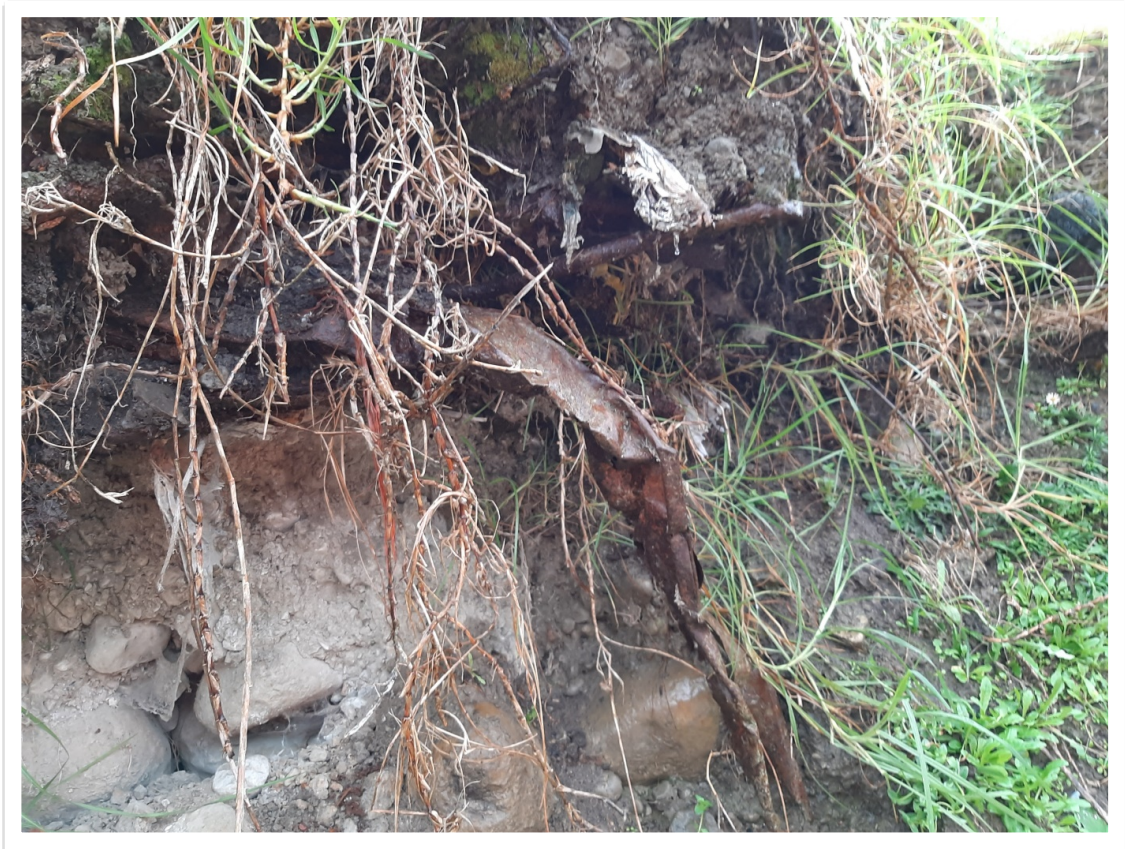
Figure 4: Further along the left bank metal continues to protrude. The Mangahauini River located to the immediate front.

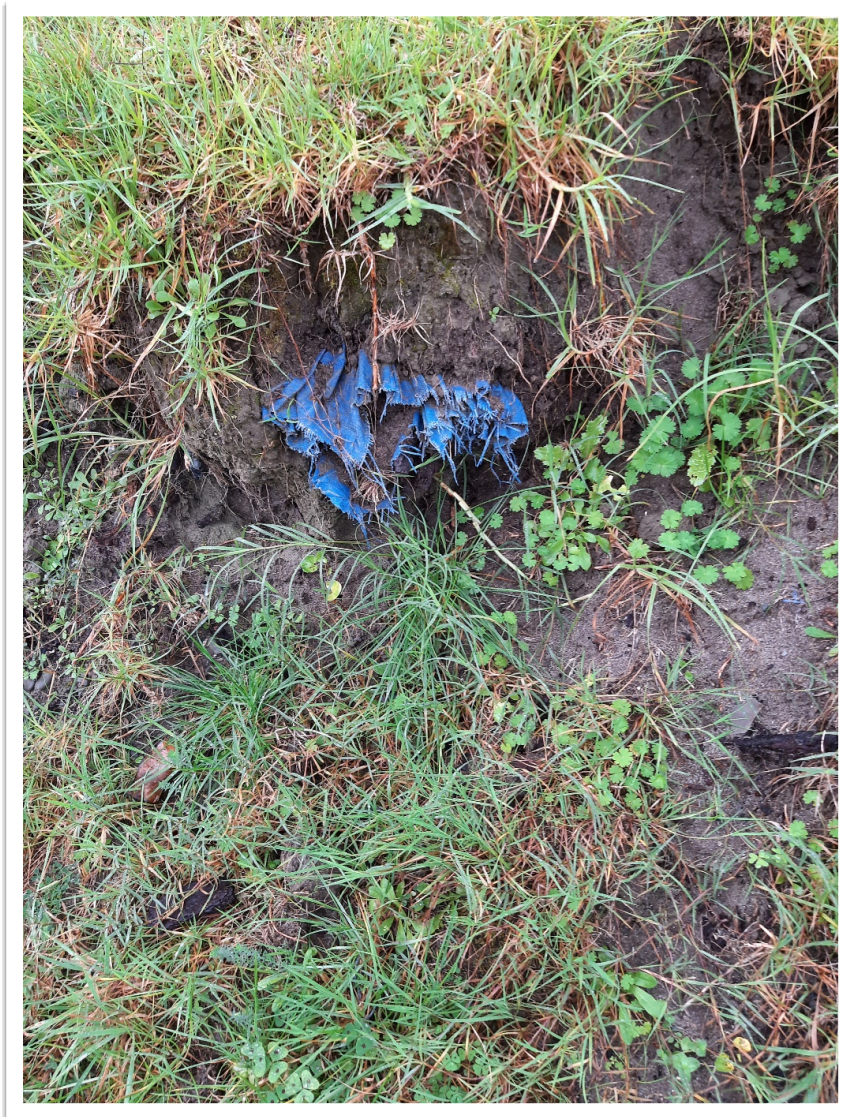
Figure 5: Close up of a tarp from the legacy landfill. The Mangahauini River located to the immediate front.

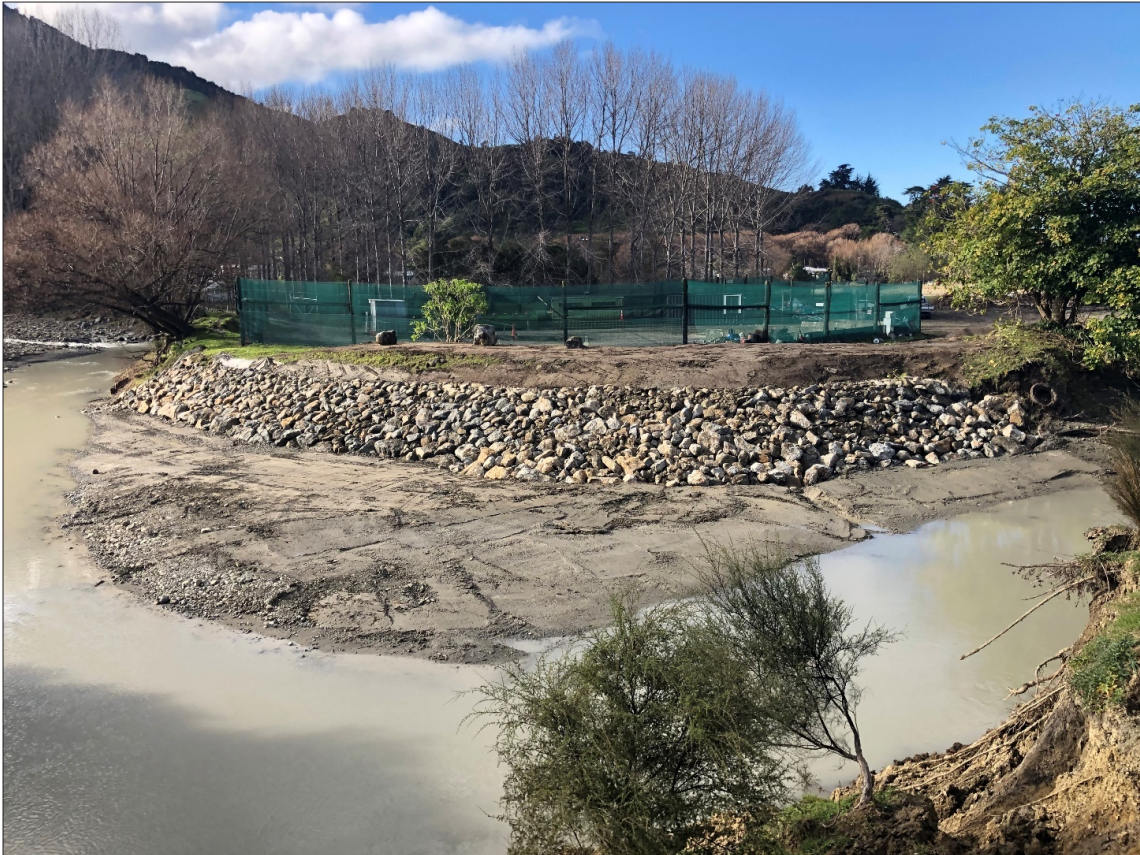
Figure 1: Rock revetment protection sealing the landfill in August 2020. Source: GDC.

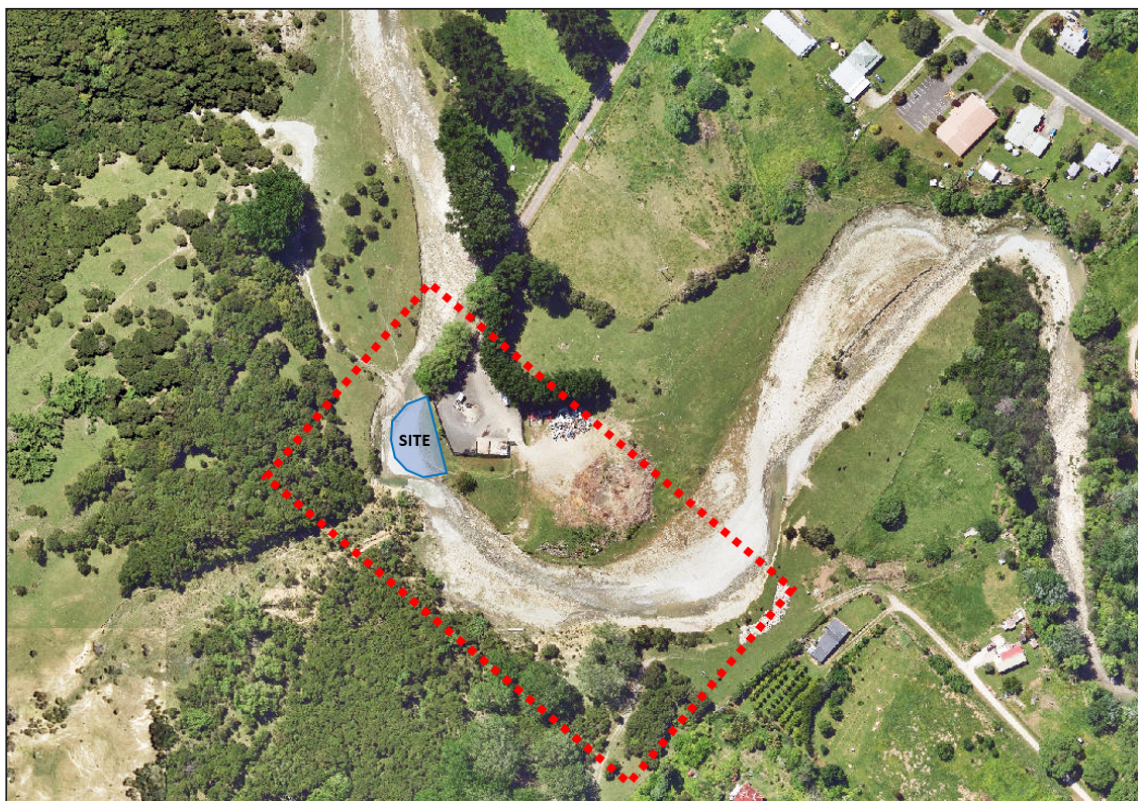
Figure 4: Aerial view of the site showing the approximate UAV survey area (red).

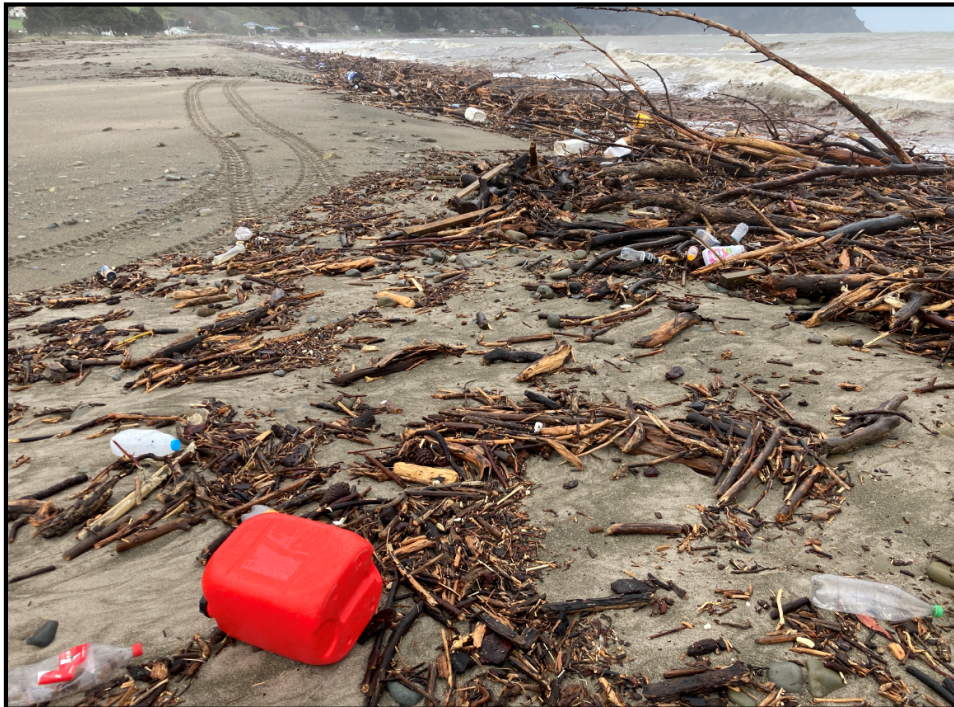
Figure 1, beached rubbish

4. A site visit was conducted 21 JUN 2021 to assess the flood damage to the Tokomaru Transfer Station. The Transfer Station perimeter fence failed to contain the contents, compiling the issue was large plastic containers and other items are stored outside the perimeter fence aligned with the consent this resulted in beached rubbish indicated by *figure 1, beached rubbish*.

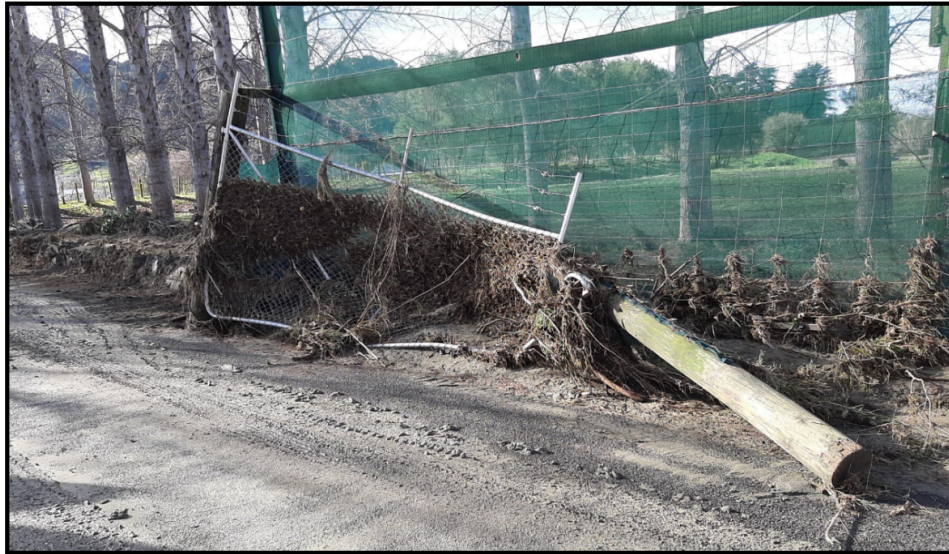
Figure 2, Perimeter fence entry gate

7. The perimeter fence suffered extensive damaged indicated by *figure 2 perimeter fence entry gate*, a new entry gate, posts, and wind break will need to be replaced. The original fencing was not fit for purpose and if repairs are conducted on the Tokomaru Transfer Station alternative wire fence netting should be consider ensuring containment of surface rubbish. Silt caught in the fence indicated the water level approx. 1 meter high over the transfer station, other areas were two meters high indicated by *figure 1 Tokomaru Landfill, low point*. The perimeter fence failed to contain surface rubbish and large containers and other rubbish were washed out along the beach it is ALMOST CERTAIN rubbish and fine plastics washed into the Pacific Ocean.
