AGENDA

OPERATIONS - INFRASTRUCTURE/NGĀ WHAKAMAHI - TE HANGANGA Committee

| 9.1. 23-39 Tonkin & Taylor Flood Investigation Report - 2022 | 4 |
| 9.2. 23-40 Tokomaru Bay Transfer Station Update..... | 98 |

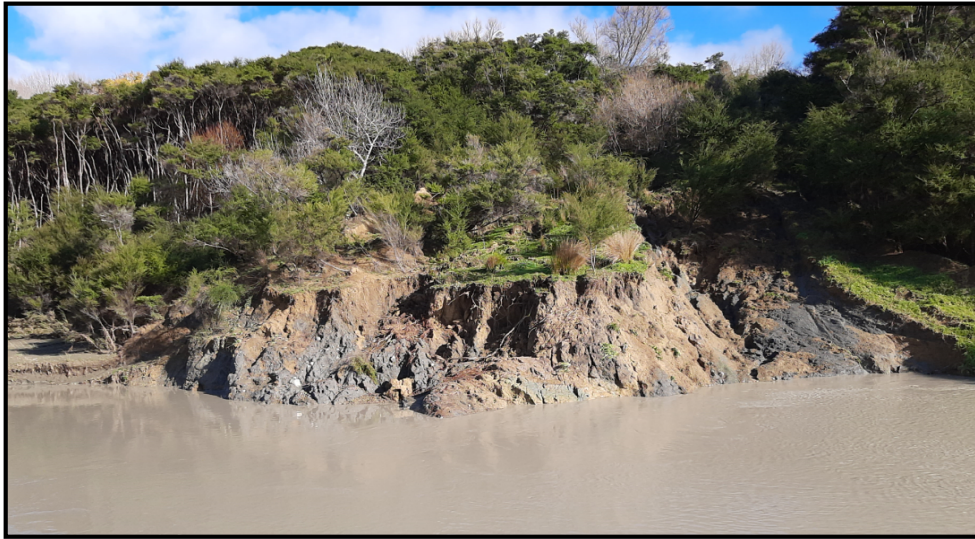
Figure 3, Landslip

10. The landslip located on the RB across from the revetment wall has moved approx. 15 meters falling into the Mangahauini river indicate in *appendix A and figure 3, Landslip*. During the site visit water was running down the slip feeding into the Mangahauini river pushing more land forward. It is HIGHLY LIKELY that this recent slip has not stabilized and will need more time to settle, It is ALMOST CERTAIN that this will not happen over the winter months.

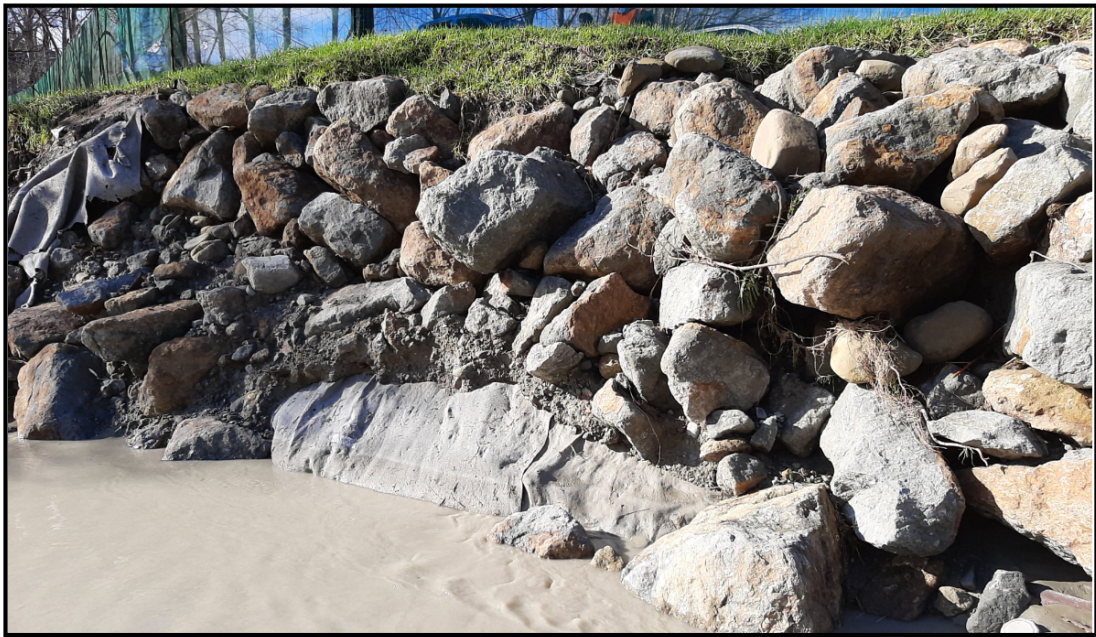
Figure 4, damage to Revetment wall

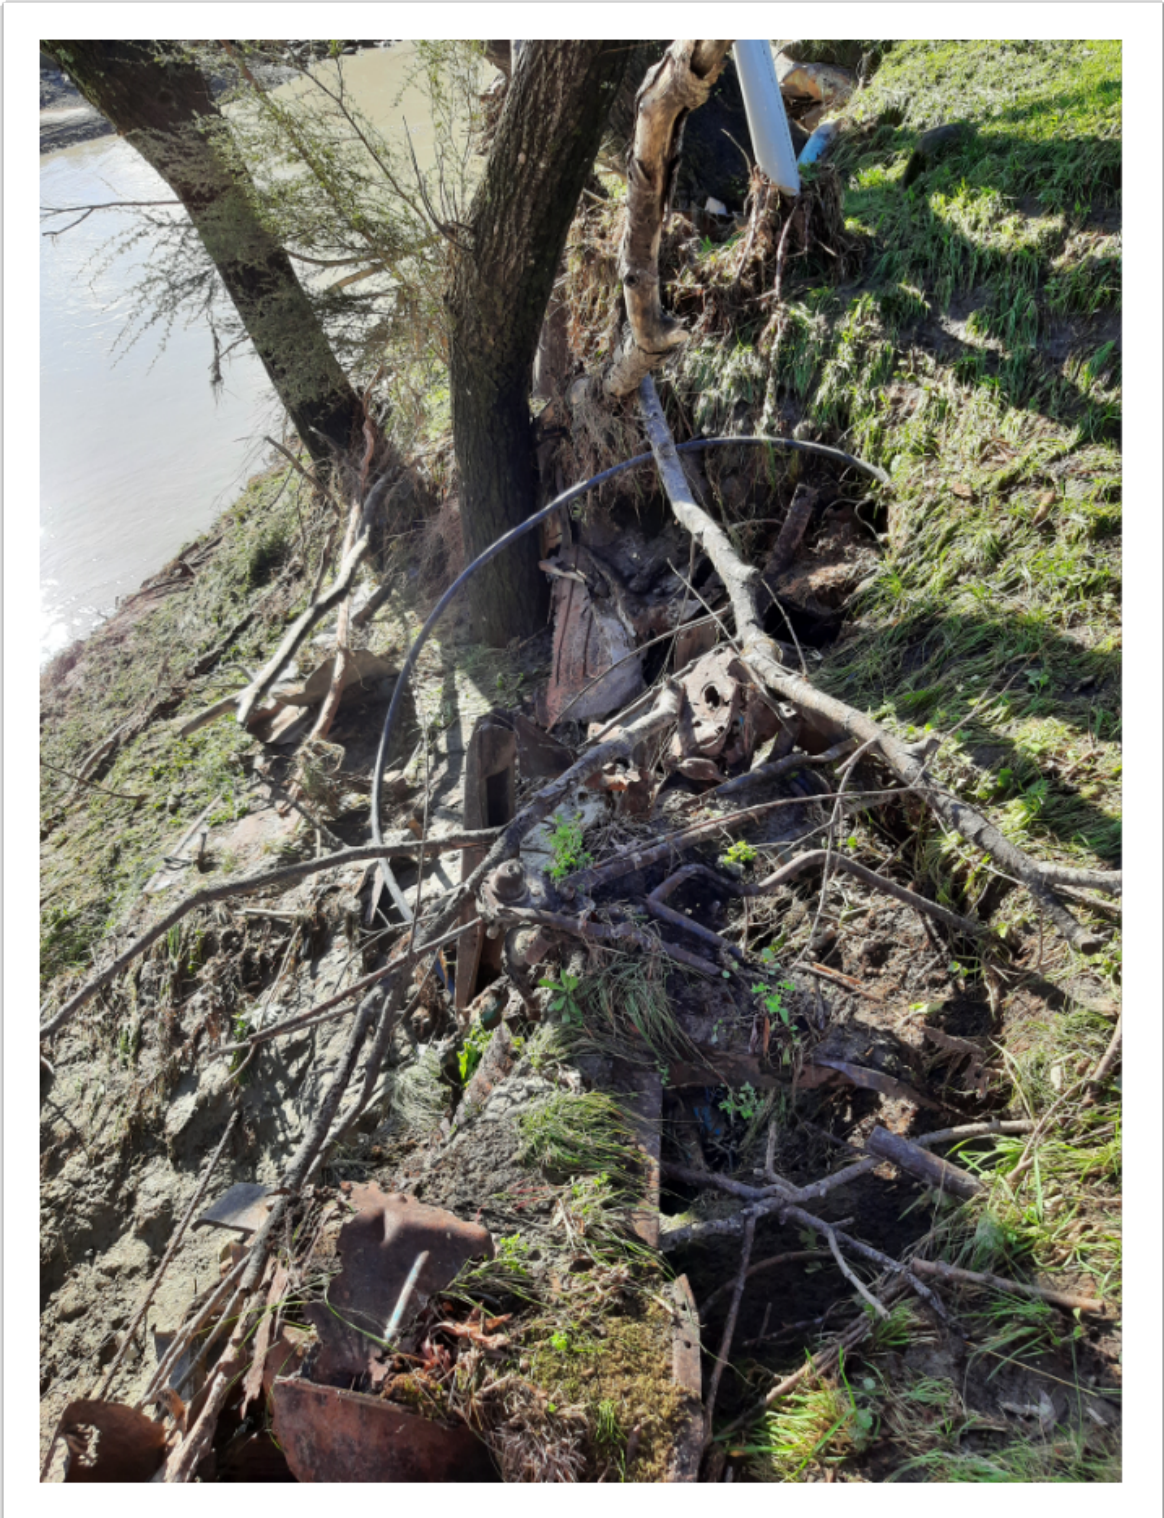
Metal protruding from the Tokomaru Legacy Landfill after the 19 JUN 21 flood event.

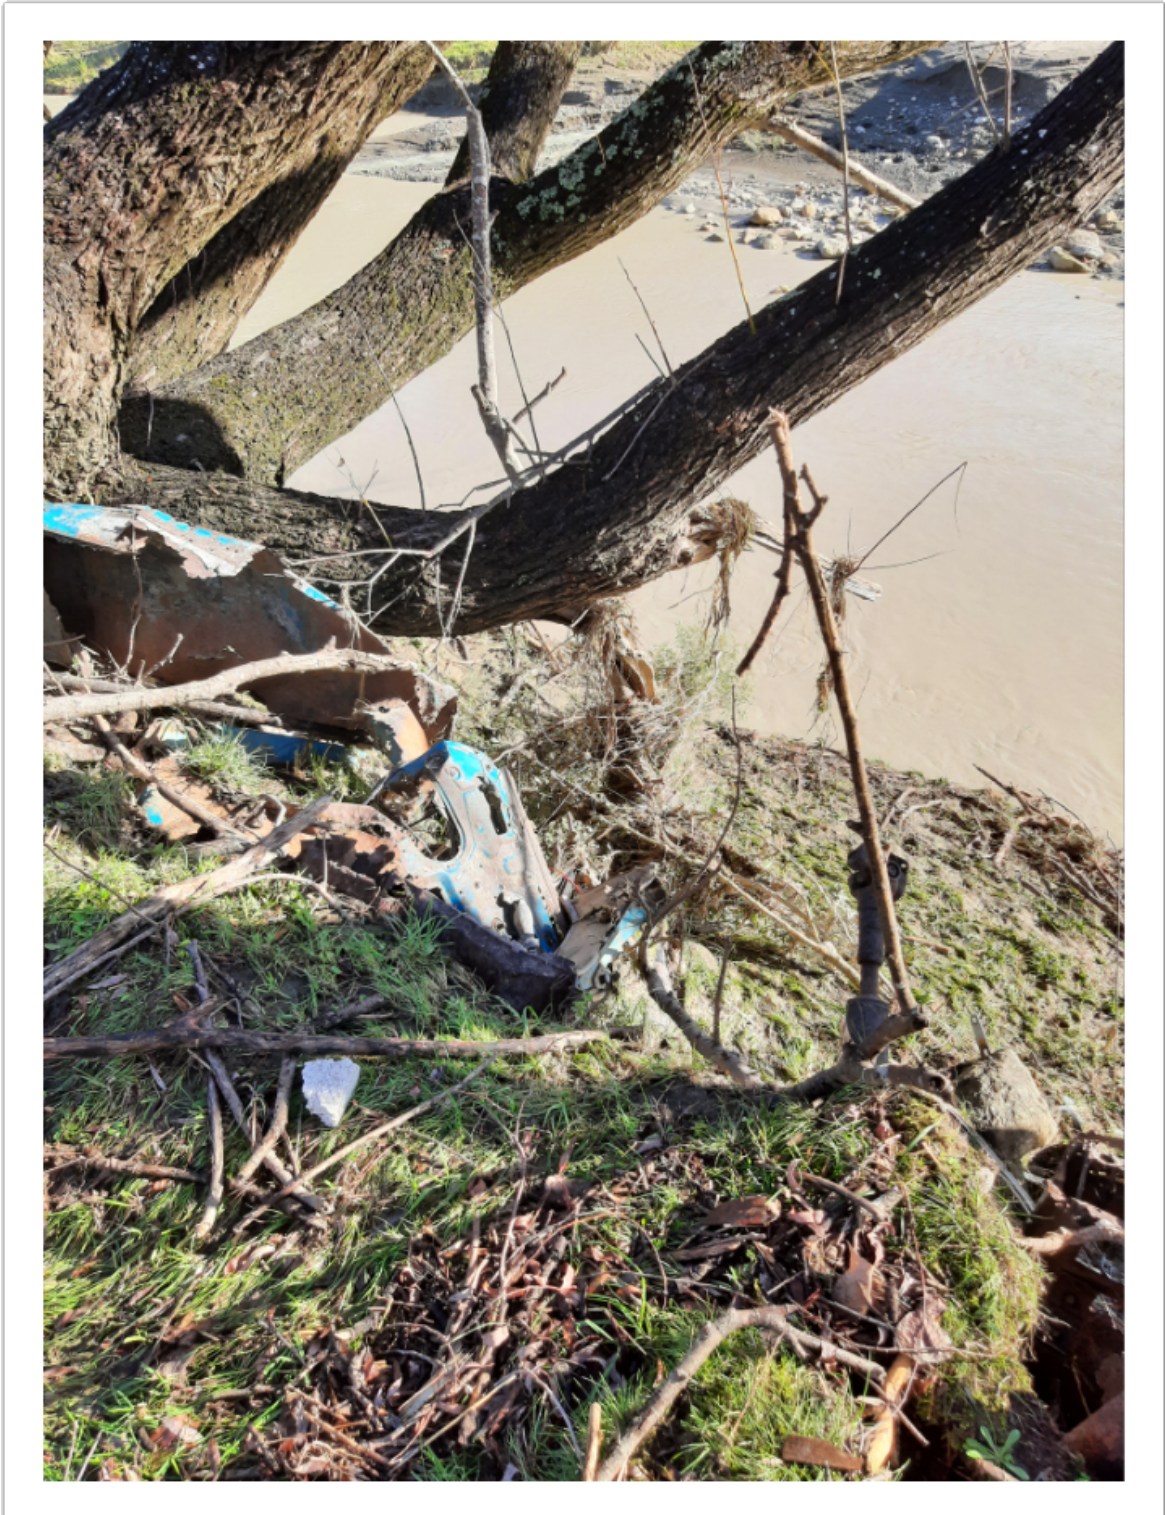
Further metal protruding from the Tokomaru Legacy Landfill after the 19 JUN 21 flood event.
