Before the Hearings Commissioners at Gisborne District Council

in the matter of: An application by Eastland Port Limited for land use consents, coastal permits and other consents related to the Port of Gisborne upgrade project known as "Twin Berth Stage 2"

Statement of evidence of **Mark Poynter** on behalf of Eastland Port Limited

STATEMENT OF EVIDENCE OF MARK POYNTER ON BEHALF OF EASTLAND PORT LIMITED

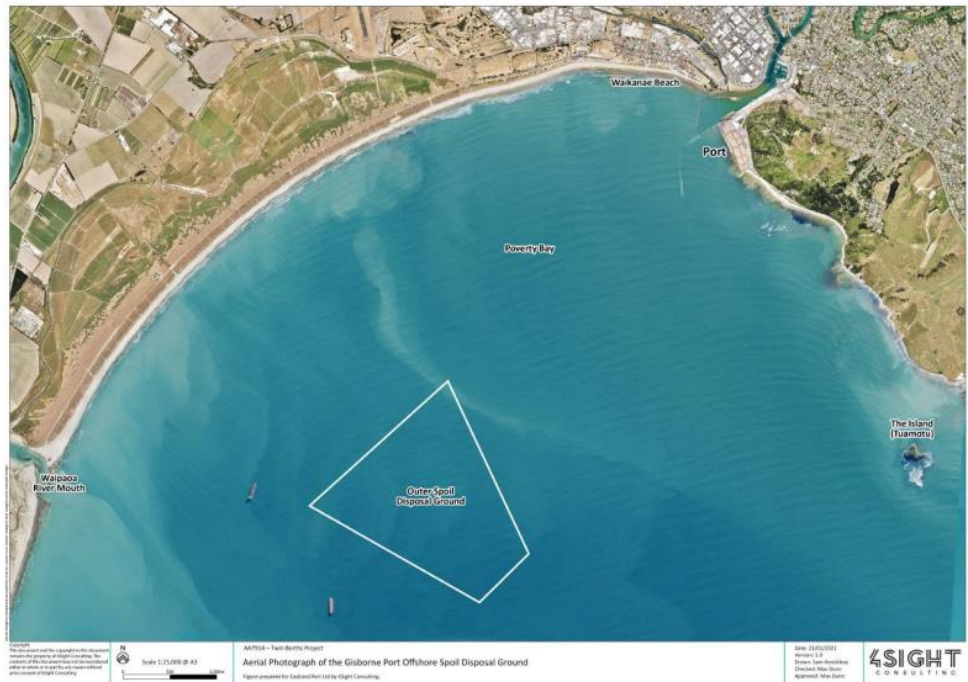
Figure 1: Key Project Elements

- 21 The physical footprint of the Project is mostly a highly modified and/or man-made environment, which is dominated, or affected, by the existing Port and its operations. **Figure 1** below identifies the Project 'footprint' which includes the Port area, the PNC and the OSDG.

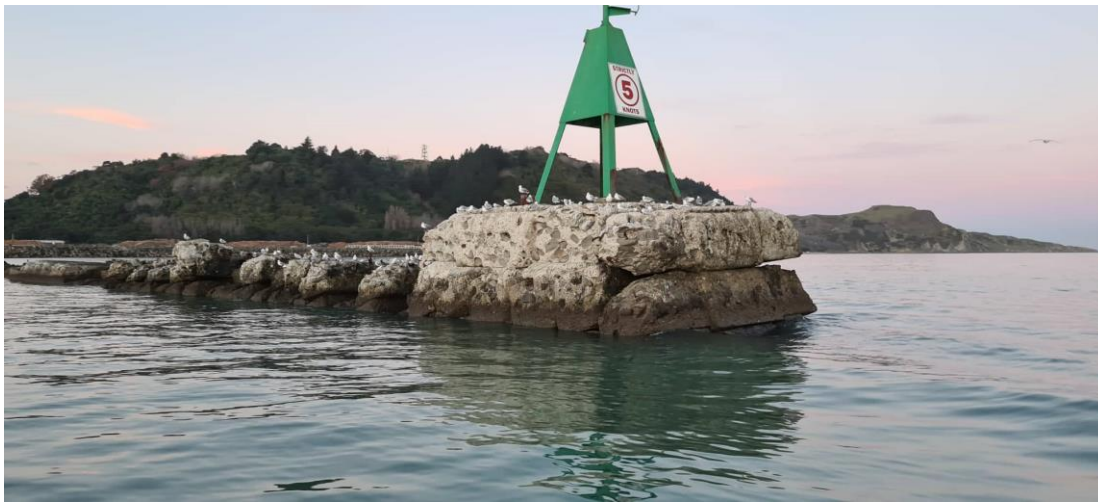
Figure 1: Flock of red billed gulls observed in June 2021 at the end of the outer breakwater.

White fronted tern (*Sterna striata*) and red billed gulls (*Larus novaehollandiae*) have been observed by 4Sight ecologists resting on the elevated outer end of the outer breakwater (near the starboard channel marker for port entry, Figure 1 in June 2021). During a 4Sight site visit in January 2023, variable oyster catchers (*Haematopus unicolor*) were observed to be foraging on the outer breakwater (Figure 2). In a different location along the outer breakwater, a pied shag (*Phalacrocorax varius*) was observed to be roosting on the rock (Figure 3).

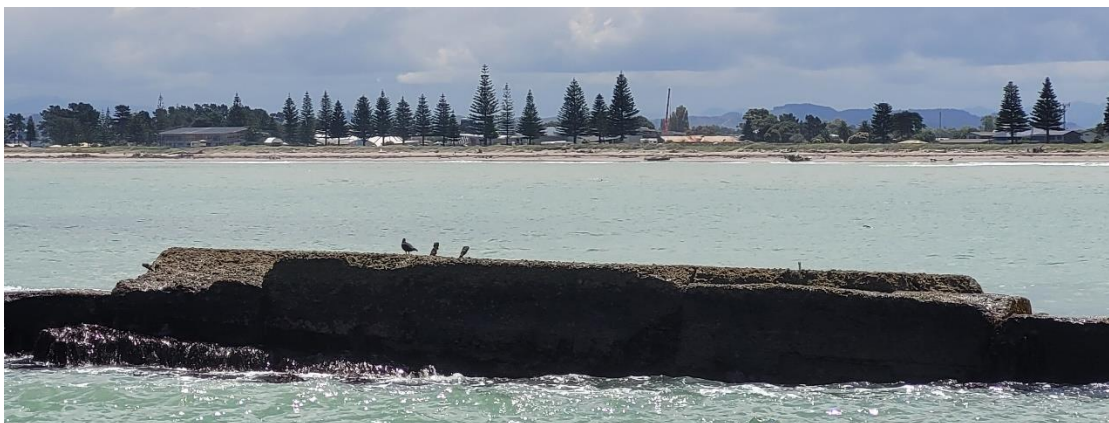
Figure 2: Three variable oyster catchers observed to be foraging on the outer breakwater on 24/01/2023.

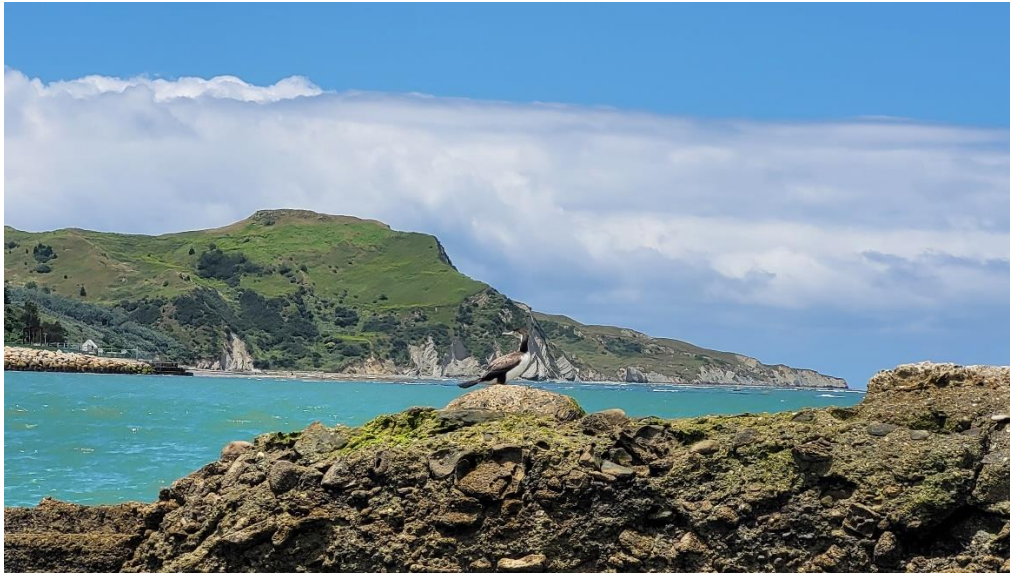
Figure 3: A pied shag was observed to be resting on the outer breakwater on 24/01/2023.

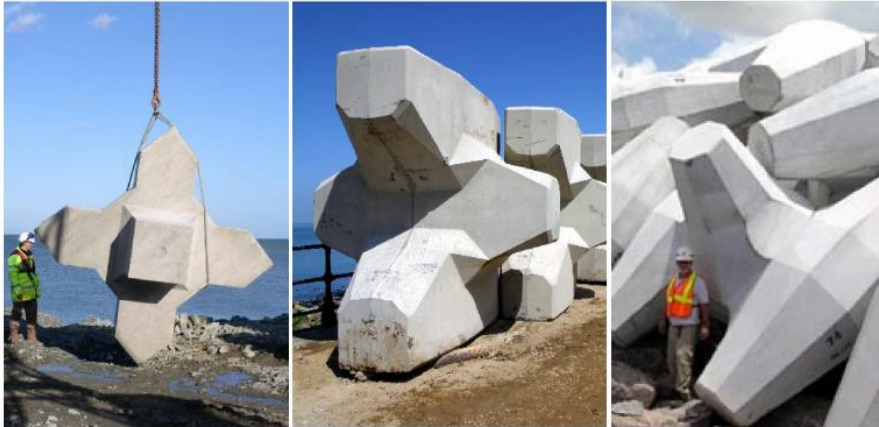
Figure 3-5 – Left – X-bloc® (4 m³/9.6 t, Port Oriel, Ireland). Centre – Accropode units (6.2 m³/14.9 t, Scarborough UK). Right – Core-loc® (15 m³/36 t, Kaunapau Harbor, Hawaii). (Reedjik & Muttray, 2009)

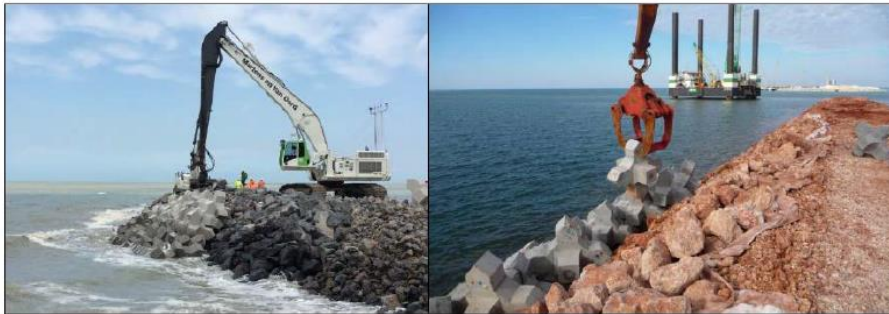
Figure 3-6 – Examples of typical random placement of X-bloc® units

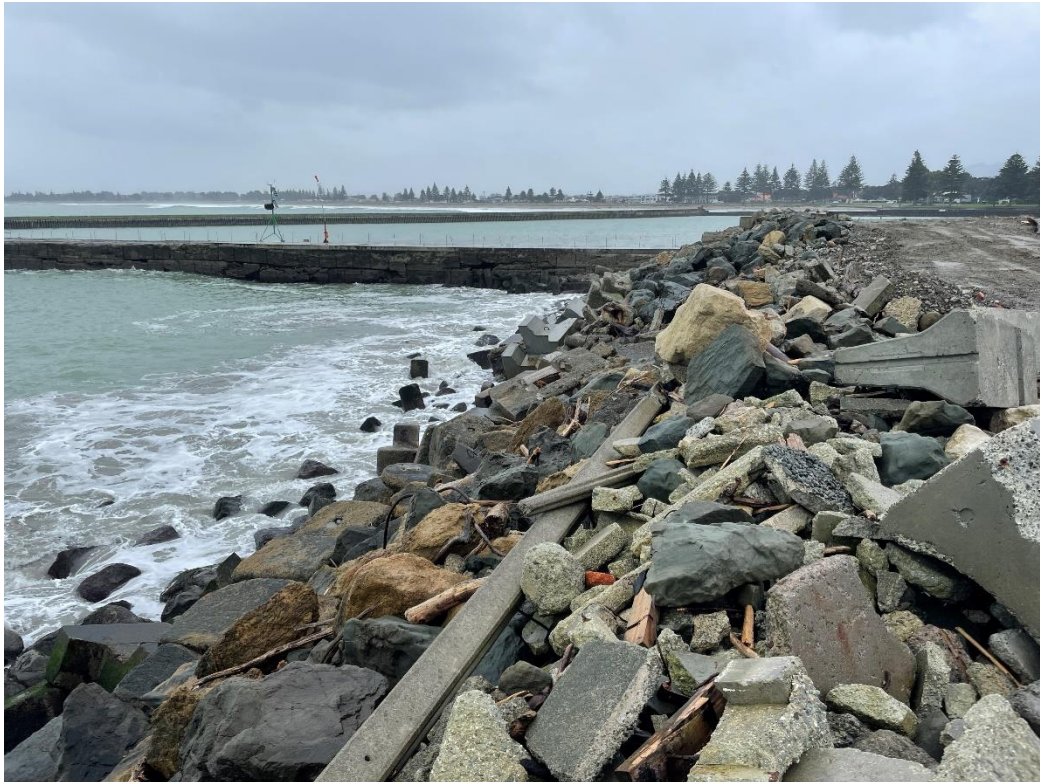
Figure 7: Outer seawall dominated by large rocks and concrete pieces.

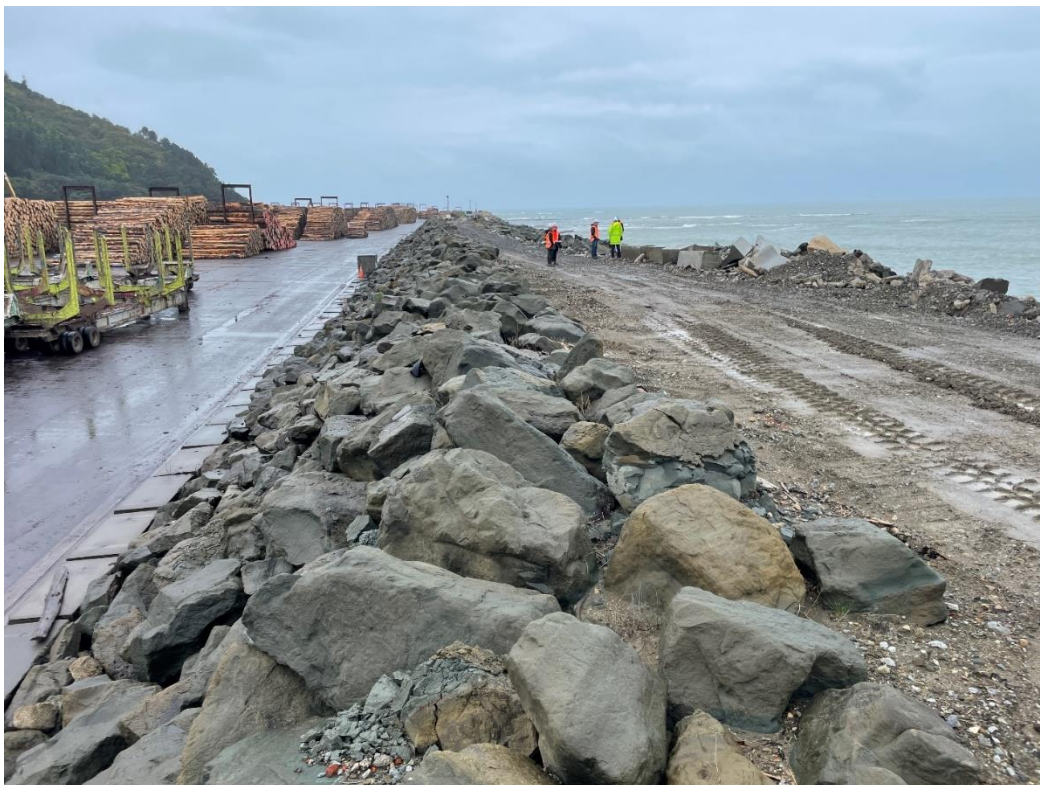
Figure 8: Inner riprap seawall that separates the logyard from the road and the outer seawall that will be deconstructed.

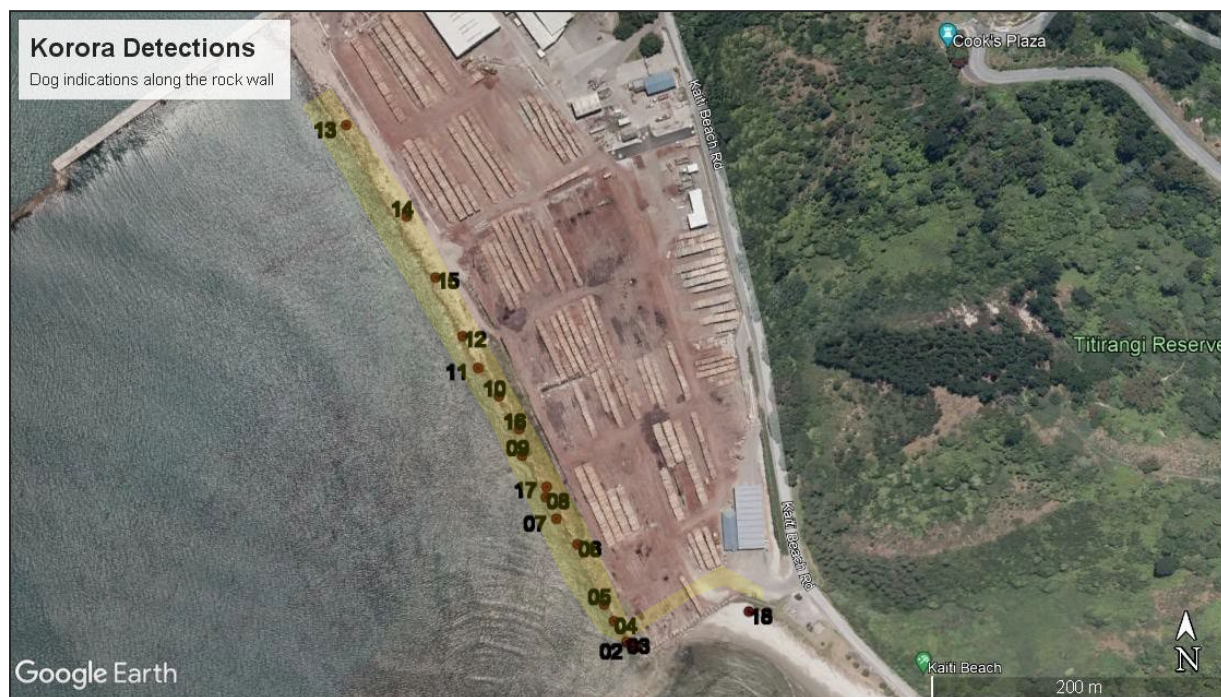
Fig 8: Locations at EPL southern log yard where kororā were identified by Jo Simm and search dogs Rua and Miro (Map Courtesy of Dabchick NZ -Jo Simm).

A total of 18 detections were recorded by Jo and Rua. Detections were made across all sections of the revetment wall. Upper and lower tiers and both old and new sections of the wall. Nine individual

kororā were sighted. Jo believes others were onsite, however were well hidden amongst the rock wall.

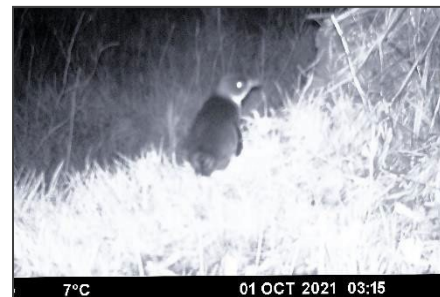
Fig 12: A kororā using a communal access track on Young Nicks Head Station, Gisborne.

Often blue penguin will use a primary access route to enter and exit a colony site to and from the tide line. In some areas these tracks are used over many generations, and we have recorded significant tracks cut into hard bedrock formed by many generations of seabird using the same access route.

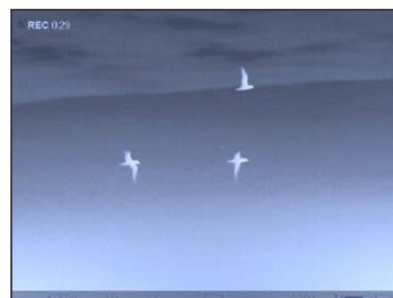
Fig 15: A group of pre-breeding grey-faced petrel (*Pterodroma macroptera*) at Young Nicks Head, Gisborne, July 2021. Observations made using a thermal camera allow us to estimate number of individuals present which is otherwise impossible with fast flying nocturnal procellariiformes.

Another option which allows for excellent observation of pelagic seabirds is to use thermal imagery. This has been used by Ecoworks NZ at a number of sites within Tairāwhiti and in Hawaii and has been an effective tool to record grey-faced petrel, sooty shearwater, blue penguin and kiwi activity at remote sights and when no moon is present.

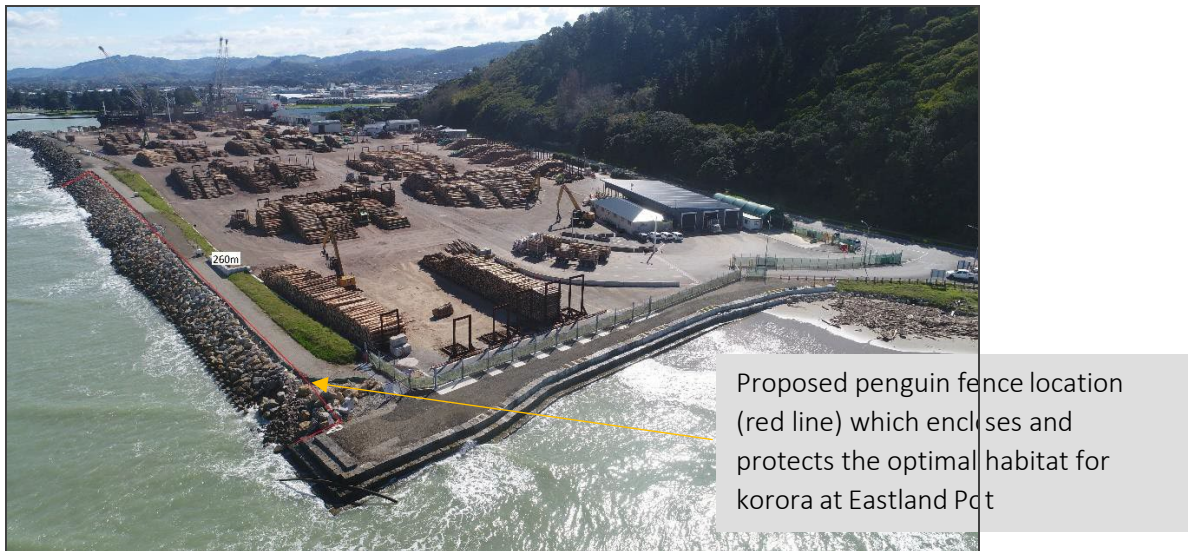
Fig 18: Aerial view of the Southern log yard revetment wall and proposed location of the penguin fence.

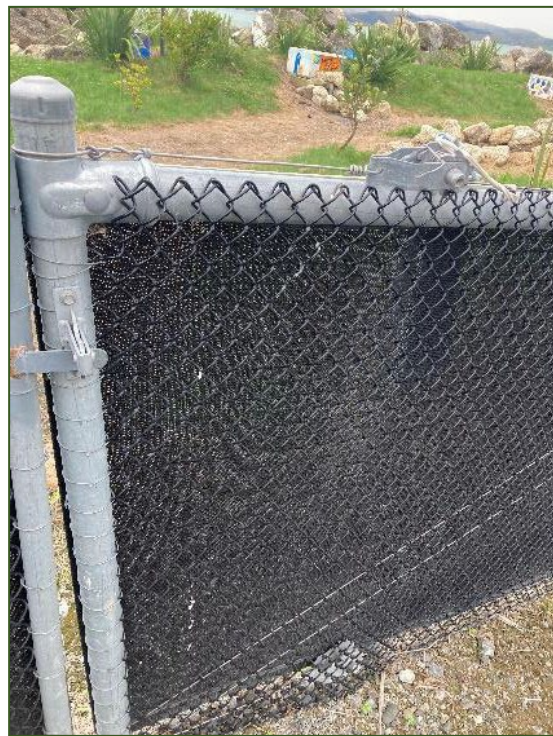
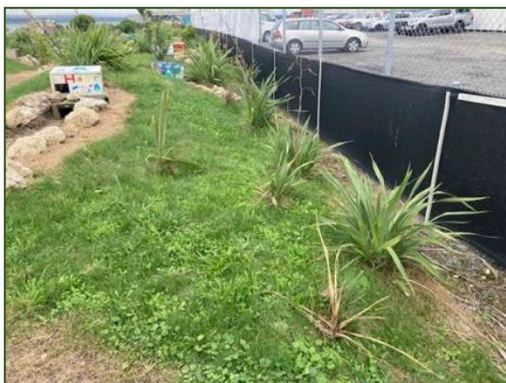
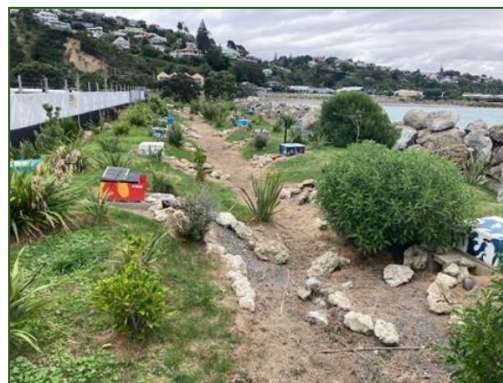
Figs 19-20: Napier Port colony site showing the penguin fence which prevents kororā exiting the colony and entering vehicle access areas (Photos Supplied – Paul Rose, Napier Port)

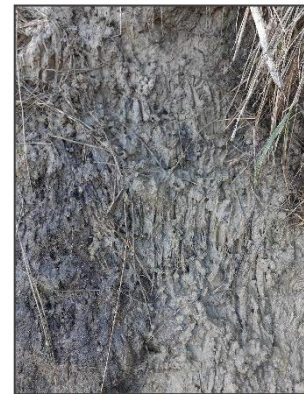
Fig 21: Kororā prints on an almost vertical face at Orongo Beach, Tairāwhiti. Many kororā use only three entry points to the colony site.

We have recorded kororā accessing steep mudstone faces at Orongo Beach on Nicks Head Station (right) and climbing over 100 metres in height to the top of southern Mana Island in Wellington to access nesting burrows. Some nesting colonies have only 1-2 access points and many individual kororā will use the one entry point and then walk several hundred metres to access their burrow.

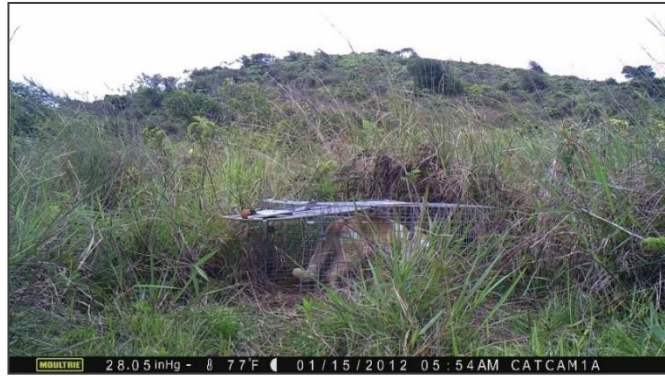
Fig 23: A feral cat enters a 'Havahart' cage trap with a disguised floor treadle trigger which ensures a humane catch method for feral or domestic cats.

Cage trapping is preferable at this site due to the number of EPL staff and possibly members of the public present. When feral cats are detected by remote camera or are sighted by EPL staff an SA kill trap on a raised ramp or a live-catch cage trap could be deployed to ensure inquisitive kororā are in no way injured. Some feral cats will not enter a cage trap therefore an SA trap is an effective option.

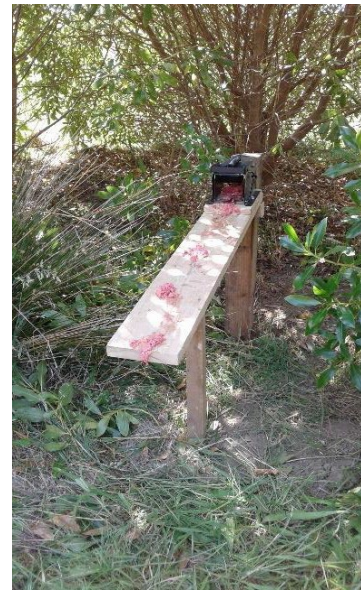
Steve Allen (SA) Trap

Traps are set at the top of a wooden ramp. The ramp is an 800mm length of 150 x 25mm H3 radiata. It runs at a 5-10° angle and extends from the tree with the lower end bugle screwed into the top of a 50 x 50mm tanalised wooden fence batten driven into the ground to a depth of 200mm (Refer photo attached).

Fig 24: A correctly positioned raised feral cat set.

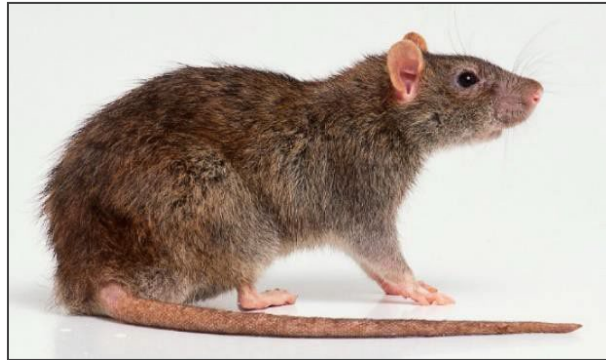
They have small ears which hardly reach the eyes if pulled forward, the blunt nose profile and the thick tail which is less than the length of the rats body.

Fig 27: Norway rat –small ears, blunt nose, thick tail, a burrowing rat species.

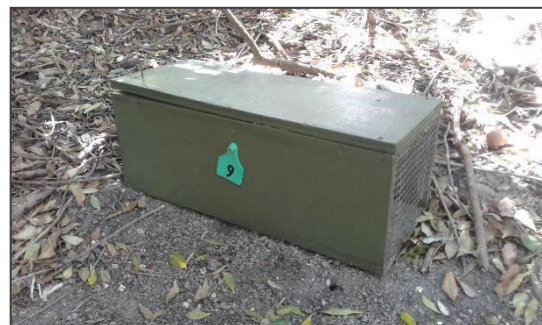
Wooden Set

The trap set is a wooden tunnel 600mm in length (800mm in weka areas). It is constructed of treated H3 radiata pine. Both 200 x 25mm for the walls and 250 x 25mm rough sawn H3 for the base. The box is screwed together using #2 square drive screws. The lid is made of 17mm plywood and cut 600 x 250mm. A warning sign must be stencilled on the lid with spray paint and in high visitor areas the trap boxes must be painted and presented to a high standard.

A plastic triangular track marker or cattle ear tag must also be screwed to the lid with the trap number on it (above). Cattle tags can be ordered from PGG Wrightsons with the printed number or code required for your traps. The 17mm ply trap box lid is screwed at diagonally opposite corners with a square drive 40mm stainless steel screw to prevent access to anyone other than the trapper. Treated ply is preferred as it does not buckle over time.

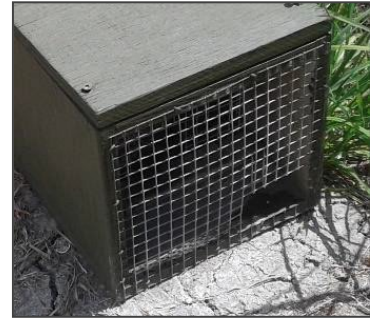
Netting Hole Size

In areas where ground nesting species such as kororā are present a double mesh screen is key. These screens also help direct mustelid's onto the 'trip plate'. Twelve- millimetre aviary mesh is stapled to each end of the tunnel using small fence batten staples and another screen is set 150mm inside the tunnel with a second mesh screen. An entrance hole is cut at the bottom corner of the outside screen (right), 5 x 5 squares in size. The inside mesh has a hole 5 x 5 squares also cut into the centre but positioned 3-4 rows high so that mustelids climb through the hole and land directly onto either the fenn or doc200 plate. I would recommend a slightly larger hole size at this site to allow easy access for ferret. It will be impossible for a kororā to access a double mesh screened trap set. An entrance hole approx 75 x 75mm will allow access to all mustelids (including ferrets) and keep out protected wildlife.

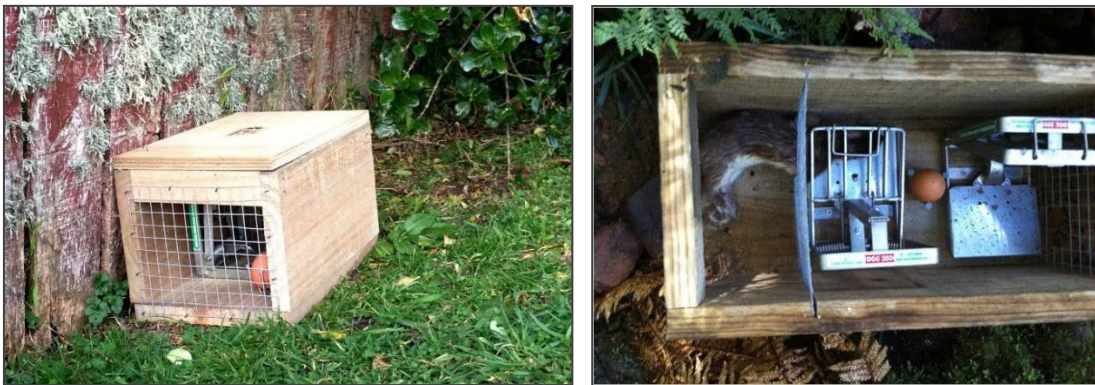
Figs 39-40: Two options using DOC200 sets, the single set box and the double set at right with mesh holes cut to direct the target species onto the trap plate. We believe that single set DOC200's catch less than double set traps (*Photo Courtesy of DOC*).

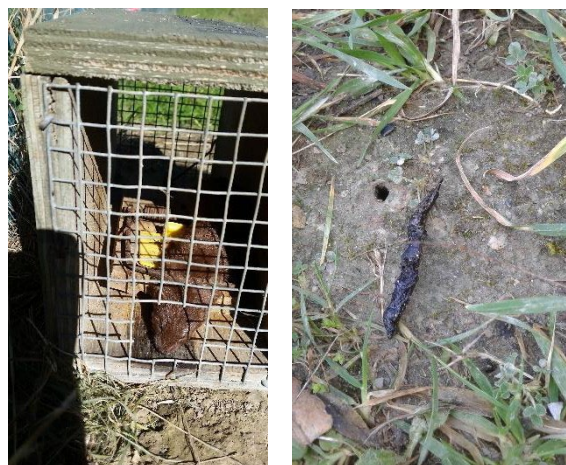
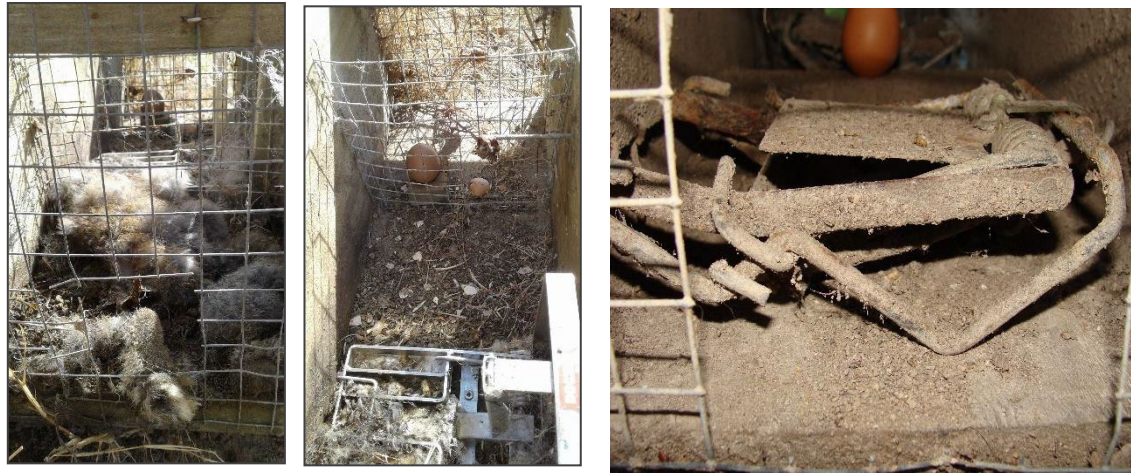
As a trapper it is vital to look for sign of predators while on the job. The far-right photo is a stoat scat (faeces). Approx 7 mm wide by 50mm long and jet black. Rat fur is usually present. Hedgehog scat is similar but does not contain rodent fur.

Predator trapping is the foundation of most species protection projects in Aotearoa. The examples above show how a trap should not be set. These traps are not at all effective, will not catch mustelids and therefore a waste of time, labour and resources. Even though the trapper has visited recently (fresh eggs!) no trap maintenance has been done.

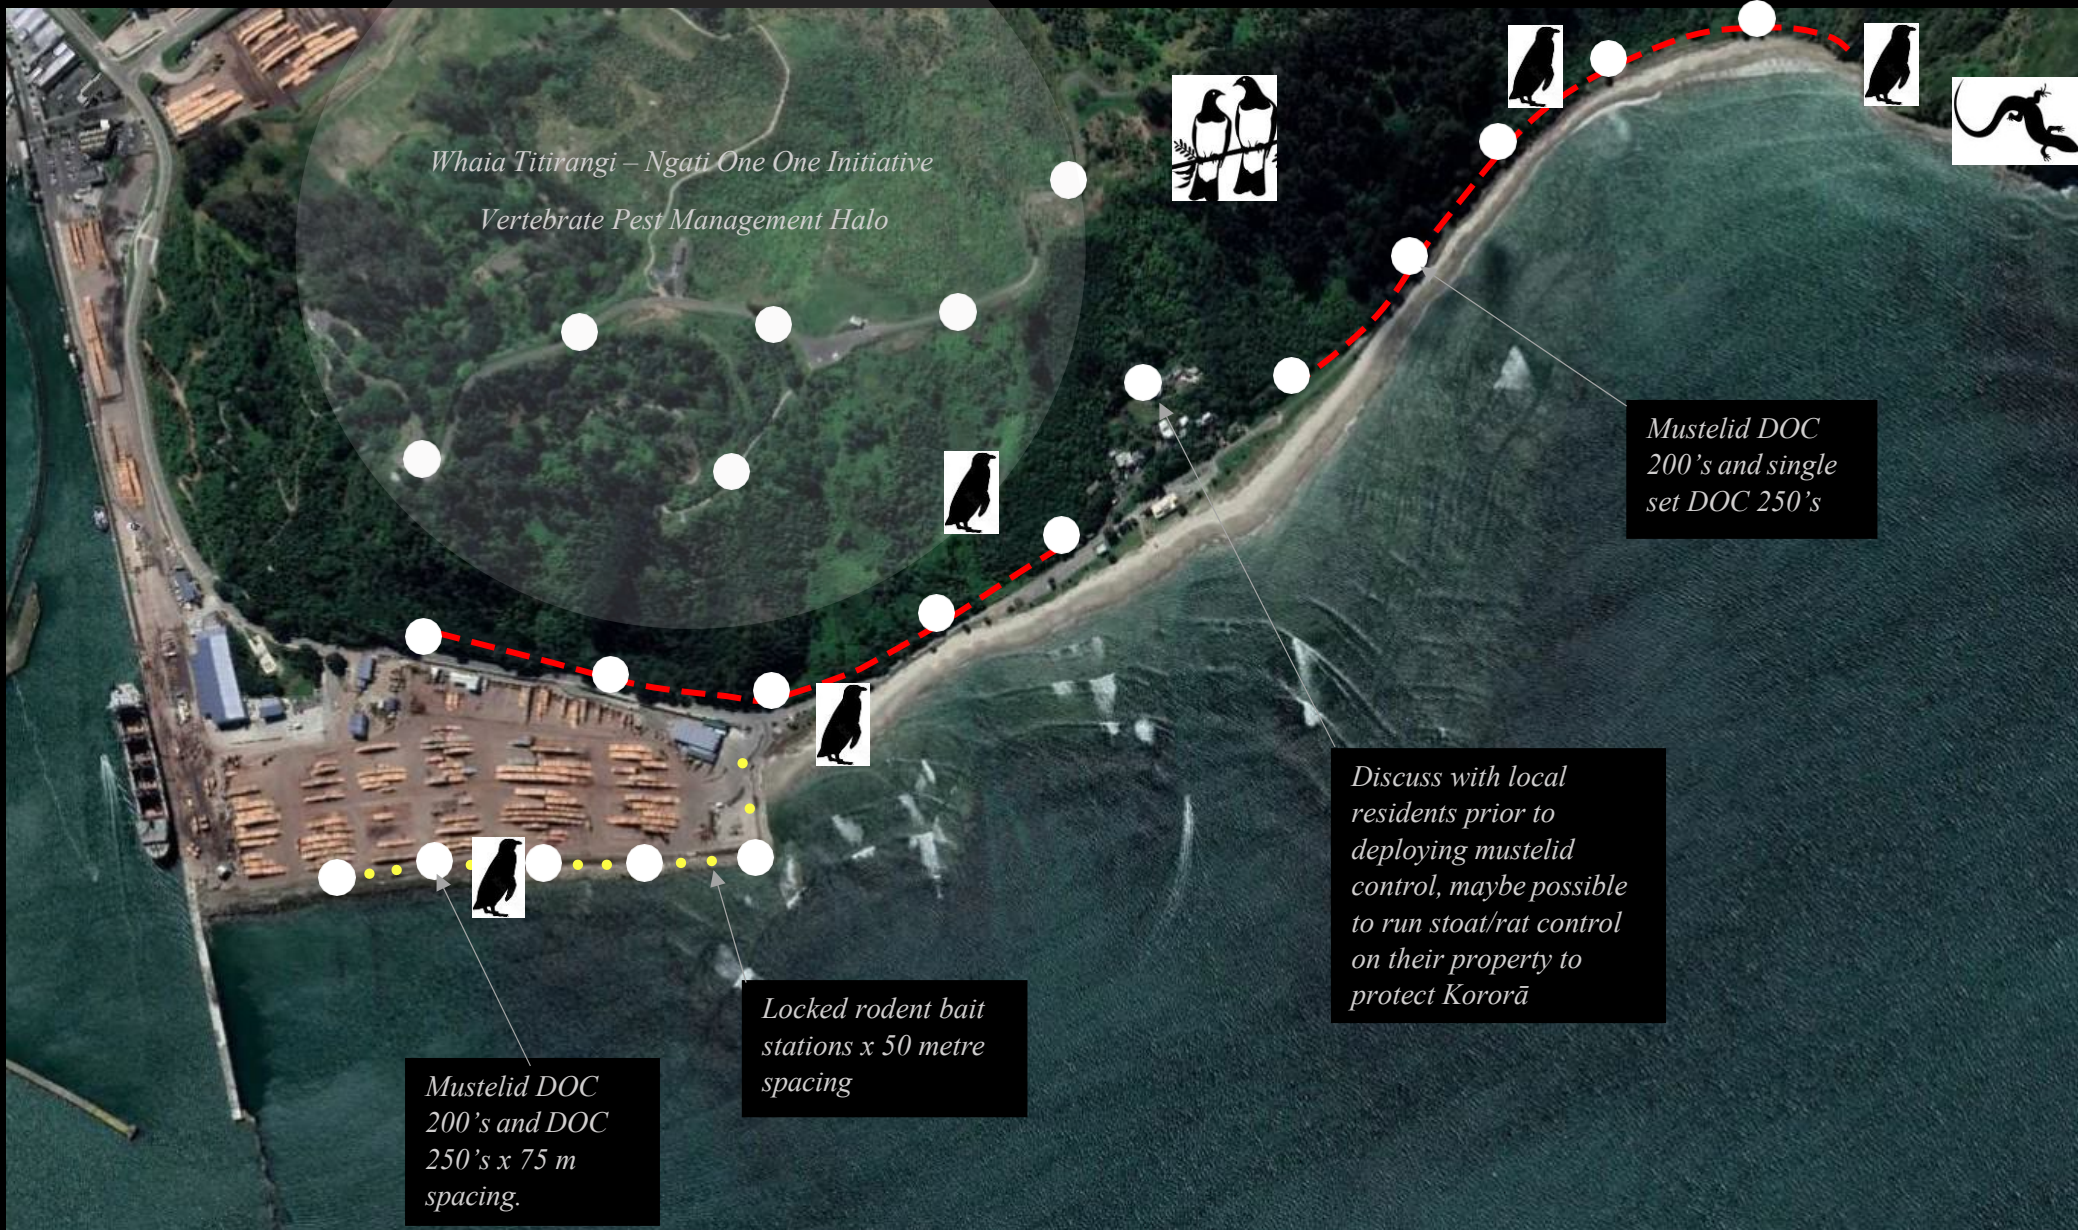
Predator Control Layout – Ferret, Stoat, Weasel and Rat Control

Target Pest Species	Control Method Options	Control or Outcome Target
Mustelids – ferret, stoat and weasel.	DOC 200 and Fenn No.6 Double sets at 200m spacing.	100% survival of juvenile & Adult Kororā at EPL/Onepoto.
Feral Cat	Cage Trap or Steve Allan trap.	100% survival of juvenile & Adult Kororā at EPL/Onepoto.
Ship and Norway rat	Ground based toxin application and Victor Pro snap traps within target areas.	Bi-annual tracking tunnel indexing target rate of <2.5% RTI.

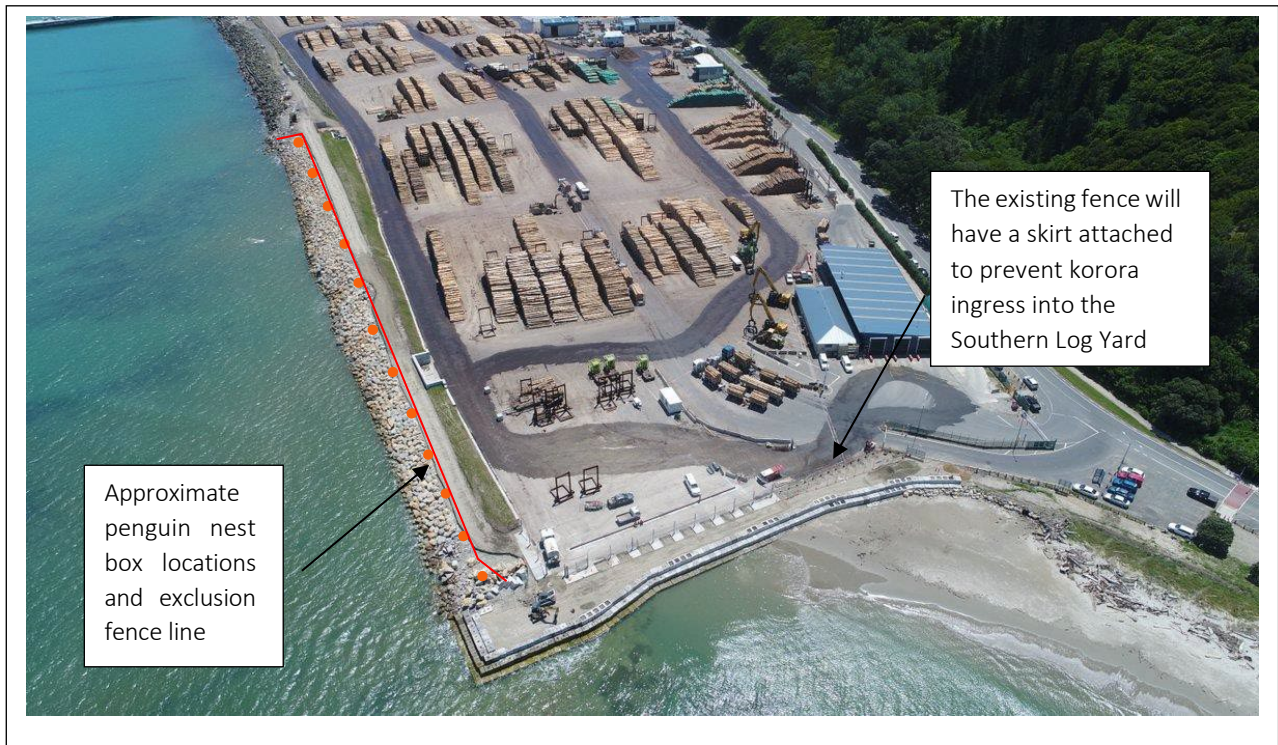
Fig 52: General nest box locations above EPL revetment (Photo Supplied -EPL).

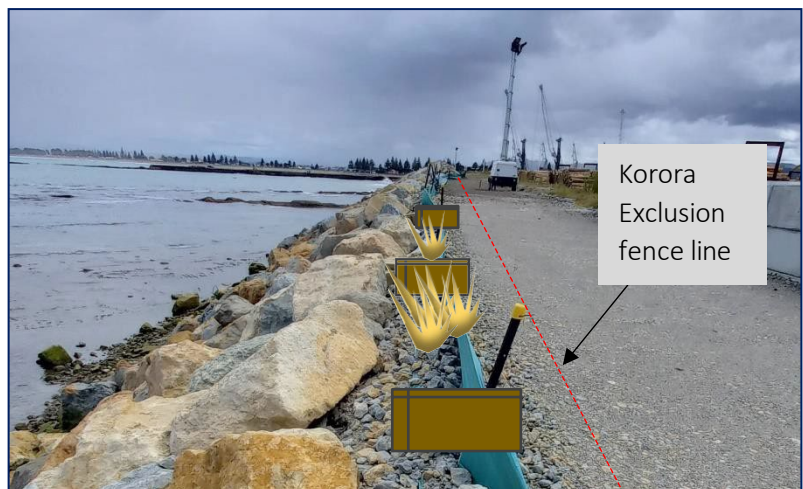
As seen here in Figure 54: the temporary shade netting fence will be removed. The new penguin exclusion fence will be positioned 1.0 metres closer to the centre of the existing access way allowing space to install the foundations and the kororā nest boxes themselves.

An excavator will be provided to supply the appropriate rock, sand and shingle to establish these nest box sites and re-locate any boulders if required to provide additional space for each nest box. A sand tussock or similar low growing coastal plant species will

also be situated between nest boxes to both improve the aesthetics of the site and to provide additional summer shade cover for visiting kororā.

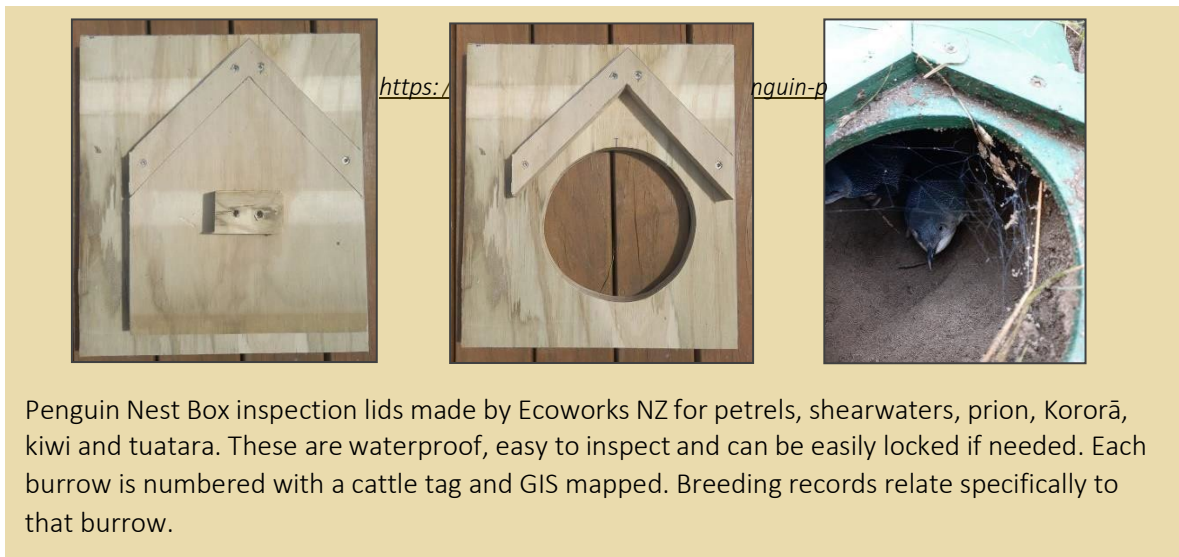
Penguin Nest Box Measurements

Penguin Nest Box inspection lids made by Ecoworks NZ for petrels, shearwaters, prion, Kororā, kiwi and tuatara. These are waterproof, easy to inspect and can be easily locked if needed. Each burrow is numbered with a cattle tag and GIS mapped. Breeding records relate specifically to that burrow.

The Eastland Port-Onepoto site will initially install 20 kororā nest boxes. The specifications for these boxes will be based on current best practice and proven design (400 x 500 x 250 high) Dave Houston, Oamaru.
