Ministry of Education
48 Hereford Street
West End
Christchurch 8013

TKKM o Horouta Wananga - 17 Ranfurly Street, Gisborne
Ground contamination investigation and assessment report

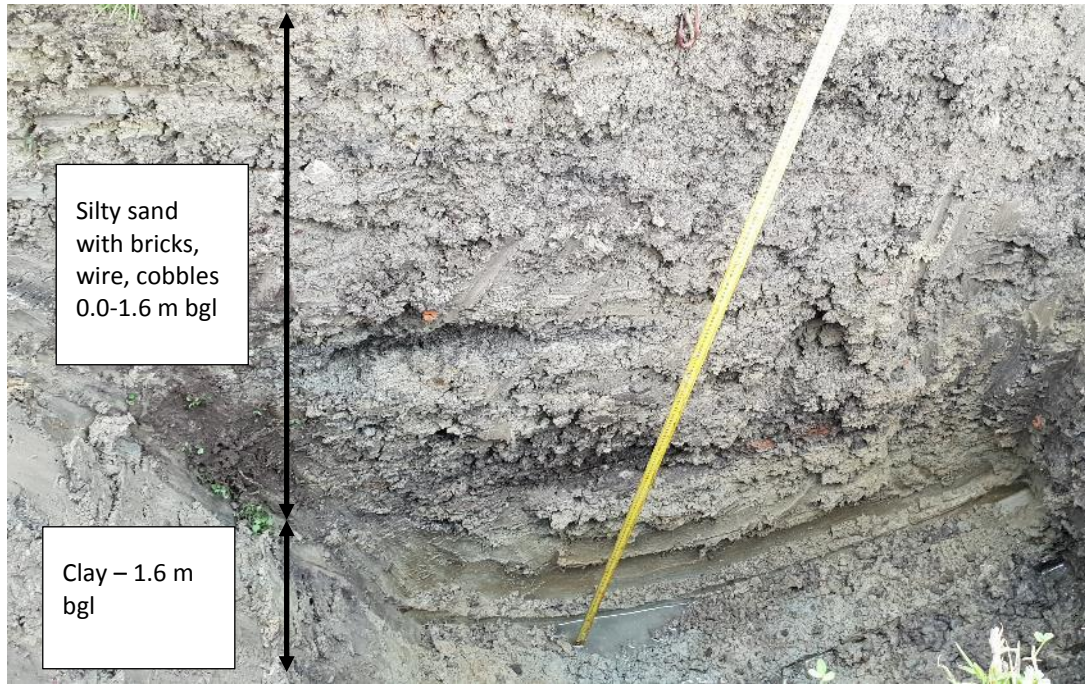
- Fill containing varying proportions of demolition material (brick fragments, concrete, wood, wire etc.) was encountered to a maximum depth of 1.7 m bgl within 11 of the 13 test pits, with the greatest thickness observed in the locations of the former office (TP11), former wagon filling stand (TP10), former tank farm (TP03) and former drum storage area (TP07).

Fragments of suspected ACM were encountered in two test pits (TP3 and TP13). Samples of fragments from both pits were collected and submitted for laboratory asbestos identification.

Photograph 1: TPO3 soil profile.

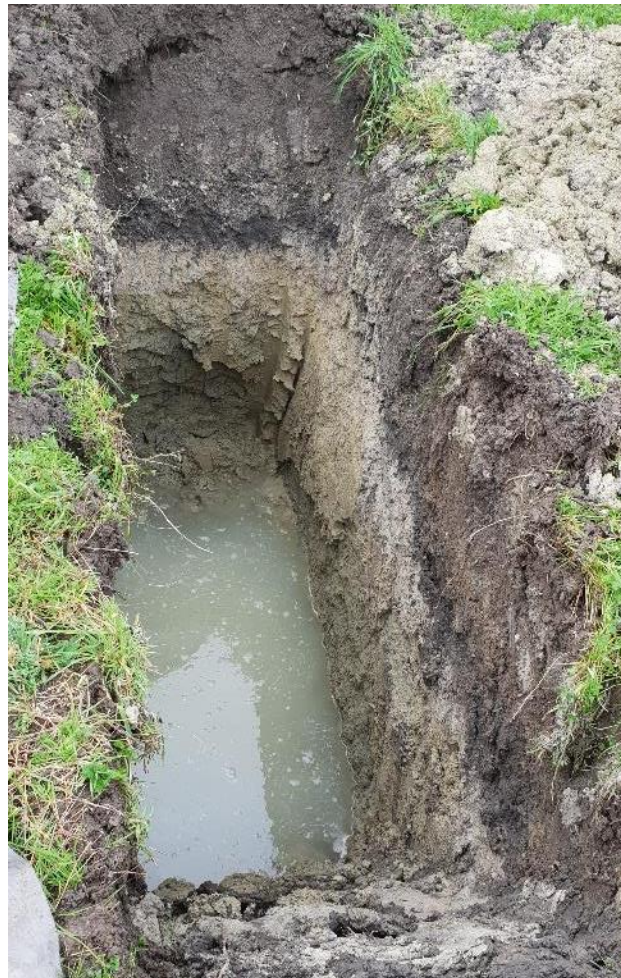
Groundwater inflow was observed in all test pits with the exception of TP01 and TP06. Moist to wet soils were generally observed from approximately 1.0 m bgl, with visible water seepage occurring at between 0.8 to 1.8 m bgl in TP07 (refer Photograph 2), TP08, TP09 and TP13.

Photograph 2: TPO5 - water seepage and accumulation at 1.9m bgl.

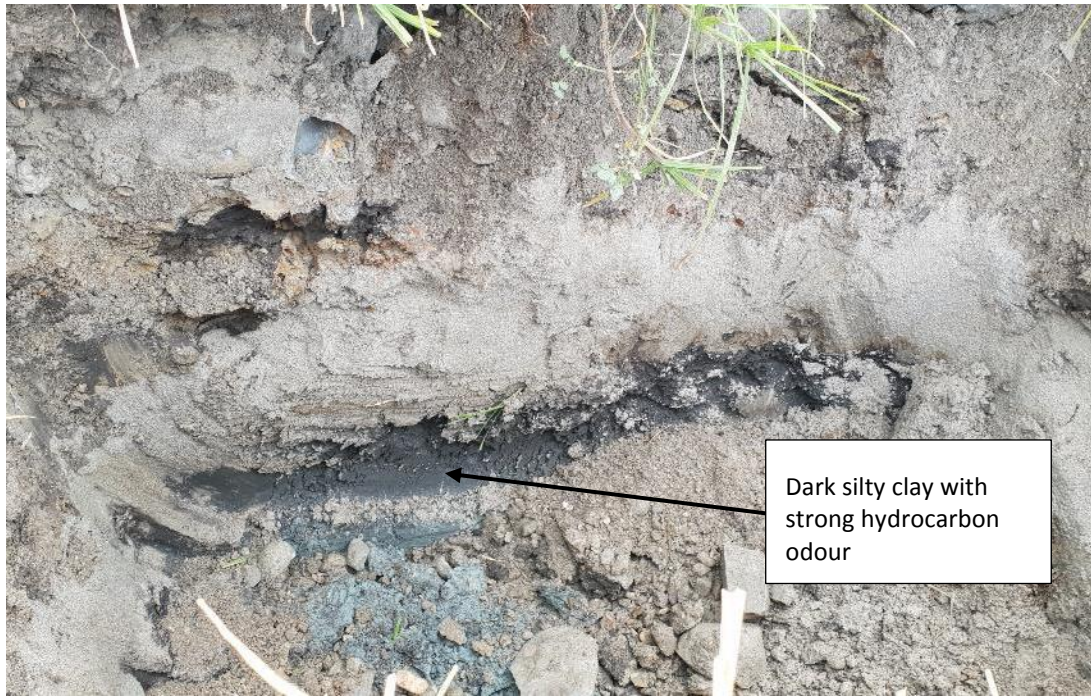
With the exception of fill containing building demolition material and associated anthropogenic elements (brick, concrete, wire etc.), indications of contamination (odours and/or staining) were noted within soils samples collected from TP06, TP07, TP10, TP11, and TP13. A peak PID screening reading of 121 parts per million (ppm) was recorded within samples that included soils containing a strong hydrocarbon odour within TP07 and TP11. Generally the strongest odours and highest PID readings in these test pits were within wet soil, close to the groundwater surface.

Photograph 3: TP06 showing odorous silty clay layer.

Silty CLAY; dark grey, black. Dry to moist; Strong hydrocarbon odour.						
			Sample TP6-1.1 @ 1.1m PID= 30.2	11	1.5

CLAY; blue grey. Dry to moist; Strong hydrocarbon odour.

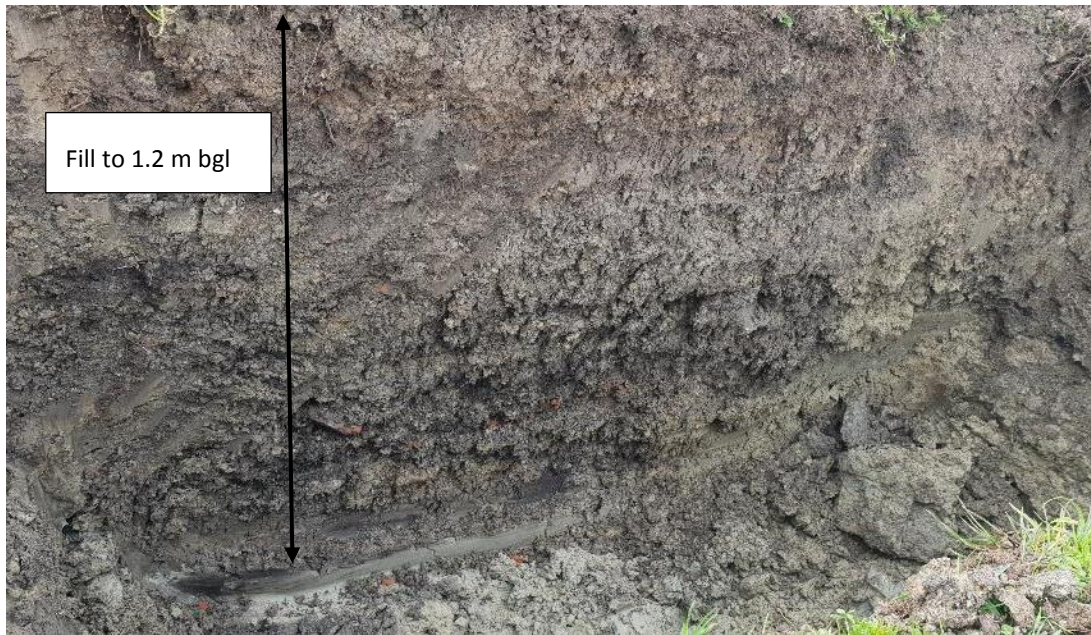
Photograph 4: TP07 showing fill material, and moist to wet soil at 1.2 m (contained strong hydrocarbon odour).

CLAY; brown grey and blue grey. Moist to wet; Slight hydrocarbon odour.				1.2m: Water seeping into testpit at 1.2m.	
			Sample TP7-1.2 @ 1.2m PID= 6.2		1.5

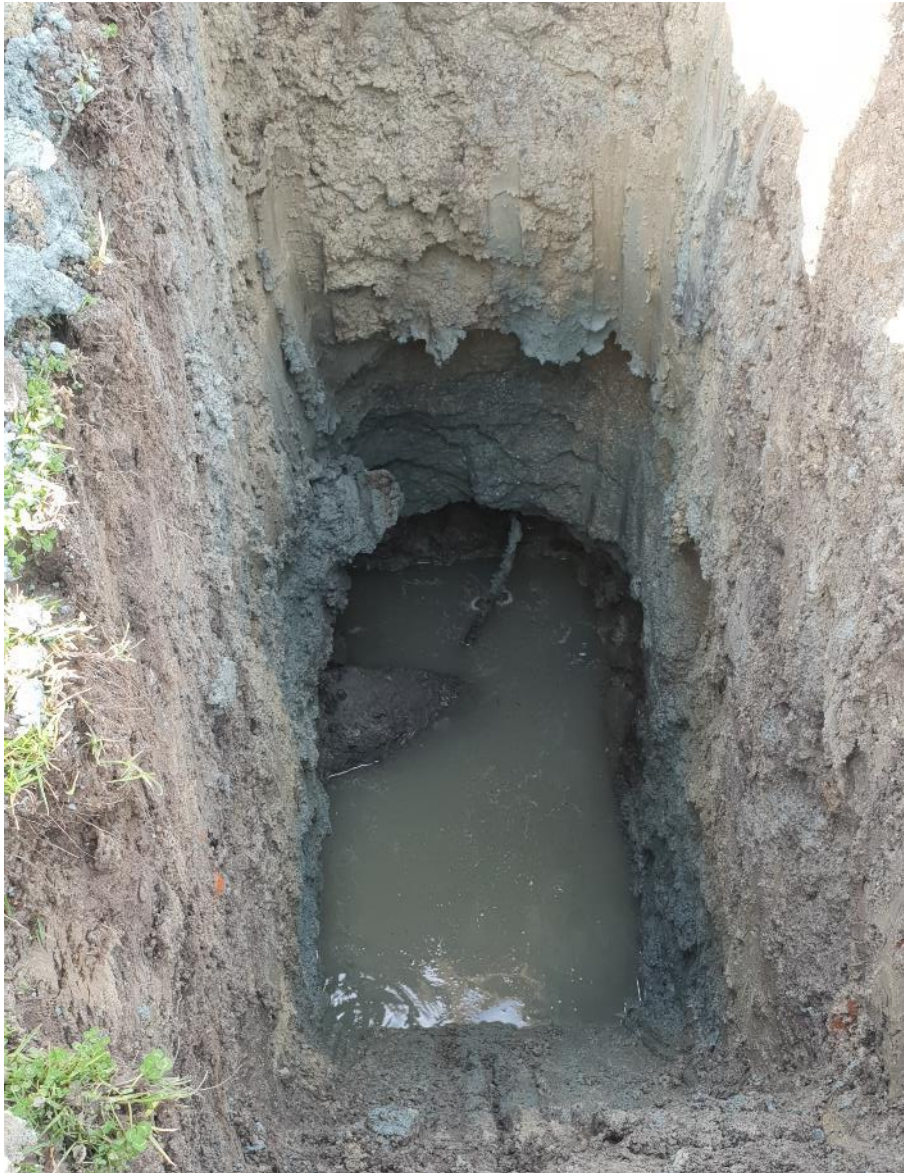
Photograph 5: TP07, water accumulation at 3.0 m bgl.
