WAIAPU RIVER MEAN BED LEVEL TRENDS; 1958 TO 2017

This is one of a series of reports on river bed level trends in the Waiapu catchment, Ruatoria, commissioned by the Environmental section and the (former) Roading section of the Gisborne District Council.

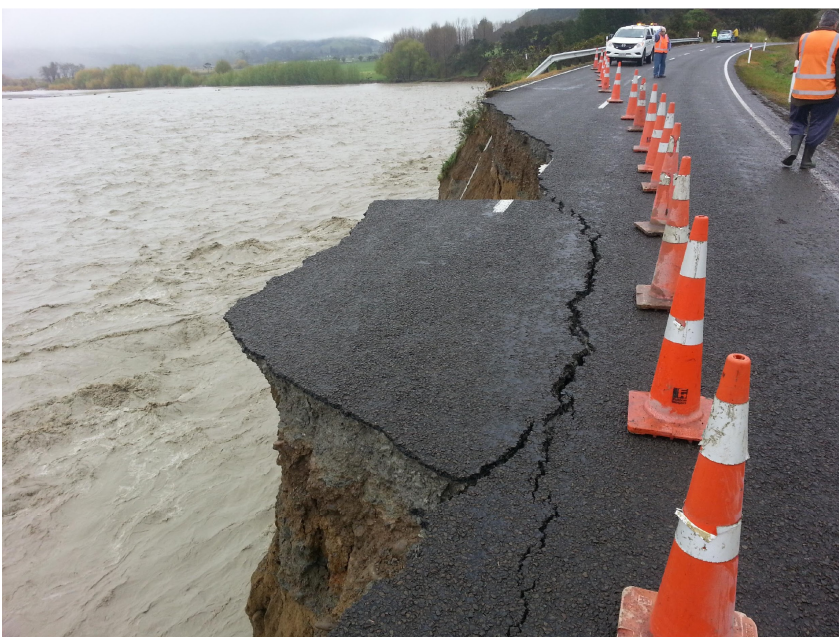
Fig.1: Erosion of SH35, Turitaka. Photo: D Peacock; 25th September 2013.

The Waiapu River is a very powerful river with a relatively steep profile even in its lower reaches close to the sea. The author understands that in te reo maori “Waiapu” means to “gobble up”, and it is known that this river has drowned a number of people who have tried to cross it by wading in pre-European days. It has also “gobbled up” land by erosion of the banks, a recent example being the loss of part of SH35 at Turitaka, near Tikitiki; see Figure 1.

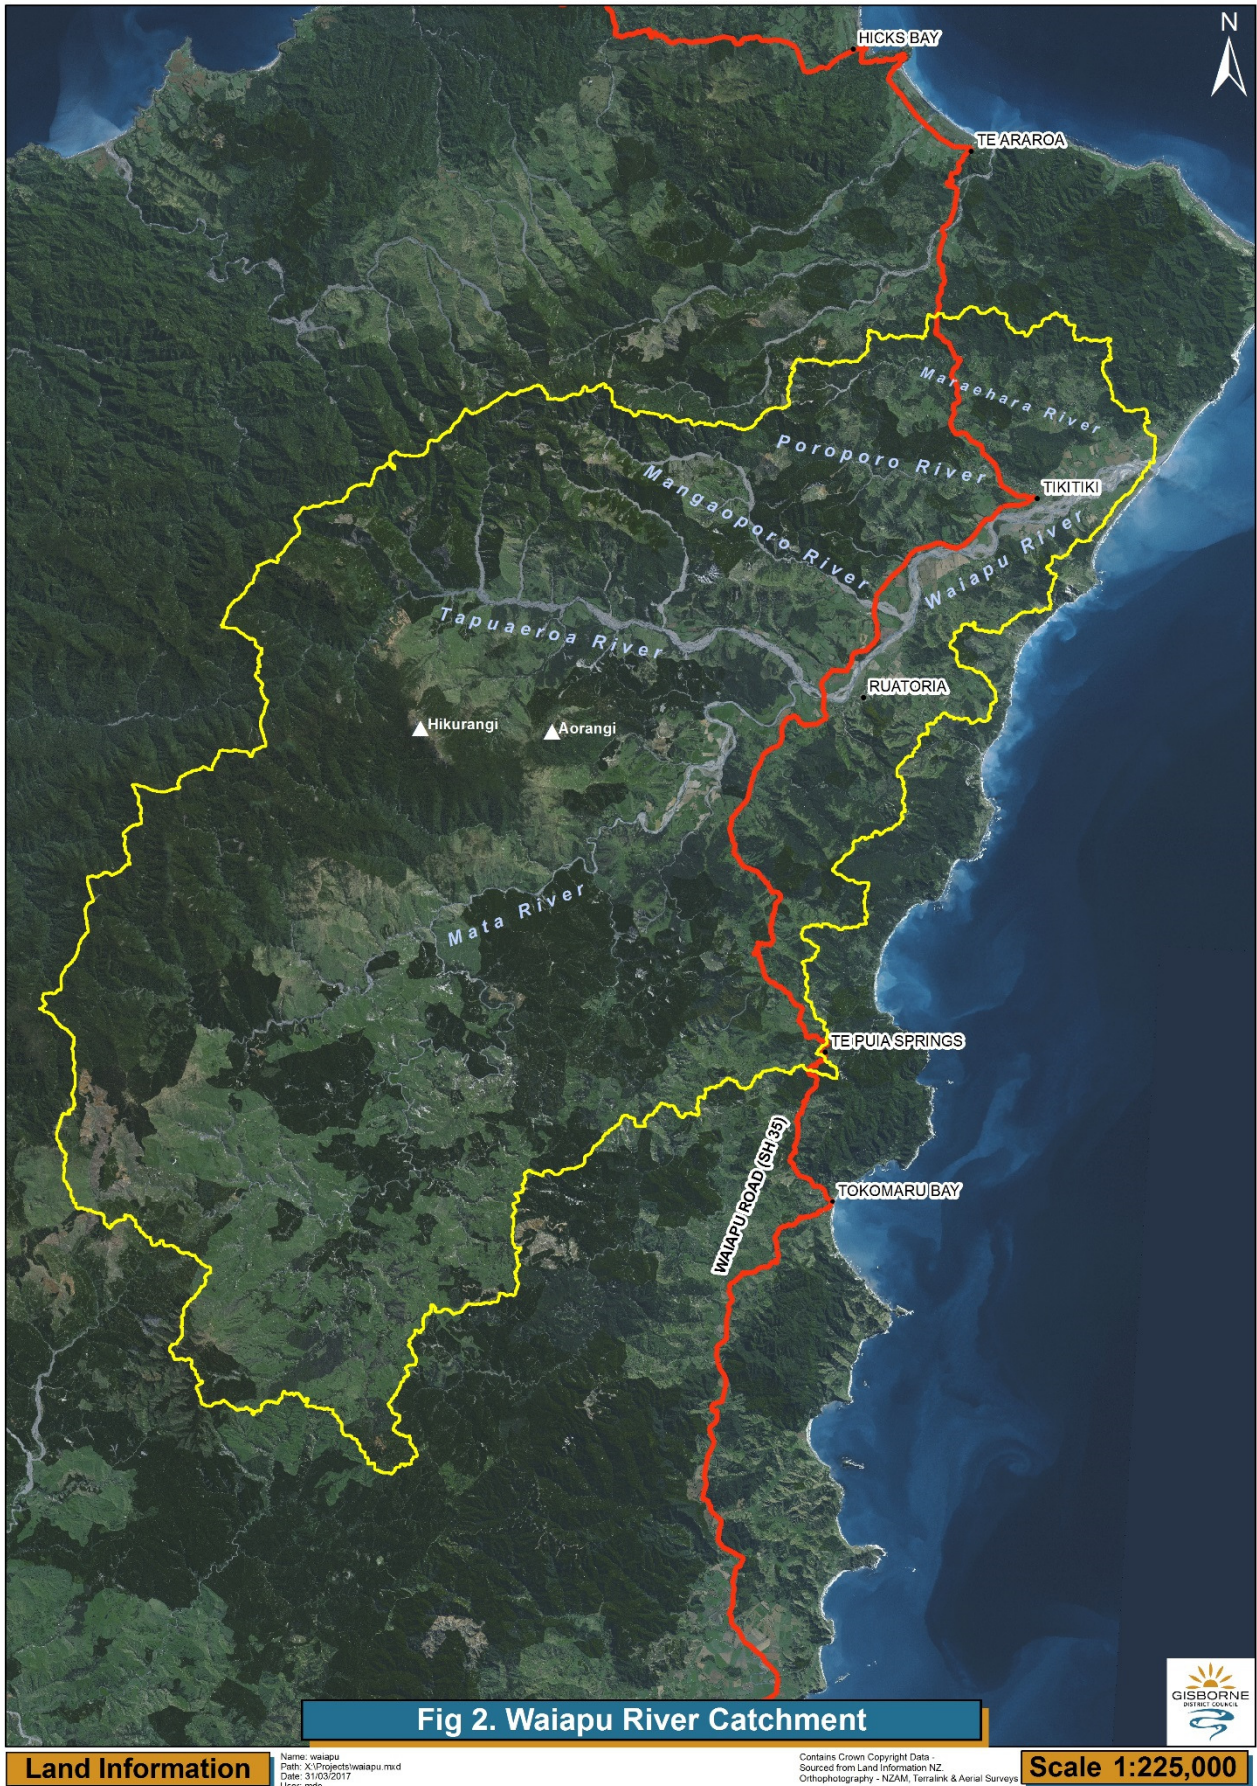
The Waiapu River catchment, Figure 2, covers some 1730 square kilometres, second only in area to the Waipaoa River catchment within the Gisborne District. The Waiapu River, Figure 3, extends some 25 kilometres from the sea to where it branches into its two main tributaries, the Mata and the Tapuaeroa rivers, 1.5 kilometres upstream of the SH35 bridge at Ruatoria.
