# An assessment of Woody Material on Tikapa Beach after the July 2020 storm and potential sources within the Waiapu

**Final report v3.5**

**Dr Murry Cave**  
Principal Scientist  
Gisborne District Council  
January 2021

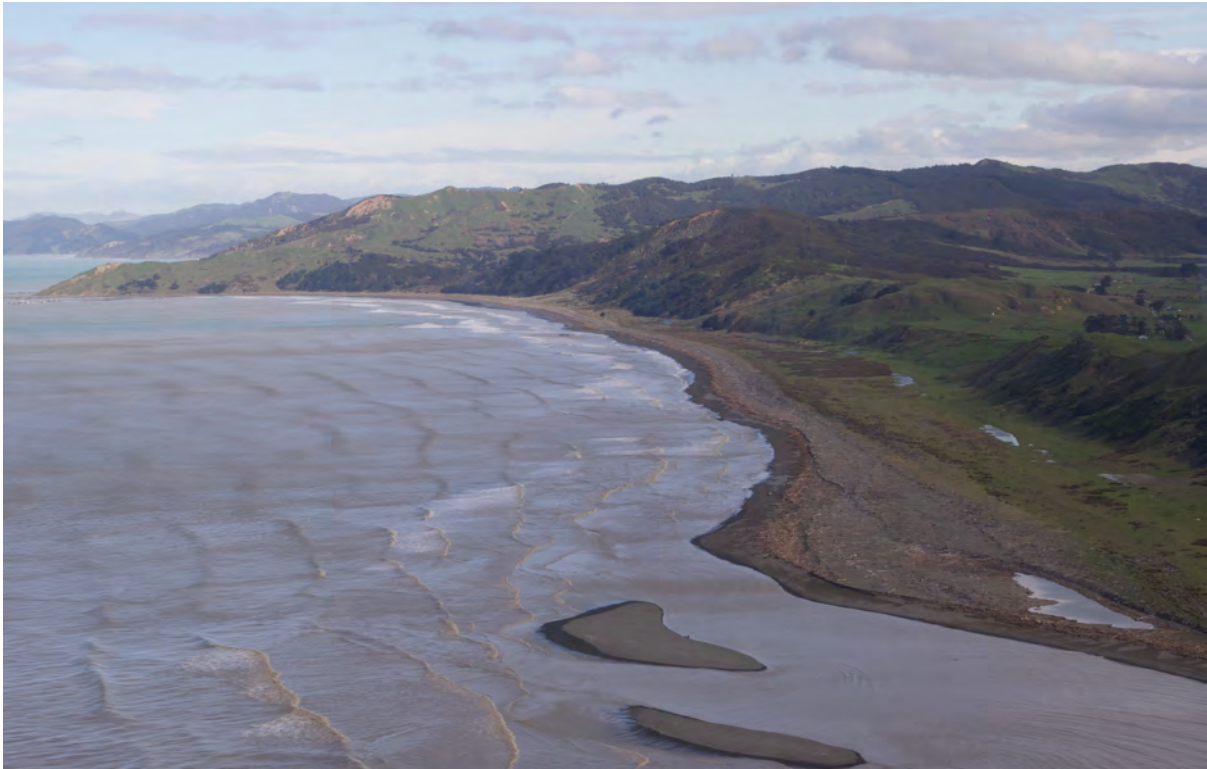
The photos taken during the flight to East Cape on the 21<sup>st</sup> of July 2020 showed that there was a significant volume of wood washed up on Tikapa Beach that appeared fresh. It is important to note, however, that any aerial assessment can only differentiate between material that has not been remobilised (ie is a weathered grey colour) and material that has either remobilised *in situ* or been freshly added to the beach stock (**Figure Four**).

**Figure Four.** Oblique aerial image of area from Waiapu River mouth (far right) to Whakariki Point showing fresh and/or remobilised woody waste (brown).

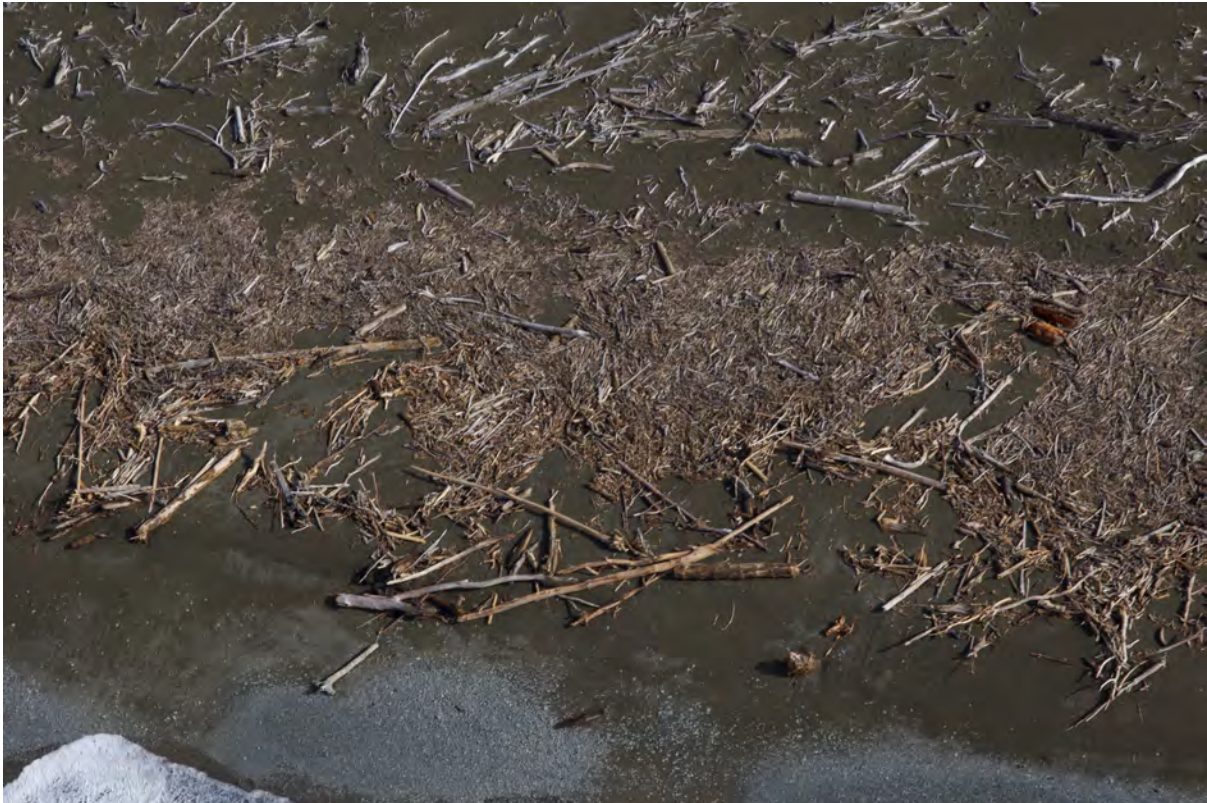
A closer view of the area close to the Tikapa roadend is shown in **Figure Ten**. This image shows a distinct separation into three zones down the beach profile with grey-weathered material from previous events higher on the beach, then a zone of largely finer dross material in the middle band and a larger log dominated lower zone. Two obvious large diameter short logs are evident in the top right of Figure Ten. When examined closely, the brighter one of these has an obvious cut end and is inferred to be a pine sloven but the adjacent log appears to be indigenous. There is an obvious long resident pine log in the middle right of the image which is close to a mix of other larger material including one grey-weathered branched log which has a cut end and is inferred to be a willow.

On the left hand end of the image is a long log with no obvious root ball but does have a spiral grain and so is unlikely to be a pine log. Interestingly, there is a fence batten lying across this log at the left end while immediately above it is a long resident pine log. Below this material is a log with no obvious root ball but with a straight grain and is hence most probably a long-resident pine log. Adjacent material includes an obvious piece of willow, a weathered pine stump, other highly-weathered larger diameter logs of probable pine origin, a poplar branch, and some moderately weathered small diameter straight grained material which is most probably pine. One long small diameter piece of wood with a root ball is probably manuka or kanuka.

**Figure Ten.** View of the woody material close to the Tikapa roadend showing the mix of material present (described in detail above).

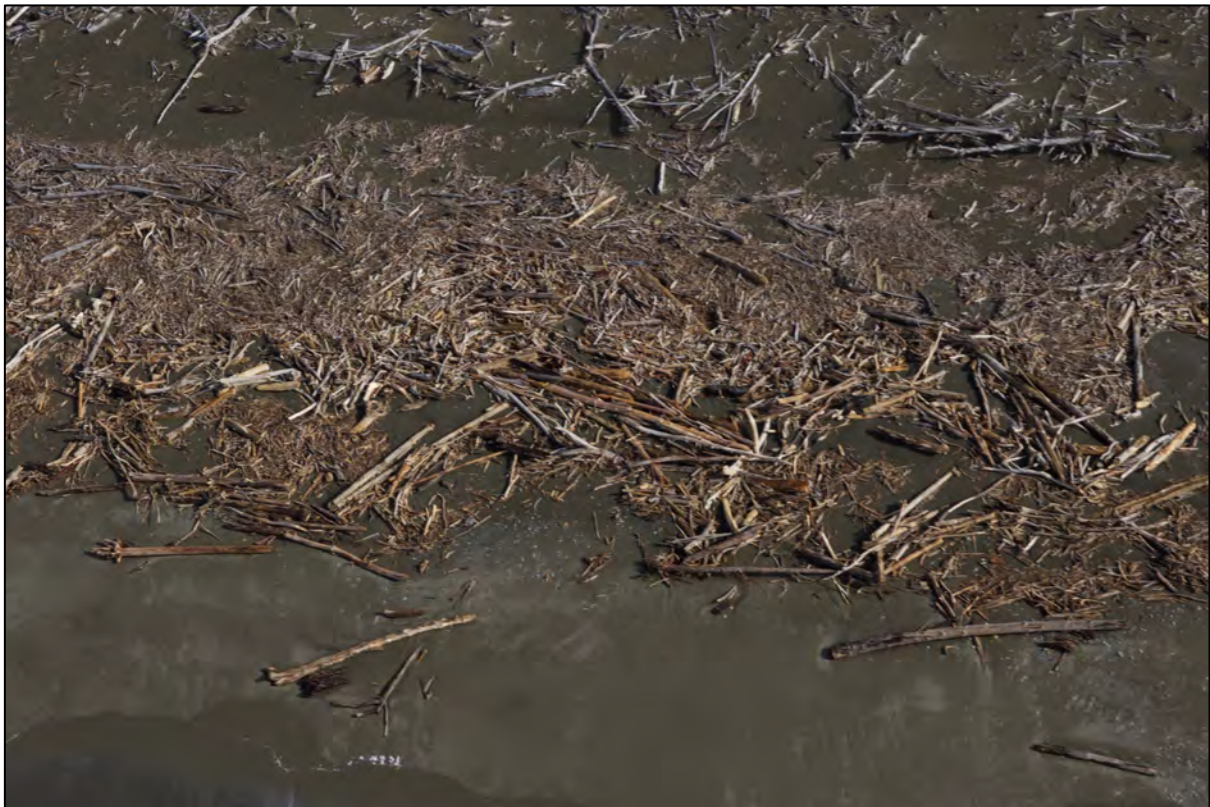
A view of the woody material 250m south of the Tikapa roadend is shown in **Figure Eleven**. This shows a similar zonation of the beach to **Figure Ten** but there is a greater proportion of larger material present. At bottom left a long pine log with a root ball is evident indicating a windthrow/waterthrow origin while an adjacent short dark red coloured log is of indigenous origin. A long-resident pine log with a cut end is evident at the bottom right.

Overall a majority of the visible larger logs appear to be pine in origin and the majority of these appear to be long-resident logs rather than windthrow/waterthrow. While present, willow/poplar and indigenous material is subordinate in this particular image.

**Figure Eleven.** View of woody debris on Tikapa Beach c.250 metres south of the Tikapa roadend as described above.

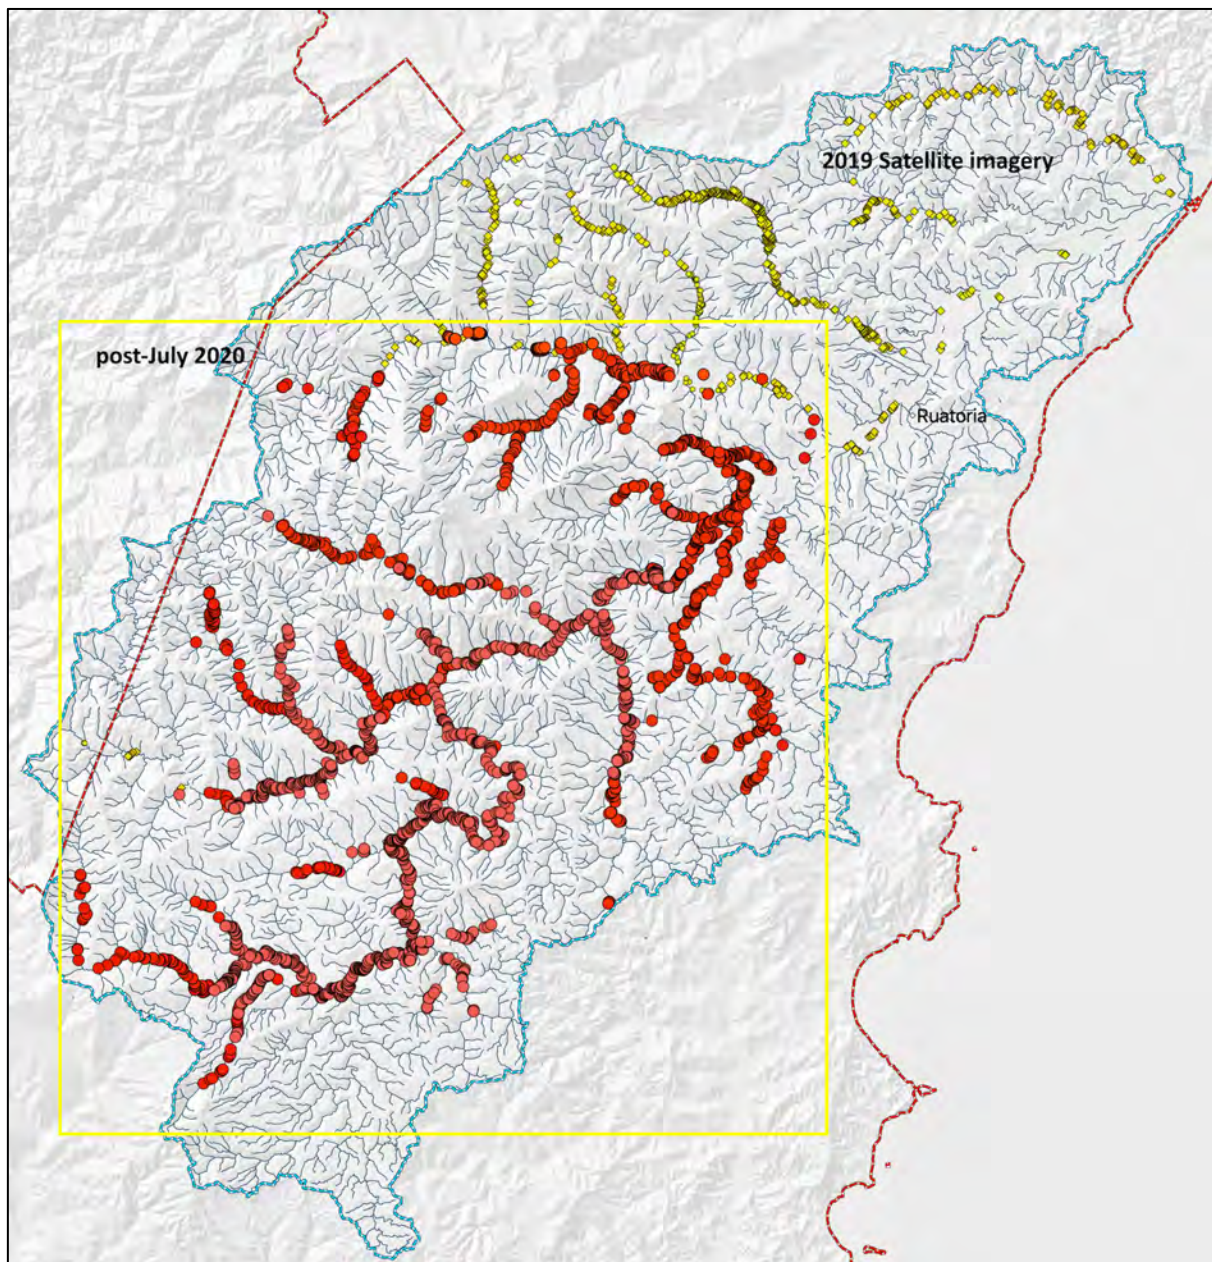
**Figure Twenty Four.** Map showing the area covered by post-July 2020 satellite imagery (yellow box), the distribution of logs in the Waiapu catchment post the July 2020 storm (red circles), and distribution of logs within the catchment from 2019 satellite imagery (yellow diamonds).

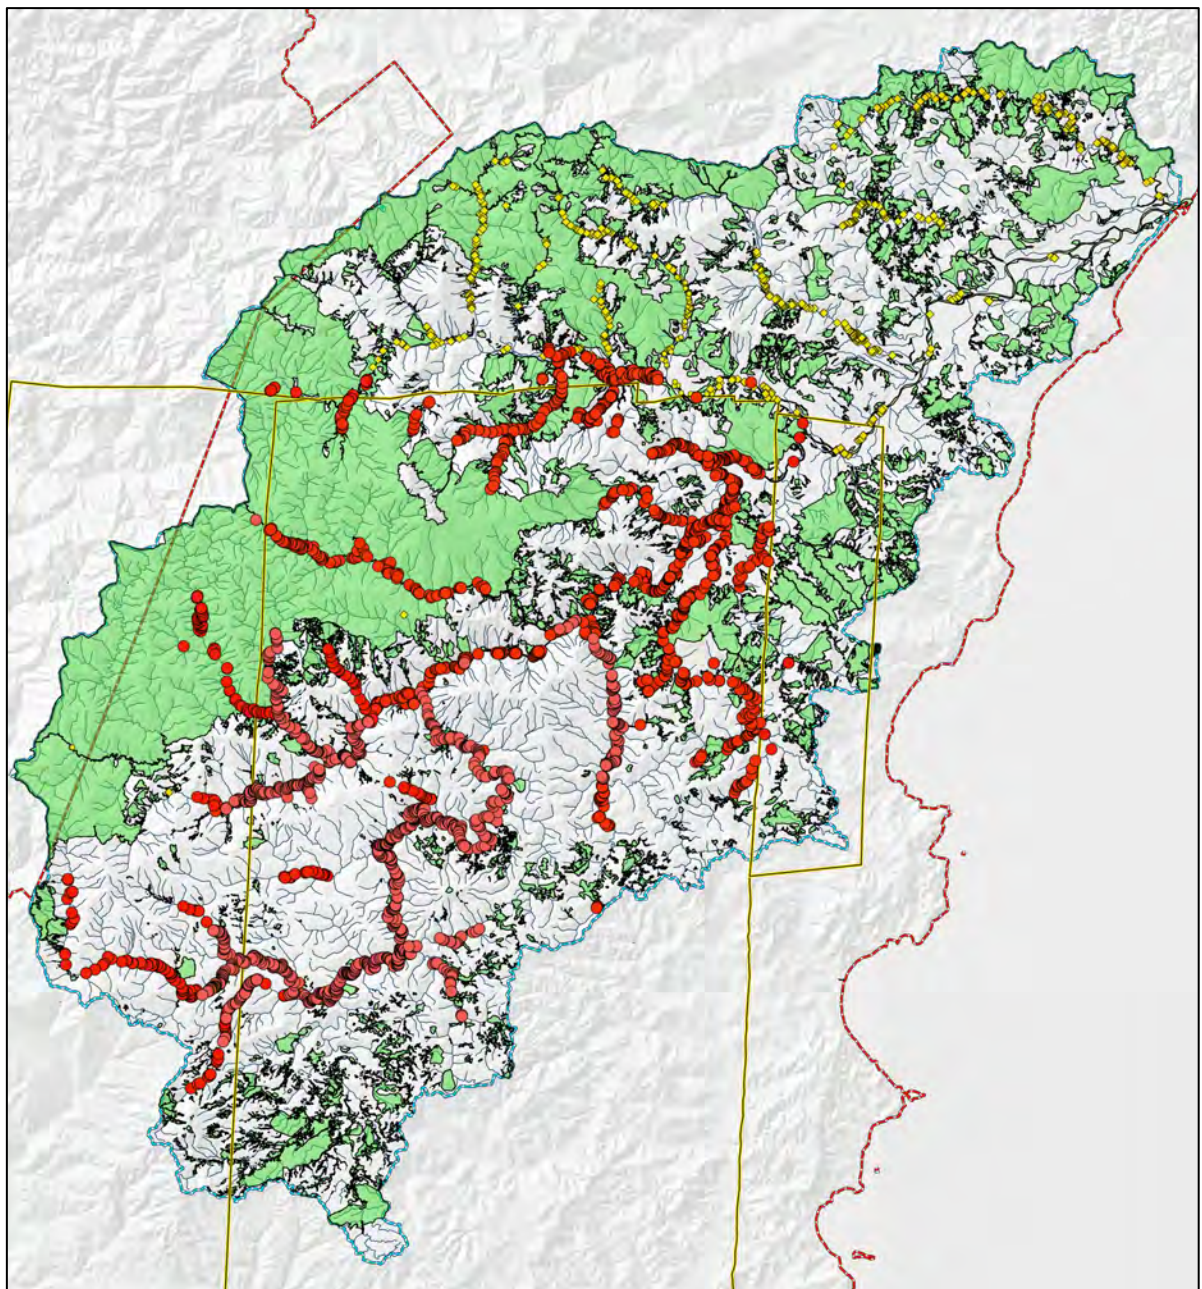
Plotting the area of each different land cover gives a good indication of the probable source of wood waste on the beach. The same log distribution from **Figure Twenty Four** is compared with the distribution of Indigenous vegetation cover for the Waiapu catchment in **Figure Twenty Five** below. This shows that areas of indigenous forest, particularly the true right tributaries of the Tapuaroa River (Mangatoitoi Stream, Mangatangaruru Stream, and Mangarata Stream) and also some true left tributaries of the Mata River (Waingakia, Mangaropo and Makokoia Streams) contributed material (**Figure twenty Six**). Equally, however, **Figure Twenty Five** shows that a considerable amount of logs in the headwaters and other tributaries of the Mata which lack significant indigenous forest and scrub cover.

**Figure Twenty Five.** Map showing the same log distribution data as **Figure Twenty Four** overlain by the area of significant indigenous land cover showing that the true right tributaries of the Tapuaroa and some true left tributaries of the Mata are likely sources of the indigenous woody debris in the Waiapu River and most probably is also the source of indigenous material on Tikapa Beach.

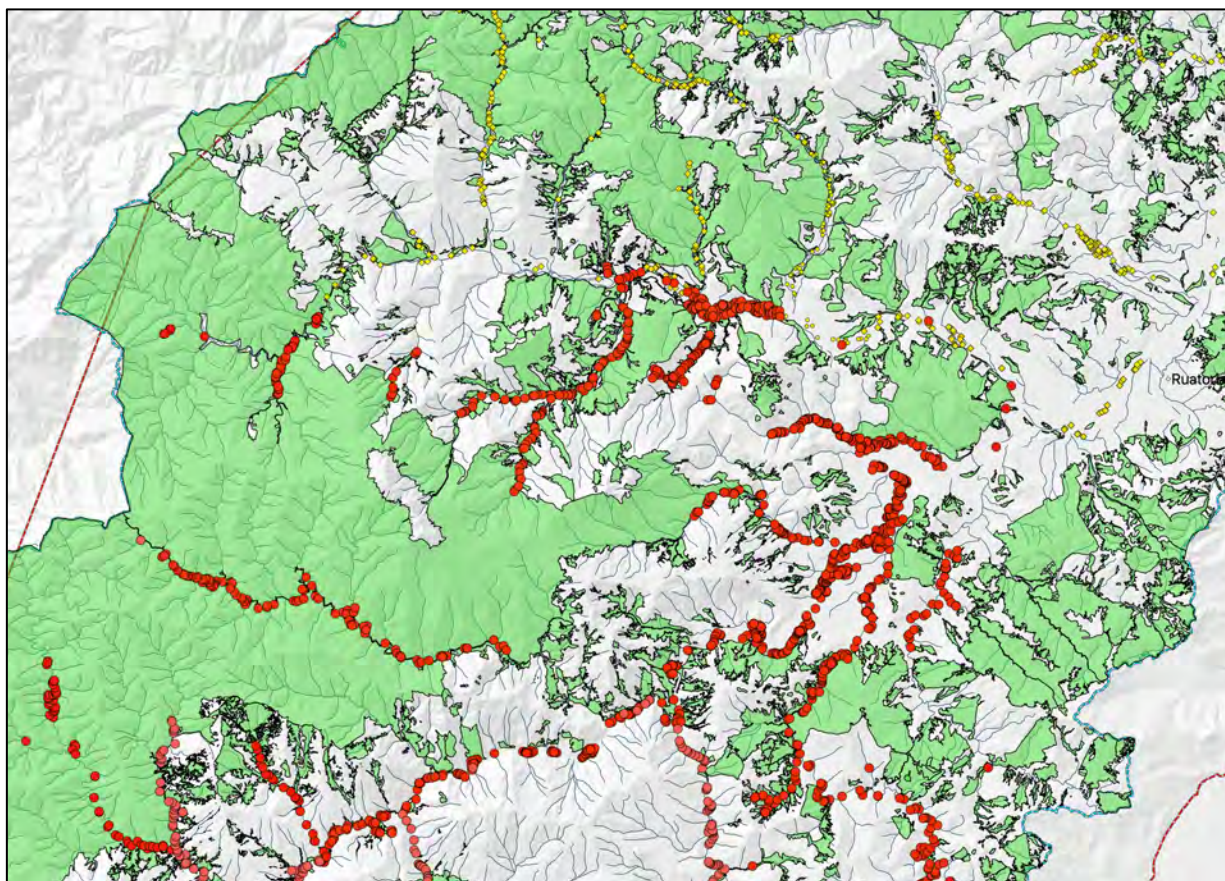
**Figure Twenty Six.** Detail of **Figure Twenty Five** showing the main tributaries with indigenous vegetation with the log pathways in the rivers. As was the case in **Figure Twenty Five**, the red circles represent post July 2020 imagery while the yellow diamonds are plots based on 2019 imagery. Note; the town of Ruatoria is on the far right of this map.

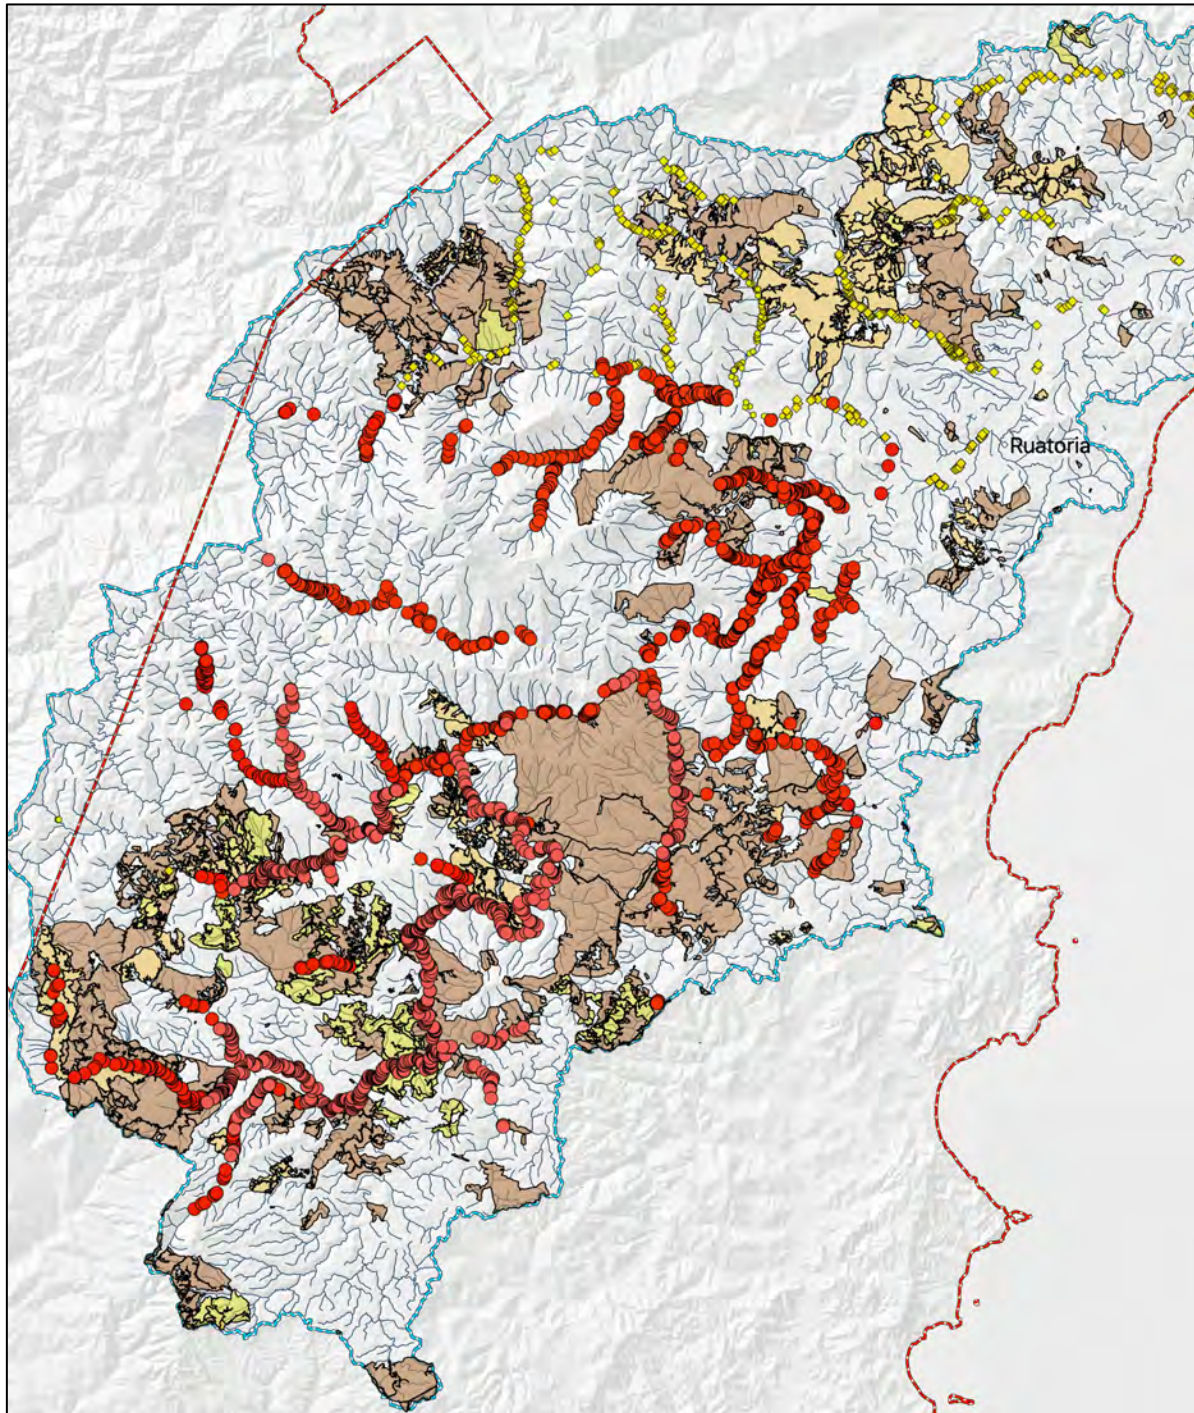
Similarly, a plot of all exotic pine plantation forests, open canopy (replanted or new plantings on pasture) and recently harvested pine for the Waiapu catchment has been overlain with the log distribution shown in **Figure Twenty Four**. This shows that the exotic forests in the upper Mata River and tributaries such as the Waitahaia, Whakoau, Mangamatukutuku and Mangatarata were a significant source of pine logs, harvest residues and displaced whole trees within the catchment following the July 2020 storms (**Figure Twenty Seven**).

**Figure Twenty Seven.** Map showing the same log distribution data as **Figure Twenty Four** overlain by the area of significant Exotic forest land cover in the Waiapu catchment showing that the upper Mata River itself and the true right tributaries of the Mata are likely sources of the Pine woody debris in the Waiapu River and thus most probably is also the source of a large proportion of the pine material on Tikapa Beach.

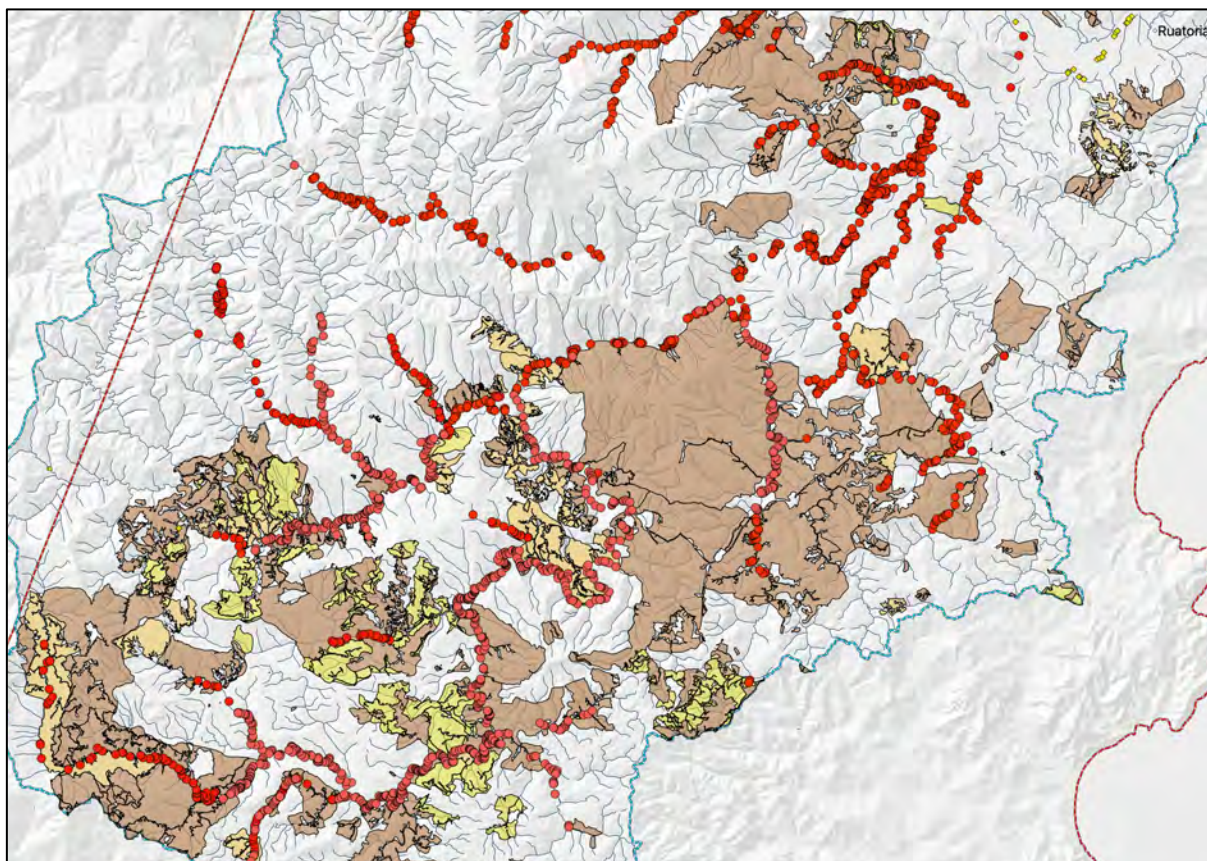
**Figure Twenty Eight.** Detail of **Figure Twenty Five** showing the main tributaries with exotic vegetation with the log pathways in the rivers. Note; the town of Ruatoria is on the top right.

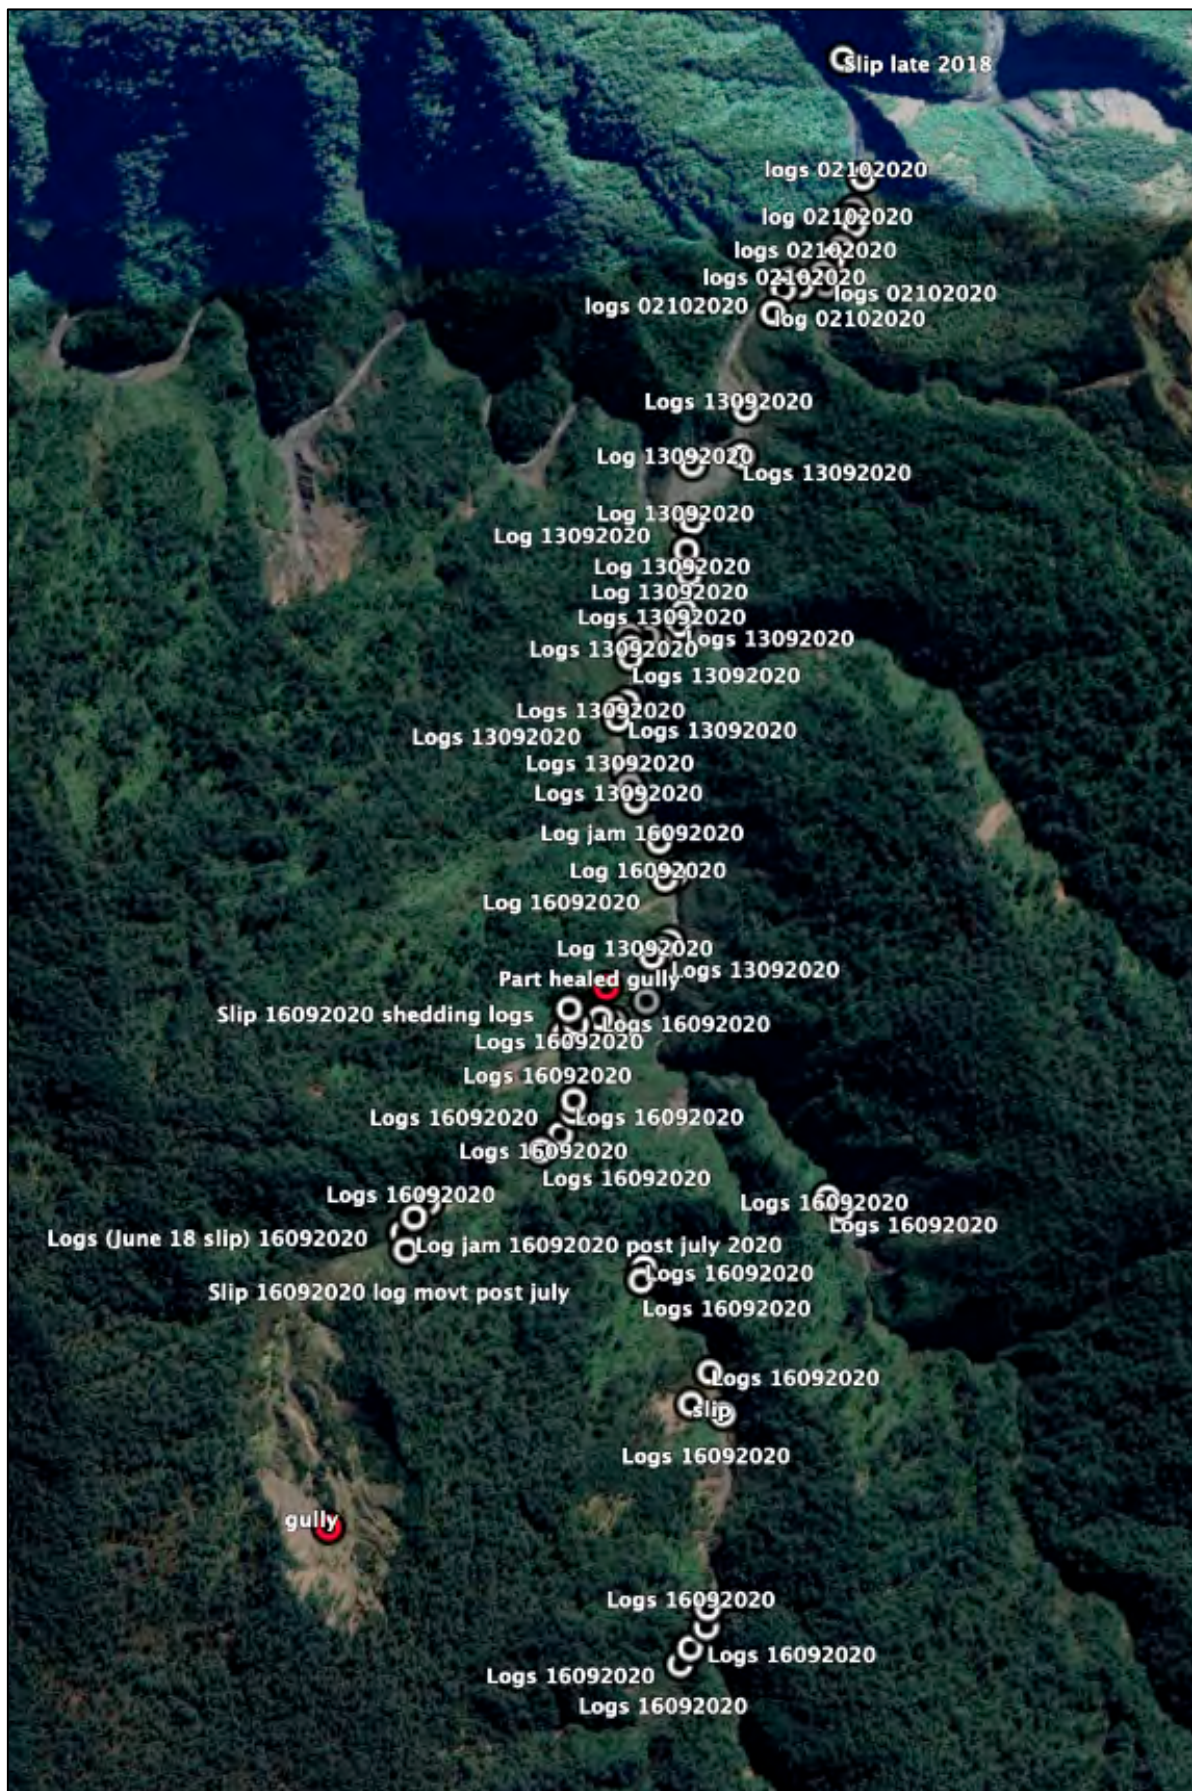
Satellite imagery for this site is available covering multiple days following the July 2020 storms. The imagery for the 21st August, 13<sup>th</sup> and 16<sup>th</sup> of September and 2<sup>nd</sup> of October 2020 have been used to plot the distribution of logs in the Mangarata sub catchment at the head of the Tapuaeroa river (**Figure Twenty Nine**).

**Figure Twenty Nine.** Satellite imagery of the Mangarata stream in the headwaters of the Tapuaeroa River showing the main gully as well as the distribution of logs downstream from the gully as well as from slips in the adjacent tributaries.

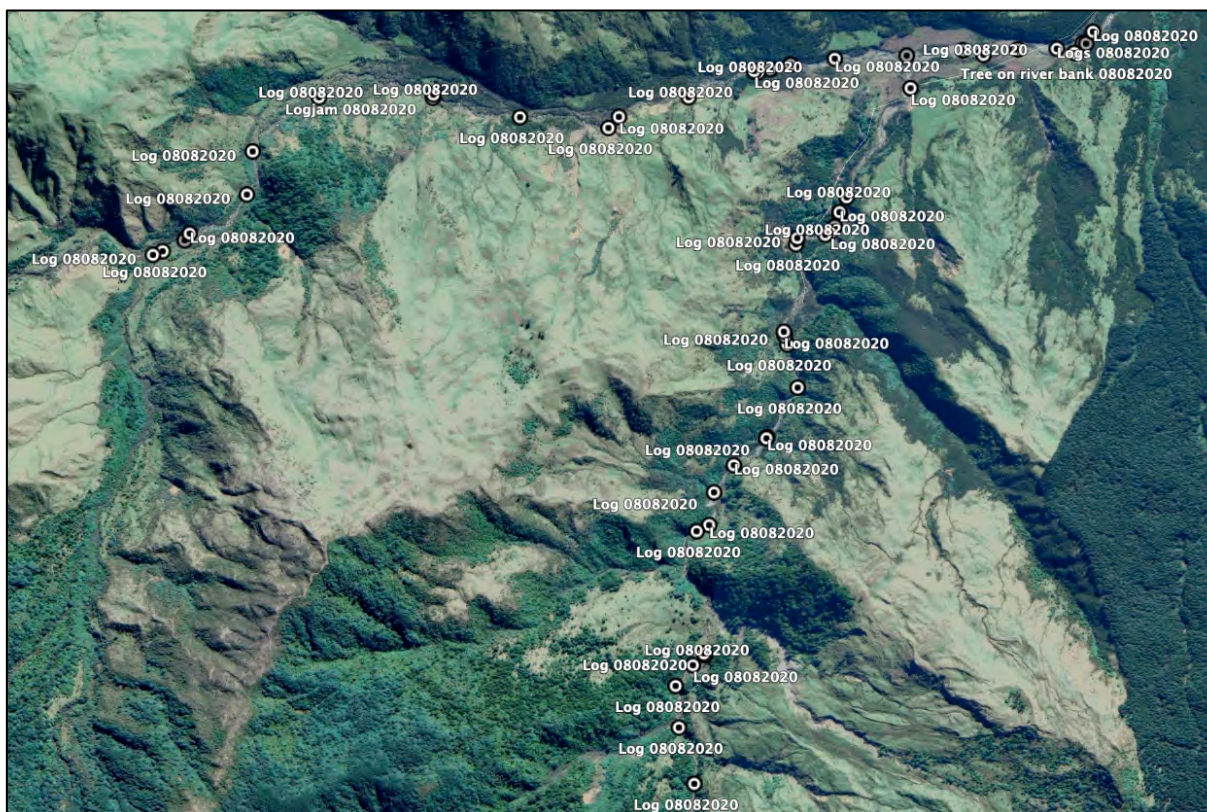
Satellite imagery dated the 8<sup>th</sup> of August 2020 was used to plot the distribution of logs in Mangatoitoi Stream. This stream is a tributary of the Mokoivi Stream which in turn discharges into the Tapuaeroa river (**Figure Thirty Two**). There is no immediately obvious cause of the migration of the logs in the uppermost reaches of the stream. There area couple of small slips immediately upstream, however, these seem too small to generate the volume of logs in the stream.

**Figure Thirty Two.** View of headwaters of Mangatoitoi Stream showing the distribution of logs downstream to the Mokoivi stream confluence.

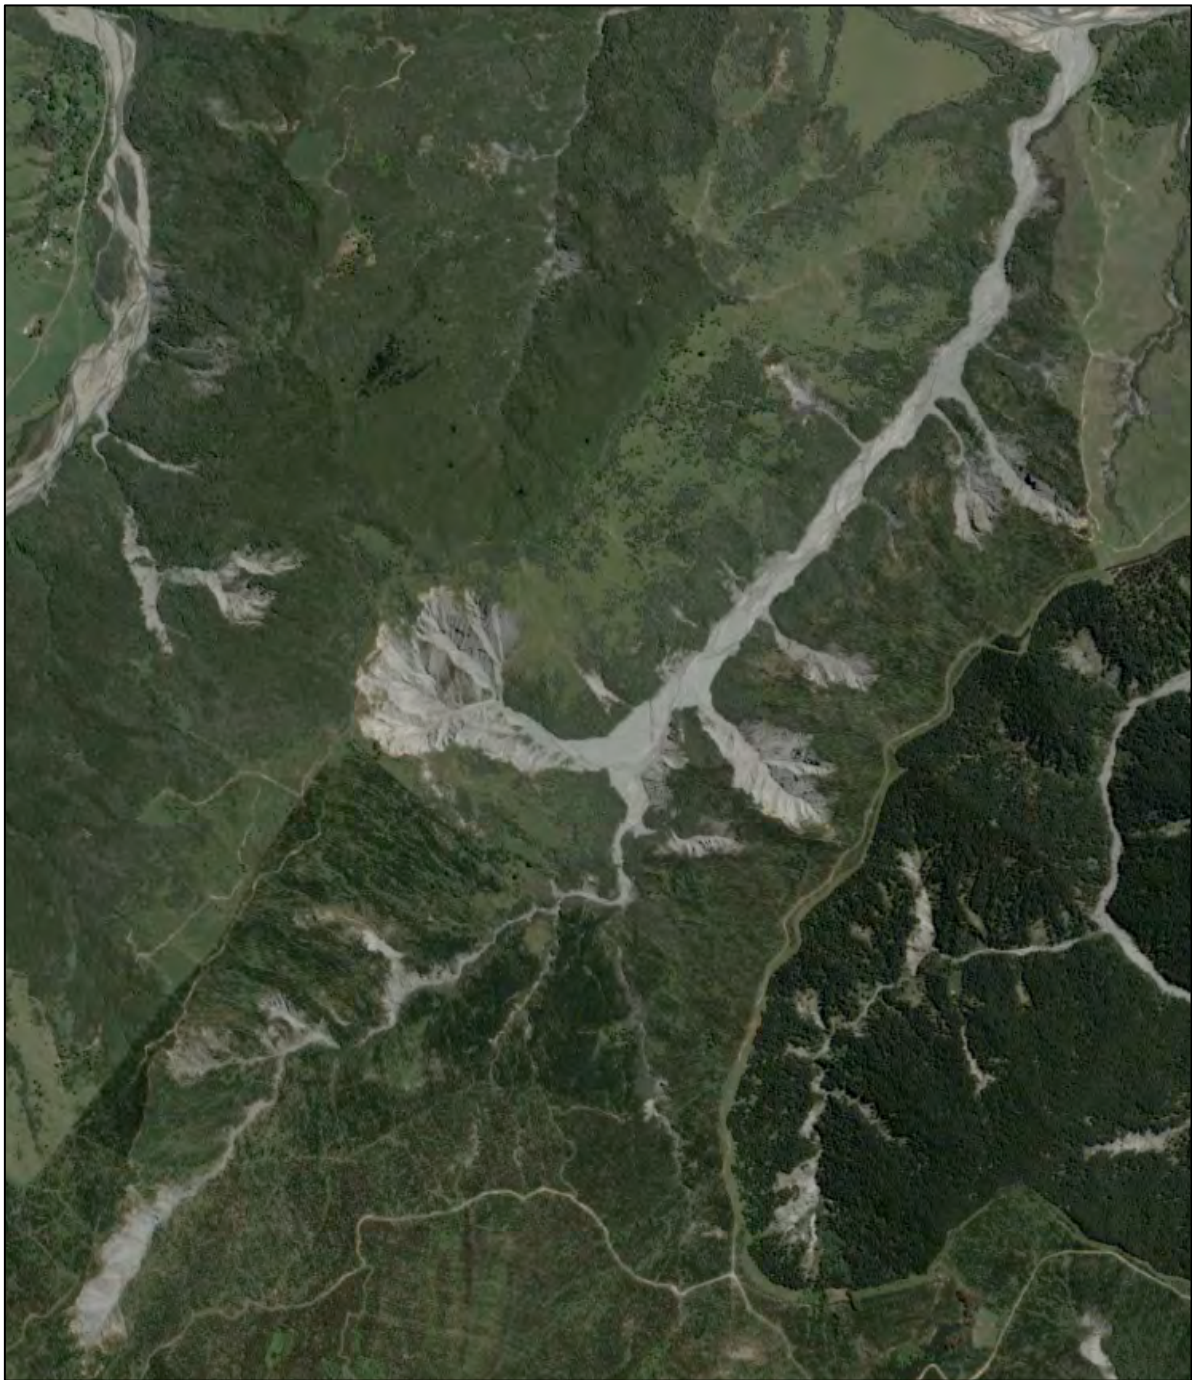
The earliest satellite imagery for this large gully system is dated 10<sup>th</sup> December 2002 at which stage the adjoining ground was largely in pasture or pasture that has recently been planted with pine (**Figure Thirty Five**). These conversions from pasture to pine have been seen as a tool to stabilise gullies with Marden *et. al.* (2005) indicating that size and shape of a gully was a key determinant of stabilisation with the larger gullies (>10Ha) not stabilising over a 28 year period.

**Figure Thirty Five.** View of gullies in Mangapekepeke Stream in the Tapuaeroa sub catchment in 2002. A linear gully forms the headwaters of the stream while a large amphitheatre gully occupies the true left with smaller amphitheatre gullies are evident on the true right. The area adjacent to the linear gully in the headwaters has been planted in pine while the remaining areas are in pasture.

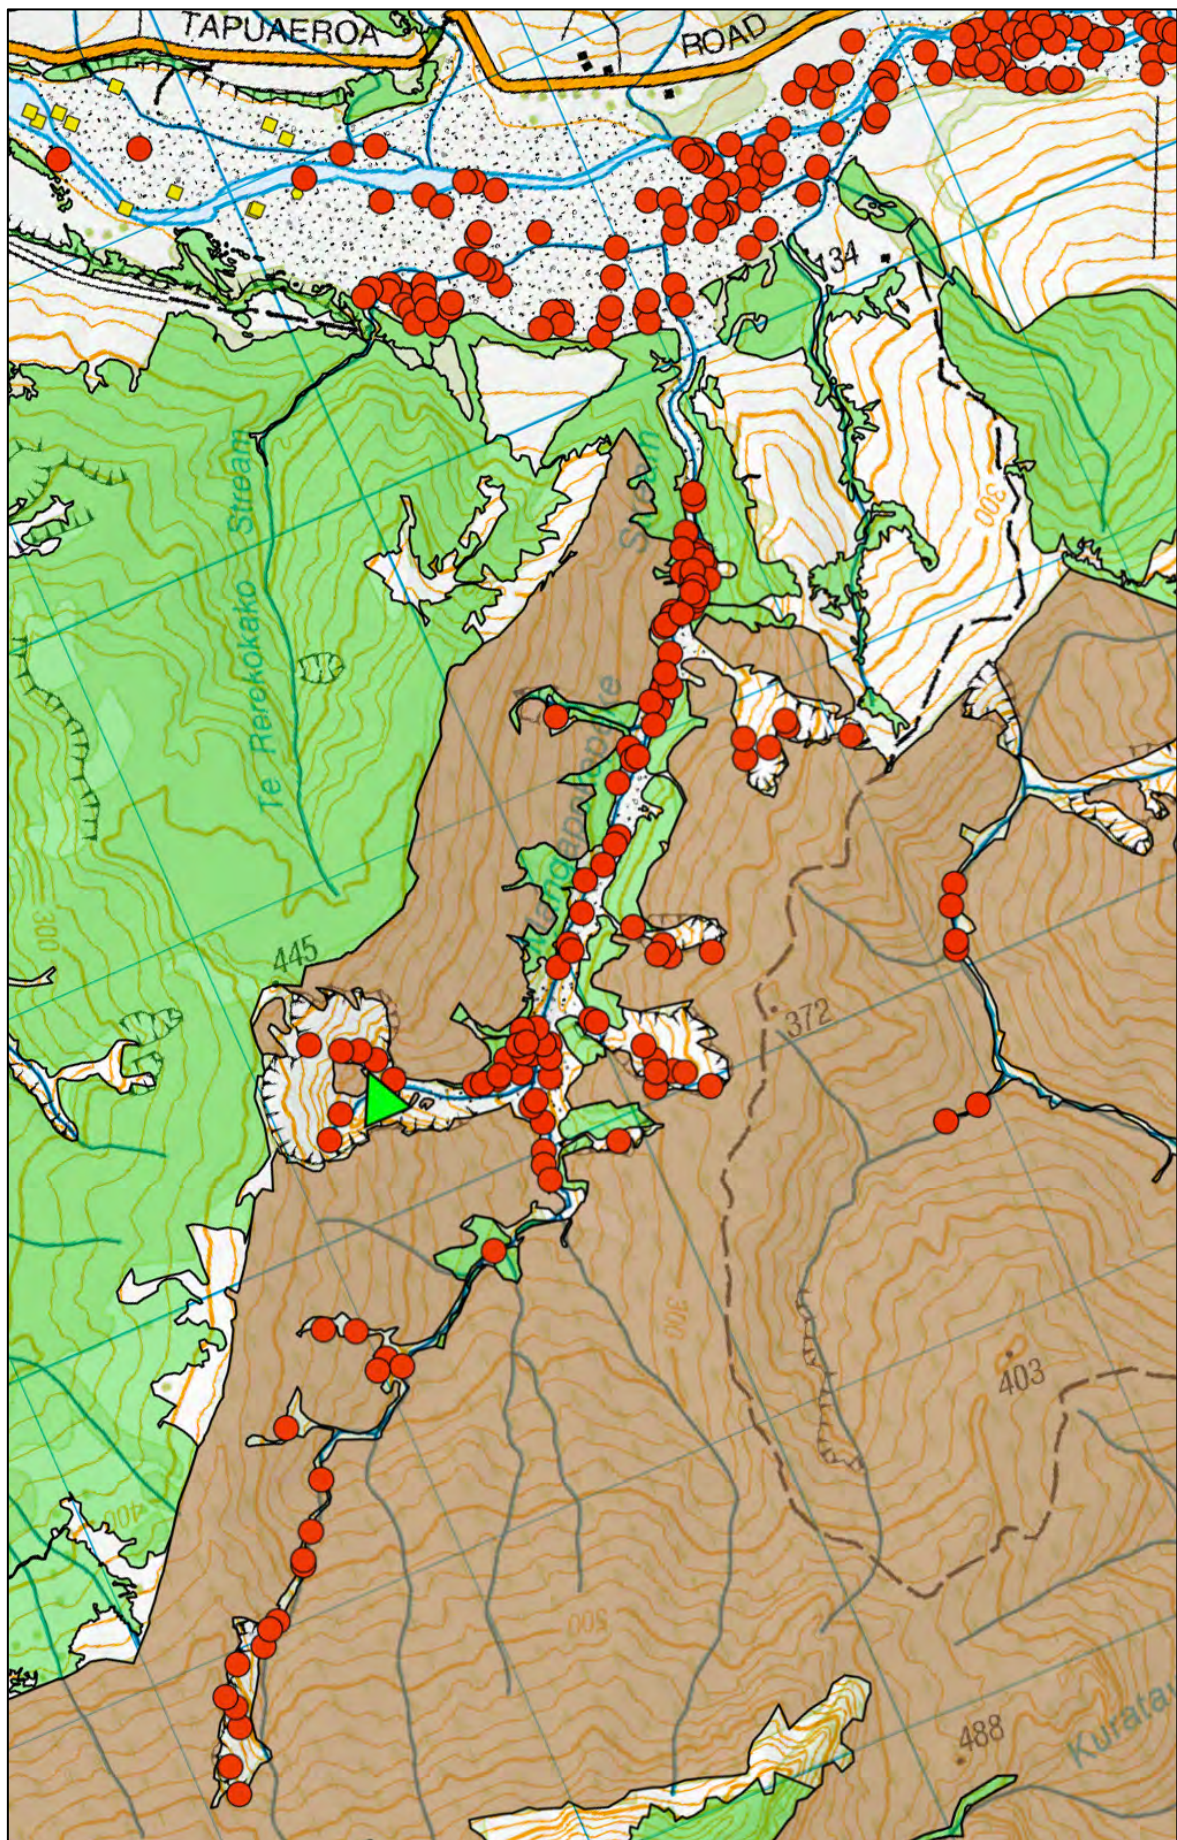
**Figure Thirty Eight.** View of Mangapekepeke Stream in the Tapuaeroa sub catchment the distribution of logs based on satellite imagery dated 8<sup>th</sup> August 2020.

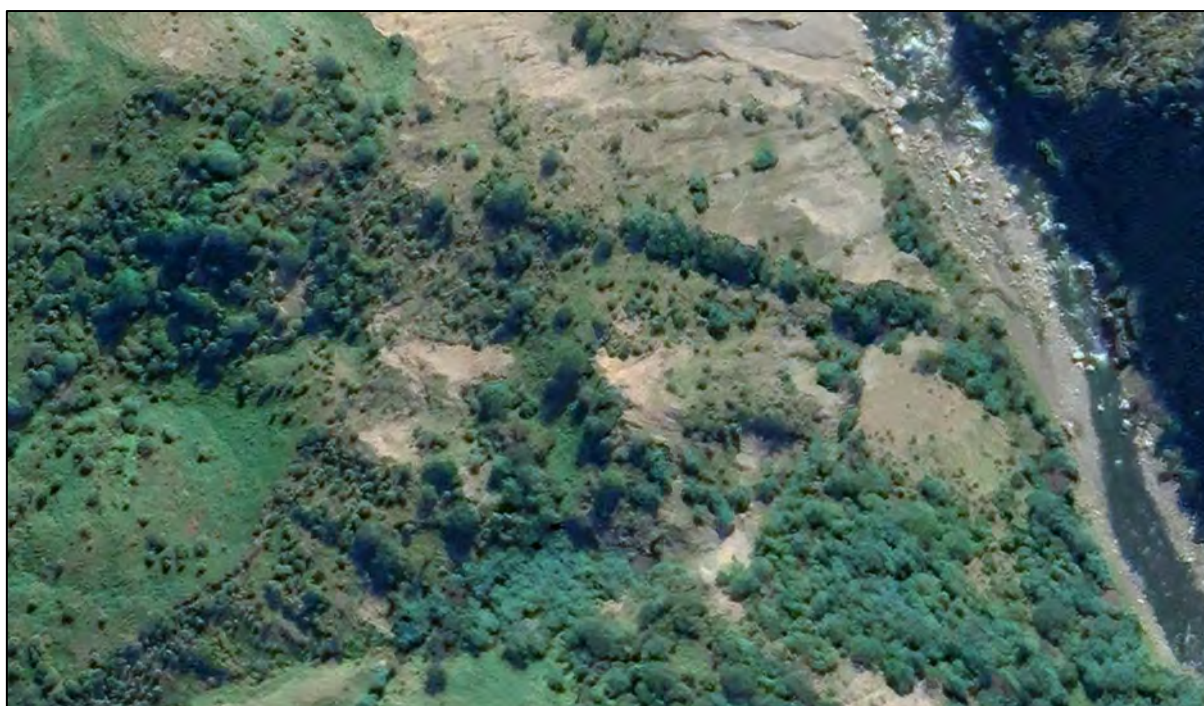
**Figure Forty.** 21<sup>st</sup> May 2020 satellite imagery showing the pre-landslide vegetation cover comprising some open pasture, indigenous scrub and larger indigenous trees.

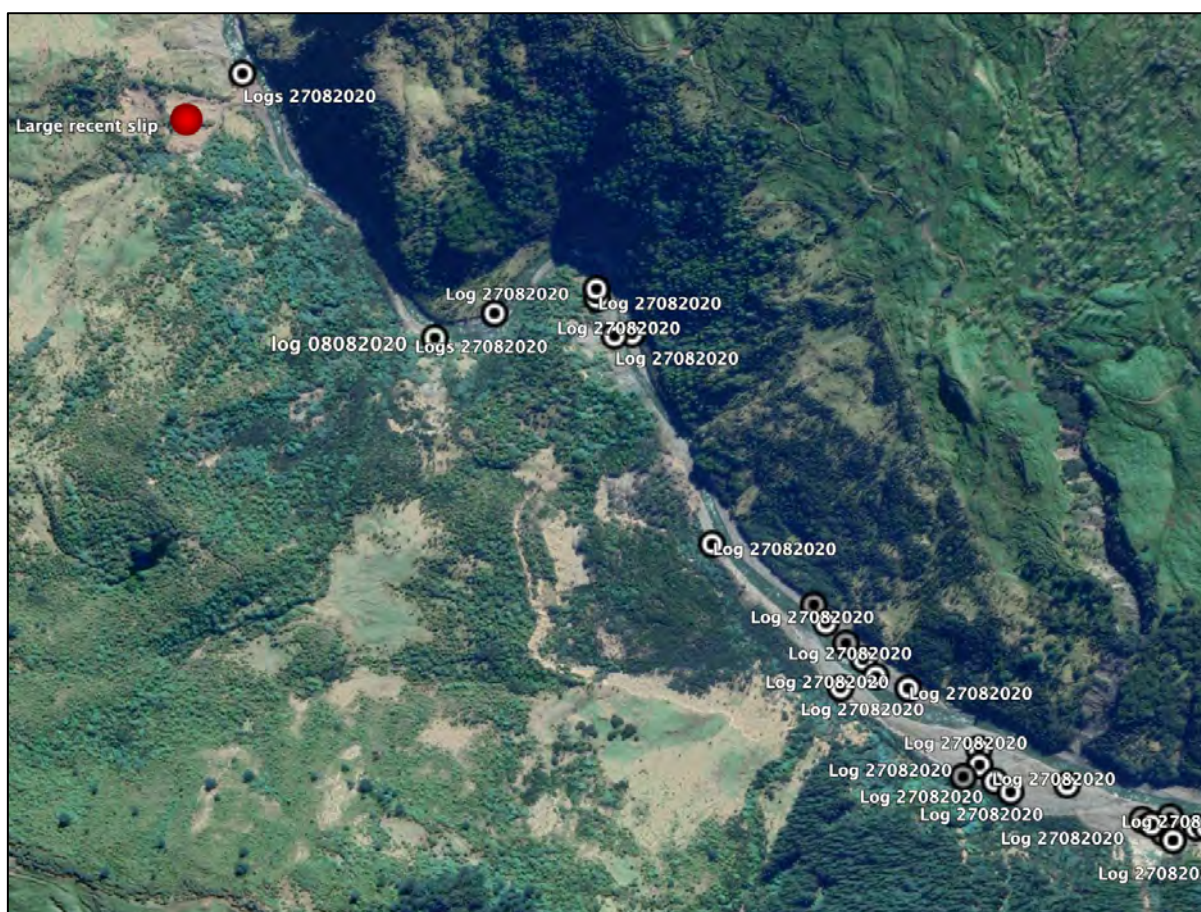
**Figure Forty One.** 8<sup>th</sup> August 2020 satellite imagery of the Waingata Stream tributary showing the distribution of logs downstream of the landslide.

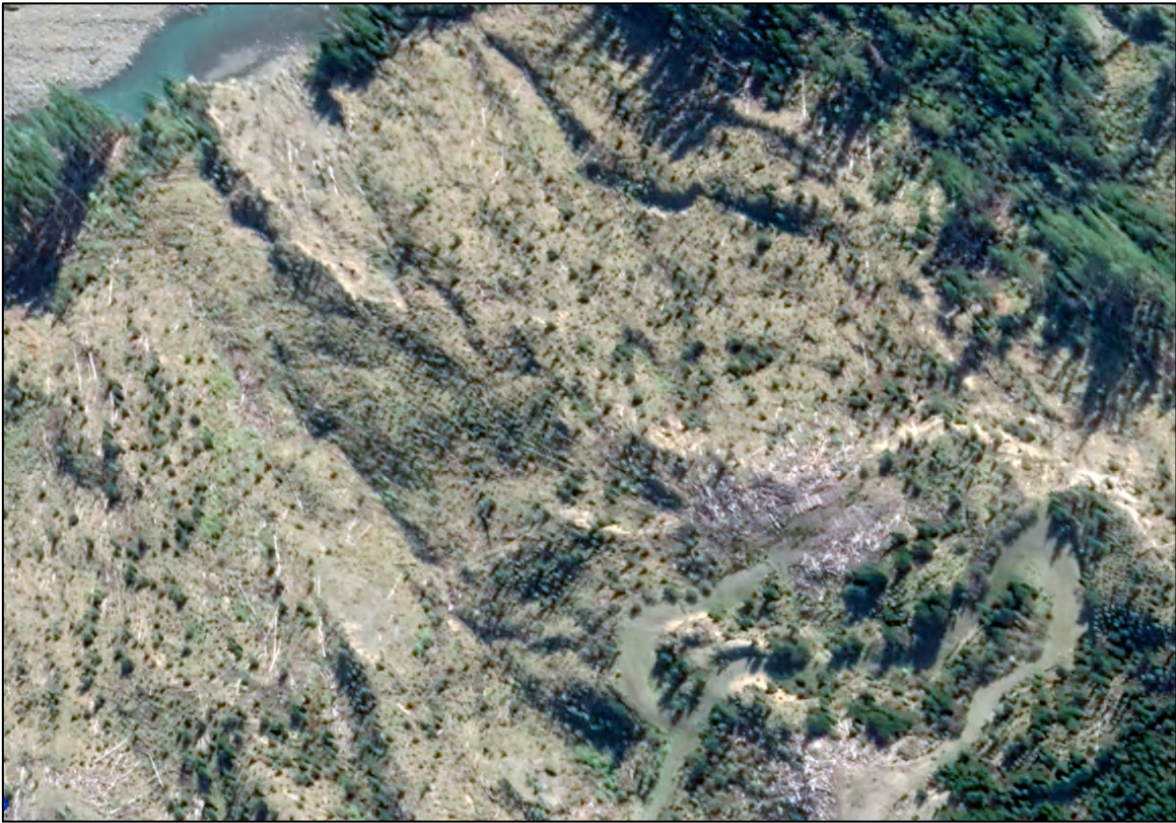
**Figure Forty Two.** Satellite image of a landing in the Waitahaia River dated 21<sup>st</sup> May 2020 showing a slip at river level but a stable landing above. Logs are evident on the slip at river level and on the river bank opposite.
