# An assessment of Woody Material on Tikapa Beach after the July 2020 storm and potential sources within the Waiapu

**Final report v3.5**

**Dr Murry Cave**  
Principal Scientist  
Gisborne District Council  
January 2021

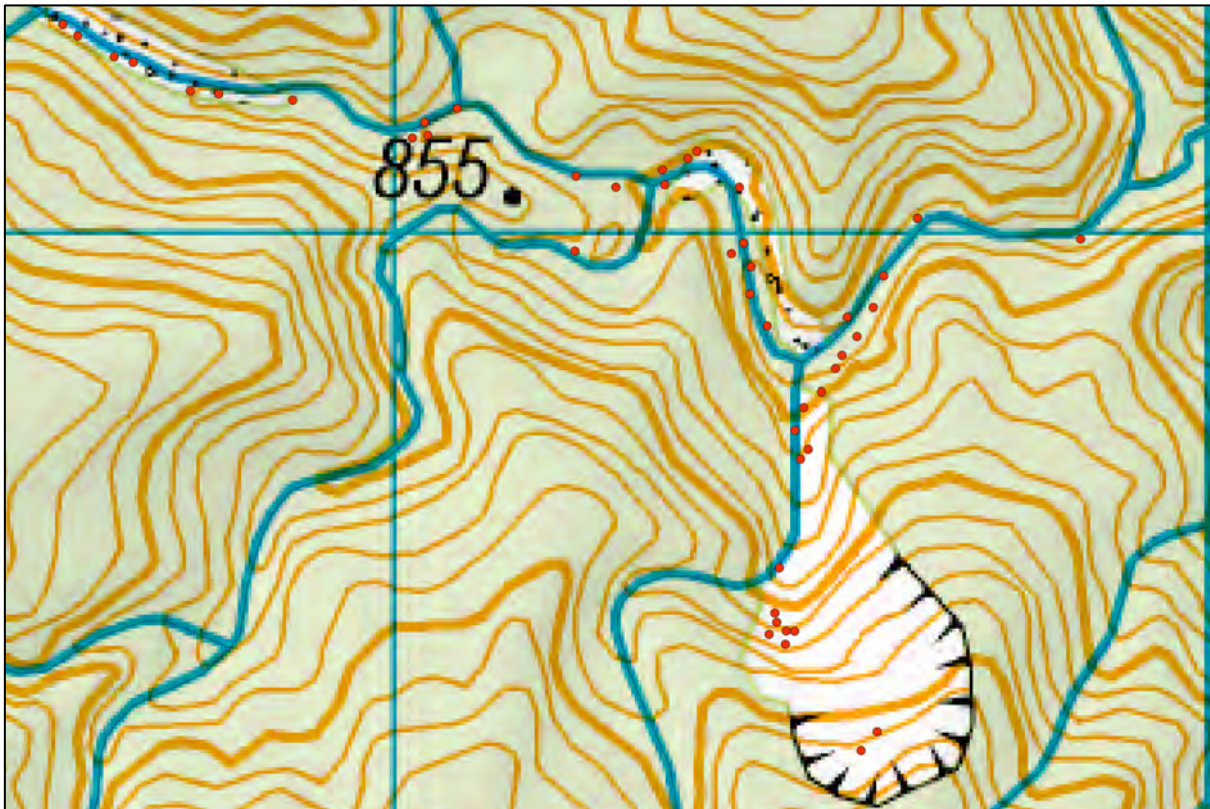
**Figure Forty Six.** Distribution of indigenous logs in Waingakia Stream being shed from an active gully and a slip further upstream.

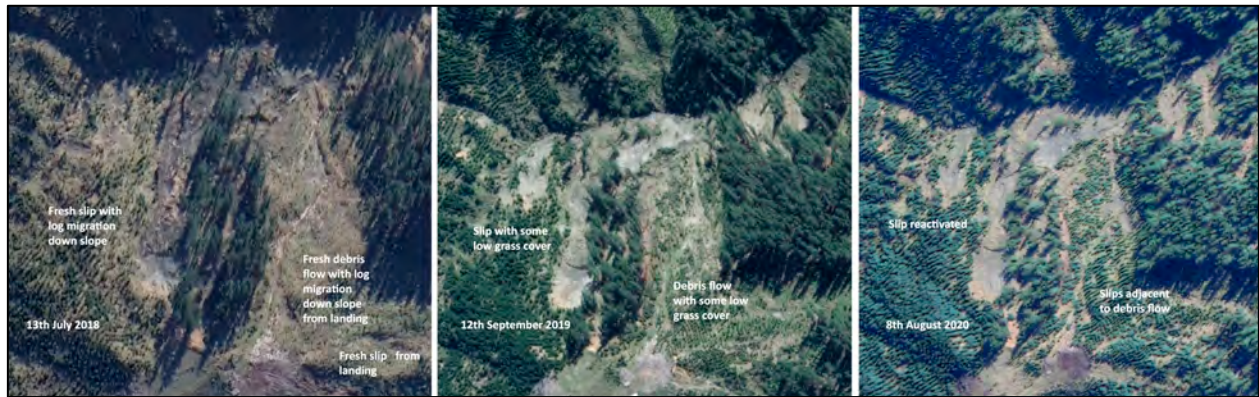
Notably, mature pine at the landing had not been harvested and remained stable. Further satellite imagery dated from 13<sup>th</sup> July 2018 and 16<sup>th</sup> September 2020 showed that the debris flow has not been active since 2018. The landslide on the lefthand side of the landing had also remained inactive between July 2018 and May 2020 but had reactivated by the 8<sup>th</sup> of August 2020 while small-scale slips associated with the debris flow are now evident (**Figure Forty Eight**).

**Figure Forty Eight.** Satellite imagery for the Waimata Stream landing dated 13<sup>th</sup> July 2018, 12<sup>th</sup> September 2019 and 8<sup>th</sup> August 2020 showing the slip and debris flow in 2018 post dating the Cyclone Cook storm, a stable period in 2019 and reactivation of the slip in 2020 with small slips associated with the 2018 debris flow.

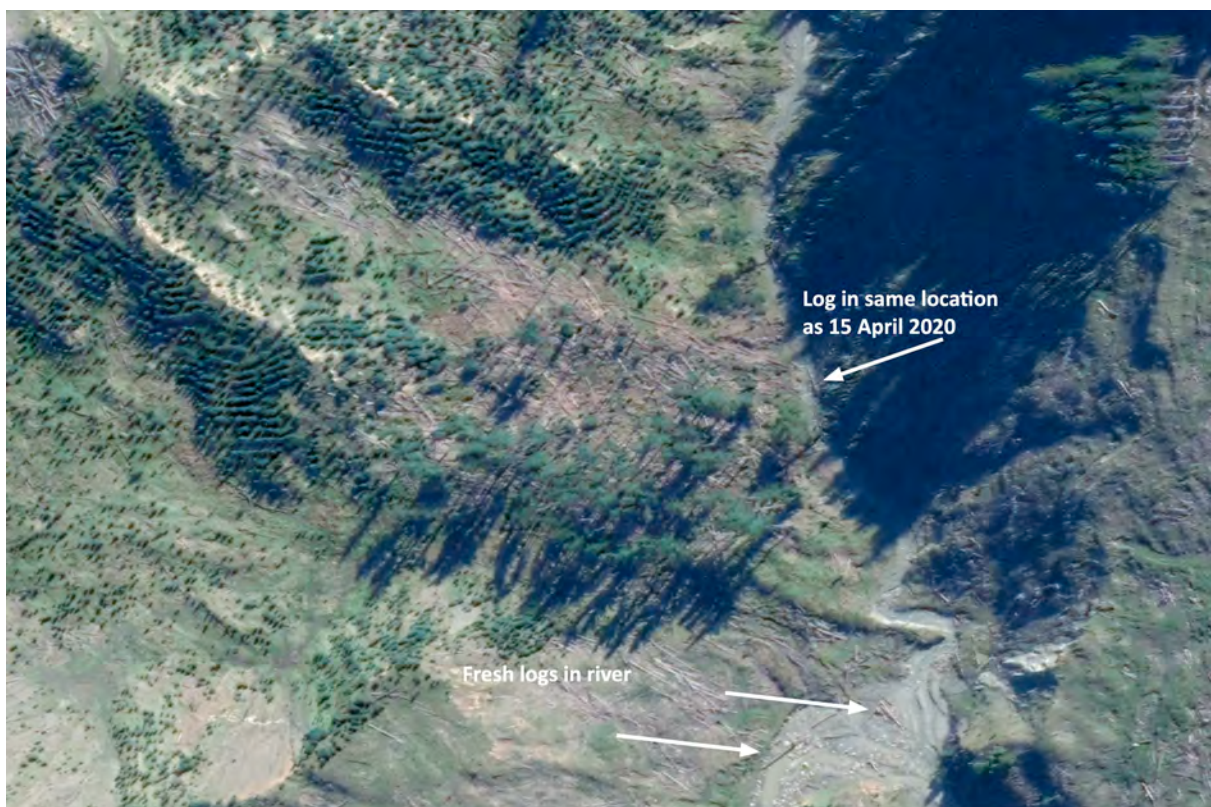
**Figure Fifty.** Satellite image of the Whakoau Stream upstream from near Bremnar Bridge dated 27<sup>th</sup> of August 2020 showing that at least one log remains in the same location but also that there are newly mobilised logs in the river below the slope that is shedding logs.

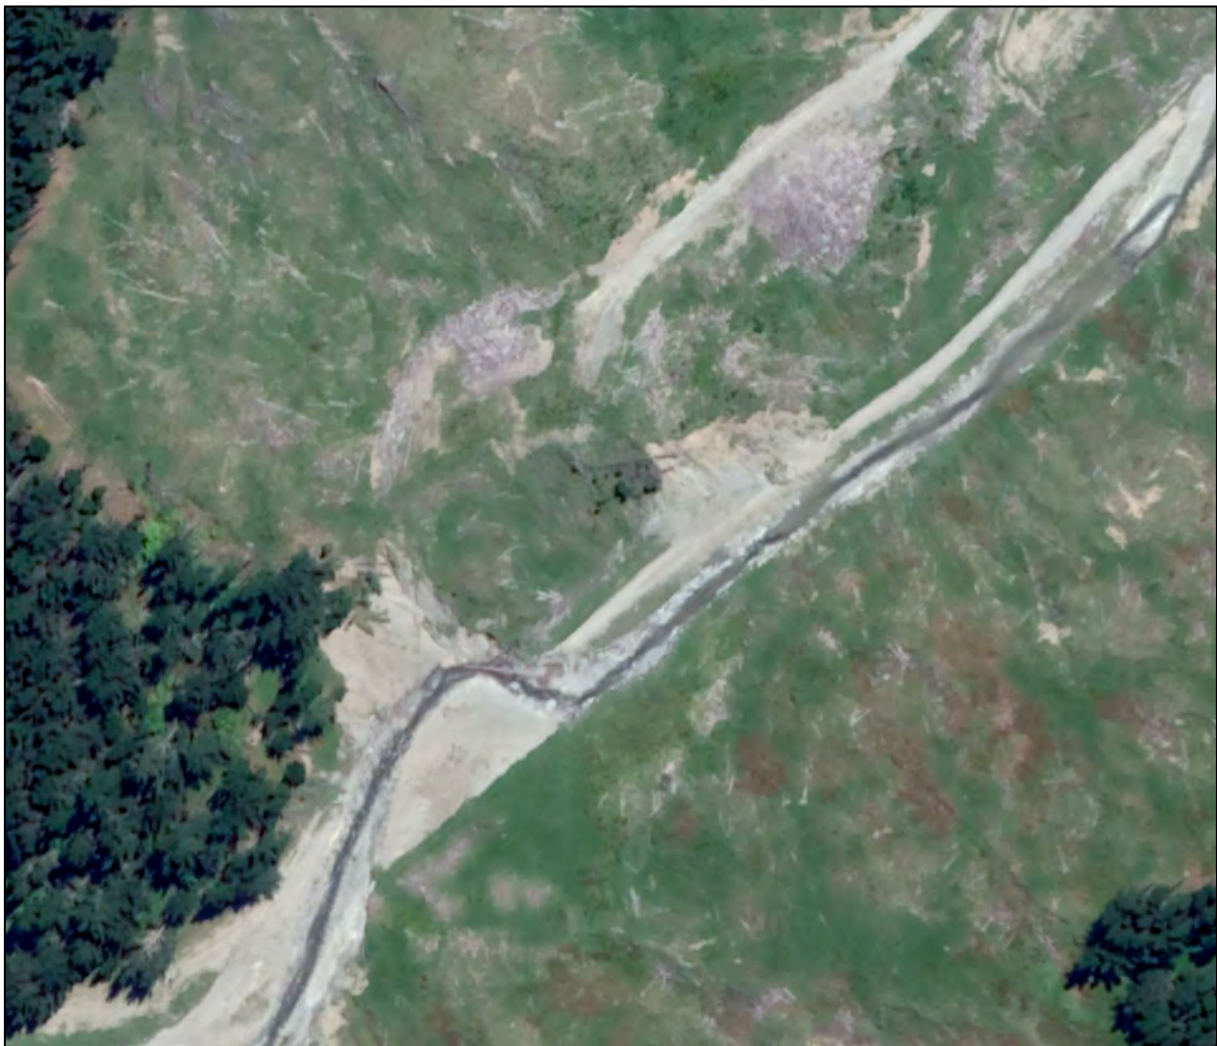
Immediately upstream from the Whakoau site is another landing that satellite imagery from the 8<sup>th</sup> of November 2019 shows to be intact (**Figure Fifty One**). Over the middle of 2020, however, the landing is marked by tension cracks which by the 8<sup>th</sup> of August 2020 has resulted in logs and soil being mobilised down slope (**Figure Fifty Two**) and there are indications of active slope failure at the site by the 16<sup>th</sup> of September 2020 (**Figure Fifty Three**).

**Figure Fifty One.** Satellite image of a landing in Whakoau Stream dated 8<sup>th</sup> of November 2019 showing no sign of failure. The slip at both ends of the site seems to date from around 2016 when the roadway was constructed.

It is not evident that this site is presently contributing a significant volume of logs to the catchment. The presence of birds-nests immediately upslope and adjacent to the slope failure indicated by the tension cracks suggests, however, that this site will a probable contributor of harvest residues to the catchment over the next few years. Remediation of the site to mitigate the risk of failure is an appropriate course of action.

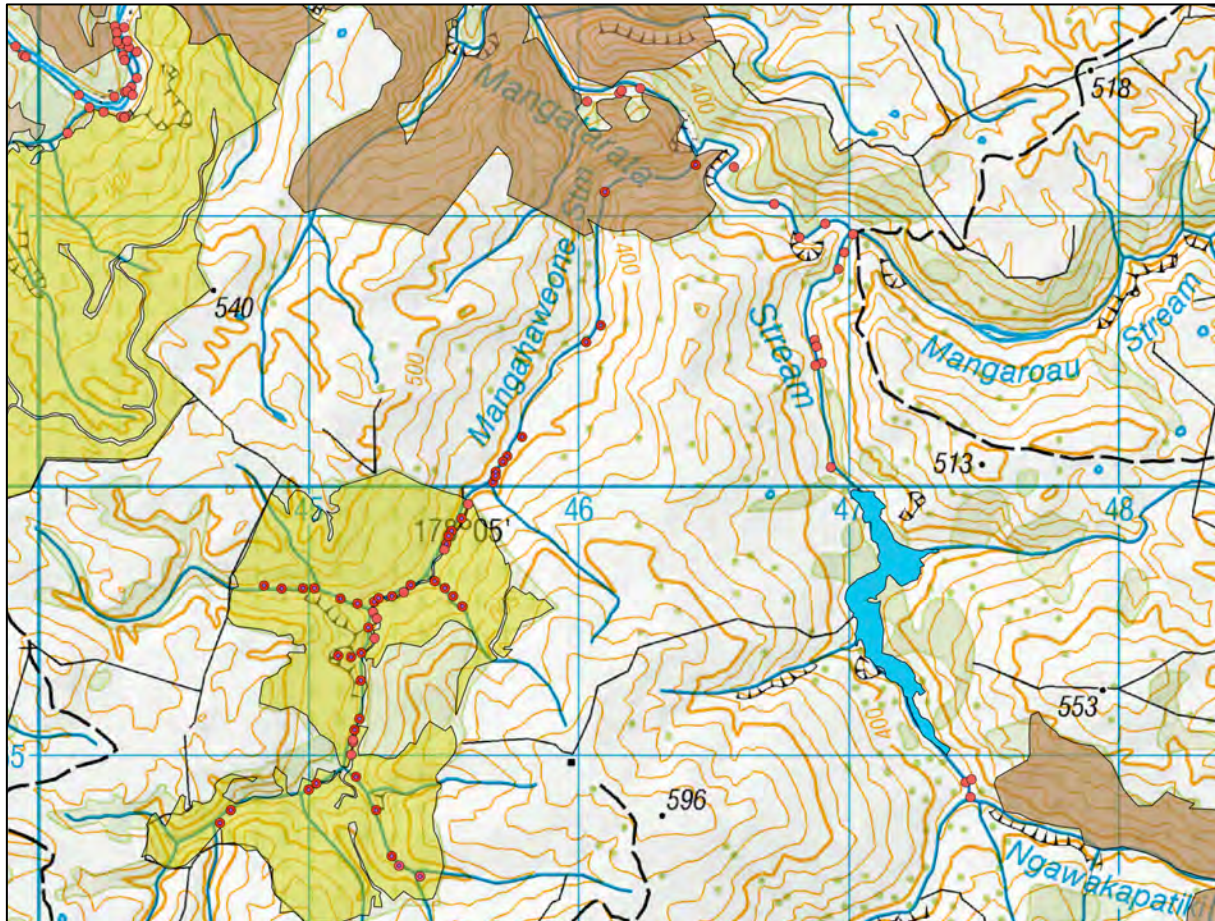
Harvesting of this forest that is surrounded by pasture started in 2015 and was completed before July 2018. The harvesting is notable for the extent to which logs are distributed on all slopes and within the Mangahaweone Stream down to the confluence with the Mangatarata Stream tributary of the Mata (Figure Fifty Four).

**Figure Fifty Four.** Map of the recently harvested forest in Mangahaweone Stream and the distribution of logs in the streams and migrating down to the Mangatarata tributary of the Mata River. Note the small lake in the adjacent stream which formed as a result of an earthflow on the boundary between Matanui and Fernside stations.

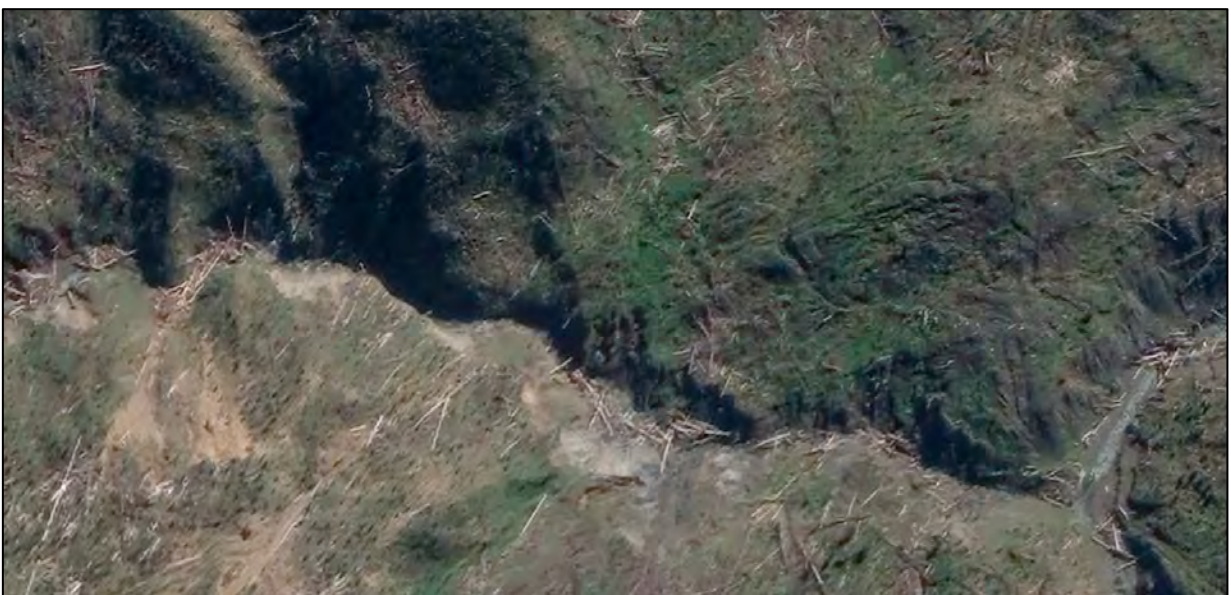
The extent of logs in the streambed is shown in **Figures Fifty Five** and **Fifty Six** below. **Figure Fifty Five** shows two log jams in the main stem of the Mangahaweone Stream on the 27<sup>th</sup> of August 2020 while **Figure Fifty Six** shows the extent of logs in a small true left tributary immediately upstream of the log jams on the 13<sup>th</sup> of September 2020. While one group of logs in **Figure Fifty Six** clearly relates to a fresh slip the other areas of logs are not related to slope failures. Assessing the position of these logs in both figures over time does not point to a significant extent of downstream migration over the period from 13<sup>th</sup> July 2018 to the 9<sup>th</sup> of September 2020 that is the latest available satellite imagery. Some movement of individual logs is occurring but generally the log jams themselves have remained in place<sup>3</sup>. This site is, however, a significant reservoir of logs with potential to mobilisation in the future.

**Figure Fifty Six.** Satellite image of Mangahaweone Stream on the 16<sup>th</sup> September 2020 showing the extent of logs within a true left tributary of the stream.

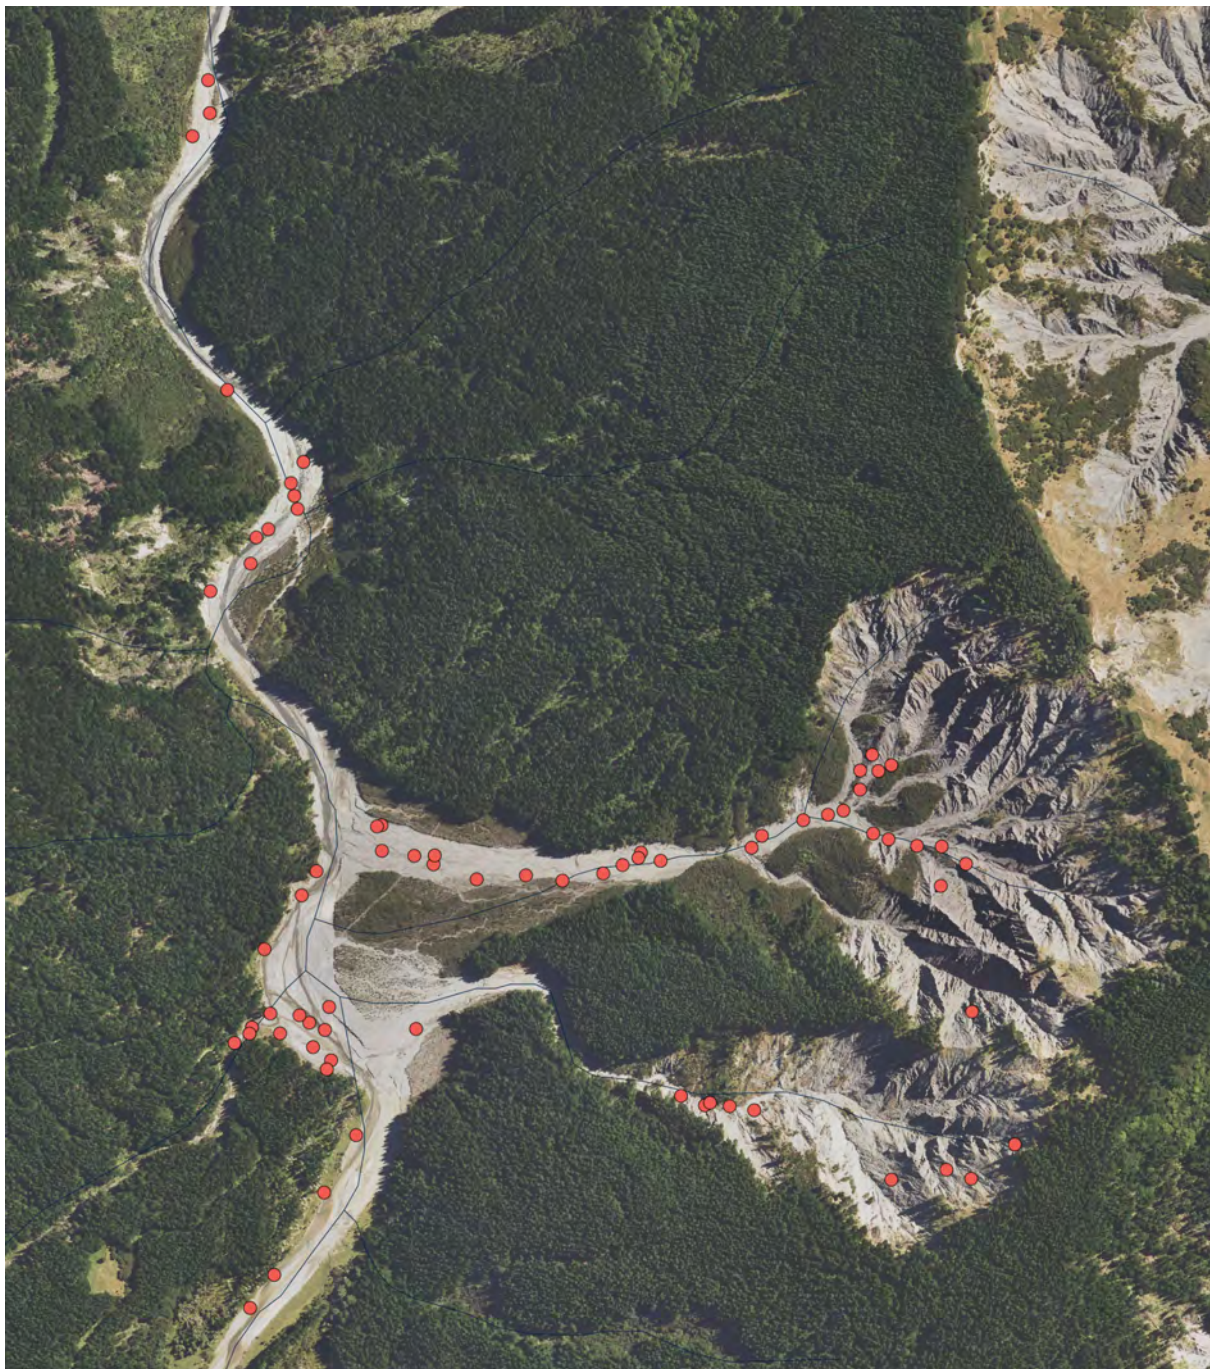
This area in the Ihungia river catchment was planted in the late 1990s-2000 and is likely to be harvested within the next few years. Analysis for the period 2007 and 2020 indicates that the gully has been relatively stable over this period with the gully increasing in size from 42.5 ha in 2007 to 43.5 ha in 2020. Some pine encroaching onto area previous in the active gully has occurred, however, while elsewhere some gully retreat has occurred. Satellite imagery for 25<sup>th</sup> November 2011, through to the 16<sup>th</sup> September 2020 all show logs being shed from the gully, however, the volume of material in the stream bed at the base of the gully is greatest after the July 2020 storms.

**Figure Fifty Seven.** Distribution of logs in the vicinity of a large (43.5 ha) relatively stable gully in the Ihungia river sub catchment. This area was planted in pine some time in the late 1990s-2000 period.

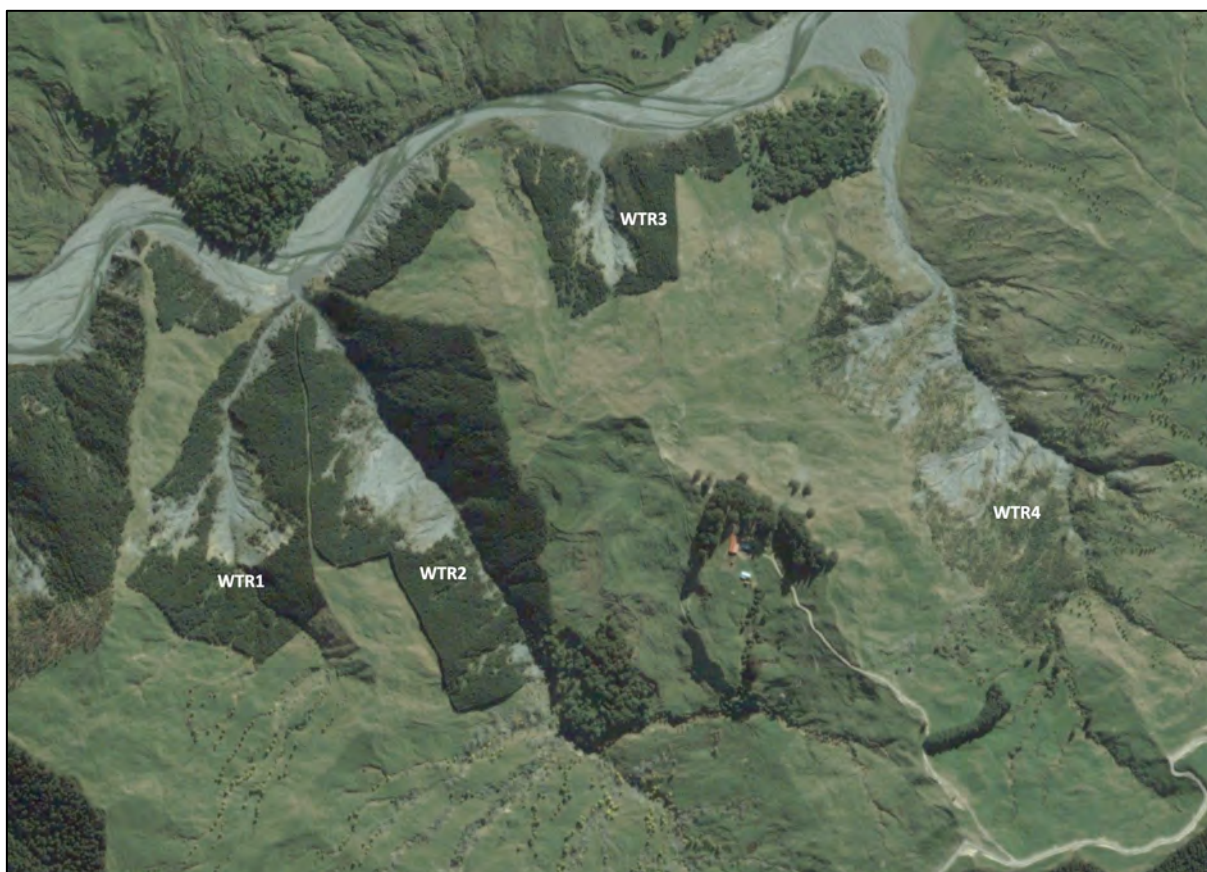
There are several gullies on the true right side of the Waitahaia River on either side of Waitahaia Road which were planted in pine in the period late 1990s to around 2005 (**Figure Fifty Eight**). The gullies have been designated WTR1 to WTR4 (Waitahaia True Right 1 to 4 upstream to downstream) to assess the effectiveness of the pine plantings as a gully treatment. The plantings appear to have been reasonably effective in stabilising the gullies with some showing signs of recovery but with the larger ones show a relatively small increase in size between 2007 and 2020 (**Figure Fifty Nine**).

**Figure Fifty Eight.** Satellite image of the Waitahaia River at Waitahaia Station dated 5<sup>th</sup> of May 2007 showing a downstream gully that has been recently planted in pine while the adjacent gullies upstream have older closed canopy pine. To aid assessment of the site the gullies have been designated as WTR1 to WTR4 (Waitahaia True Right 1 to 4).

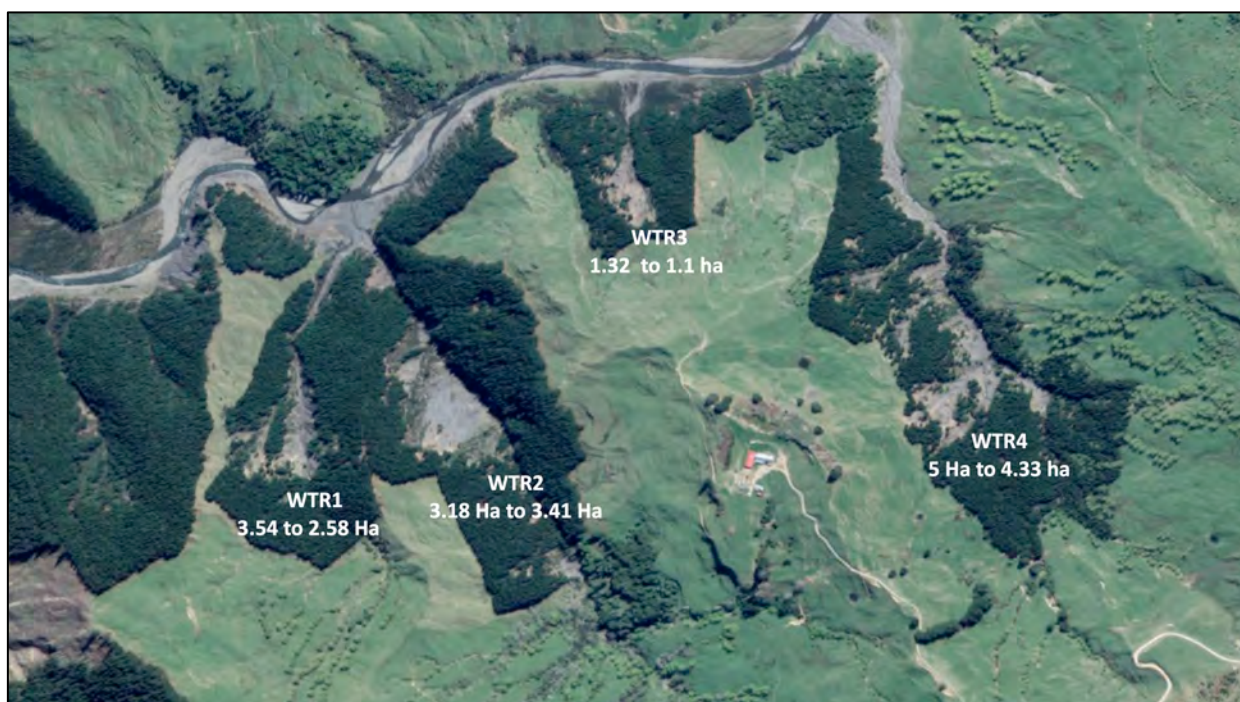
Gully WTR1 has shown the most improvement decreasing in size from 3.54 ha down to 2.58 Ha while gully WTR3 has shown less of an improvement decreasing in size from 1.32 ha down to 1.1 ha. Gully WTR4 has also shown a decrease down in size from 5 ha to 4.33 Ha over the period. Gully WTR2 on the other hand has increased in size over the period from 3.18 Ha to 3.41 ha. Furthermore, while the overall area of the gullies may have decreased, all of them show signs of recent slipping at the head scarp with trees displaced and mobilised down slope to the streams<sup>4</sup>. Generally, it appears that gully recovery has been the result of good tree growth on easier parts of the gully but this has been at the expense of head scarp retreat.

**Figure Fifty Nine.** Satellite image of the Waitahaia River dated 8<sup>th</sup> of August 2020 with the change in area of each gully from 2007 shown.

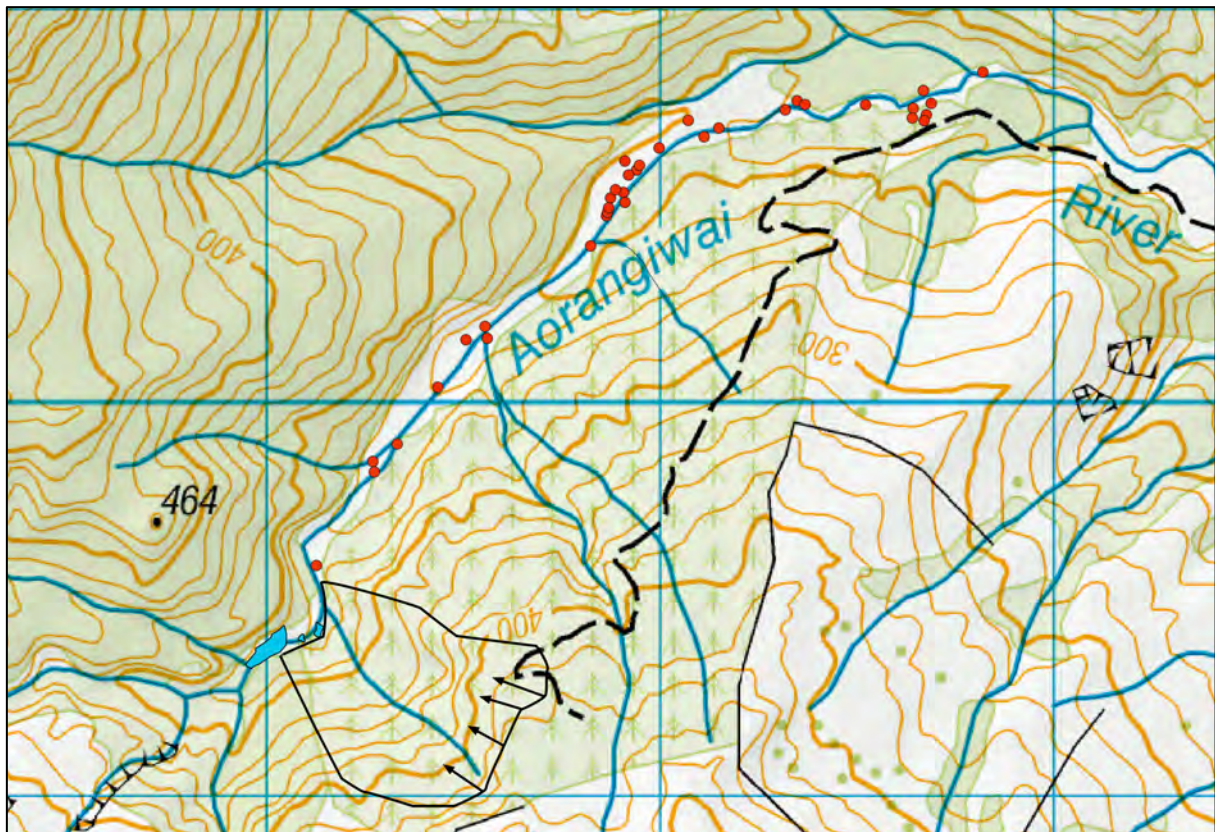
The Cave (2020) report concluded that the event most likely occurred during heavy localised rain that fell in the area overnight on the 21<sup>st</sup> July and that antecedent rainfall had primed the slope for failure. The failure area was about 7.4 Ha and appears to have occurred in an area of pre-existing instability. The report also determined that the lakes that had formed were relatively small and unlikely to fail rapidly but in the event of a failure the volume of water released would be low relative to the capacity of the river below and hence the risk of damage to bridges and other facilities downstream was low.

The loss of trees to the catchment as a result of the landslide was not assessed at that time. An assessment has been made using satellite imagery dated the 8<sup>th</sup> of August and the 12<sup>th</sup> of September 2020 and shows that there were a significant number of logs distributed downstream of the landslide (**Figure Sixty Three**). Not all of these logs will have come from the failure however, as a small slip in indigenous on the true left side of the river just downstream of the landslide dams also contributed a small amount of material.

**Figure Sixty Three.** Map of the Aorangiwai River showing the location of the landslide from Stevensons forest and the distribution of logs identified by satellite imagery dates 8<sup>th</sup> August and 12<sup>th</sup> September 2020.

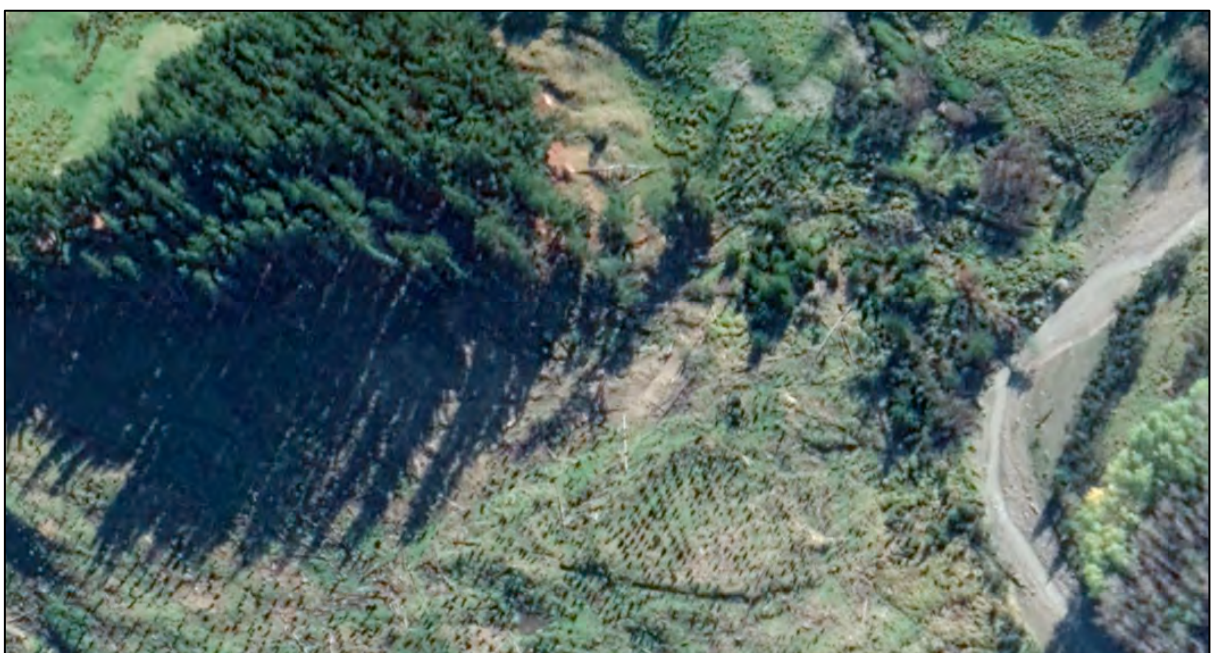
Satellite imagery from the 8<sup>th</sup> of August 2020 shows a 0.8 Ha slip on the true left bank of the Whakoau River just downstream from Bremnar Bridge (**Figure Sixty Four**). Imagery from the 21<sup>st</sup> of May 2020 pre-dates the slope failure but highlights the impact of large volumes of harvest residue logs left on slopes post-harvest when heavy rainfall then occurs (**Figure Sixty Five**). This slip and the other failures higher in the Whakoau River appear to have contributed a significant volume of logs to the catchment (**Figure Sixty Six**).

**Figure Sixty Five.** Satellite image of the Whakoau Stream immediately downstream of the Bremnar Bridge dated 21<sup>st</sup> May 2020 showing the pre-failure presence of harvest residues on the slope.

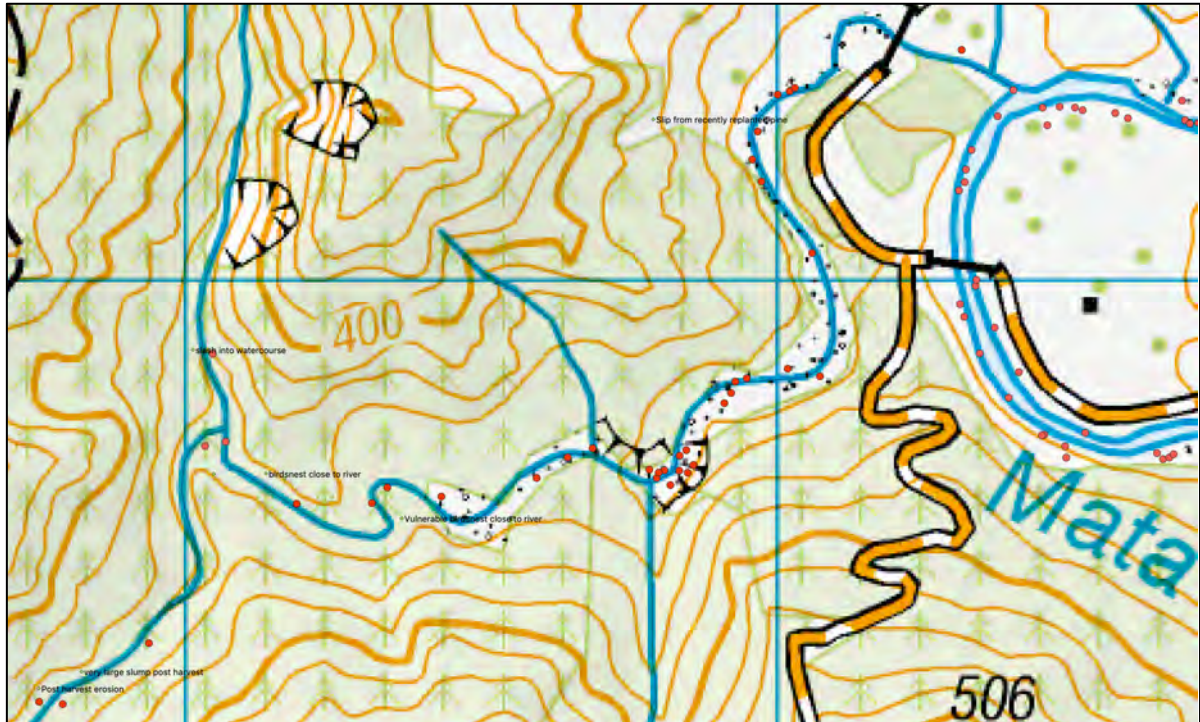
**Figure Sixty Six.** Map of the lower Whakoau Stream showing the distribution of logs downstream from the failure sites upstream from the confluence with the Mata River.

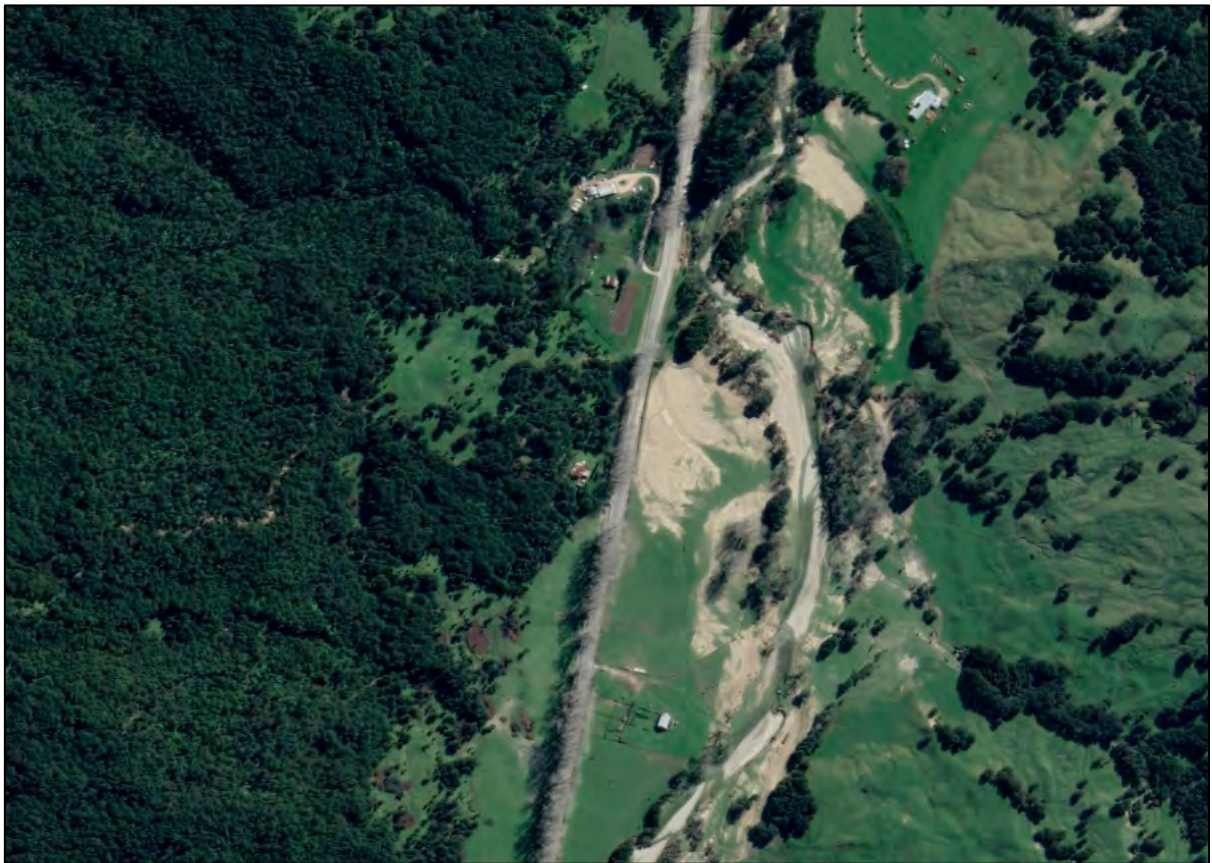
Satellite imagery dated 17<sup>th</sup> of August and 16<sup>th</sup> of September 2020 show flood spread on the banks of Makatote Stream adjacent to State Highway 35 and just south of Hiruharama Marae (**Figure Sixty Seven**). Prior satellite imagery from the 21<sup>st</sup> May 2020 does not show any evidence of flood spread in this vicinity. Earlier imagery indicates that this area did not flood during either Cyclone Cook (2017), the Queens Birthday storms (2018) or the October 2019 storms. A small amount of flood spread in Mokoiwi Stream occurred between May and August 2020 occupying an obvious flood channel. Similarly a small flood spread occurred at the mouth of Makomete Stream where it joins State Highway 35 at Waiotaapi (Takapau). During the July 2020 storms a significant amount of flood spread also occurred on the Mata River just west of the Matahiia Road re-occupying in full or in part an area of previous flood spread from the Queens Birthday storm of 2018 (**Figure Sixty Eight**).

**Figure Sixty Seven.** Satellite image of the Makatote Stream in the vicinity of Hiruharama Marae on State Highway 35 showing the extent of flood spread from the July 2020 storms.

Overall the extent of flood spread during the July 2020 storms does not appear to be as significant as that which occurred during the Queens Birthday storm of 2018 and is not associated with the deposition of a large number of logs.

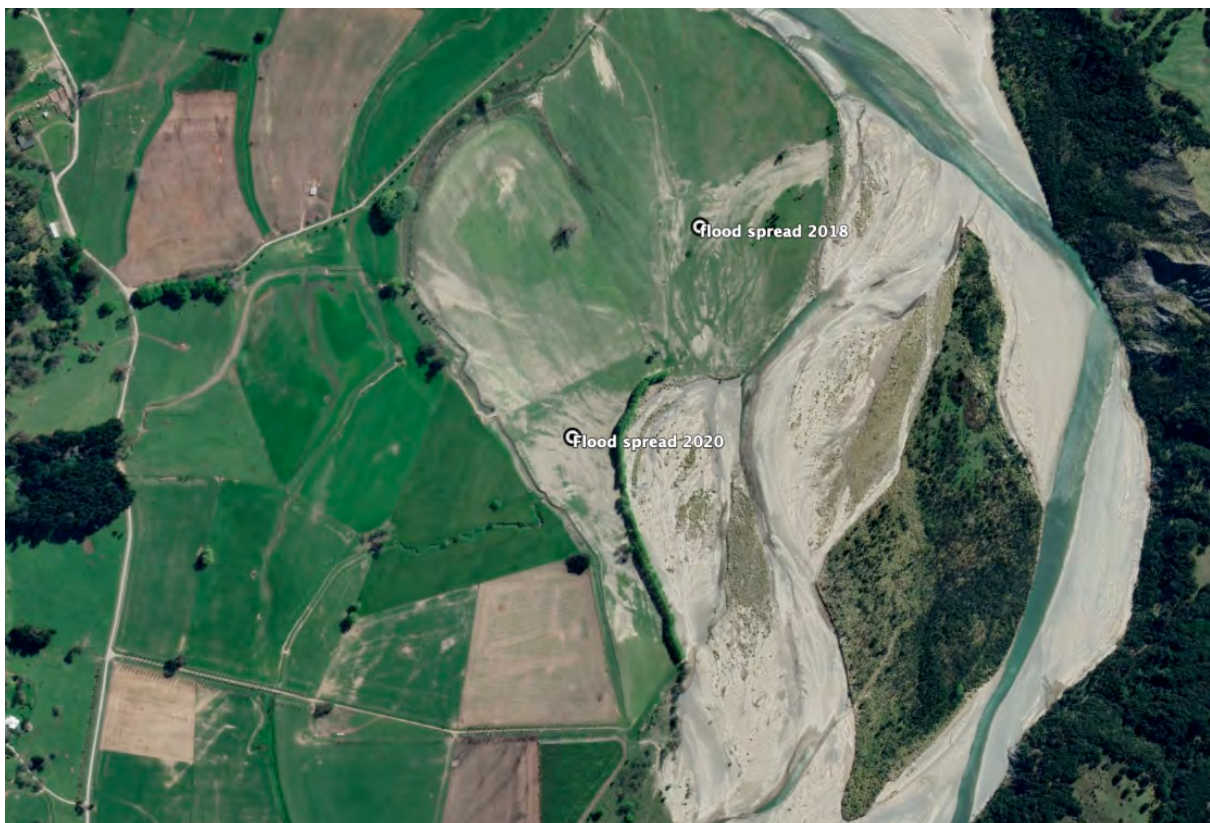
**Figure Sixty Eight.** Satellite image of the lower reaches of the Mata River dated 16<sup>th</sup> September 2020 showing the area of 2020 and 2018 flood spread.

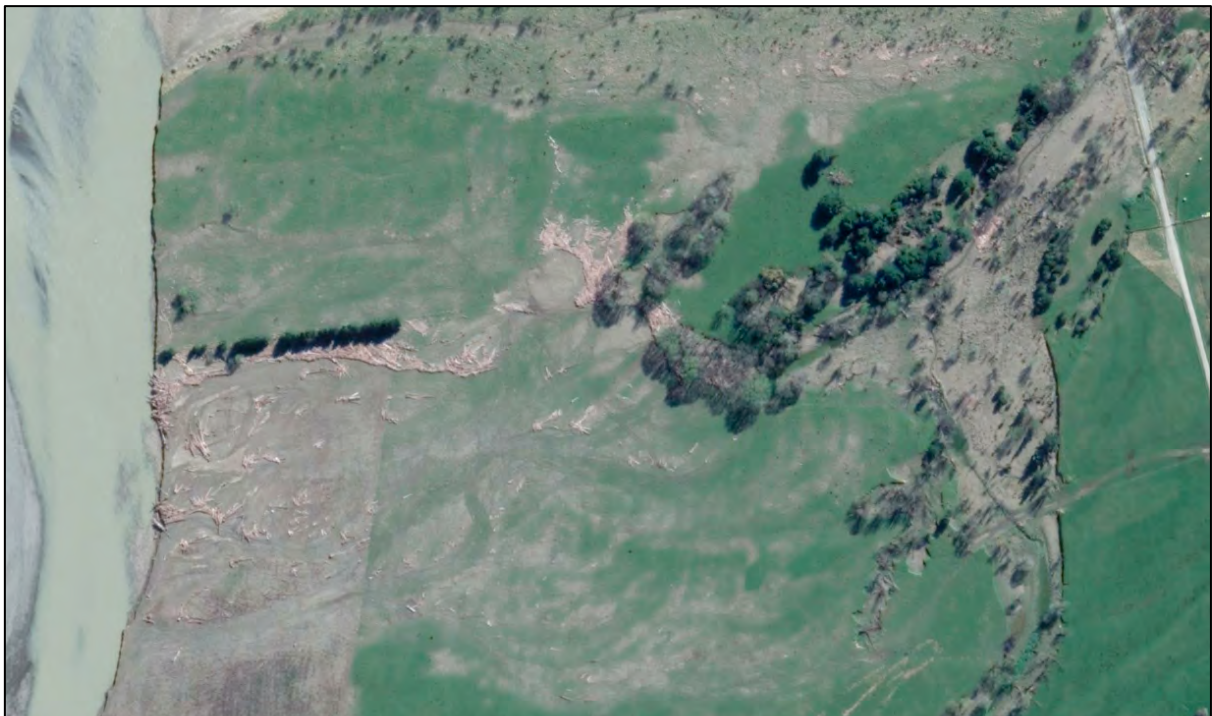
In contrast, satellite imagery from the 25<sup>th</sup> of August 2018 shows that there is an area of significant flood with significant numbers of logs spread over the flood plain and pasture in the lower reaches of the Mata River just west of Karewa Road at Aorangi (**Figure Sixty Nine**). Based on the date the most likely origin for this flood spread was the Queens Birthday storm of June 2018. Fresh silt on this flood plain is visible in satellite imagery dated 16<sup>th</sup> of September 2020 but does not have the same extent as the 2018 flood spread but may have remobilised logs on the flood plain.

*(Figure Sixty Nine) image of the lower Mata River at Kawera Road dated 25<sup>th</sup> of August 2018 showing the flood spread and logging debris from the Queens Birthday storm 2018.*

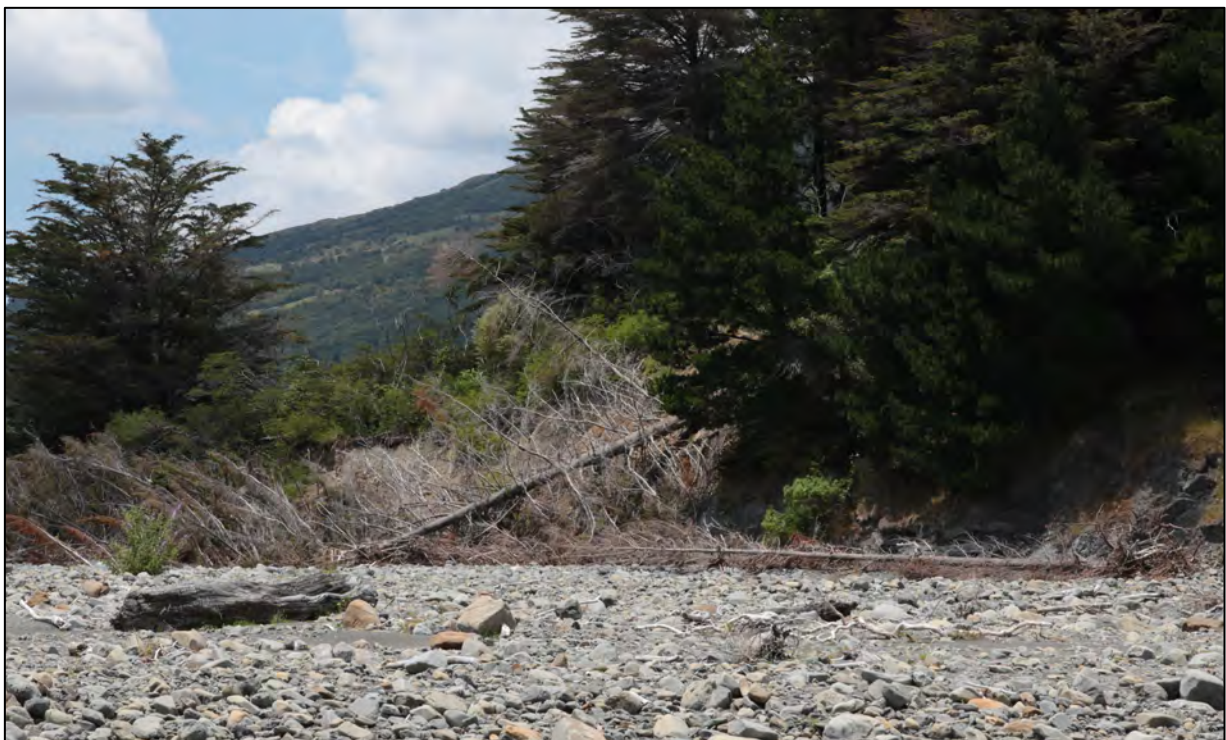
**(Figure Seventy)** Photograph of collapsed pine tree resulting from river bank scour (toe failure). Tapuaeroa River immediately upstream of Pakihiroa Bridge (6<sup>th</sup> January 2021).

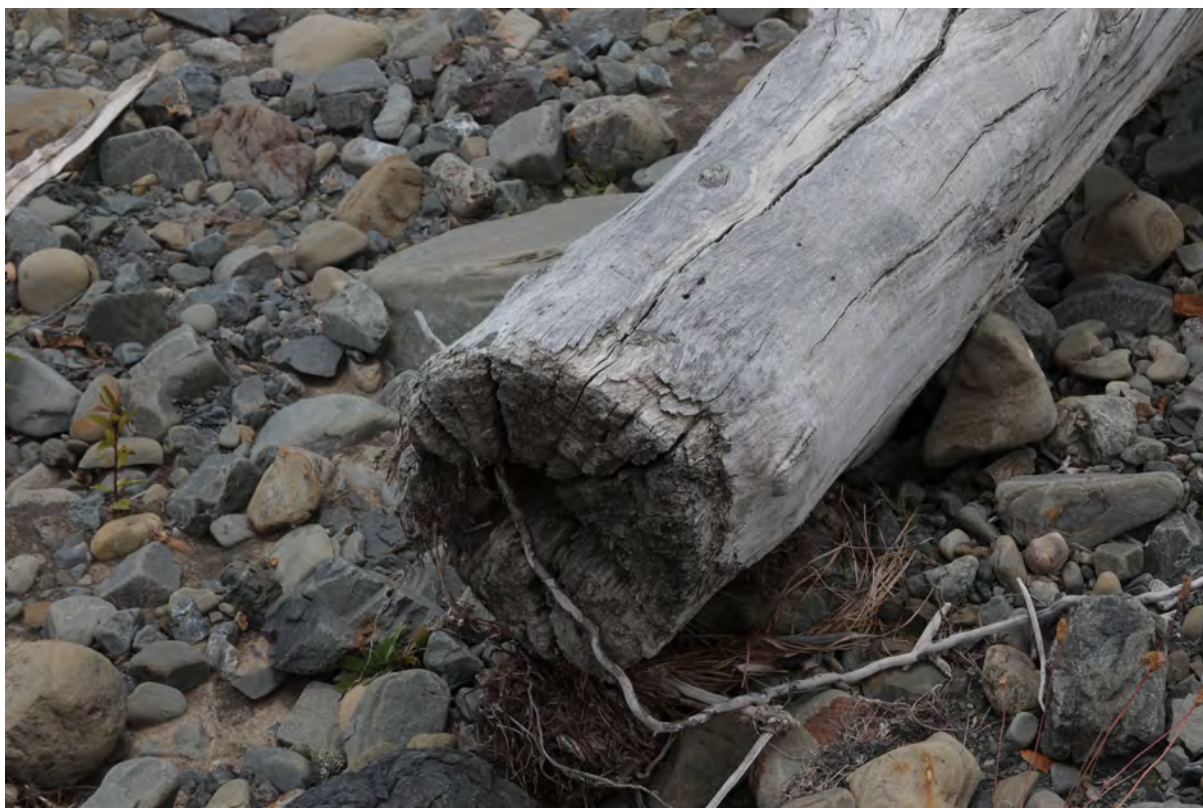
For pine forests the failure mechanisms were more varied. While some were generated by gully erosion or by incremental failure of stream banks, (**Figure Seventy One**) ten out of fifteen failures were associated with forestry landings (skid sites) and roadways, as well as birds-nests in vulnerable locations and clear-felled slopes directly connected to waterways.

**(Figure Seventy One)** Photograph of weathered pine log with an obvious cut end. Tapuaeroa River approximately 1km upstream of Pakihiroa Bridge (6<sup>th</sup> January 2021).
