Cyclone Cook Slash Investigation

Dr Murry Cave Principal Science Advisor GDC
Nicki Davies, James Langford GDC Land & Soil Team

October 2017

Executive Summary

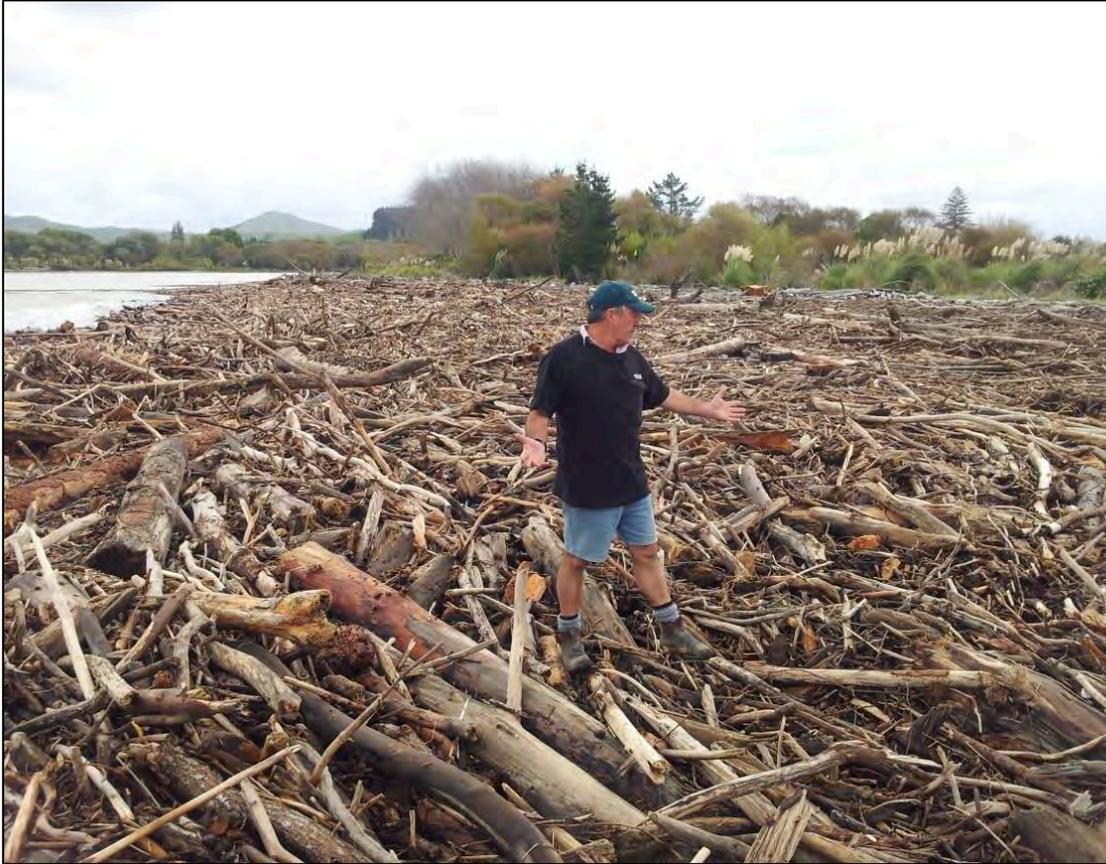
Figure 3. Resident viewing slash on Tolaga bay Beach 2012

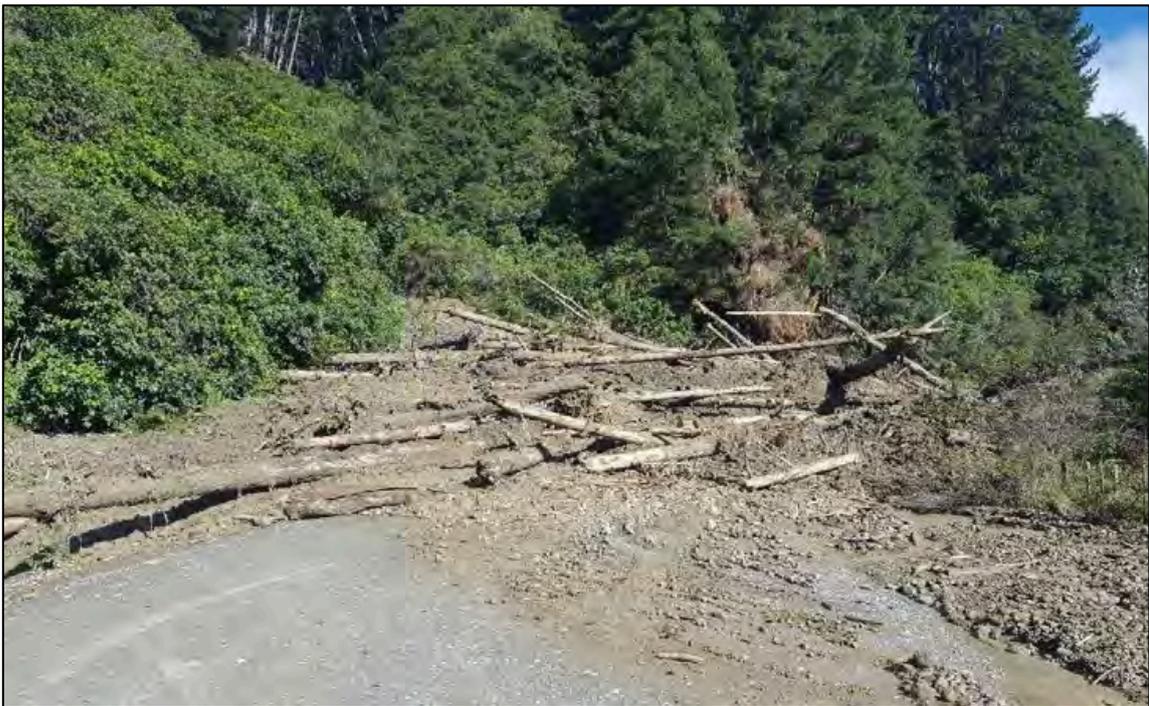
Figure 12. Photograph of Doonholm Landslide taken before work to clear the photo (Photo SSL via Tairiwhiti Roads).

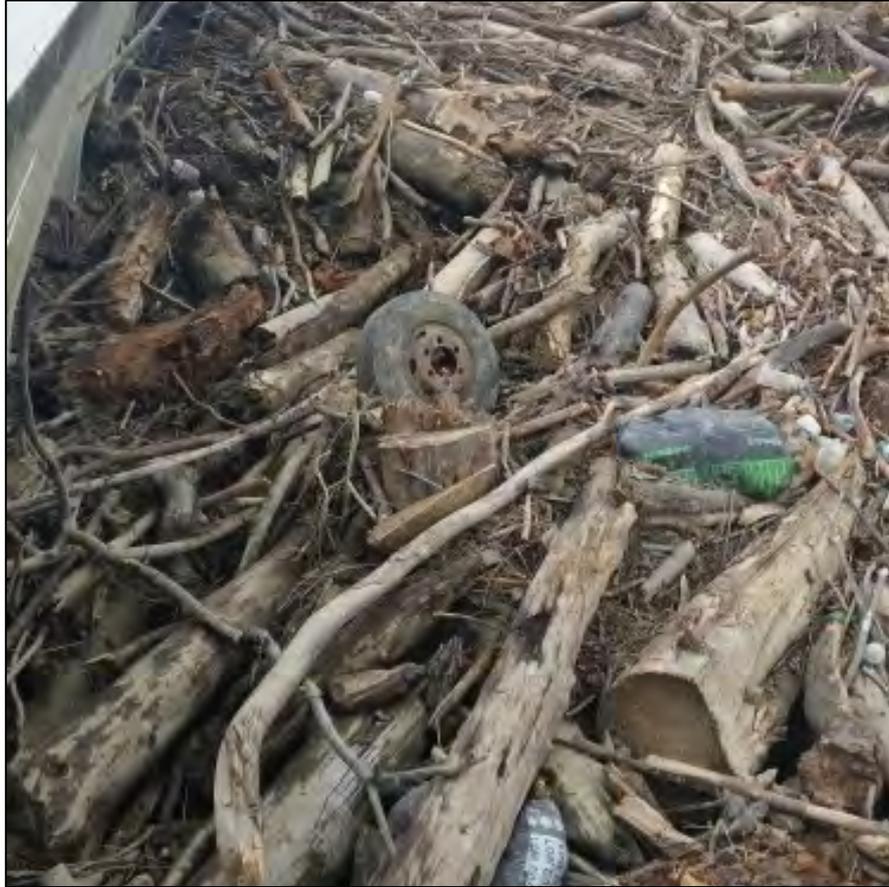
Figure 13. Debris caught up against Wigan Bridge; note the presence of cut pine logs and butt ends.

Based on a comparison of the volume of material at Wigan Bridge on the 18th of April (see *Figure 13*) and that shown in *Figure 35*, it is assessed that the debris in the river shown in *Figure Thirty Five* is most likely to be mainly composed of slash released from Wigan Bridge during slash clearance following Cyclone Cook. Based on a traverse undertaken on the 13th of May, this unconfined slash had largely mobilised further downstream during a small flood event around one week after the flight. No slash was subsequently observed between here and Tolaga Bay but significant volumes of new slash was reported on the beach.

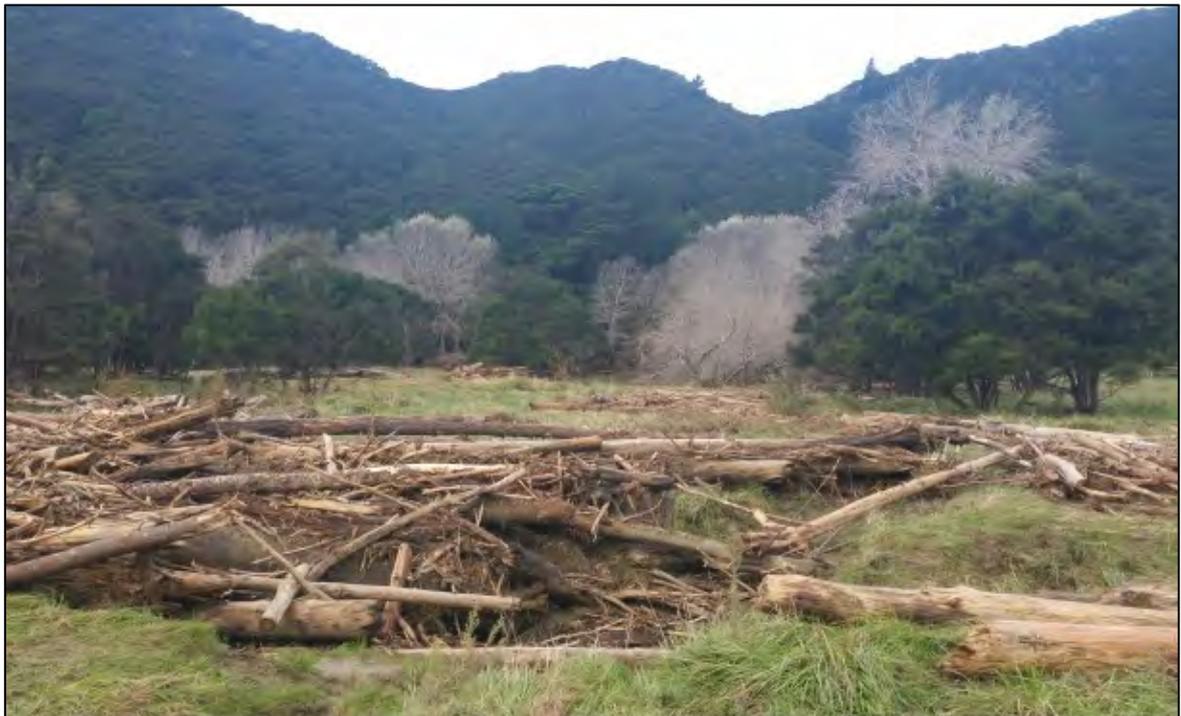
The presence of significant pine was evident in many places (Figure 14) but there was also a considerable volume of smaller finer woody debris caught up against the river-side willows (Figure 15). The considerable amount of material piled up against the road indicates that the full valley floor was occupied by the flood event (Figure

Figure 14. Pine logs and finer woody dross caught up on the Mangatokerau river flats.

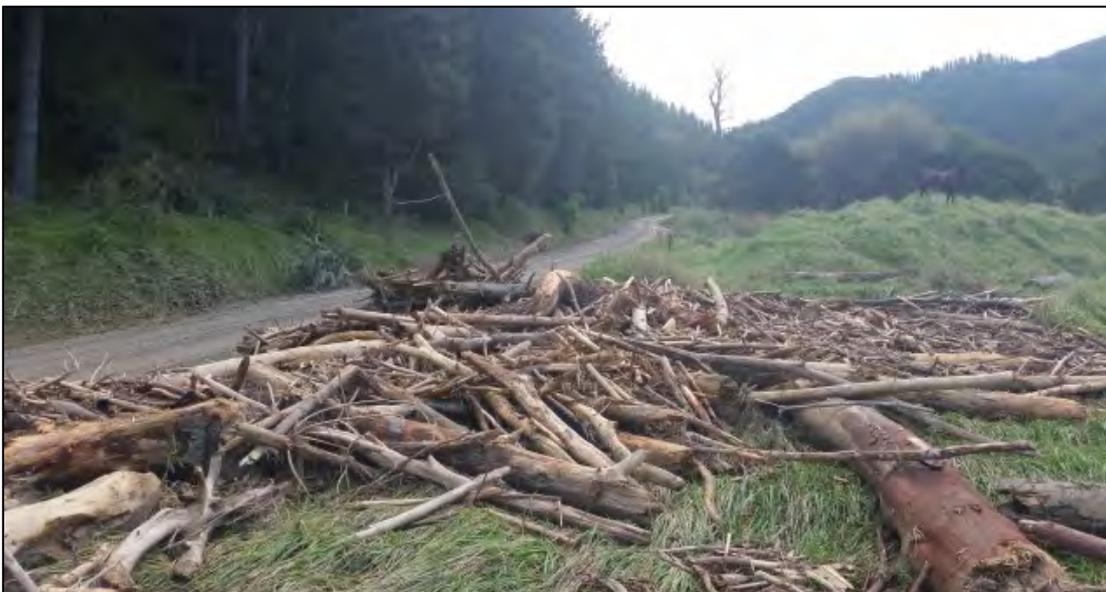
Figure 16. Pine logs and dross piled up against Managtokerau Road. This debris and the flattened grass in the foreground gives a strong indication of flood height suggesting that the entire valley floor was flooded.

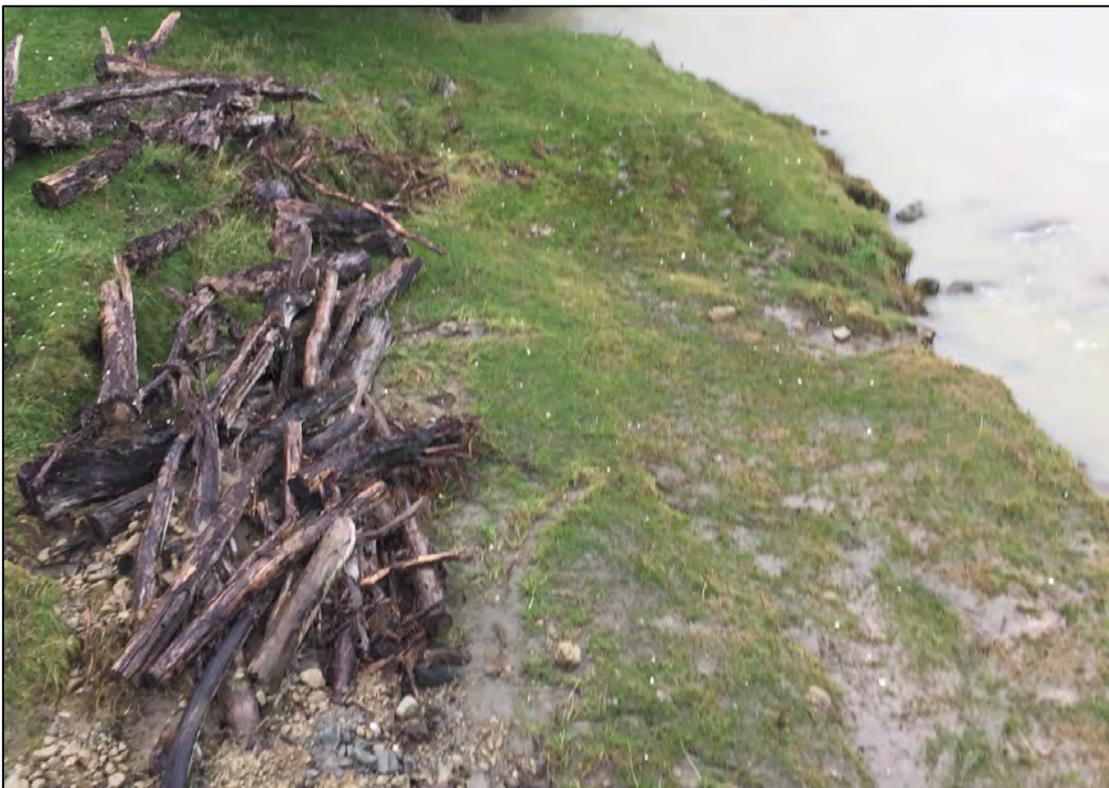
valley. Examination of the river banks showed signs of significant failure of river banks (Figure 17) and some signs of woody debris but the volumes were not significant (Figure 18). Similarly, the volume of wood caught against the Gladstone Road bridge were not significant (Figure 19).

Figure 18. Woody debris on the banks of the Waimata River 18th of April 2017.

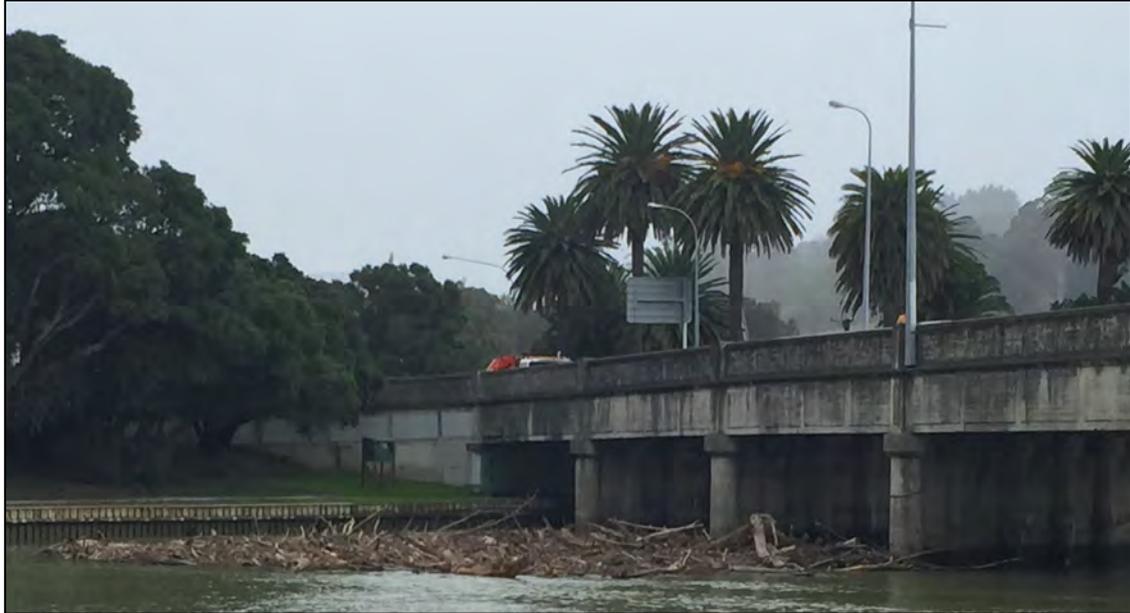
Figure 19. Woody Slash lodged against the Gladstone Road Bridge in Gisborne City.

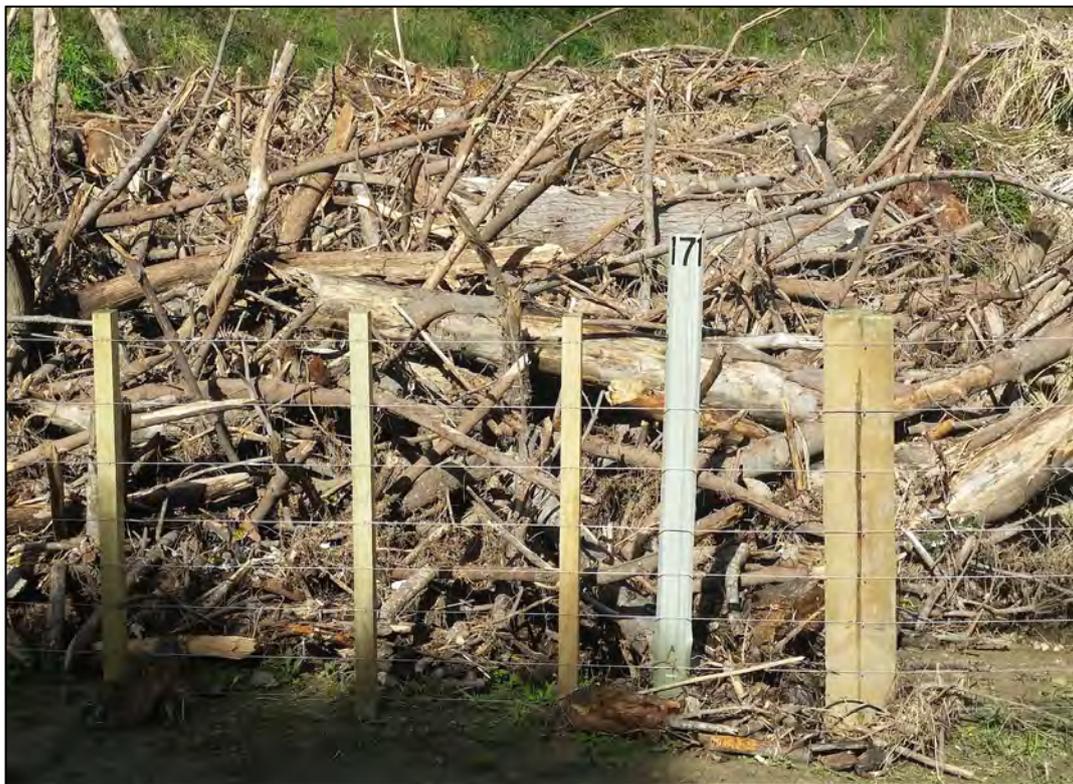
Cave Road was visited by the Land and Soil team on the 19th of April following the receipt of a request for service (RFS) from a member of the public. Significant movement of slash from a recently harvested pine plantation was identified with woody debris mobilised downslope and lodging against a fence. The fence acted to stop most of the slash from reaching Cave Road itself (*Figure 20*).

Figure 20. Forestry slash held up against a fence on Cave Road, Waimata Valley.

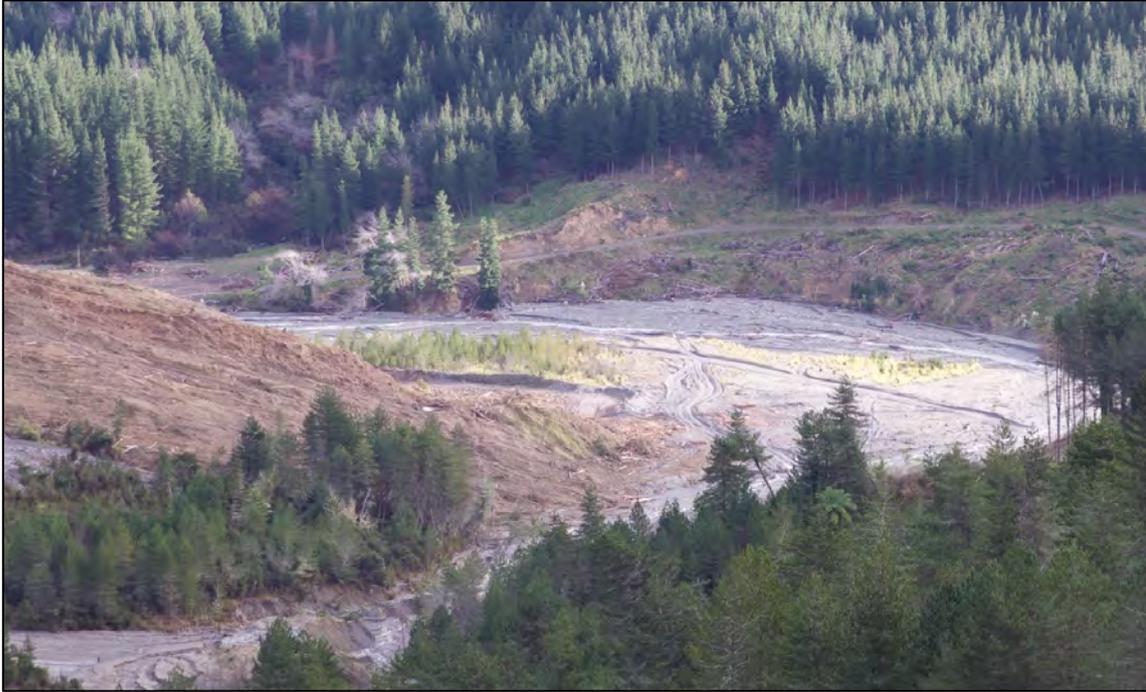
The Tardale landslide in the head reaches of the Waipaoa was visited on the 25th of June. Although the Waipaoa catchment had not been identified as having a significant slash event, observations of the Whatatutu River tributary of the Waipaoa from Tardale showed that forestry slash was stored on the flood plain. It was also observed that there signs that this slash had been mobilised and subsequently cleaned up into piles on the flood plain (*Figure 23*).

Figure 23. View of the Mangatu River from Tarndale show slash piles located on the flood plain.

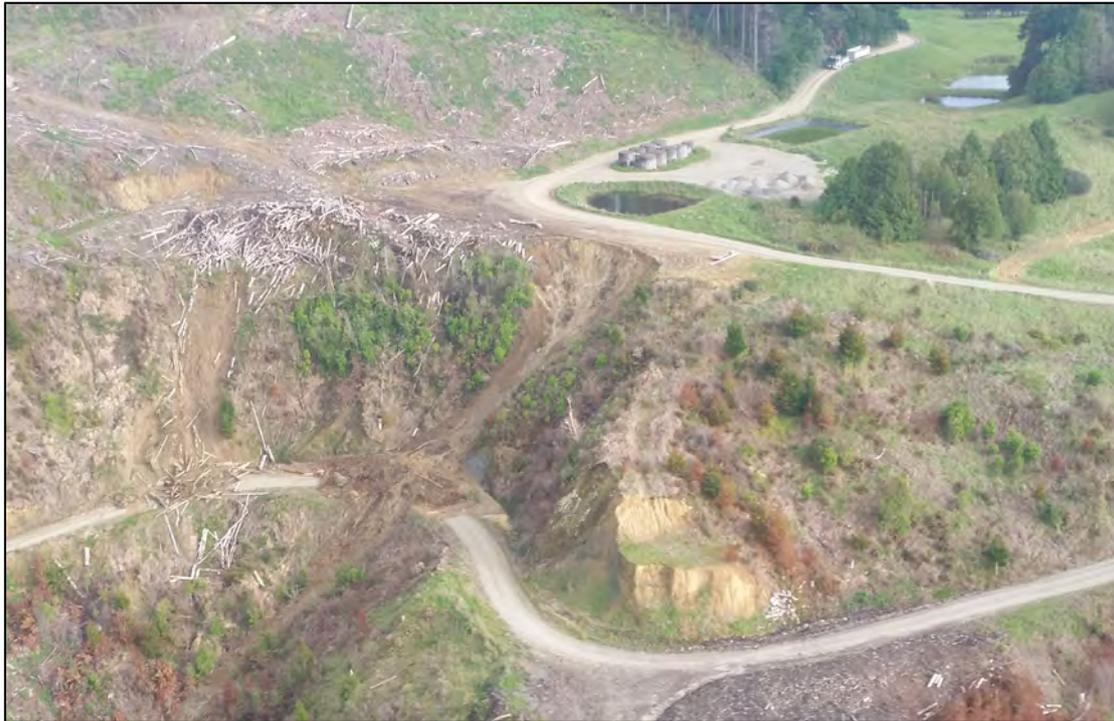
North of Waimanu Forest a number of minor fresh landslides were observed (Image 1D1A0687) as well as pre-existing larger landslides (1D1A0657, 1D1A0658, 1D1A0692) (see **Appendix One**). Between Duncan and Waimata Valley Road south of Wakaroa a number of fresh landslides were observed including in replanted pines, as well as a landing failure and edge of roadway collapse (*Figure 27*).

Figure 27. Two fresh landslides adjacent to Duncan Road, near Wakarua.

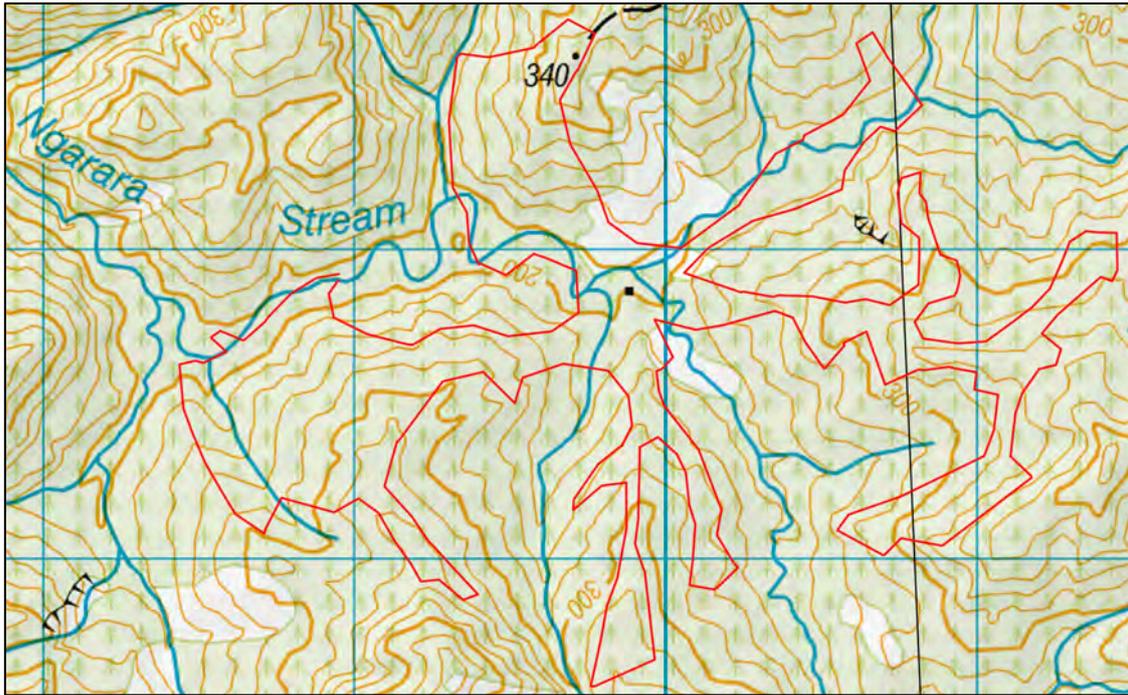
In the Hokoroa Road area, fresh harvesting was underway in Makahakaha Ngarara Stream (*Figure 28*) and pine slash was evident caught up in the stream and adjacent to the stream in an area vulnerable to mobilisation during a major storm event (*Figure 29*).

Figure 28. Harvest area in Makahakaha Ngarara Stream

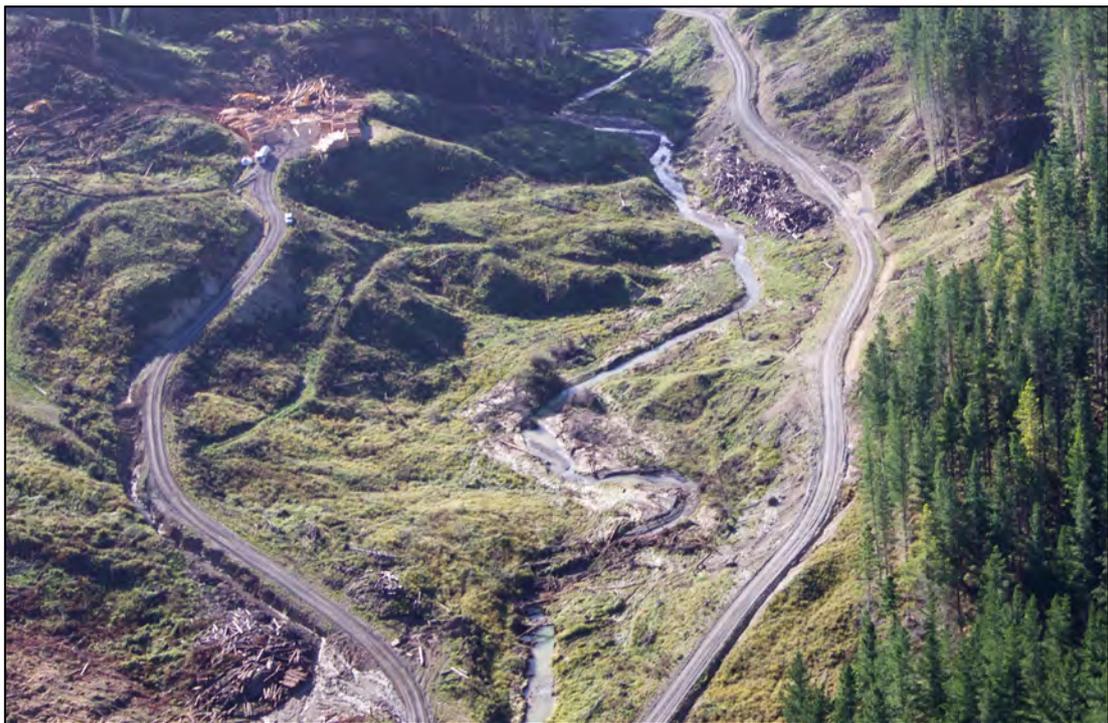
Figure 29. Fresh harvest area in Makahakaha Ngarara Stream showing slash caught up in the stream (middle right) and slash stored close to the river at a site vulnerable to mobilisation.

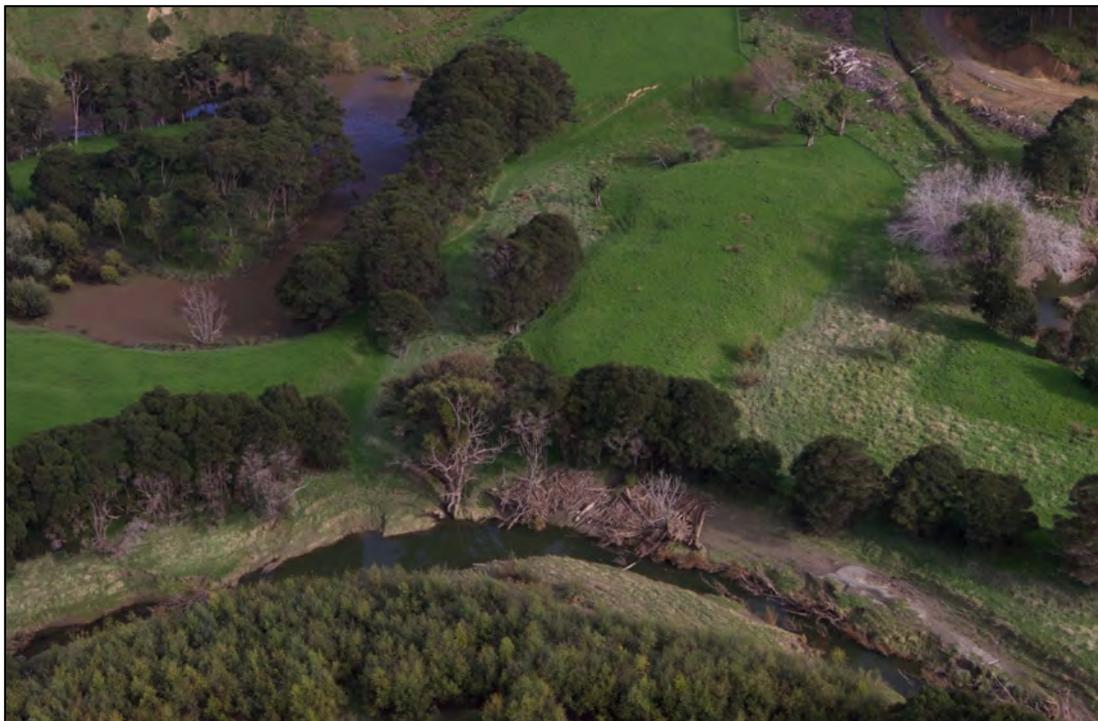
A meander loop immediately below the river crossing at Willowbank Forest shows a significant pile of slash caught up against willows on the river bank as well as silt deposition and bent over grasses marking the flood level (Figure 32). Upstream of the meander loop, the river crossing from Tauwhareparae Road to Willowbank forest

Figure 32. View of meander loop on the Mangaheia River immediately below Willowbank Forest showing woody debris caught up against willows as well as silt deposition. Note the two flood channels marked by discoloured pasture.

- a. Well establish indigenous vegetation or willows in riparian margins were significant in being effective in reducing the downstream migration of slash (see *Figures 26, 32*).

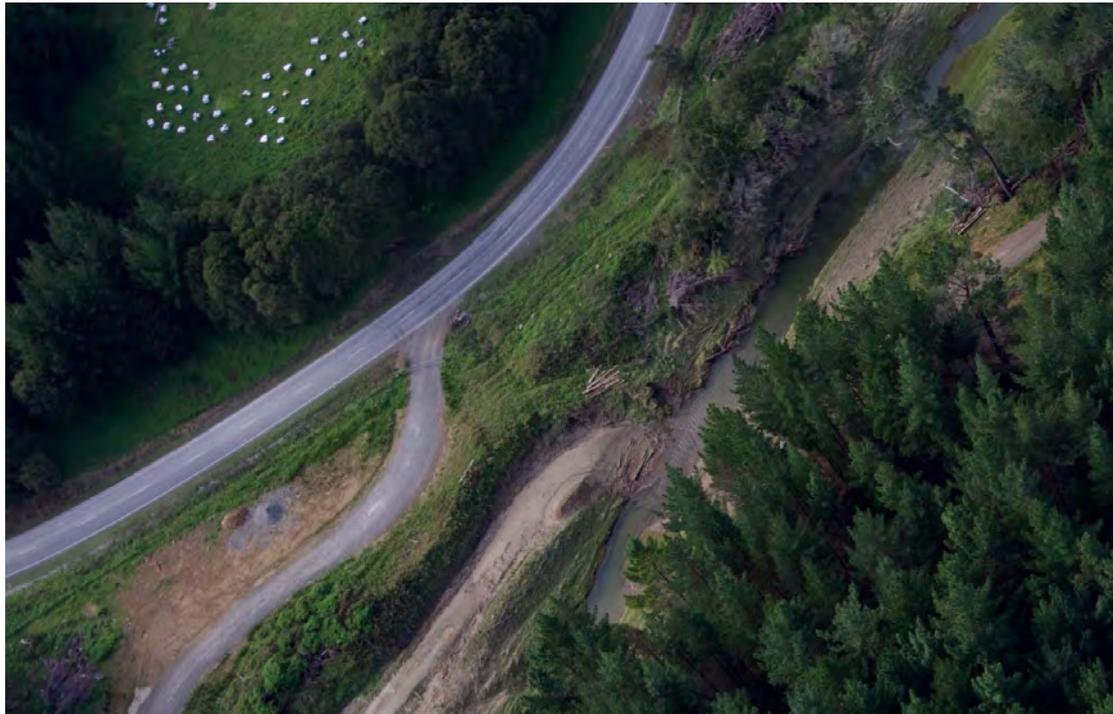
also showed significant signs of flooding as well as clearly evident cut pine logs lying on the crossing just above water level (Figure 33).

Figure 33. View of river crossing at Willowbank showing logs in the ford approaches and at river level.

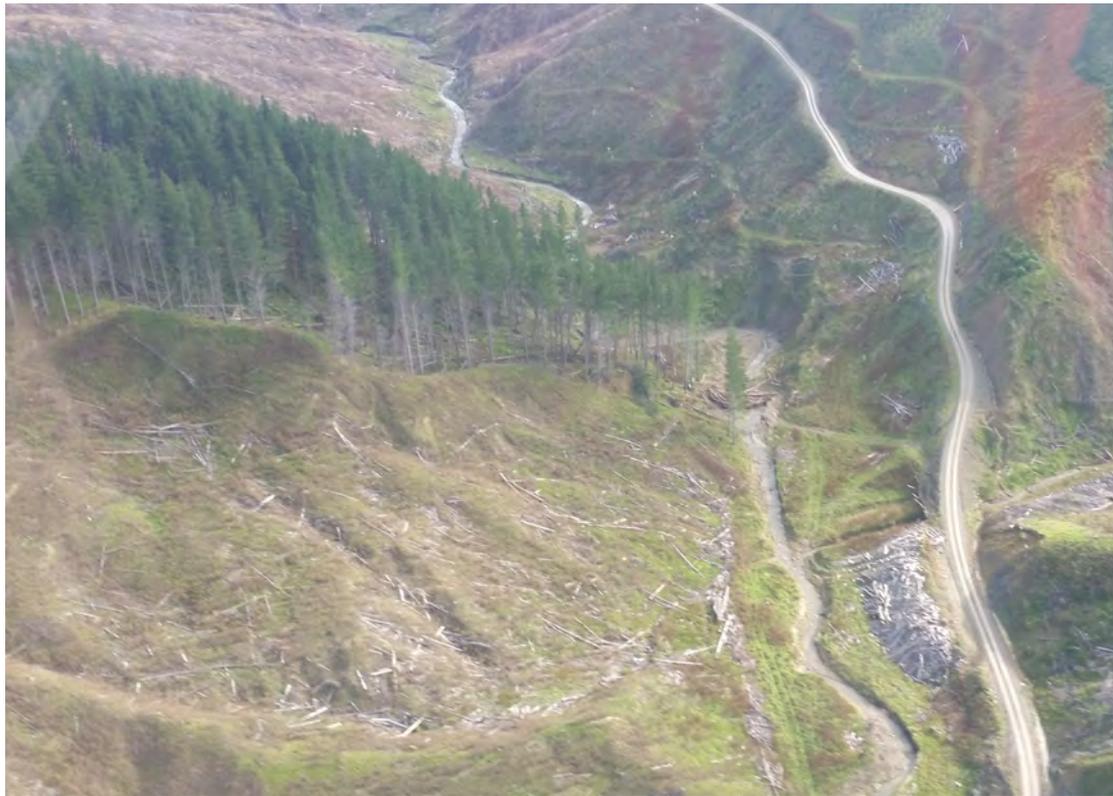
Georeferenced image 1D1A0981 and image 092913 (geo-located using topographic features) give an indication of the impact of Cyclone Cook in the Mangatoitoi Stream. The bottom end of the Mangatoitoi is shown in *Figure 39* while *Figure 40* shows a view up Mangatoitoi from approximately the same position.

Figure 40. View looking up the Mangatoitoi shows slash in the middle reaches and stored against the flood plain on the true left bank (bottom right).

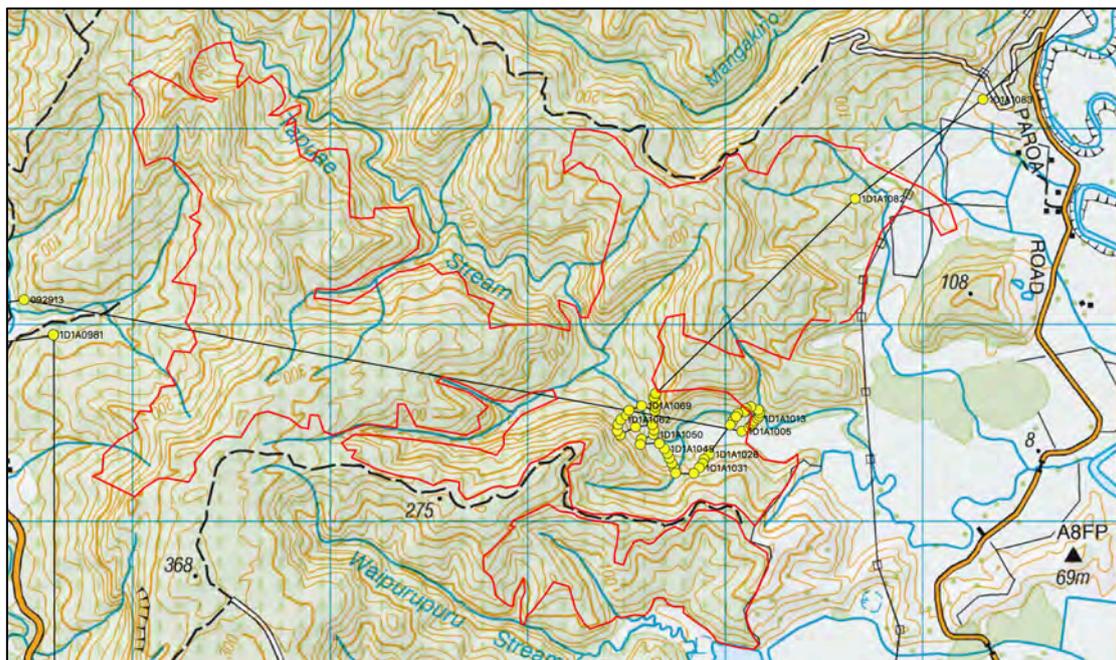
Tapuae Stream is located partway between the Mangaheia and Mangatokerau Catchments and has been largely harvested between 2013 and January 2017 (*Figure 41*). A large suite of images was taken in this general location (Georeferenced images 1D1A1005 to 1D1A1078). Two images have been selected from this suite for discussion here and the remainder are documented in **Appendix One**. This stream is characterised by areas of slash forming small dams, as well as slash either stored or scattered across the flood plain (*Figure 42*).

Figure 41. Tapuae Stream located between the Mangaheia and Mangatokerau catchments showing the flight path and image locations and the areas harvested by January 2017.

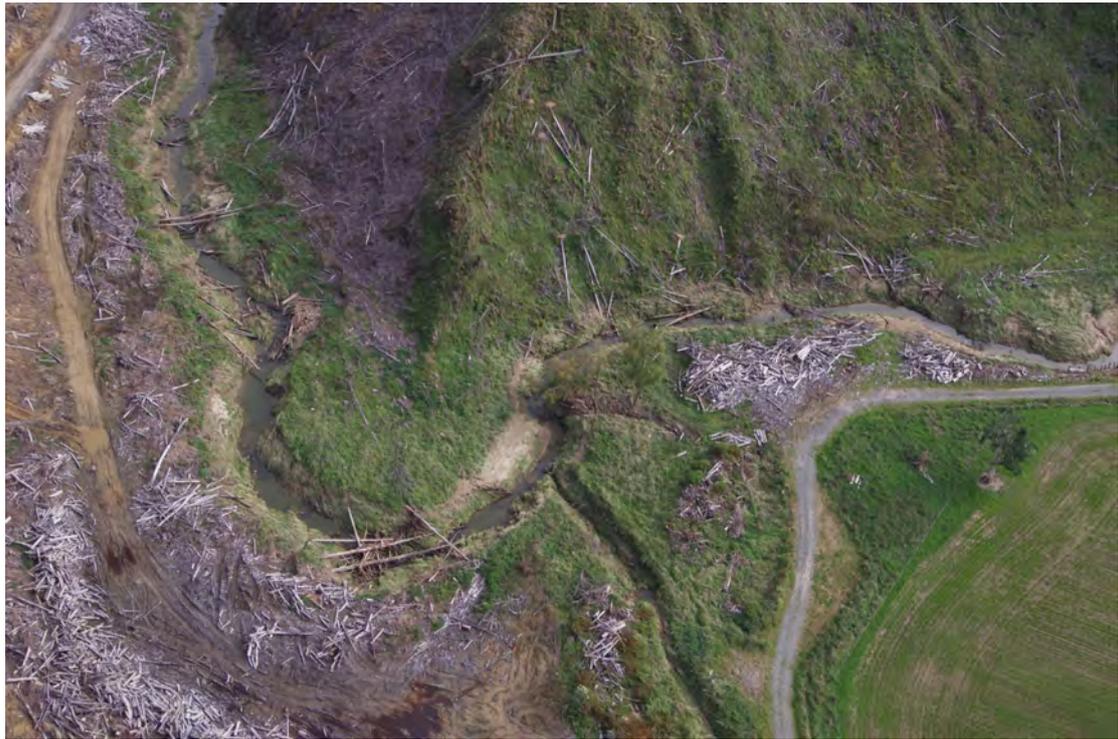
Figure 42. Lower end of Tapuae Stream showing logs forming birds-nests across the water course and either stored or scattered along the flood plain.

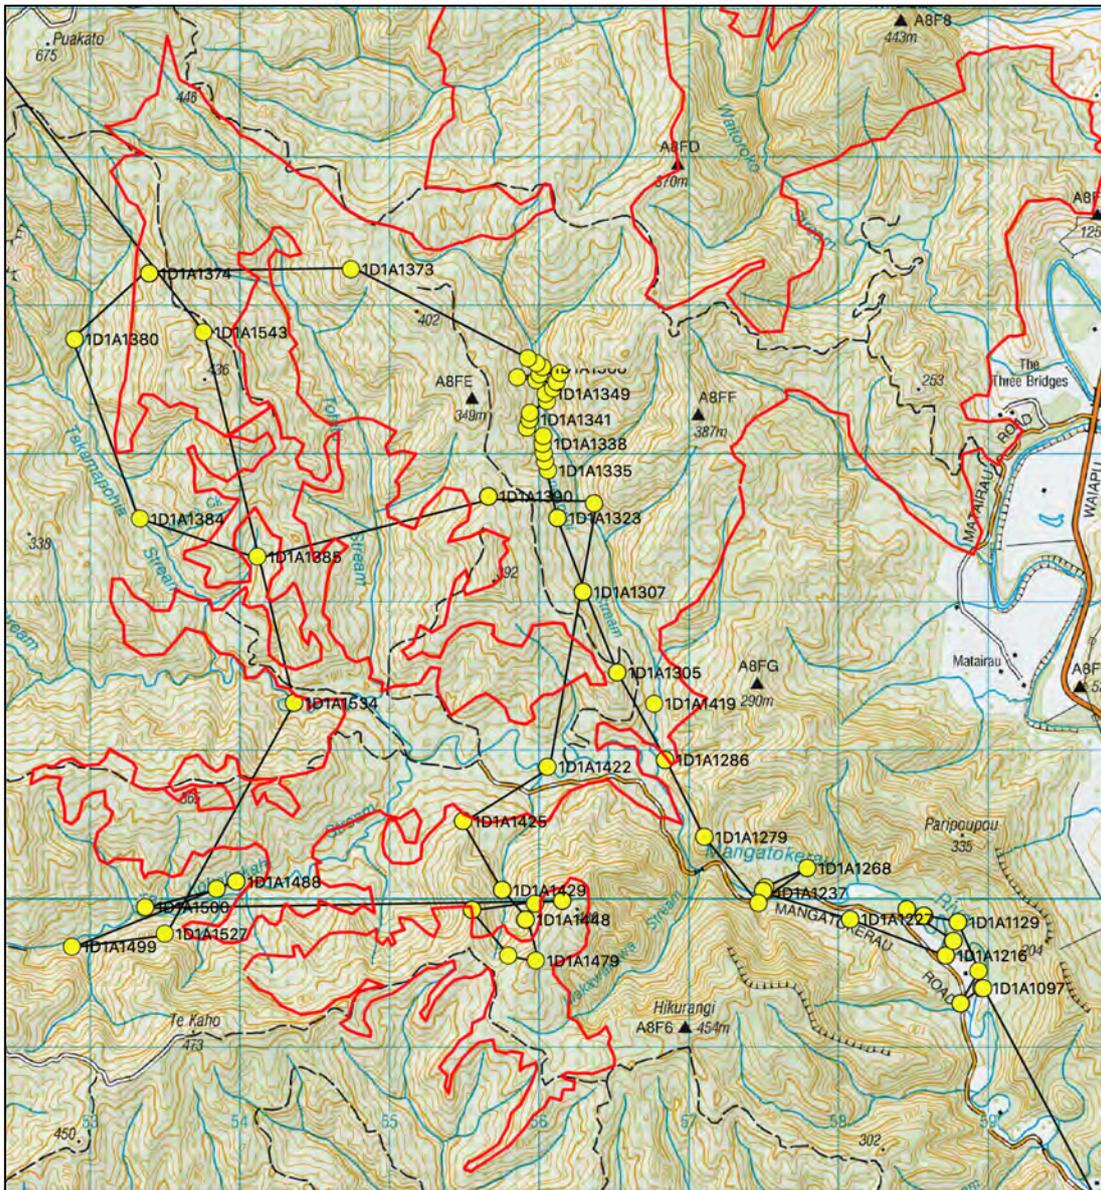
The Mangatokerau Catchment (*Figure 44*) was a principal focus of the overflight since both the newspaper reports and the immediate on-site rapid assessment indicated significant mobilisation of slash in this area and it was the site of one of two significant debris flows generated during Cyclone Cook. As a result the over flight of this area was relatively comprehensive and particularly focussed on the east facing slopes where the debris flow originated.

Figure 44. View of the Mangatokerau Catchment showing the area harvested as at 10th of January 2017, the flightpath and the key images used in this analysis.

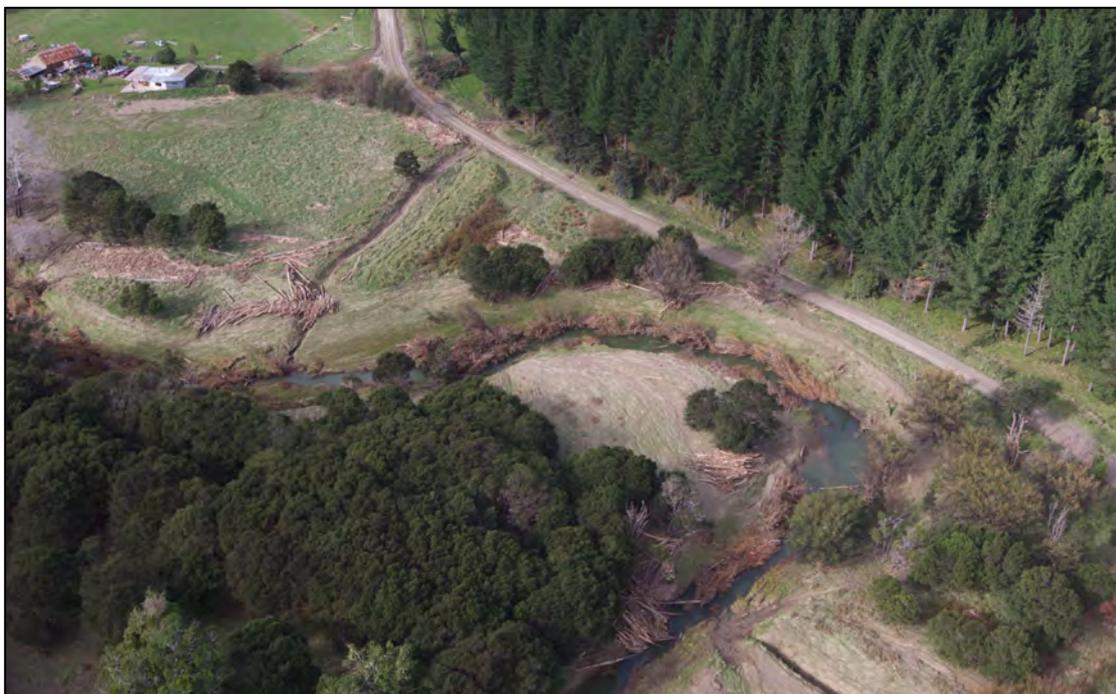
lodged against standing vegetation on the flood plain (*Figure 46 Image 1D1A1114*). Further downstream both the volume of woody debris and the extent of the flood spread is evident with the discolouration of the grass showing how close to the house the flood was (*Figure 47 Image 1D1A1174*).

Figure 47. View of the farmhouse in the Mangatokerau Valley showing how close the flood and woody debris came to impacting on the farmhouse (Image 1D1A1174). The light coloured band upstream of the hosue is a bund the landowners have constructed to protect the house from flood events.

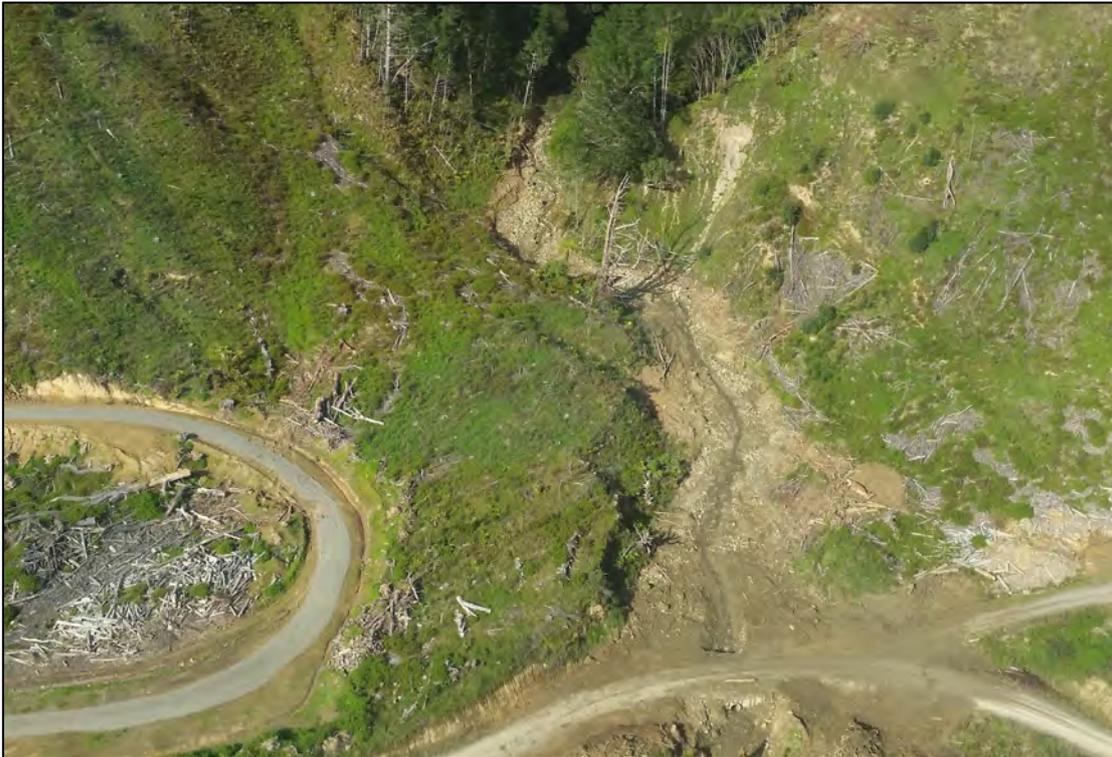
Figure 49. View of the debris flow fan base of “Waterfall Creek”, Mangatokerau River showing the significant silt and slash deposition.

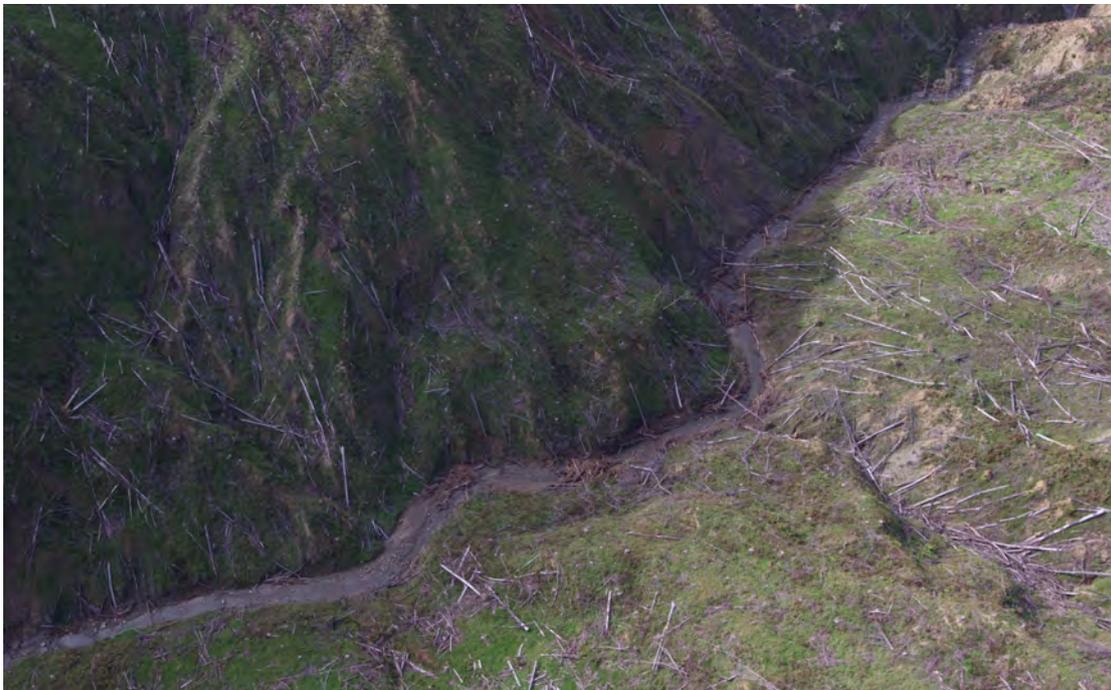
Further north from Waterfall Creek, the flight took in views of Mangaonui Stream where a series of birds-nests of slash formed dams in the stream (*Figure 50*). West of Mangaonui Stream similar masses of slash within the water course could be observed in Tohitu Stream.

Figure 50. View of Mangaonui Stream showing woody debris caught up in the watercourse.

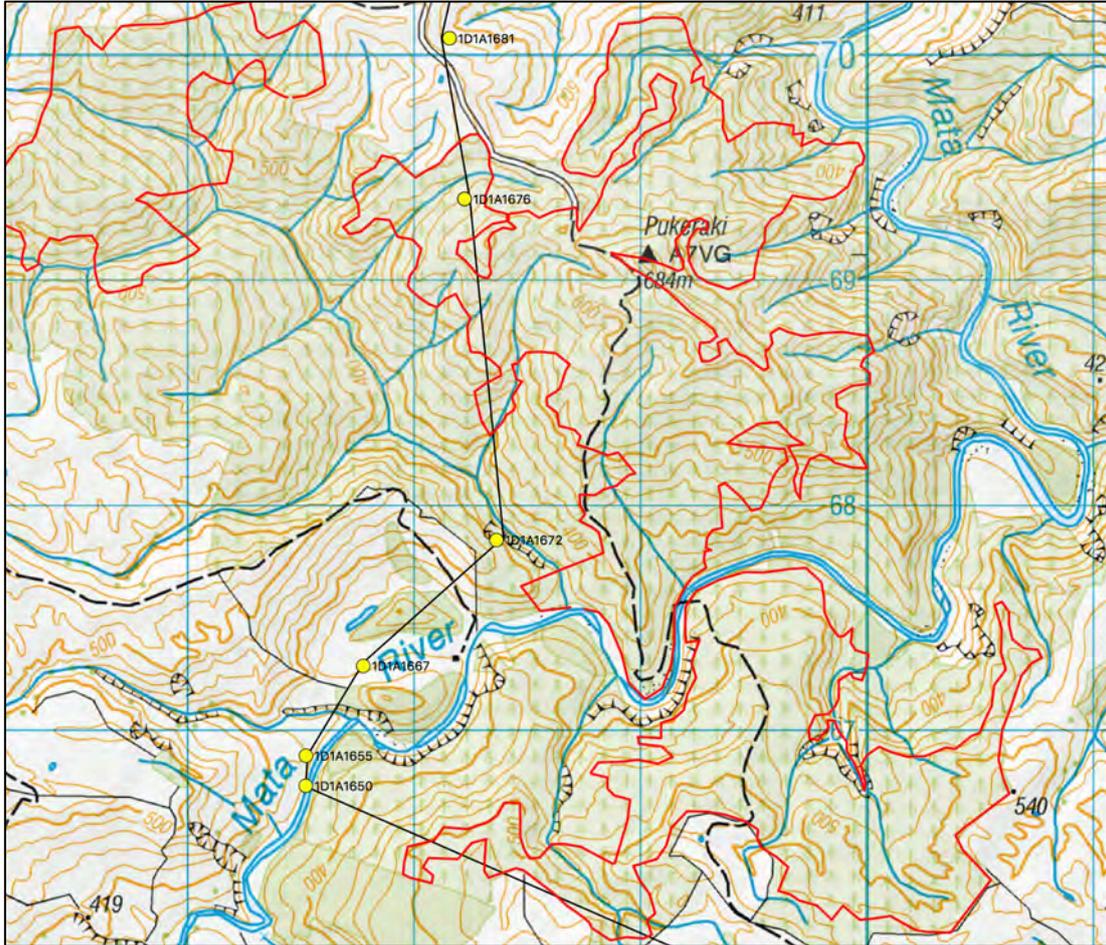
Figure 51. View of the headwaters of the Mata River showing the areas harvested up until the 25th December 2015, the flight path and image locations.

The number of images taken of the Mata River during the over flight was relatively low. Images 1D1A1650 and 1D1A1655 shows that some windthrow pine logs reached the river due to pines being planted at the top of an unstable face (**Appendix One**). There was, however, no indication of mobilisation of either slash stored on the flood plain or pine logs mobilised by debris floods or flooding.

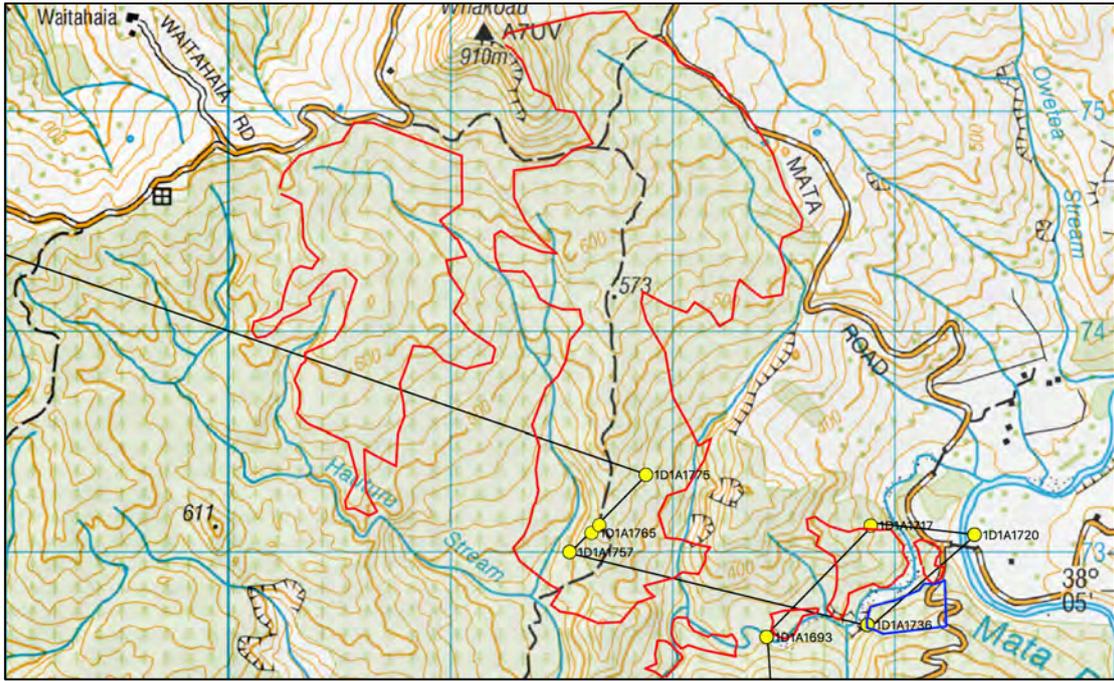
The situation at the Whakoau Stream was rather different, however, with a large series of images indicating mobilisation of pine slash stored on the rivers' flood plain. This area had been identified as being at risk during a flood event during a site visit in December 2016 and indicates that landing and operational parameters at this site did not adequately address the risks associated with the landing site. This area is discussed in more detail in the next section of this report.

Figure 52. View of Whakoau Stream showing the areas harvested up until 25 December 2015, the area harvested between December 2016 and January 2017 (Blue), the flight path and image locations.

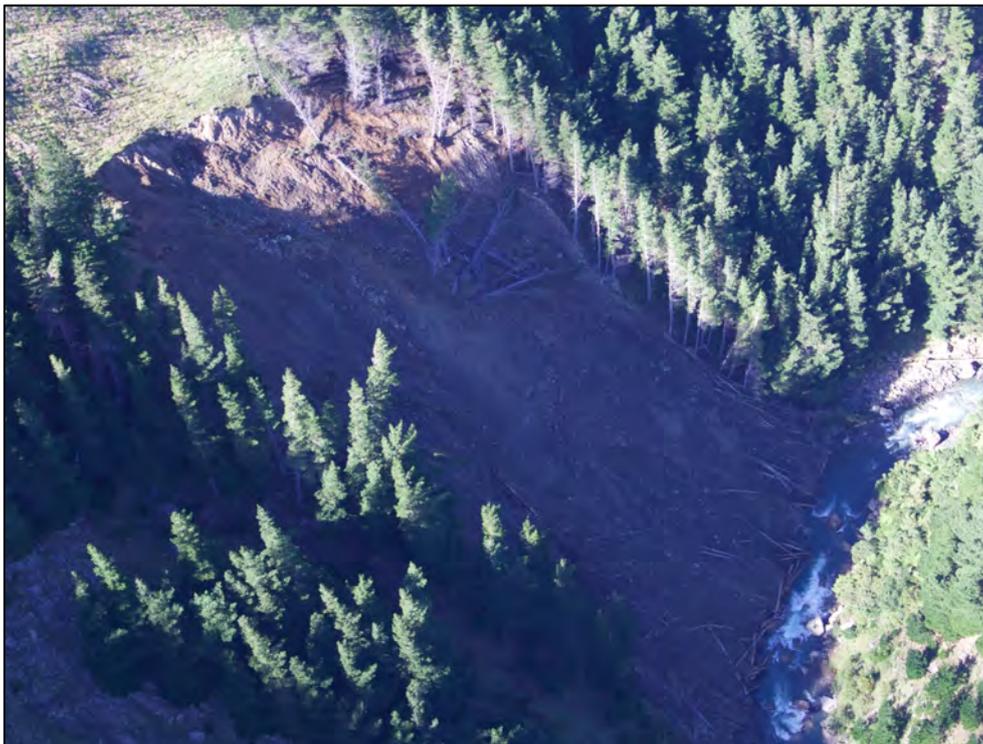
Figure 53. View of pre-existing landslide in Ruatahunga Stream showing some signs of remobilisation.

This landslide had indications of some recent slope movement, probably related to Cyclone Cook. The feature was, however, also pre-existing and was evident on the published 1:50,000 topography map and Google Map Pro imagery going back to January 2003. Some mobilisation of trees on the landslide may have occurred but the landslide is considered a largely pre-existing feature reactivated during the storm. Some slash can, however, be seen on the river banks below the landslide.
