Cyclone Cook Slash Investigation

Dr Murry Cave Principal Science Advisor GDC
Nicki Davies, James Langford GDC Land & Soil Team

October 2017

Executive Summary

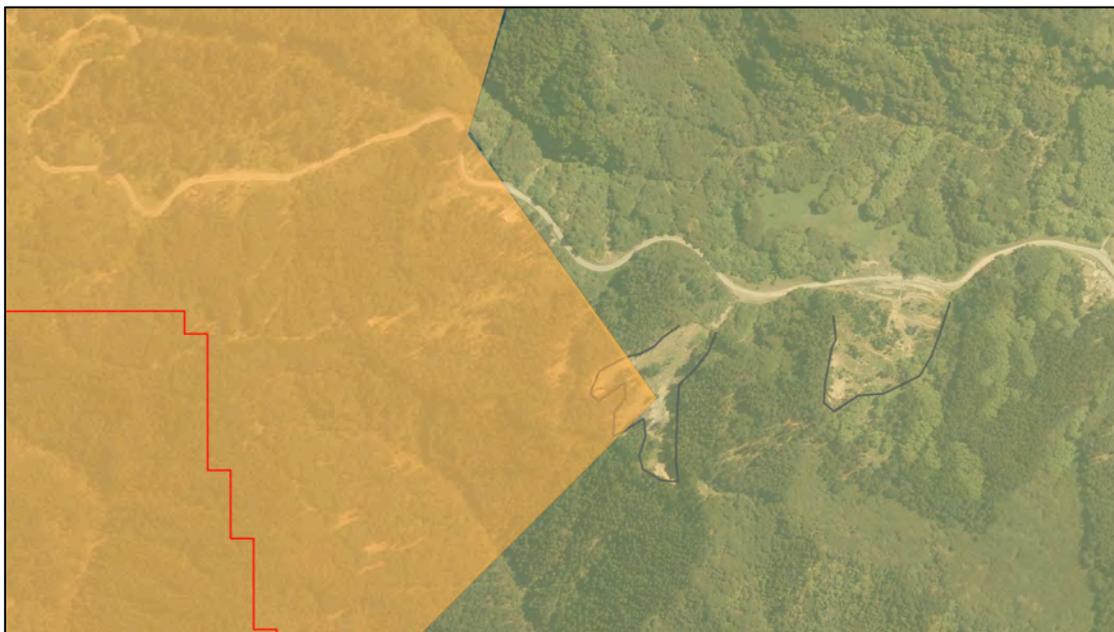
Doonholm Landslide is a complex pre-existing debris flow associated within a mature exotic forest. The Tauwhareparae Road in this area is oriented roughly East-West and the landslide is situated on the south side of the road and thus faces north north east. The headscarp was located in undifferentiated Pliocene mudstones, and alternating sandstones of the Mangaheia Group while the body of the debris flow is underlain by Miocene aged interbedded sandstones and mudstones of the Tunanui Formation (*Figure 54*). The entire landslide is classed as 7e15 in the landuse capability classification and has an approximate slope angle of 30°.

Figure 54. Coarse scale geology of the Doonholm Landslide (outlined in black) based on the 1:250,000 Raukumara Geological map (Mazengarb and Speden, 2000). Pliocene Mudstones on left and undifferentiated Miocene Mudstone and alternating sands on right.

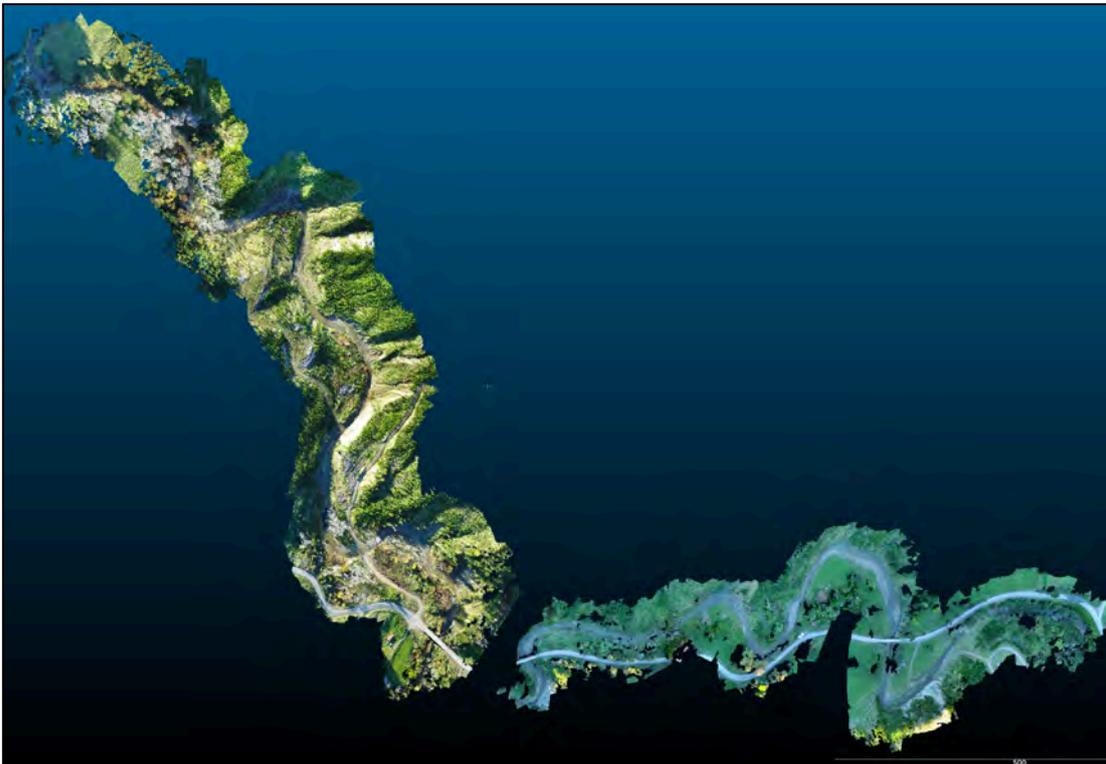
Figure 58. Dense point cloud of the Tauwhareparae Road drone flight (Cloud Compare screenshot) showing the two flight segments and degree of coverage up the river from the junction with Everetts Road (far right) to just below the Doonholm Landslide.

A scan of the image showed that there was no significant debris in the river either at the point closest to Doonholm landslide or from there to Everetts Road (Managteao Stream). The image file was examined in detail, particularly where a small landslide on the true left bank had originated from a failed forestry road edge to see if that had sourced debris to the river as well as other small-scale bank failures (*Figure 59*). This also allowed for areas replanted in pines on the flood plain to be looked at closely to see if any of the slash stored in this post-harvest had been mobilised. (*Figure 60*). It was concluded that the Doonholm Landslide did not contribute to the slash event observed downstream nor were there signs of significant mobilisation of slash in the stretch of the Mangaheia upstream of Everetts Road (Mangateao stream).

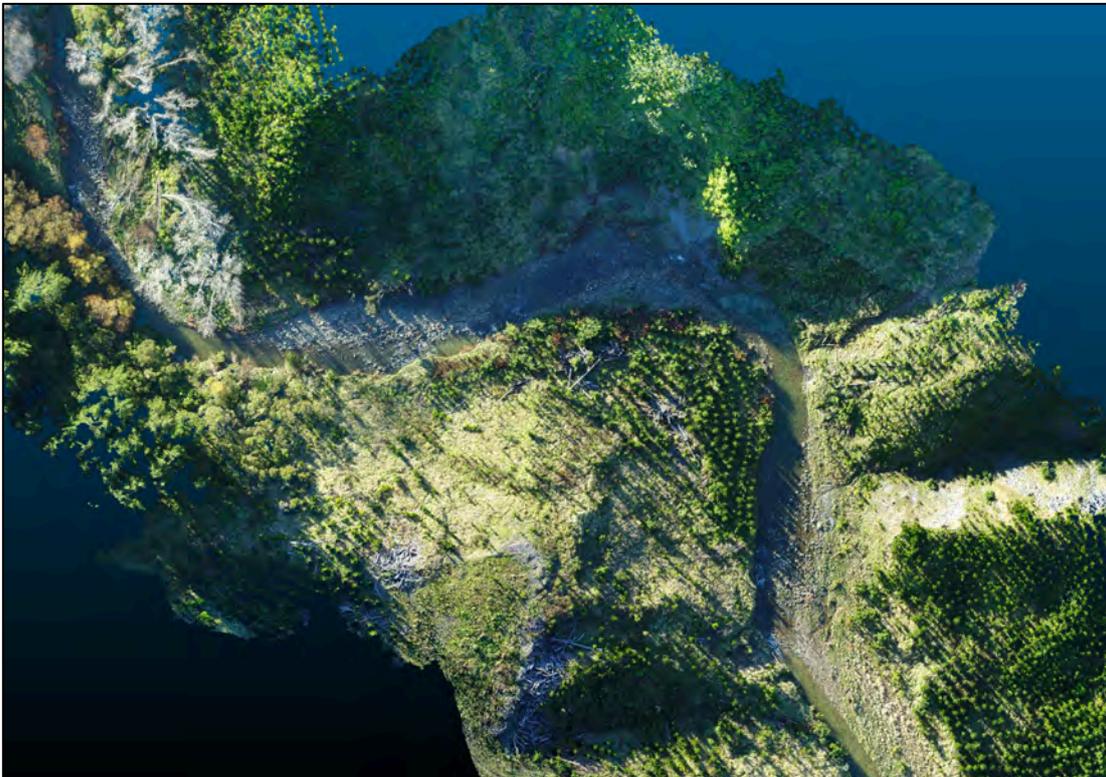
Figure 60. Point cloud imagery of a bend in the Mangaheia River showing slash piles stored on the flood plain replanted with pine.

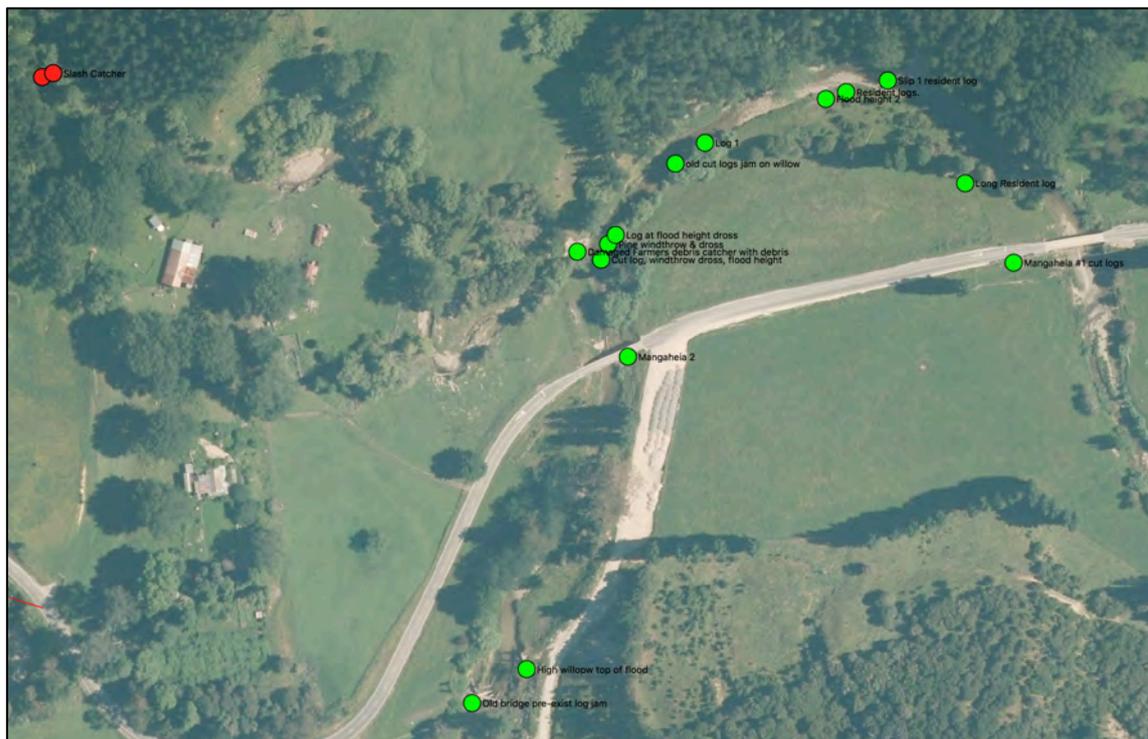
The Everetts Road area and the Mangaheia River downstream of Everetts (Mangateao Stream) are shown in *Figure 61* below. This shows the end of the drone flight (red line) at left, as well as key geo-referenced photo points in the Mangaheia below Everetts (green circles). The red circles are images taken at the cleared and repaired slash catcher within Mangateao Stream (*Figure 62*) and looking upstream from the slashcatcher showing the logs at flood height (*Figure 63*).

Figure 61, View of Everetts Road (Mangateao Stream) area in the Mangaheia showing the location of georeferenced photographs and the end of the drone flight path.

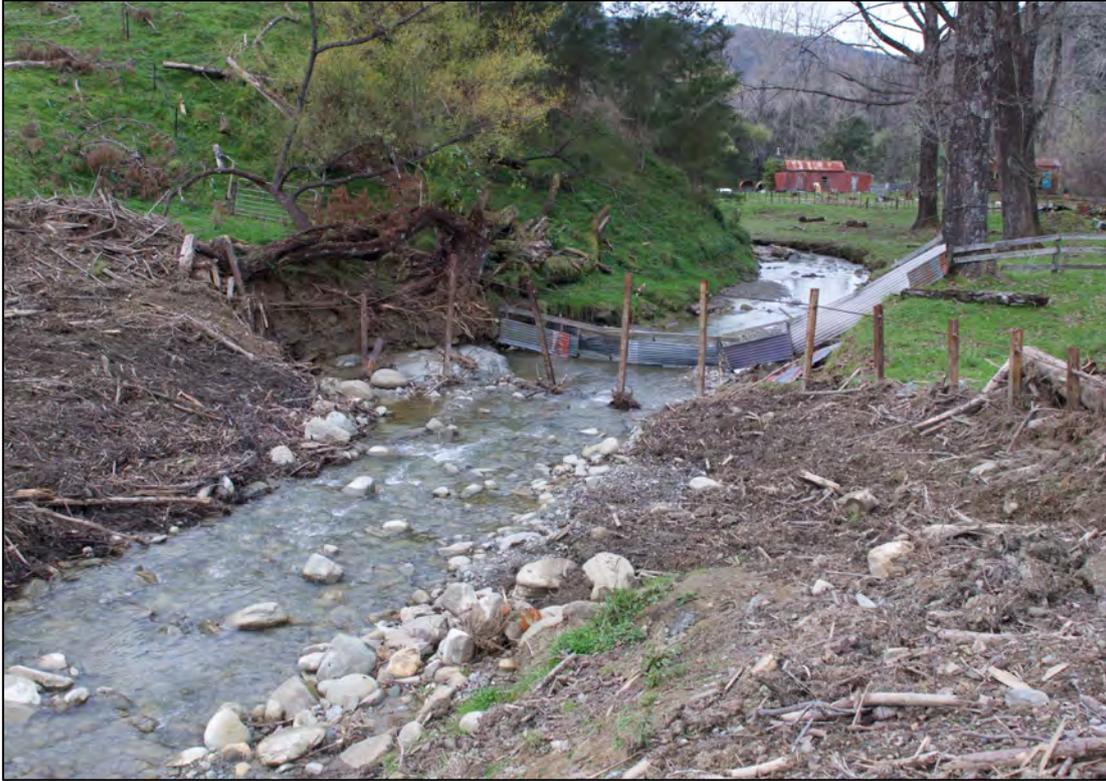
In effect, these site inspections just highlighted what had been apparent from the flight. Namely, that a significant amount of slash had been mobilised in the catchment. The farmer confirmed that the slash catcher had been cleared and repaired. No incident report was received from the forestry company operating in the forest but they subsequently advised that the catcher did not need repair. Judging by the amount of material cleared from the catcher it was overtopped distributing slash downstream.

Figure 62. View of the cleared slash catcher on Mangateao Stream. Note the presence of logs on the riverbank, middle background below the catcher and the flood height above catcher height on the true left. This catcher is under-engineered for the catchment.

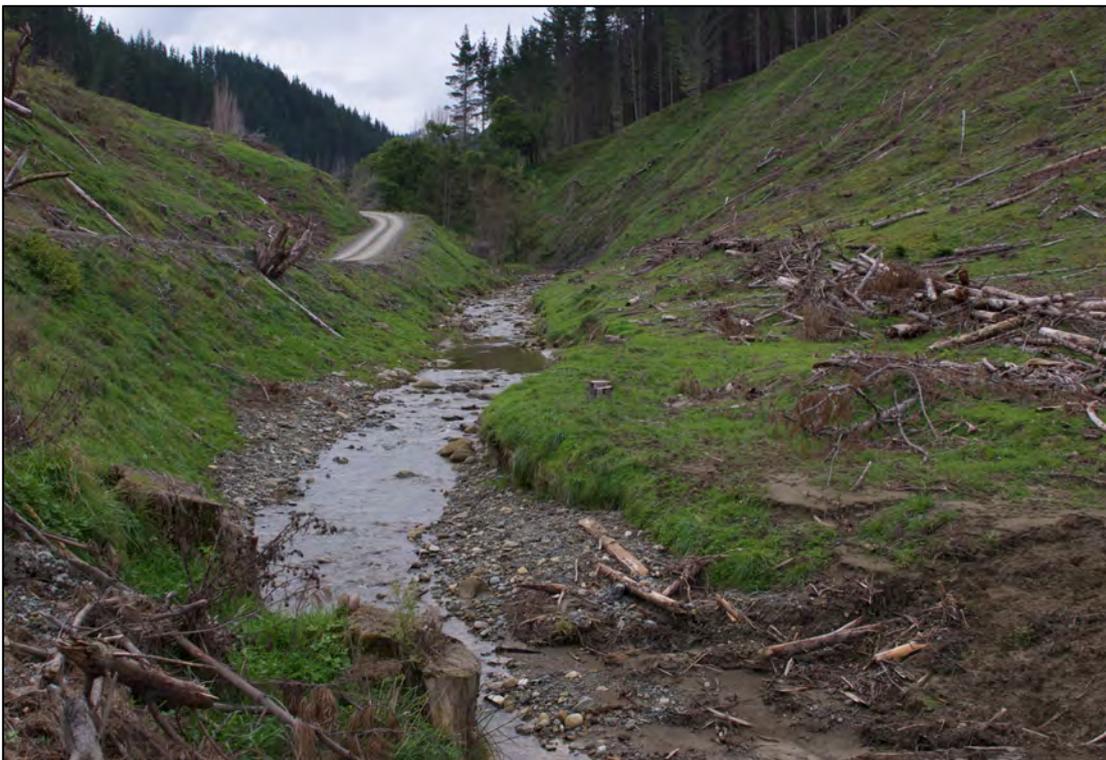
Figure 63. View up Mangateao Stream showing a levee of slash at flood height on the true left bank.

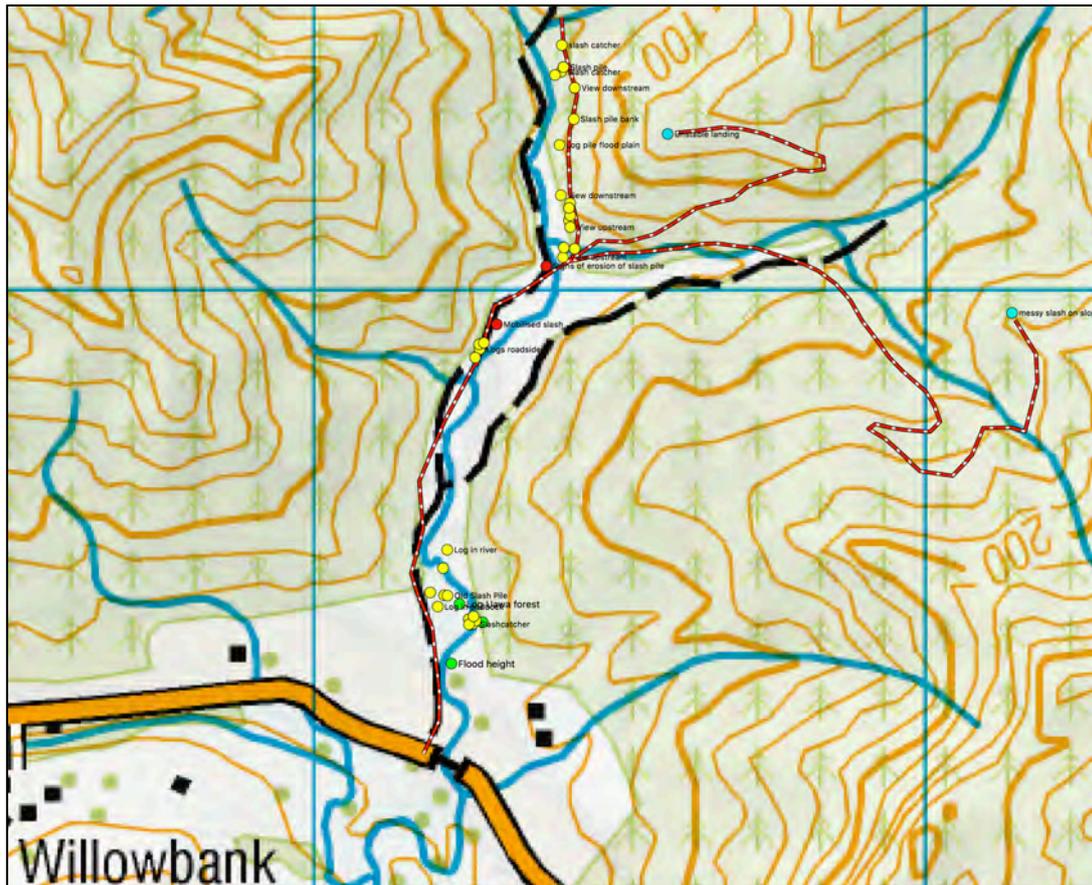
Mangatoitoi stream, a tributary of the Mangaheia was first visited on the 13th of May and then again on the 16th of May, the 17th of June, and the 3rd of September (*Figure 64*). As was the case with the Mangateao stream, no incident reports were received from the forestry company operating within the catchment. The flight path did not fully cover the catchment but the active operational area was imaged (*Figure 65*) and did not indicate the presence of any significant slope failures. What is clear from *Figure 65*, however, is the presence of a pronounced levee of slash on the true right bank below the bird's nest of slash caught up in the slash catcher. This indicates that while the slash catcher caught some woody debris far more was able to overtop the catcher and migrate downstream.

Figure 64. Plan of the Mangatoitoi sub-catchment showing the route taken as well as photograph and observation sites.

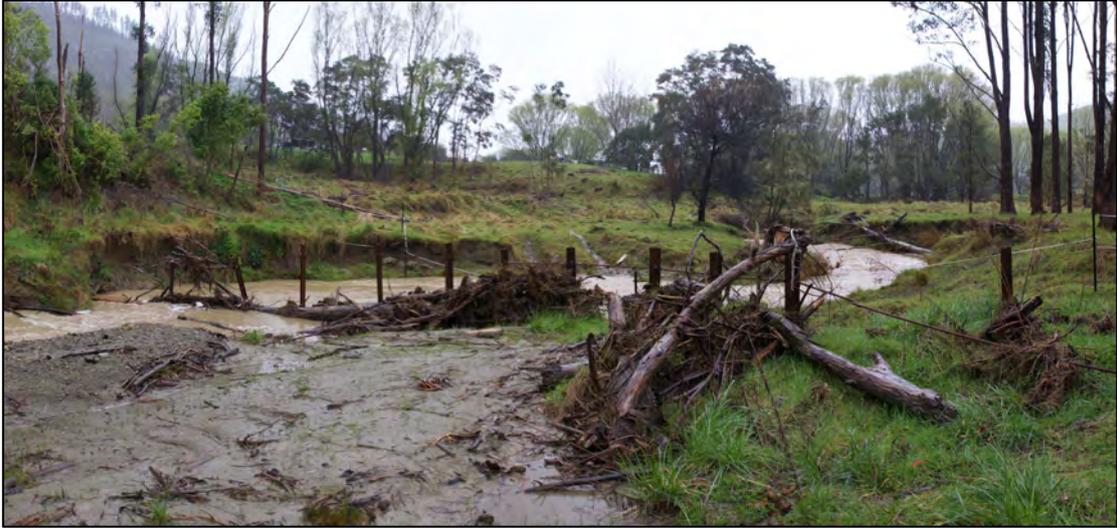
The lower slash catcher showed no signs of being cleared or repaired and while it had some debris caught against it (Figure 67), there was also woody debris downstream of the catcher indicating that the catcher had been overtopped. A wider examination of the true right bank showed that the meander loop within which the slash catcher was constructed was bypassed by a low-lying area of paddock that formed a channel between the stream and the access road to Mangatoitoi stream transporting some material (Figure 68).

Figure 67. Bottom slash catcher in Mangatoitoi Stream showing woody debris caught against the catcher on the true right bank with a mix of willow, small pine and dross with considerable frsh silt deposited.

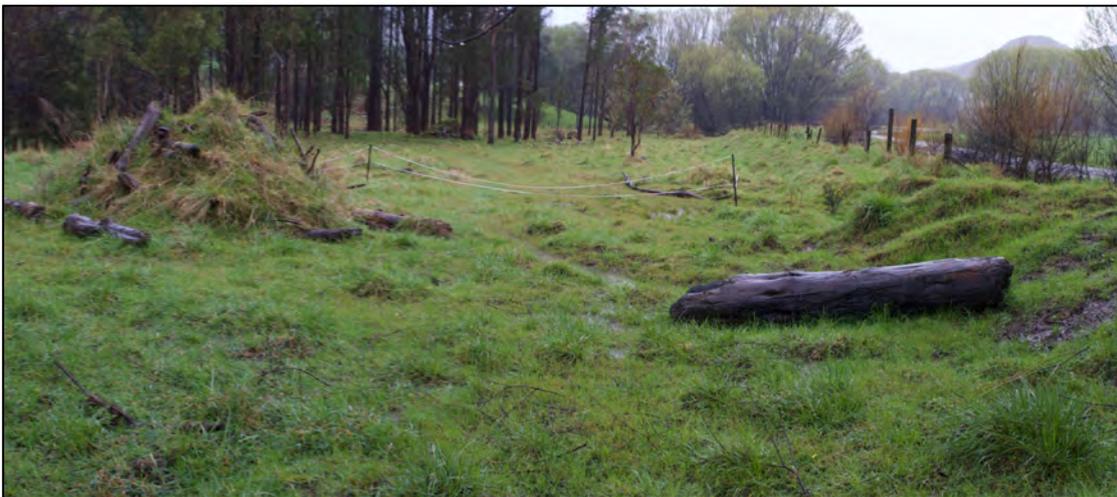
Figure 68. Bypass flood channel in Mangatoitoi Stream between the stream (out of view left) and the forestry access road. Note the long resident pine log in the foreground and smaller debris caught against the small slash pile from an earlier event. It is not obvious in this view but some cut logs are evident caught in a gap in the trees in the middle background and a pre-existing slash pile against the trees to the left of the gap.

Based on the field investigations, it is considered that a considerable volume of slash had been mobilised in the Mangatoitoi Valley. Both the upper slash catcher and that close to Tauwhareparae Road showed evidence of overtopping and bypass, and the lower catcher in particular was located in a meander loop that was by-passed completely by a channel. As the full width of the valley was flooded, slash was able to reach the Mangaheia across flooded lowlying paddocks. Both the overflight and field inspections showed that slash had been stored in vulnerable locations within the catchment where it was able to be mobilised during Cyclone Cook (additional images of the Mangatoitoi are shown in **Appendix One**).

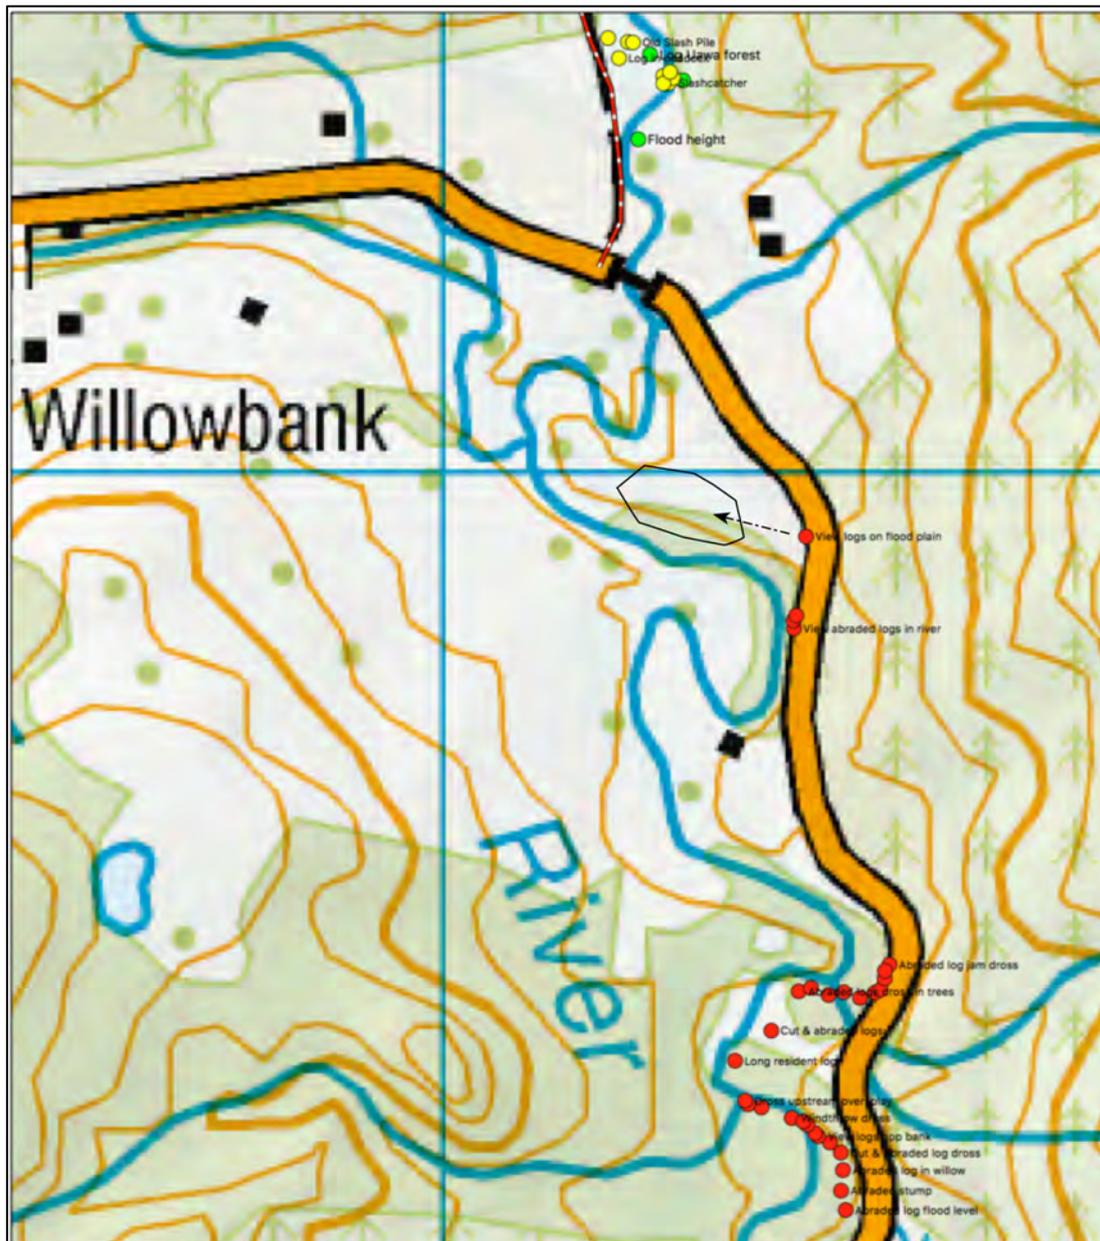
Figure 69. Map of the section of the Manageheia River below the confluence with the Mangatoitoi showing the location of photographs taken of logs.

There was a significant volume of slash in this section of the river although less concentrated than in the Mangatoitoi or present closer to Wigan Bridge (see below). The proportions of different woody debris types has been estimated by counting the different types of logs in each photograph. Since the dross comprises aggregated fine sized material this was estimated by assigning a count of “1” to a small amount, a “2” to a moderate amount and a “4” to a large dross pile. This analysis indicates

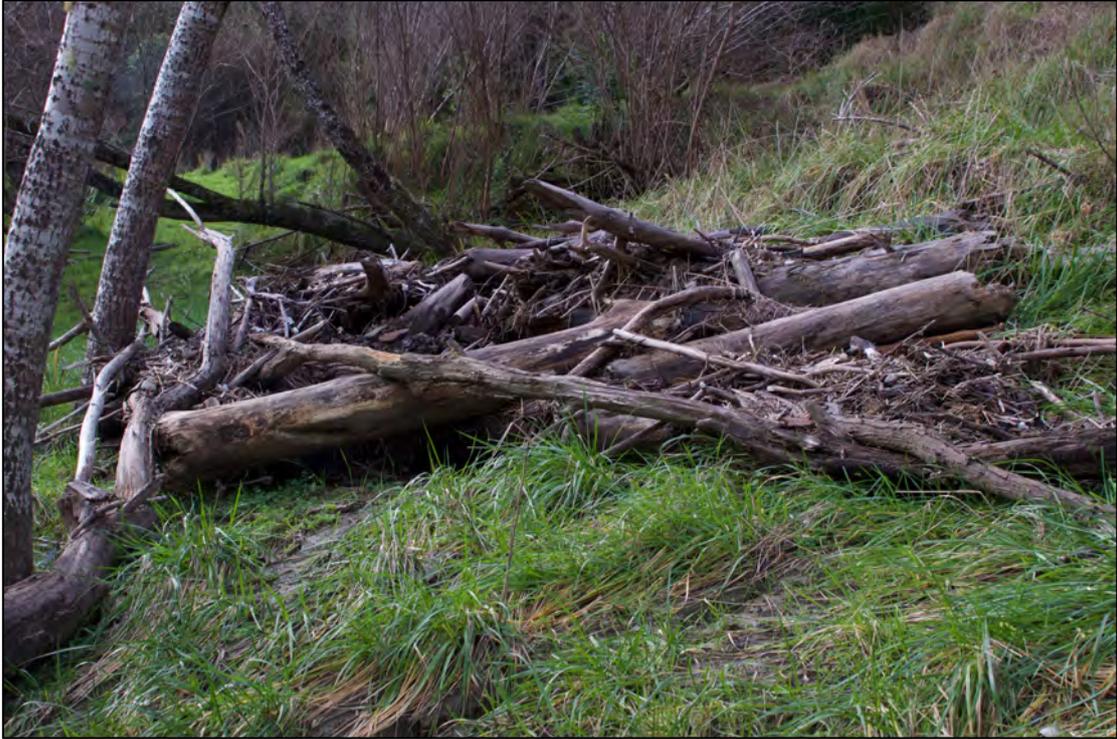
that the woody debris was dominated by abraded or old pine logs and dross with moderate amounts of windthrow pine and willow, and small amounts of cut or fresh broken end pine (Figure 70). In percentage terms, 38% was abraded pine, 6% was cut pine logs, 3% fresh broken pine, 10% windthrow, 30% dross and 13% willow (Figure 71). When aggregated, pine comprised 57% of the total material. A typical situation with largely abraded logs, dross and small amounts of probably windthrow and willow caught up against a tree is shown in Figure 72 below.

Figure 72. Abraded logs and dross with minor willow and windthrow about halfway between the Mangatoitoi and Willowbank Forest.

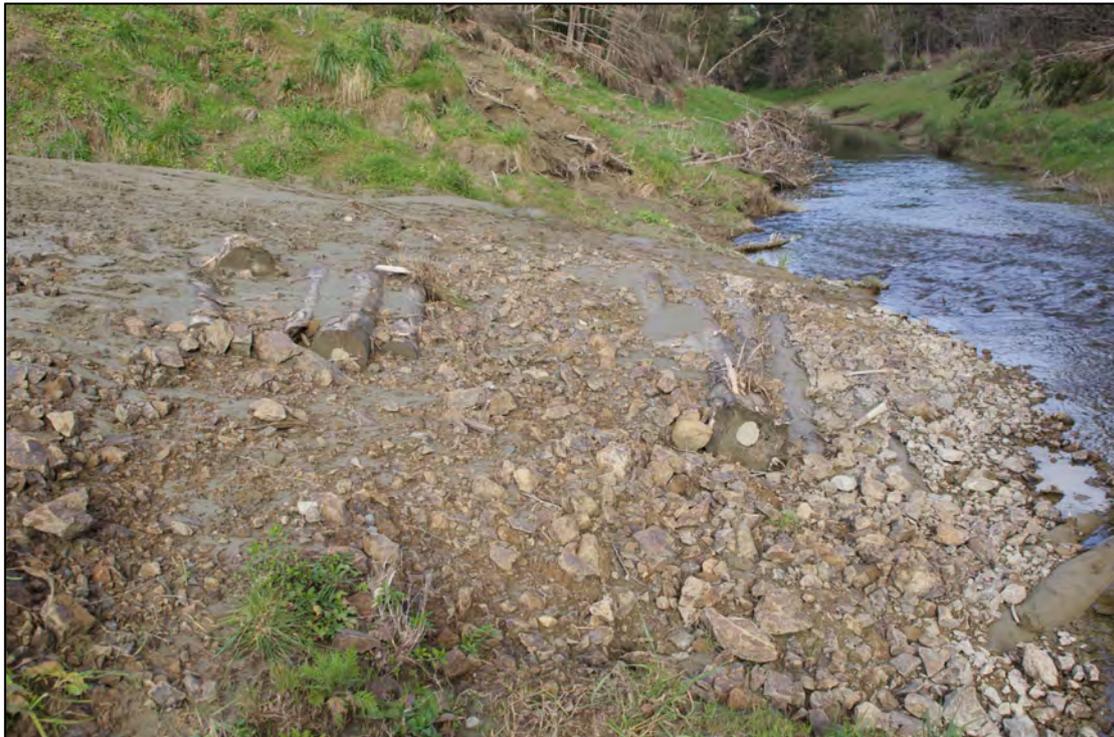
The construction of the corduroy base to the road can be seen in *Figure 74* and as this image makes clear, a number of the logs making up the corduroy have been washed away during the flooding during Cyclone Cook. The true right bank of the river can be seen in *Figure 75* and also shows silt deposition during the flood with two partially buried cut logs and two other cut logs below flood level. The remaining logs that made up the corduroy pre-flood appear to have been washed away. Poorly stored cut logs positioned at flood height are shown in *Figure 76*. Further work is required to establish whether logs from this stow were mobilised during Cyclone Cook.

Figure 74. View of the corduroy base to the river crossing on the true left bank of the Mangaheia River at Willowbank Forest. Note the silt deposition from the flood and the loss of logs.

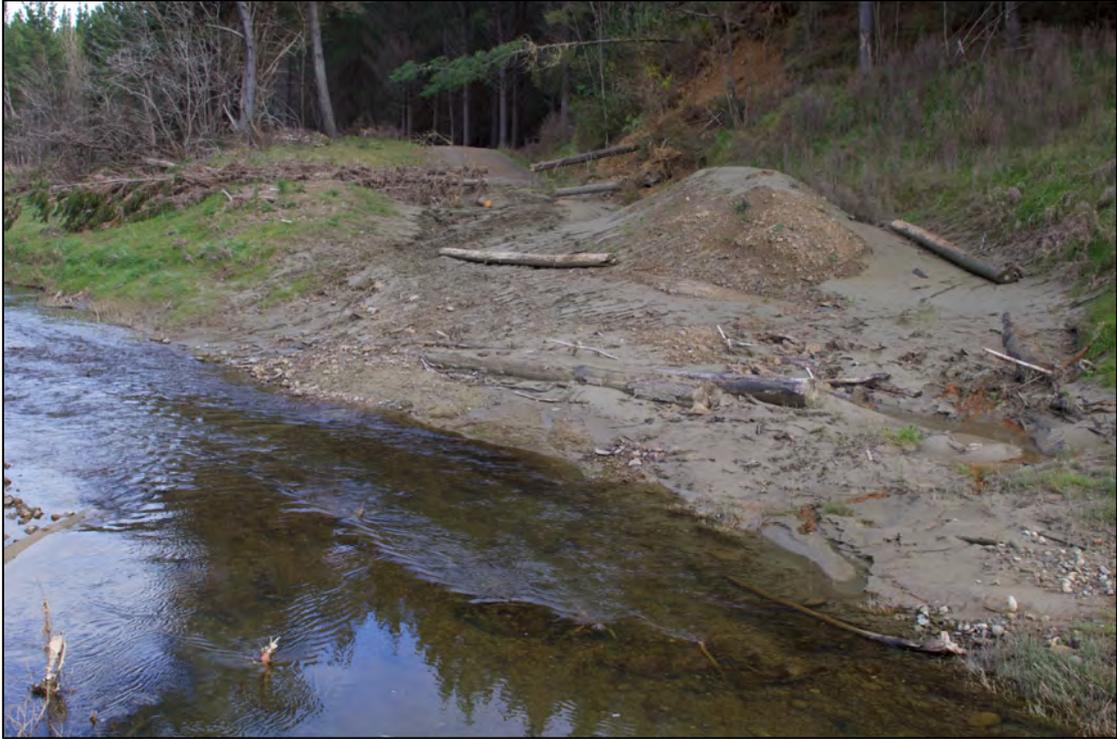
Figure 75. View of the true right bank of the Mangaheia River at Willowbank Forest showing two logs from the corduroy remaining and two further logs at flood height.

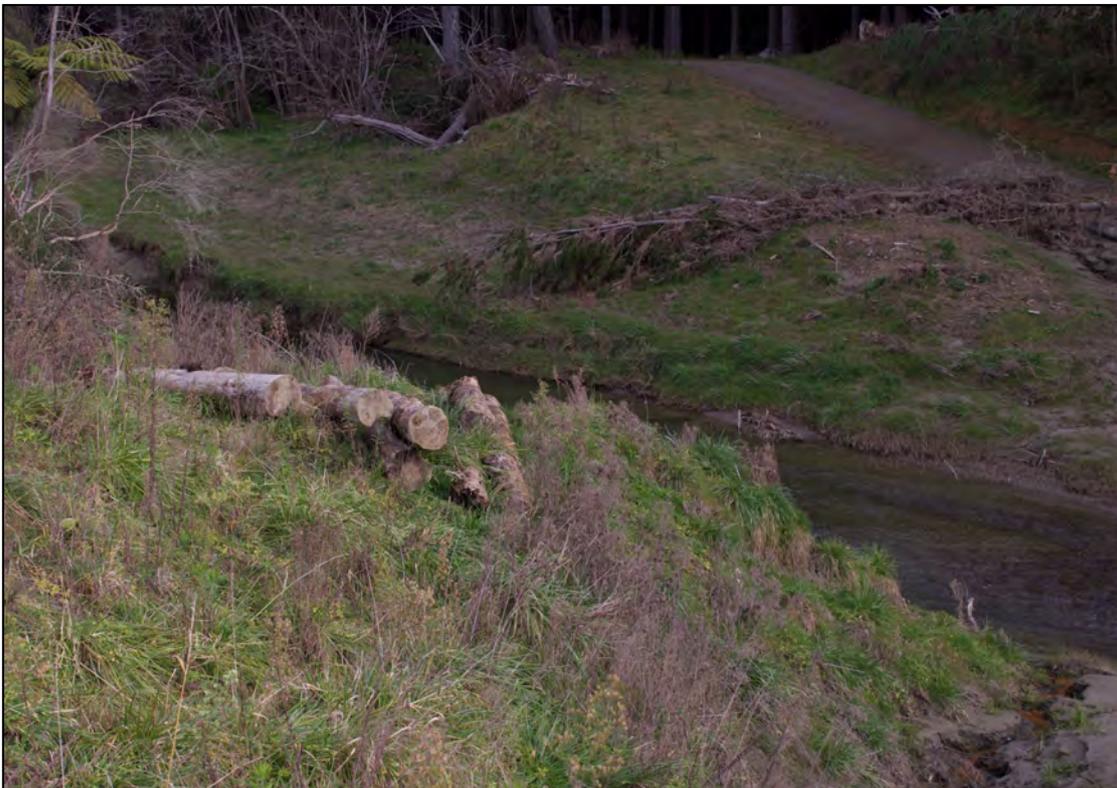
Figure 76. Poorly stored cut logs located at flood height at Willowbank Forest.

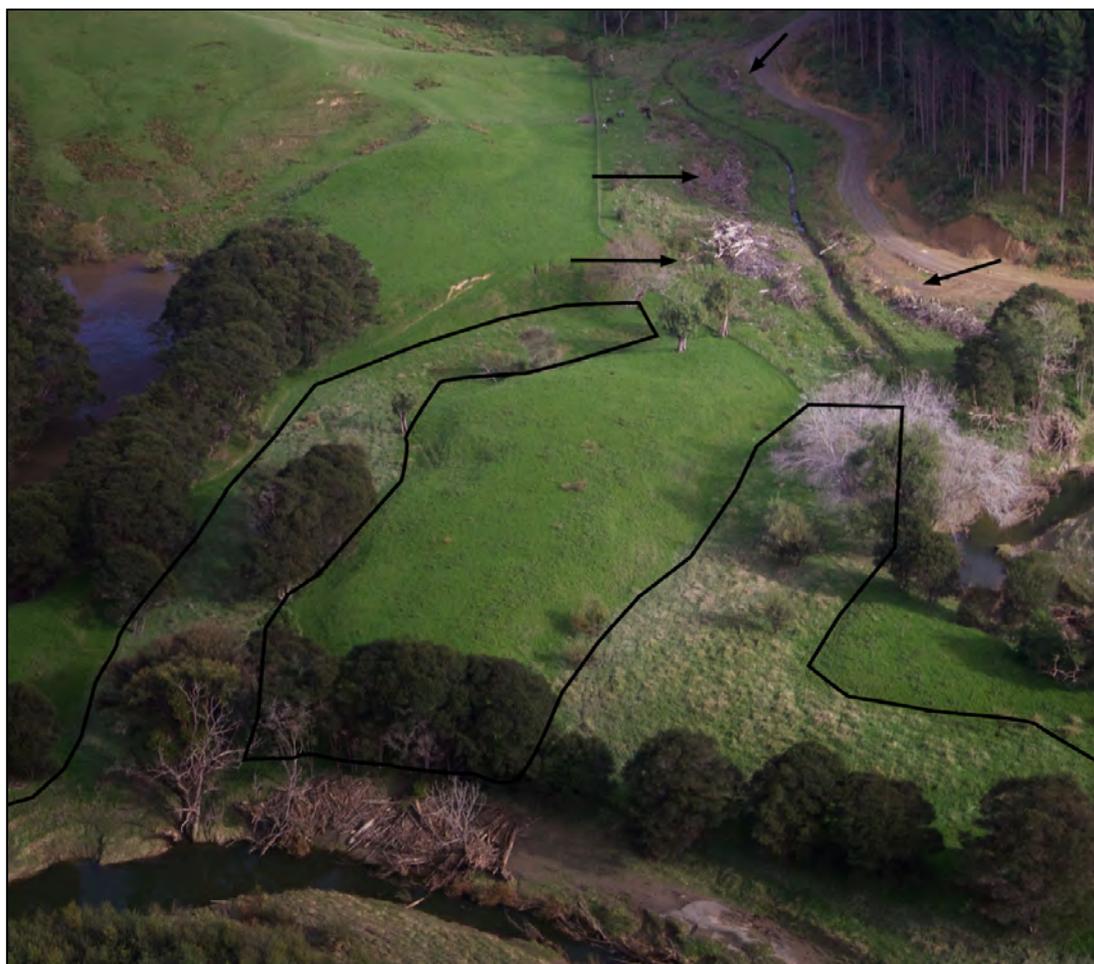
Willowbank Forest is close to Wigan Bridge and was partially harvested in 2016 (Figure 77). An area of slash and the two flood channels downstream of Willowbank was shown in Figure Thirty Two above. While the catchment area is not large, a close examination of the area in Figure 32 indicates that slash was also mobilised in the small stream that the Willowbank access road follows. The banks of the flood channels lack sign of woody debris which may suggest that the channels were only occupied by flood waters rather than significant debris at peak flow (Figure 78) [Note that the photo in Figure 78 has been processed in Adobe Photoshop to assist with identifying the areas of interest but the processing was limited to reducing the shadows in the top right of the photo. The overlays were drawn on top of the image using Autodesk Graphic].

Figure 78. Detail of the same base image as Figure Thirty Two showing the flood heights and levees of slash (arrowed) adjacent to the stream discharging from the Willowbank forest.

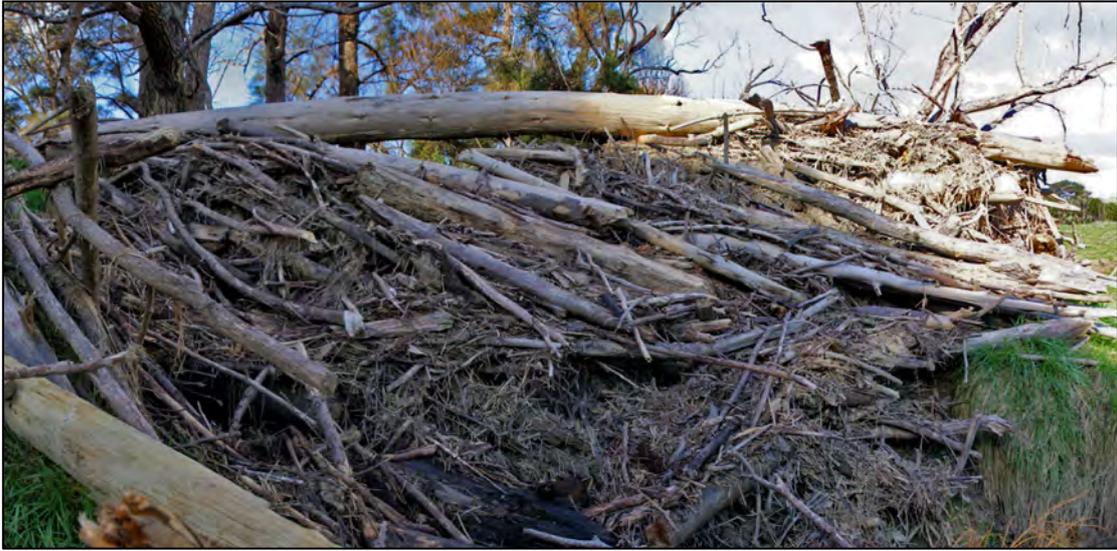
A margin of error of 10% is allowed in this data, since counting the different types of debris falling within sometimes quite messy slash piles, is difficult (Figure 82). Overall, however, the results are consistent with the results achieved at Wigan Bridge where a more accurate quantification of woody debris could be achieved. As was found elsewhere, the dominant type of material were pine logs that show signs of being within the river system for some time. These can have rounded or cone shaped ends but sometimes the ends are at right angles to the log indicating that they were cut at some stage.

Figure 82. Accurately counting the material within a large slash pile can be difficult. This pile contains both pine and willow and a lot of “dross”.

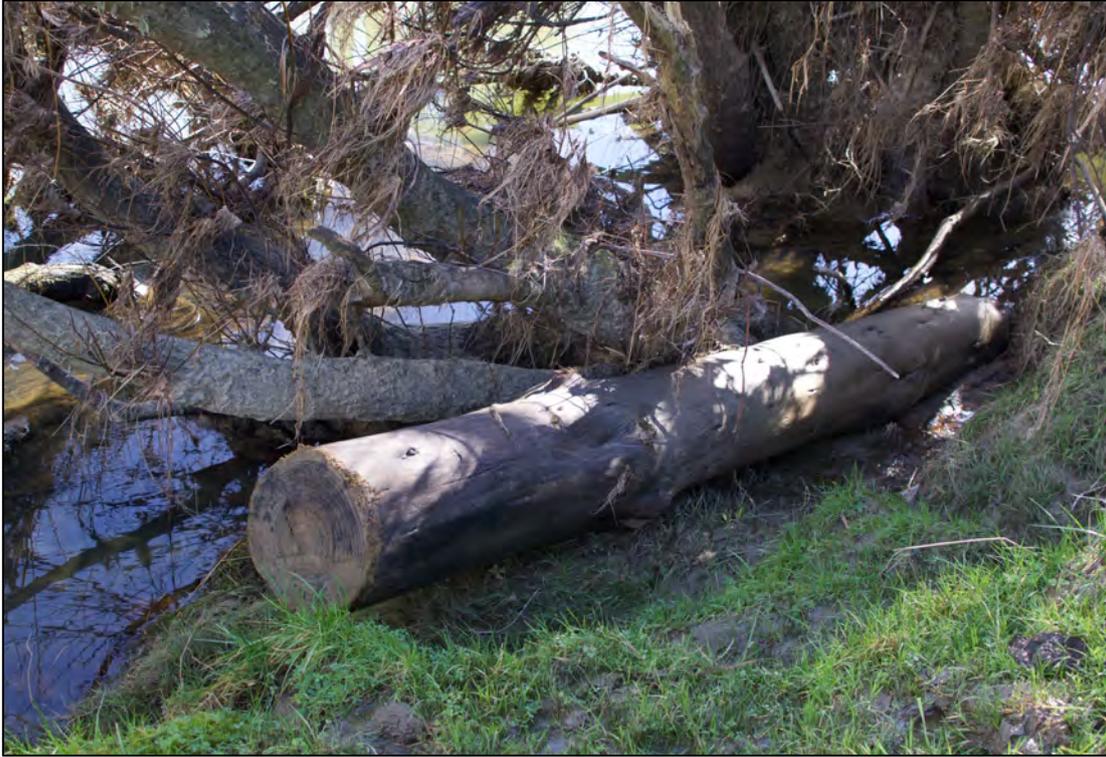
Two abraded logs were found with waratah marks (Figure 83). Fresh cut pine logs were a small but significant portion of the debris (Figure 84) and windthrow pine negligible. Willow and unidentifiable small “dross” were significant but were proportionally less than pine materials. Much of the willow appeared to have failed but remained *in situ*. Several willows were cut.

Figure 84. Fresh cut log caught up in willow above Wigan Bridge on the Mangaheia River.

Both the over flight and field investigations showed that standing vegetation on flood plains and riparian margins can be effective in catching slash in some circumstances. This was observed in Taraewarere Stream in the Waimanu Forest (*Figure 24*), above Wigan Bridge (*Figure 84*), and at Te Kokokakahi stream in the Mangatokerāu (*Figure 94*) as well as further downstream in the Mangatokerāu. The long term effectiveness of this needs to be assessed as it's possible that larger events will mobilise these slash piles and damage the vegetation within the riparian margins.

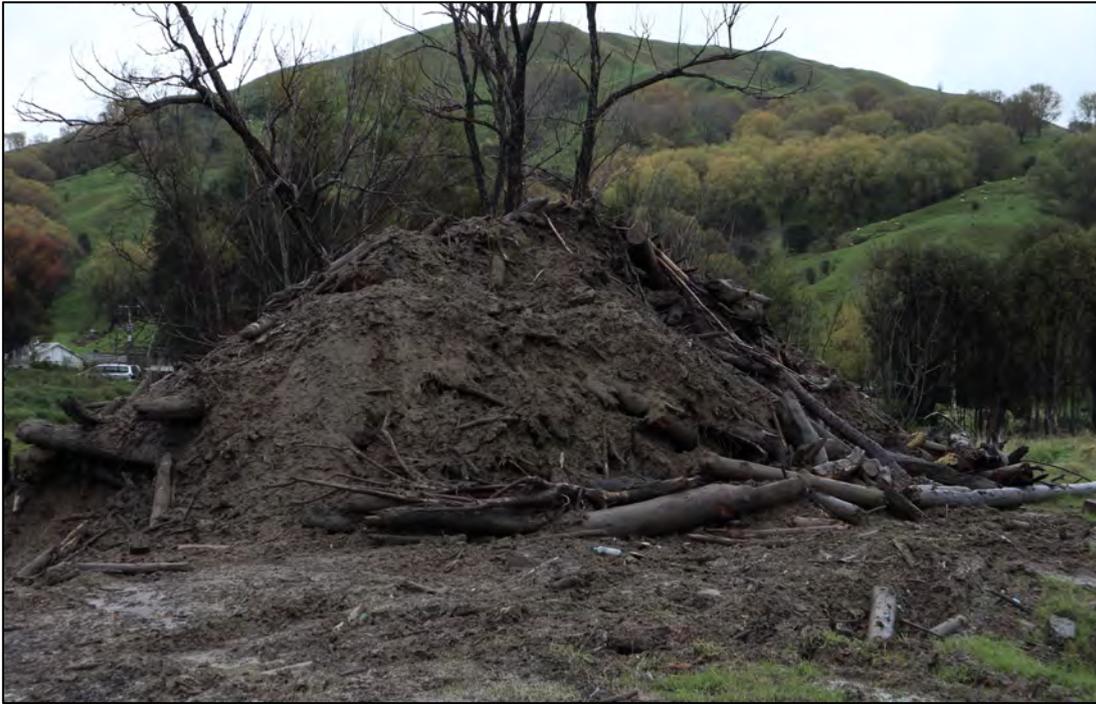
From an initial inspection, all 3 piles contained a mix of material with cut logs, a few withthrow logs, and abraded logs particularly along with some willow and dross/mud, but an accurate quantification of the material within the piles was impossible as a result of the incorporation of bank material in the slash piles (Figure 85). As a result, it was decided that the only way that the material could be accurately determined was to deconstruct the slash piles with a digger (Figure 86).

Figure 85. View of the northern most slash pile at Wigan Bridge prior to deconstruction. The process of pulling the slash from the river resulted in riverbank material being included in the piles.

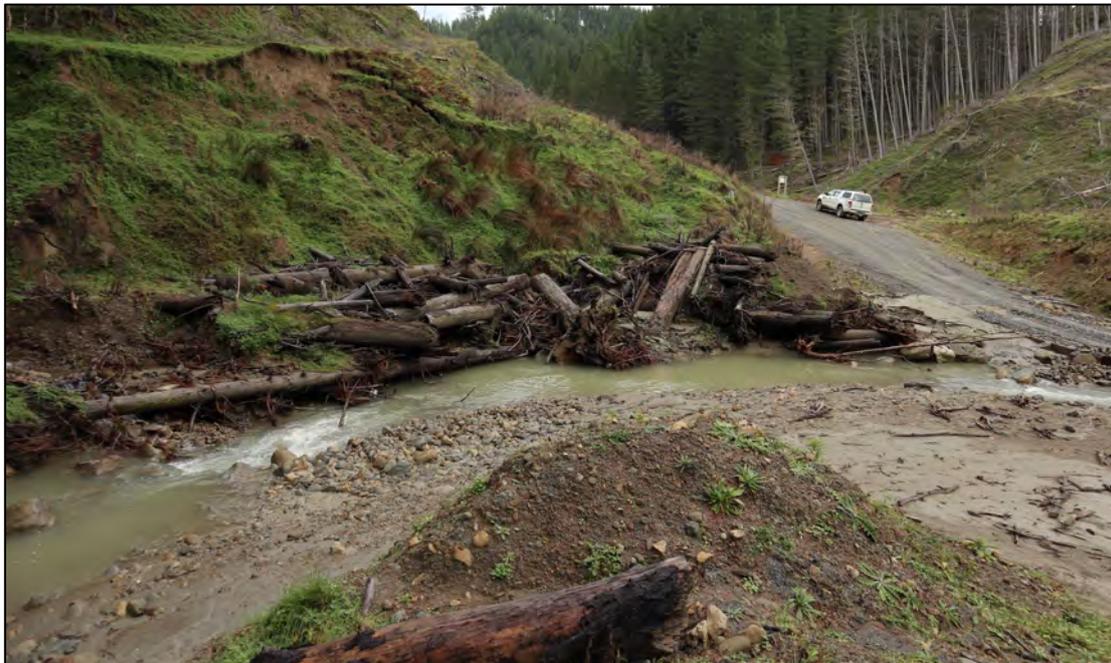
West of Te Kokokakahi Stream, the main forestry road climbs gradually around the hill following the Takamapohia Stream. At the first ford crossing the river at a location known as Staircase, recent flood sediment along with mobilised pine logs banked up on the bank in the river was observed. Accordingly, the area beyond the ford was traversed to see if any debris flows that could have contributed material to the river could be identified. No evidence of mass movement was seen and much of the area had not yet been harvested although there are some areas of harvest above Staircase in the catchment (See figure 44 above).

Figure 95. View of the ford at Staircase showing considerable silt deposition and logs caught up in the bend of the stream above the ford.

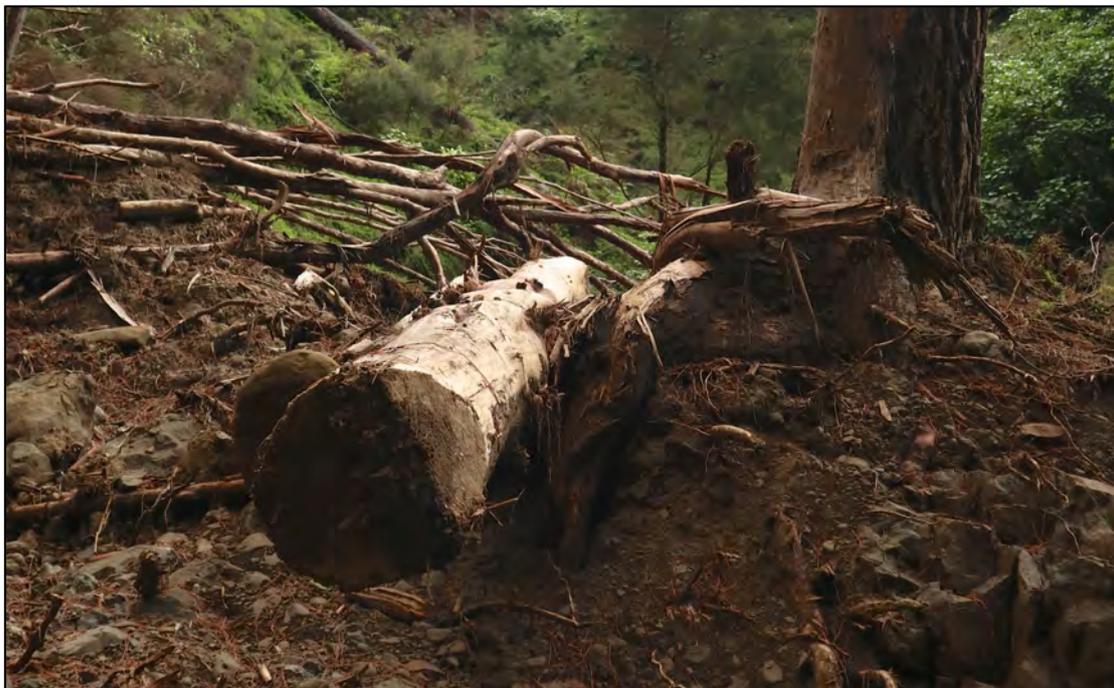
An incident report on the waterfall Creek debris flow was provided by the forestry company operating in the area but this did not provide enough detail on the mechanisms of failure at the source. What is clear from the data from the creek and the overflight is that the debris flow originated adjacent to a landing on Spencer Road and that both stored and fresh potentially merchantable cut logs were involved in the debris flow. An example of the type of material in the creek is shown in *Figure 101* below and additional images are shown in **Appendix One**.

Figure 101. Example of a fresh cut log wedged on a tree at debris flow height, Waterfall Creek.

The presence of the fresh cut logs is problematic. They occurred not just at Wigan Bridge, but also in the Whakoau (*Figure 122*) and were evident in Waterfall Creek (*Figure 101*). The observations at Willowbank where cut logs were used to corduroy the approaches to a ford, could suggest that this is the source of some of the fresh cut logs at Wigan. On the other hand, the number of fresh cut logs counted at Wigan (25) as well on the banks upstream (29) is significantly greater than those lost out of the ford at Willowbank. Even if it is assumed that additional logs were supplied from the pile stored on the side of the river at Willowbank the number counted at and above Wigan still exceeds that possible from a Willowbank source.

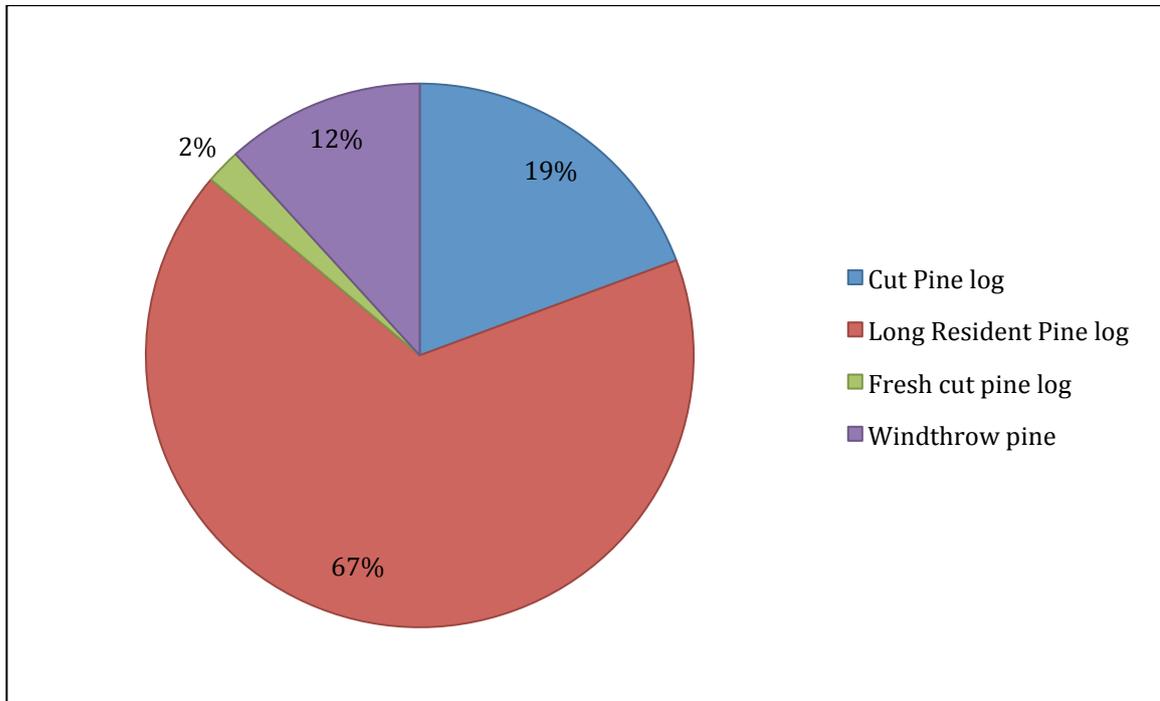
The types of pine log materials present is also significant with 88% of all pine being pine logs that have been either or partially fully processed and only 12% being windthrow (*Figure 107*). As was the case at Wigan Bridge, long resident-time pine logs are the most common. The presence of these weathered processed logs with abraded cut ends indicates two things. Firstly, it indicates that there is a significant population of pine logs present (resident) in the river systems and available to be mobilised during extreme rainfall events. Secondly, as has become apparent in the overall investigation, there are a number of slash piles within the operational forest areas that are vulnerable to mobilisation during flood events.

Figure 107. Proportion of the various types of pine wood on Tolaga Beach. Calculated for windthrow vs fully or partially processed pine (fresh cut pine, cut pine and long resident pine), the proportions are 12% windthrow vs 88% processed or partially processed.

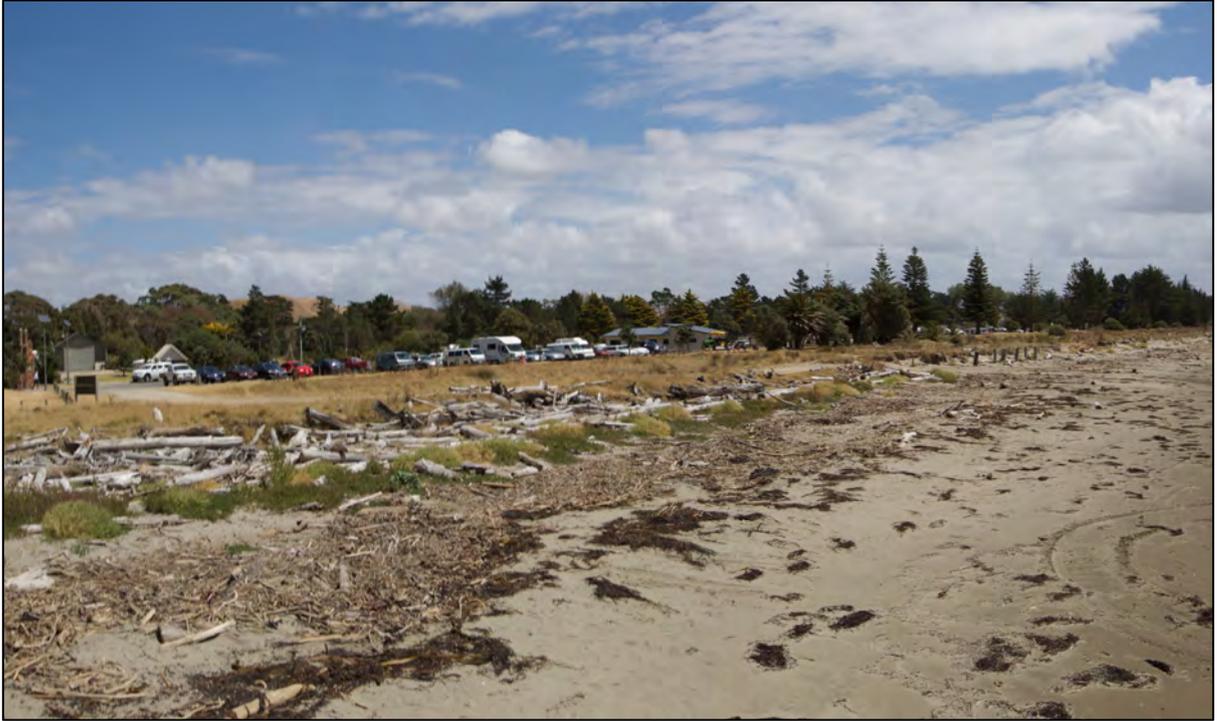
On the 28th of January 2017 a photograph of Tolaga Bay Beach from the Wharf was taken to demonstrate the then current state of woody debris on the beach (Figure 108). This image shows residual slash which according to the local community was deposited in 2015. In front of that is a band of vegetation and in front of that again is a line of small woody material (dross). The same point on the wharf was then revisited on the 11th July to examine the impact of Cyclone Cook on the beach (Figure 109).

Figure 108. Photograph of Tolaga Bay Beach taken at 11:49AM, 28th of January 2017.
