Cyclone Cook Slash Investigation

Dr Murry Cave Principal Science Advisor GDC
Nicki Davies, James Langford GDC Land & Soil Team

October 2017

Executive Summary

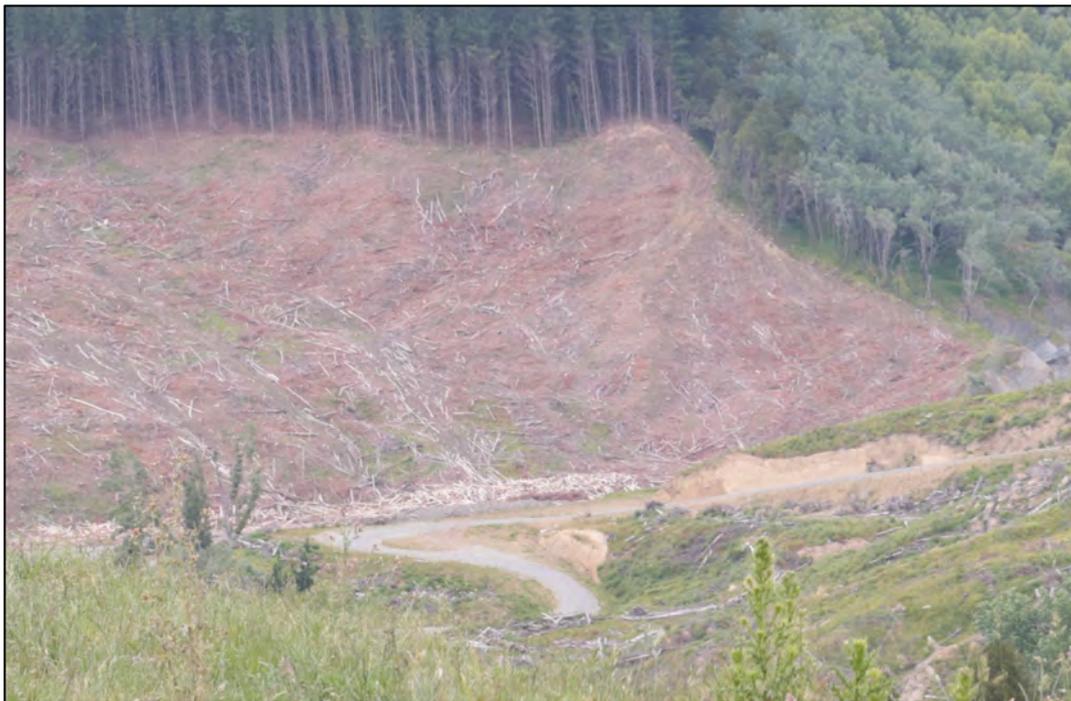
The Whakoau River tributary of the Mata River was the only river within the Waiapu Catchment where enough information was available to undertake a detailed assessment of the impacts of forestry slash. A operational landing at the beginning of River Road off the Mata Road was visited on the 13th of December 2016. It was noted that the landing was close to river level at broad loop in the river and would thus be vulnerable to flood events (*Figure 110*).

Figure 110. View of landing on the Whakoau River, bottom of River Road, Mata 13th December 2016 showing the landing with stored logs on the flood plain.

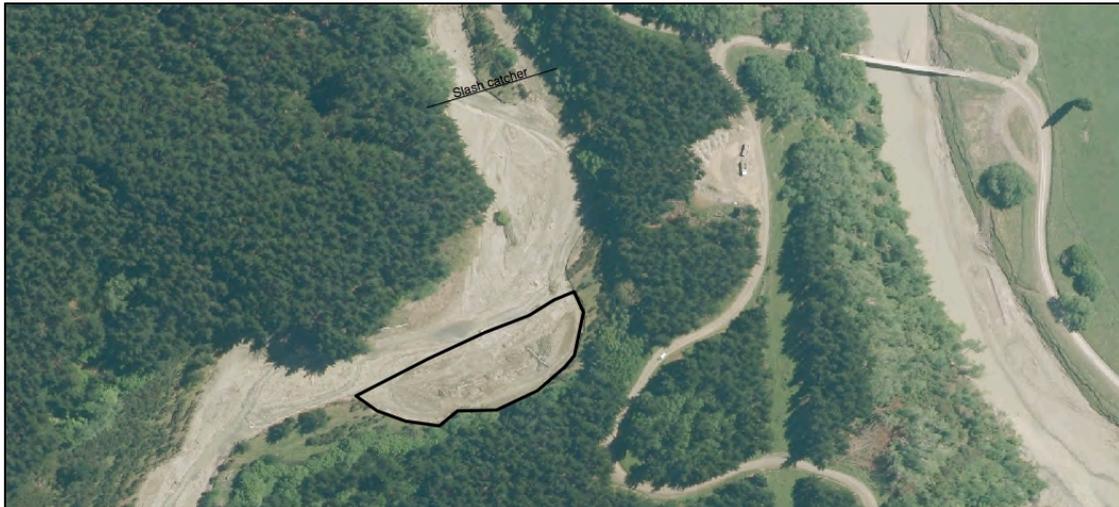
The landing is located on a flat portion of the Whakoau River and is approximately 1 to 1.5m above normal water level in the river and relied on a slash catcher immediately downstream to protect the river from slash mobilisation (*Figure 111*).

Figure 111. Aerial image of the bottom end of the Whakoau River on River Road showing the location of the forestry landing on the river flats on the true right side of the river. Also shown is the position of the slash catcher downstream of the site.

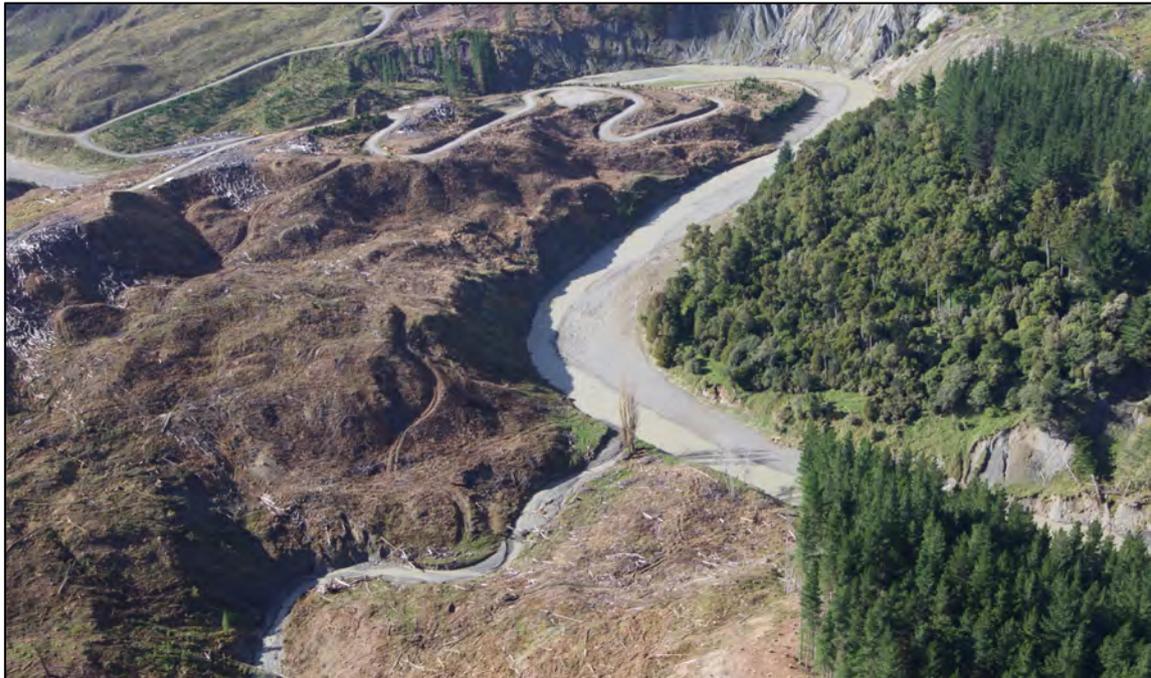
One further photograph taken further upstream and looking down towards the slash catcher indicates that the river upstream of the area shown above is now largely free of slash but this may indicate that it had been swept clean during the event. The side stream on the true left does, however, show some material that is clearly in a vulnerable position and at risk of mobilisation (*Figures 117 and 118*).

Figure 117. View of the Whakoau River showing the main channel clear of slash above the area shown in Figure 116 although the side stream in the foreground does have some material at risk of mobilisation.

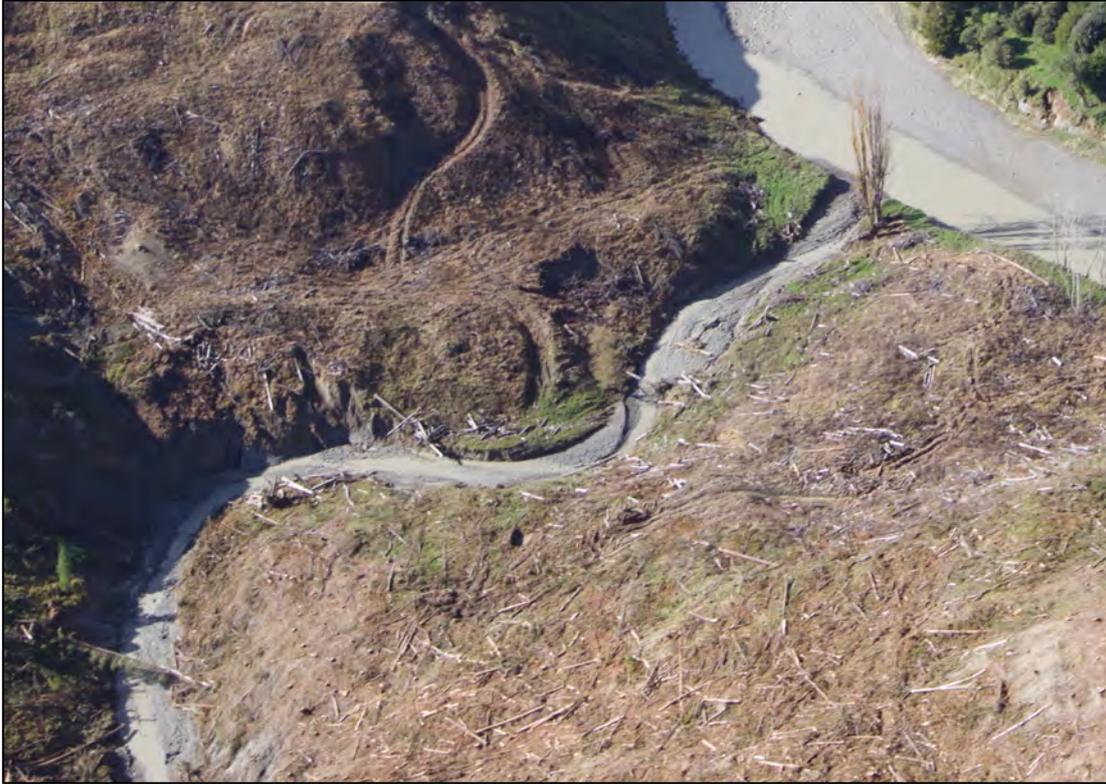
Figure 118. Detailed view of the side stream shown in Figure 117 showing material adjacent to and in the watercourse.

Gullies and flood plains with accumulations of pine slash were ubiquitous in all forests (*Figures 27, 29, 38, 40, 42, 43, 50, 52, 65, 79, 91, 92, 116, 118, and 124* and see **Appendix One**). Such slash accumulations were particularly evident in Tapuae Stream (*Figures 42 and 43*), the Mangatokerau sub catchment (*Figures 91, 92, and 124*), and the Whakoau (*Figures 116 and 118*).

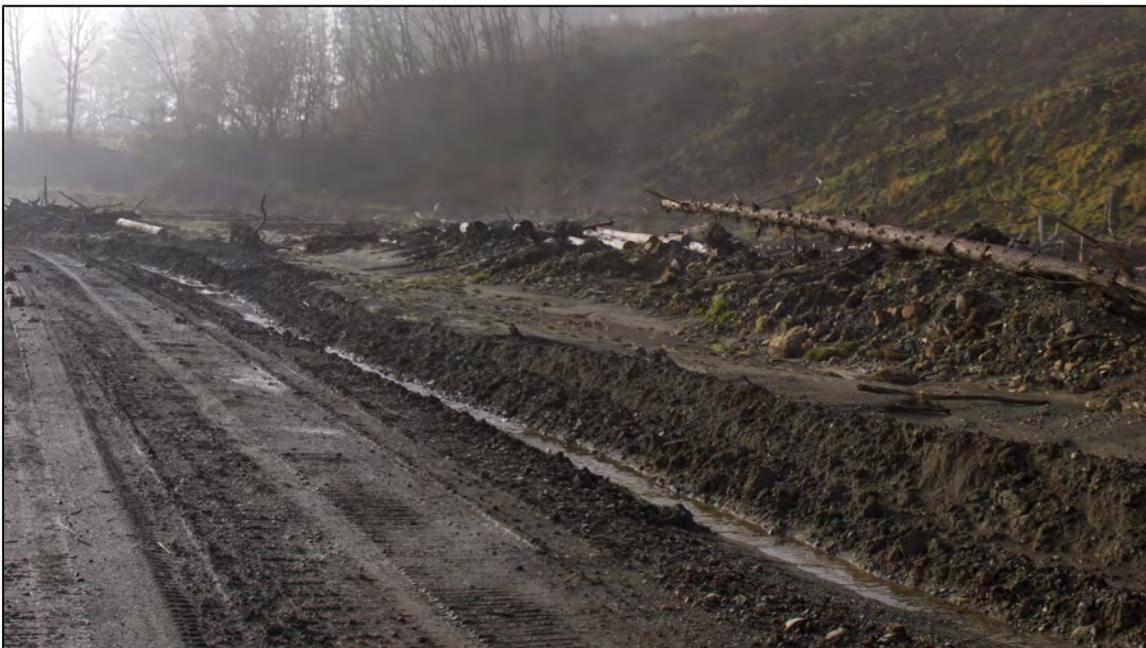
A view of the eastern end of the slash pile is shown in *Figure 119* and in closer detail in *Figure 120* below. While a comparison with the aerial imagery shown in *Figure 112* indicates that some remediation of the slash pile has occurred. It also shows clear signs that the material to the right of the track was exposed to floodwaters and that the slash was most likely mobilised during Cyclone Cook.

Figure 120. View of the landing showing the extensive silt deposition within the slash pile and the clearly demarked trim line. Note the cut logs above the trim line.

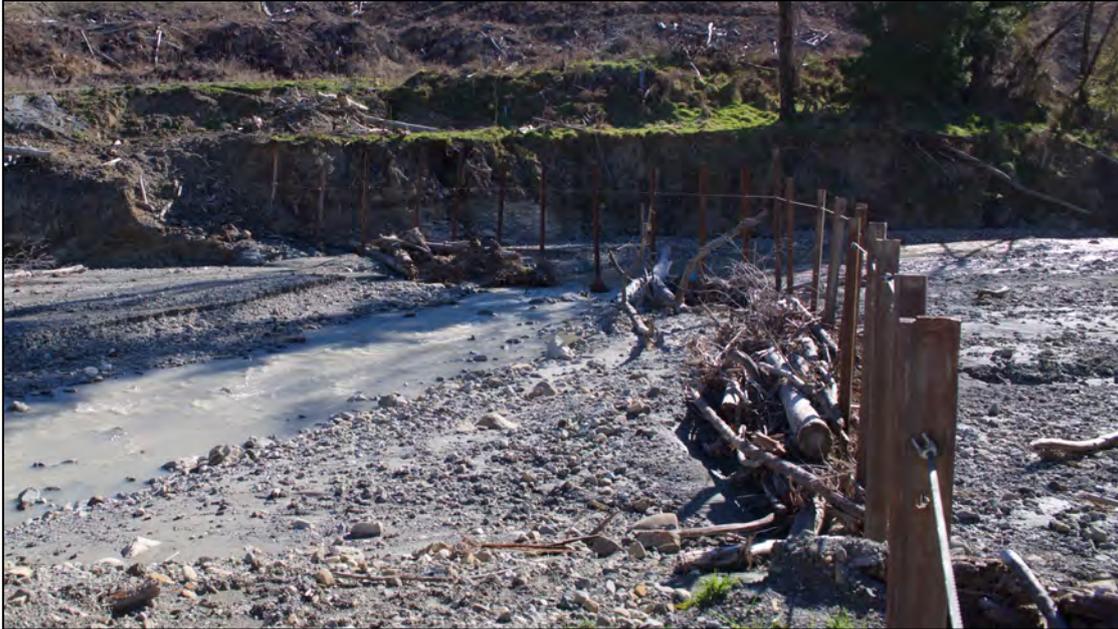
A visit on the 29th of August showed that a new slash catcher had been installed and despite the lack of any significant recent storm events, the catcher was collecting new slash including fresh cut logs (*Figure 121*). A further fresh cut log was stranded on the river bank immediately upstream (*Figure 122*).

Figure 121. View of the Whakoau River showing the new slash catcher with recently collected logs including fresh cut logs.

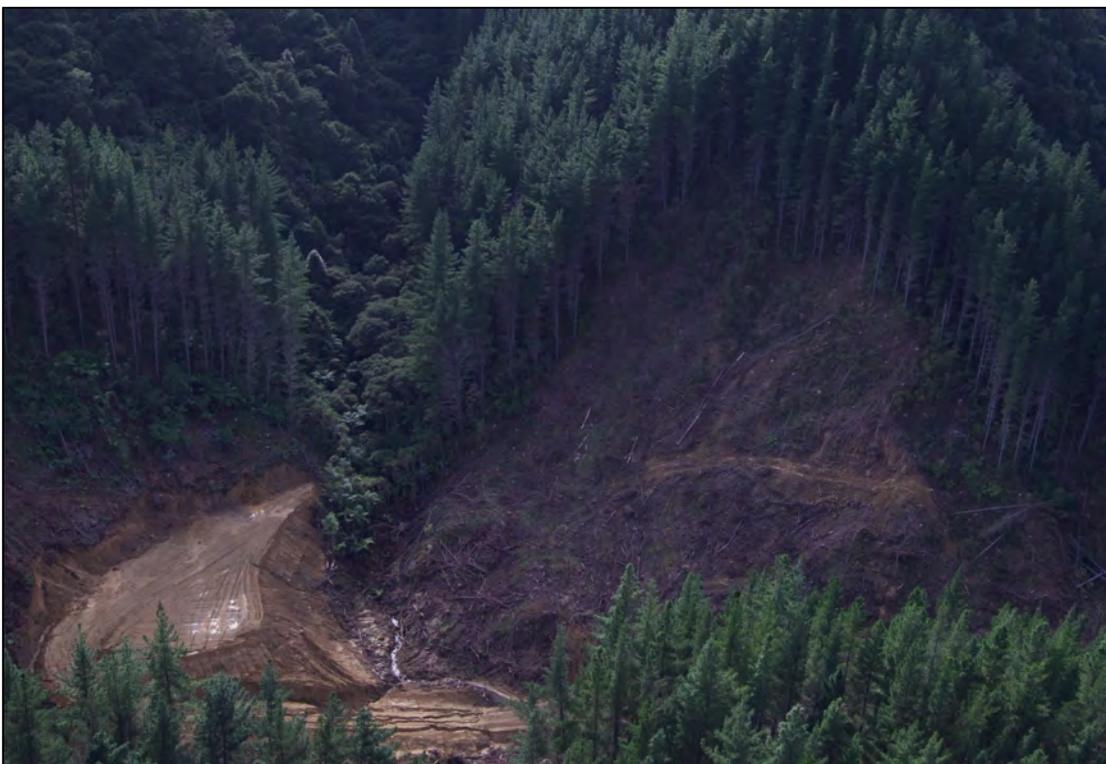
Figure 124. View of earthworks at river level in the Mangatokerau sub catchment.
