Gisborne District Council

## **PRELIMINARY SITE INVESTIGATION (PSI)**

Te Karaka Stopbank

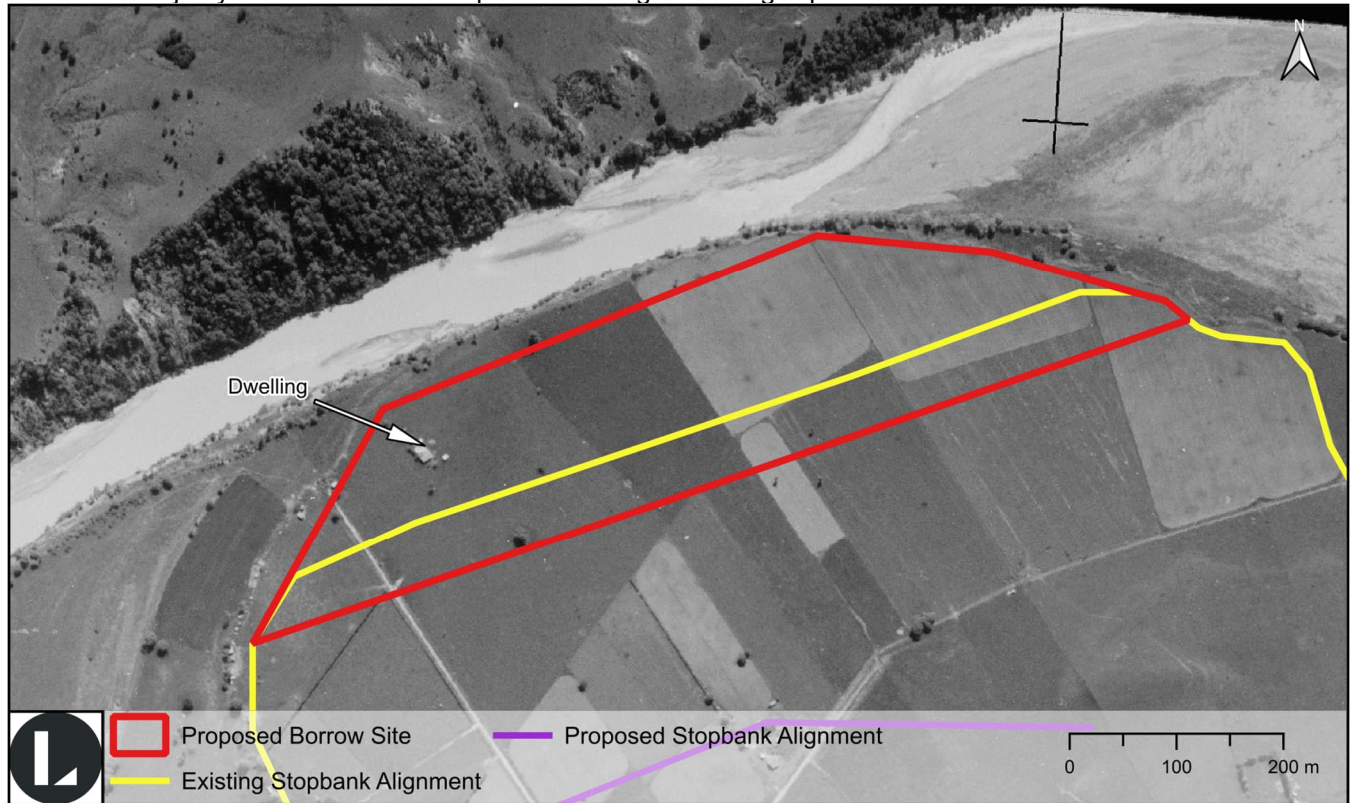
**1949:** The majority of the borrow site is pasture. A single dwelling is present to the west.

Figure 14. Aerial imagery 1949. Sourced from Retrolenz.nz and licensed by LINZ (annotated image).

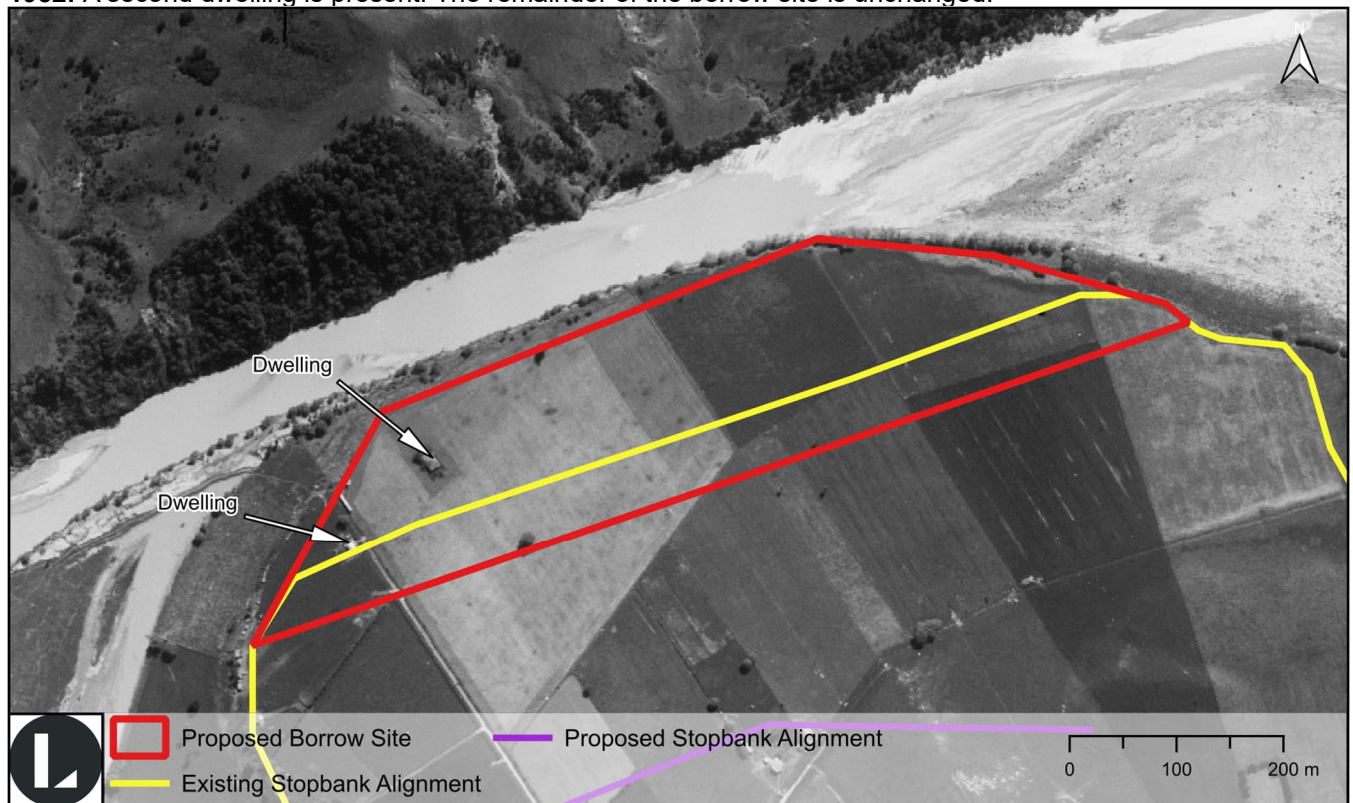
**1952:** A second dwelling is present. The remainder of the borrow site is unchanged.

Figure 15. Aerial imagery 1952. Sourced from Retrolenz.nz and licensed by LINZ (annotated image).

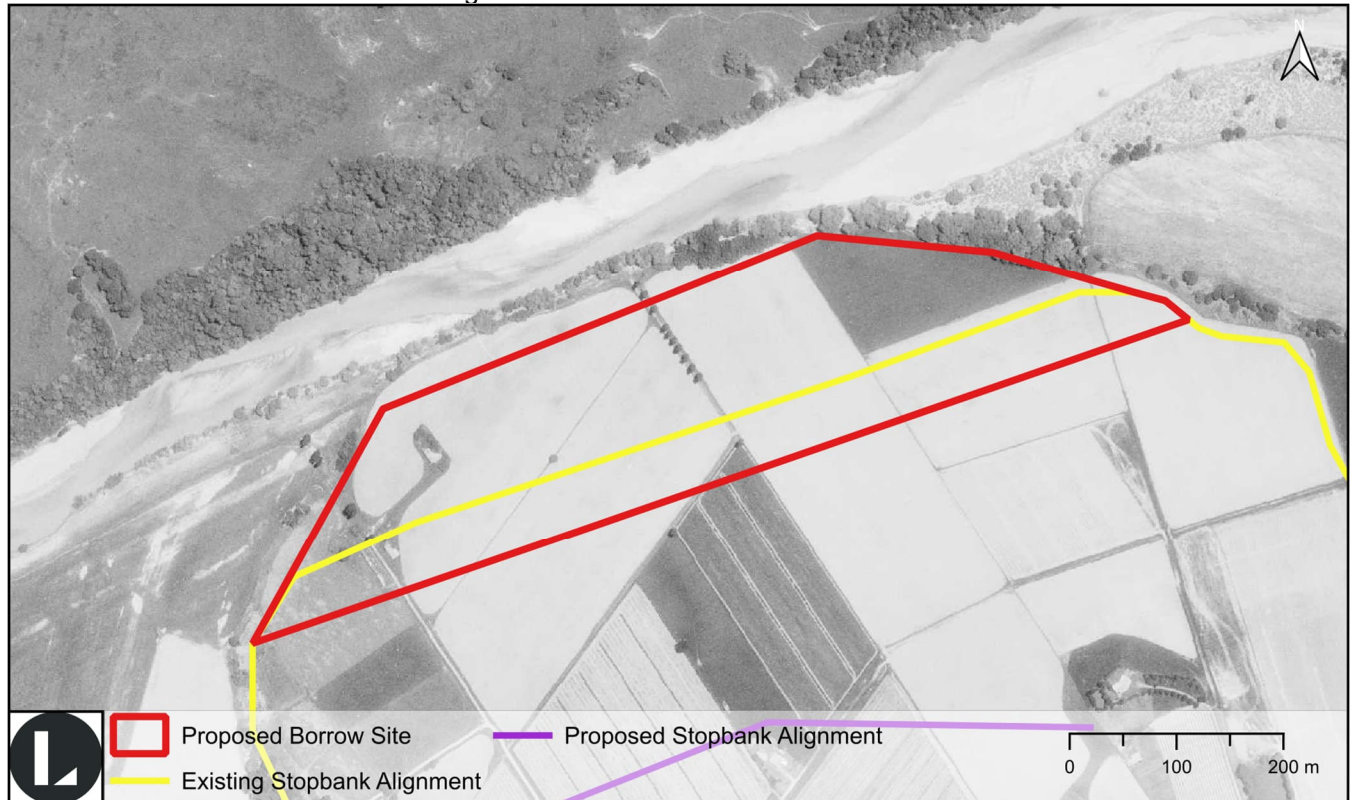
**1982:** The borrow site remains unchanged.

Figure 18. Aerial imagery 1982. Sourced from Retrolenz.nz and licensed by LINZ (annotated image). Approximate site boundary shown in yellow.

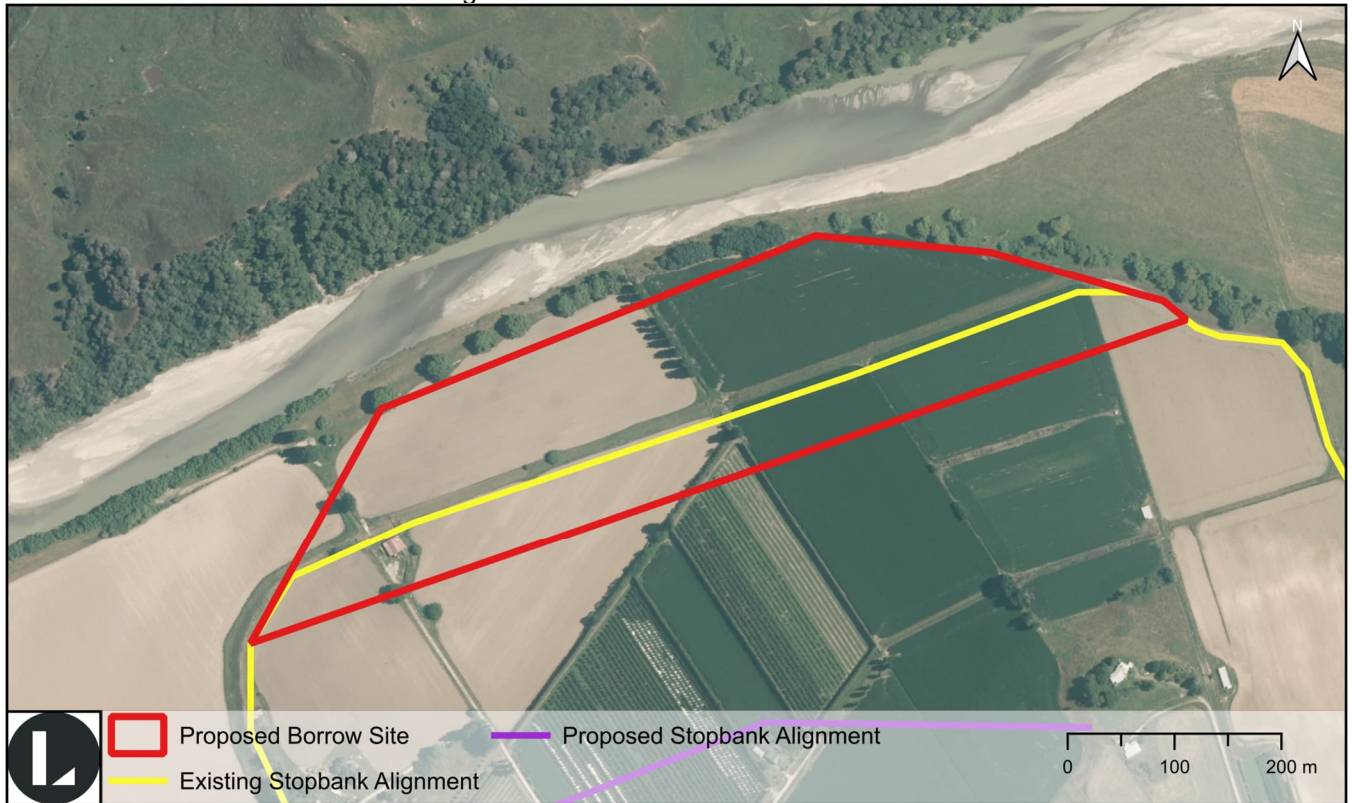
**2013:** The borrow site remains unchanged.

Figure 20. Aerial imagery 2013. Sourced from LINZ (annotated image). Approximate site boundary shown in yellow.

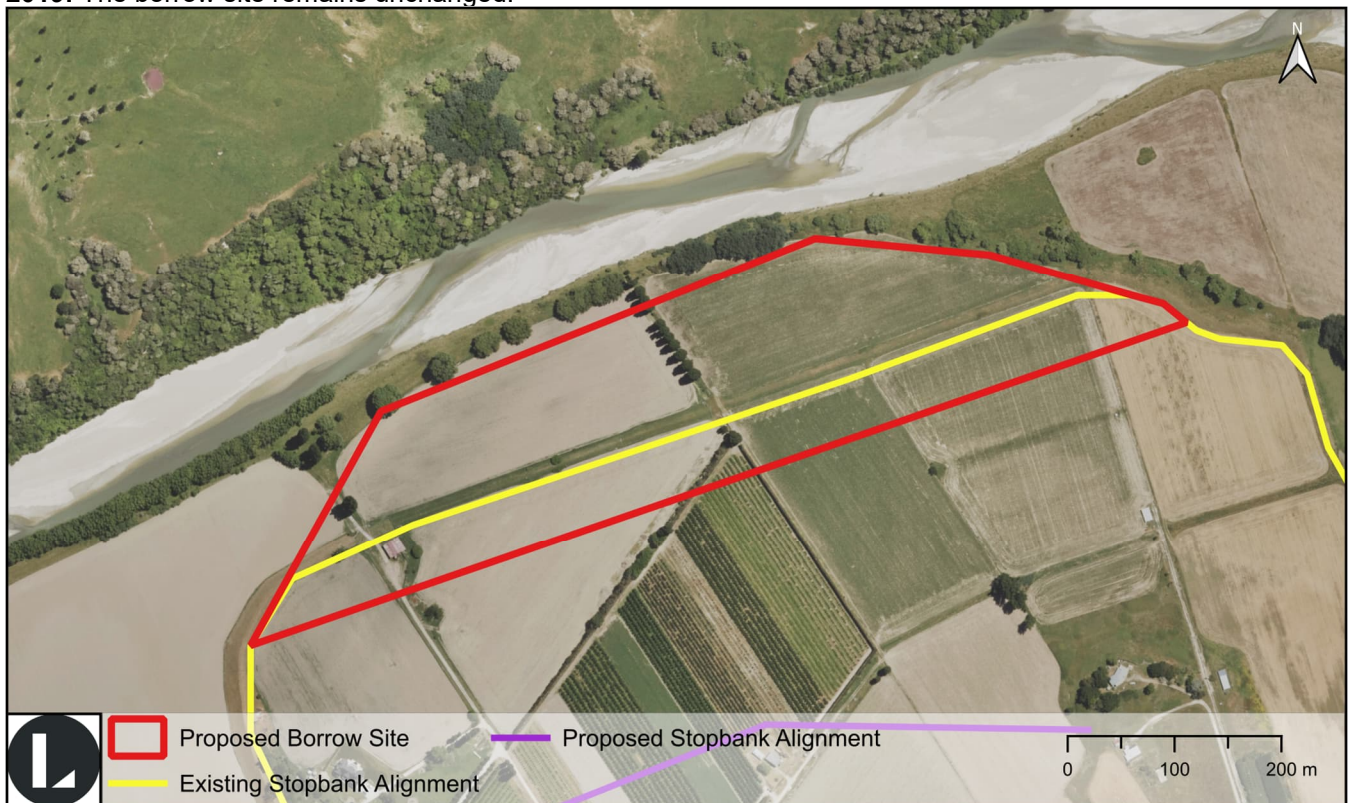
**2019:** The borrow site remains unchanged.

Figure 21. Aerial imagery 2019. Sourced from LINZ (annotated image). Approximate site boundary shown in yellow.

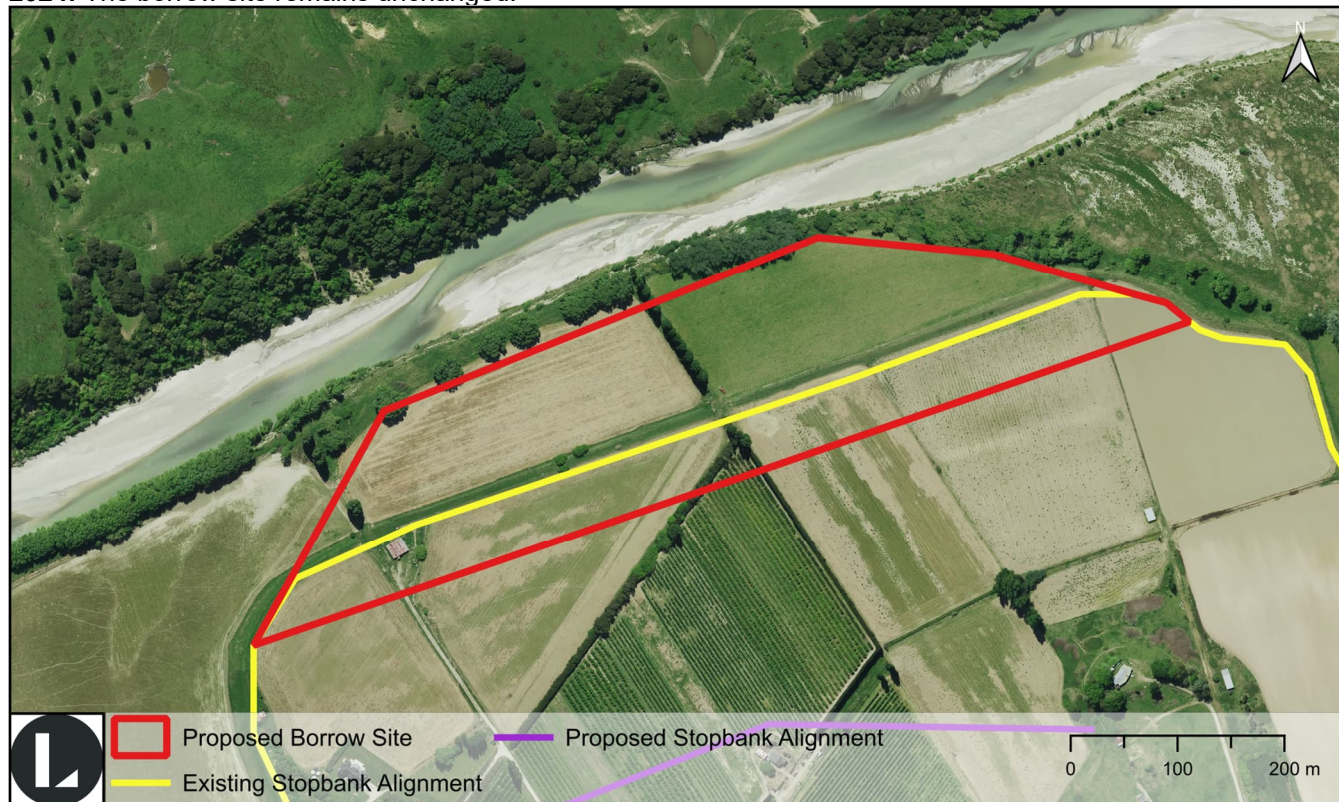
**2024:** The borrow site remains unchanged.

Figure 22. Aerial imagery 2024. Sourced from Tairāwhiti Maps<sup>3</sup>. Approximate site boundary shown in yellow.

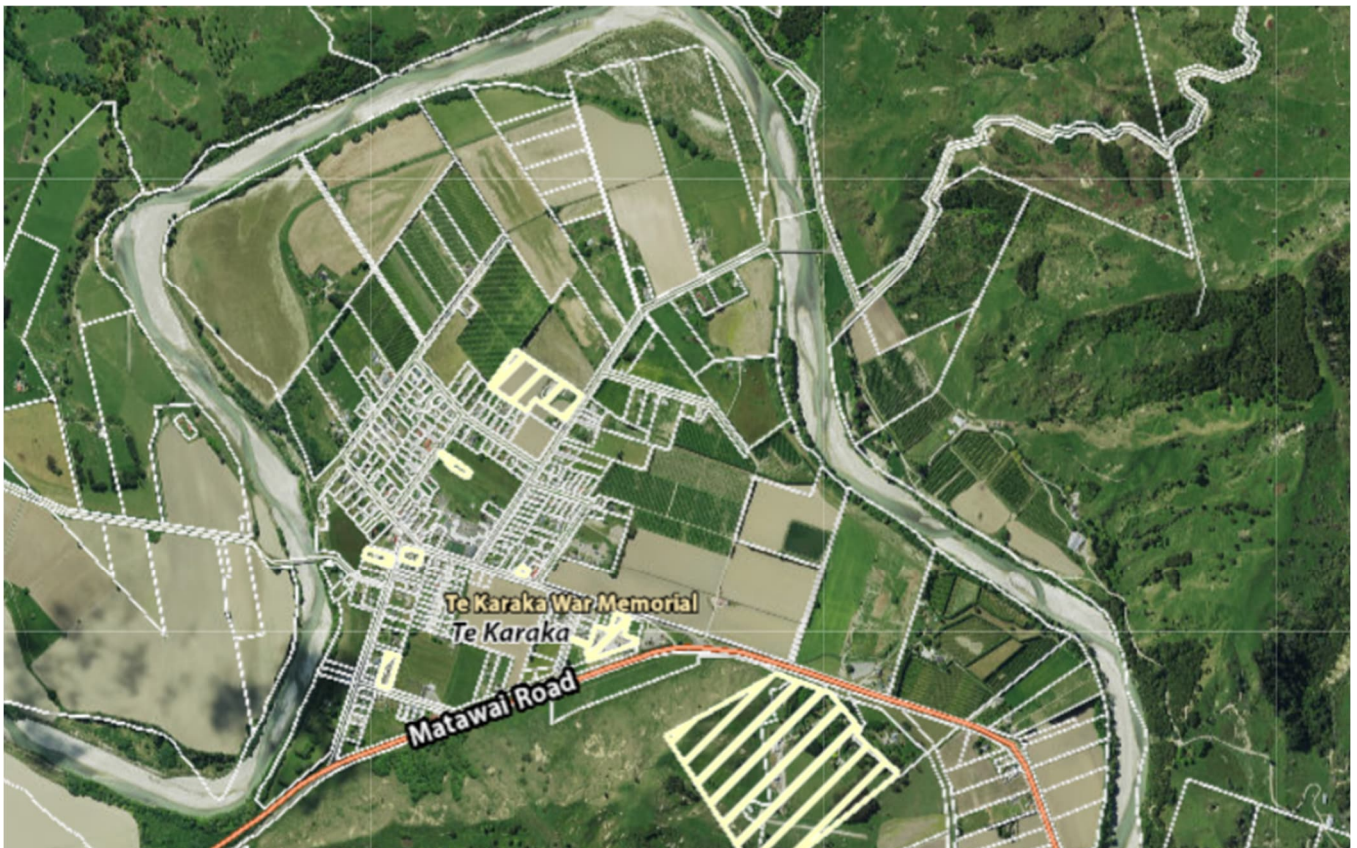
The Gisborne District Council (GDC) HAIL register<sup>4</sup> was reviewed as part of this investigation. No registered HAIL sites intersect with either the proposed alignment or the proposed borrow site.

Figure 23. Extract from GDC HAIL Register, showing location of known HAIL sites within the Te Karaka township.

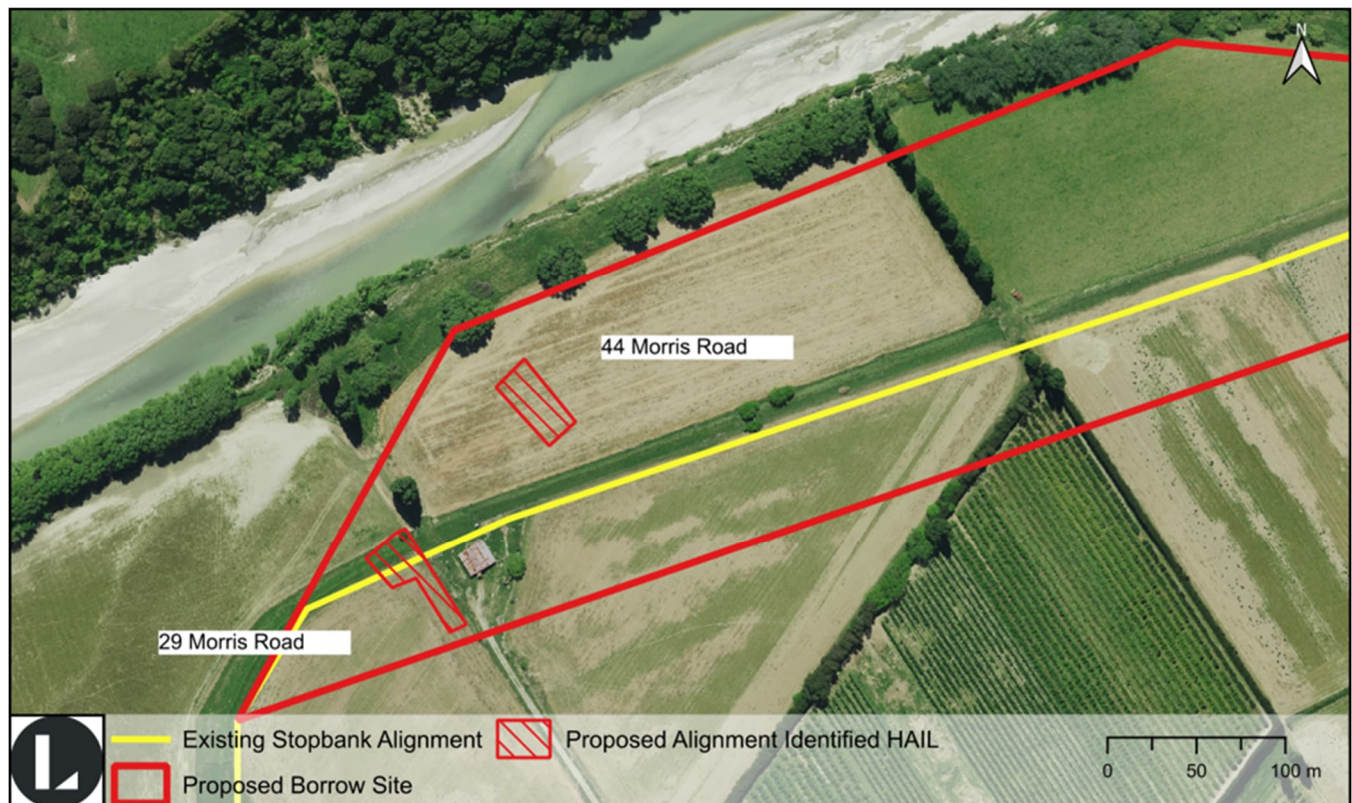
Figure 26. Site plan showing location of identified HAIL sites along the proposed borrow site.

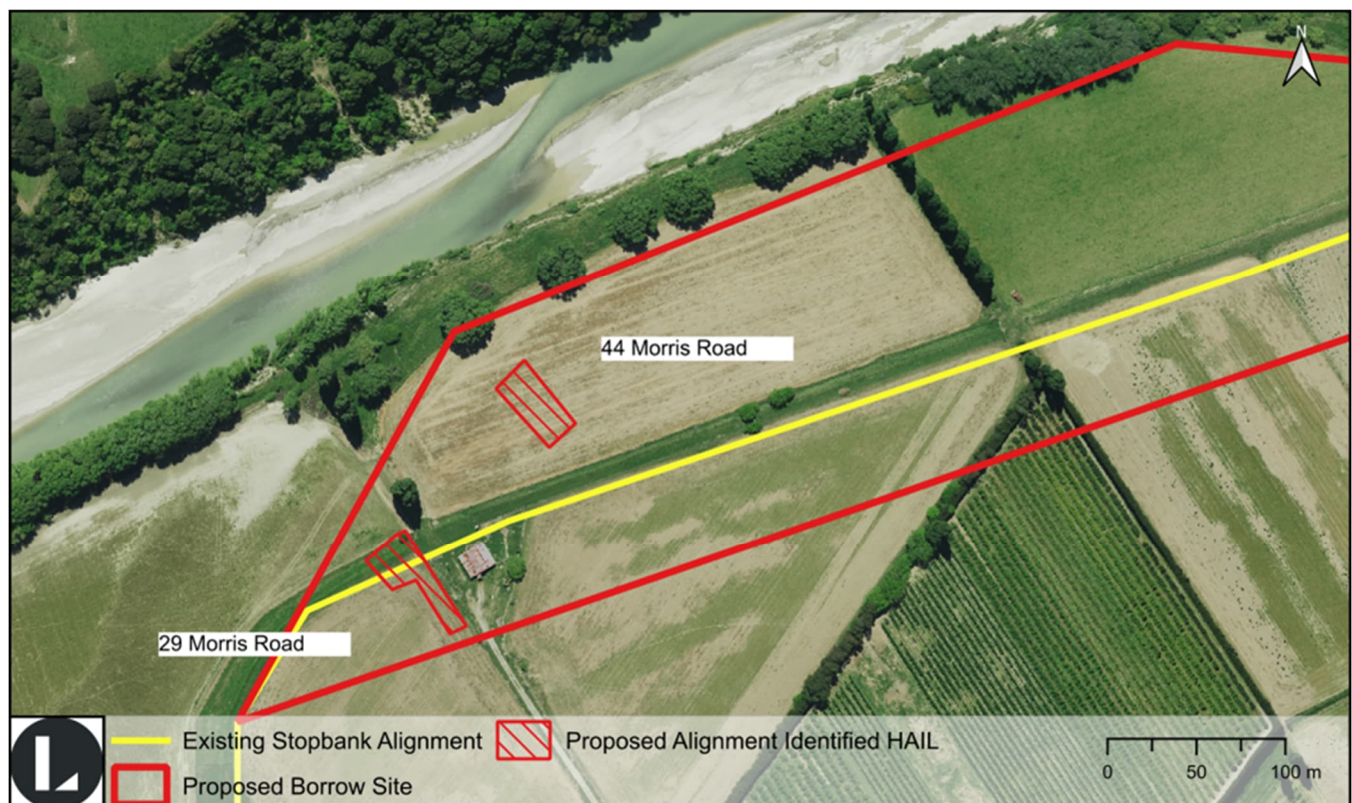
| Address | HAIL Category and date observed | Potential for contamination (Y/N) |
|---|---|---|
| 44 Morris Road | HAIL E1/I – 1949+ | Y – demolition of structures prior to 2000s possibly containing asbestos and/or lead paint. |
| 29 Morris Road | HAIL I – 1960+ | Y – demolition of structures prior to 2000s possibly containing asbestos and/or lead paint. Miscellaneous storage. |

Figure 4. Site plan showing location of identified HAIL sites within the proposed borrow site.

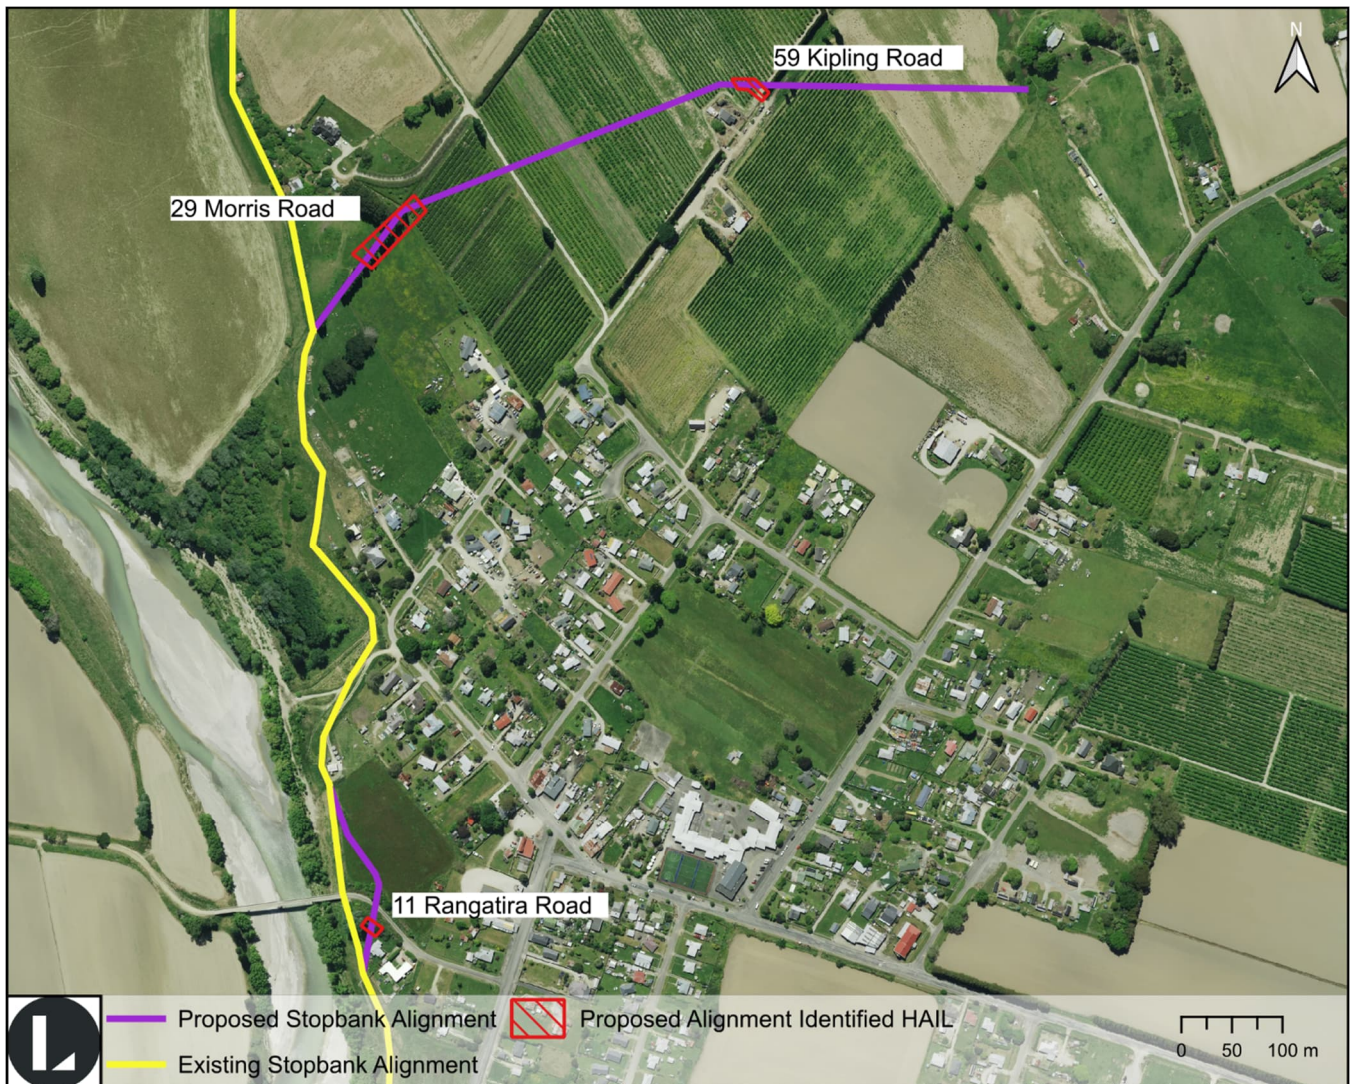
| Address | HAIL Category and date observed | Potential for contamination (Y/N) |
|---|---|---|
| 29 Morris Road | HAIL A18 – 1960 | Y – storage of potential treated timber and miscellaneous storage |
| Morris Road / Kipling Road / Paulson Road / Matawai Road | HAIL A10 – 1982+ | Y – various orchards cross the proposed alignment. |

Figure 5. Summary plan showing location of identified HAIL sites along the proposed stopbank alignment. HAIL A10 also identified at various orchards along the proposed alignment. No additional HAIL activities were identified following the updated proposed alignment (March 2026).

A detailed site investigation (DSI) is recommended to establish if soil contamination exceeds the applicable standard to determine if the site is a restricted discretionary or controlled consent under the NESCS. Soil sampling is proposed to be undertaken within the identified HAIL locations, as well as systematic sampling along the proposed alignment where orchards are or were historically present.

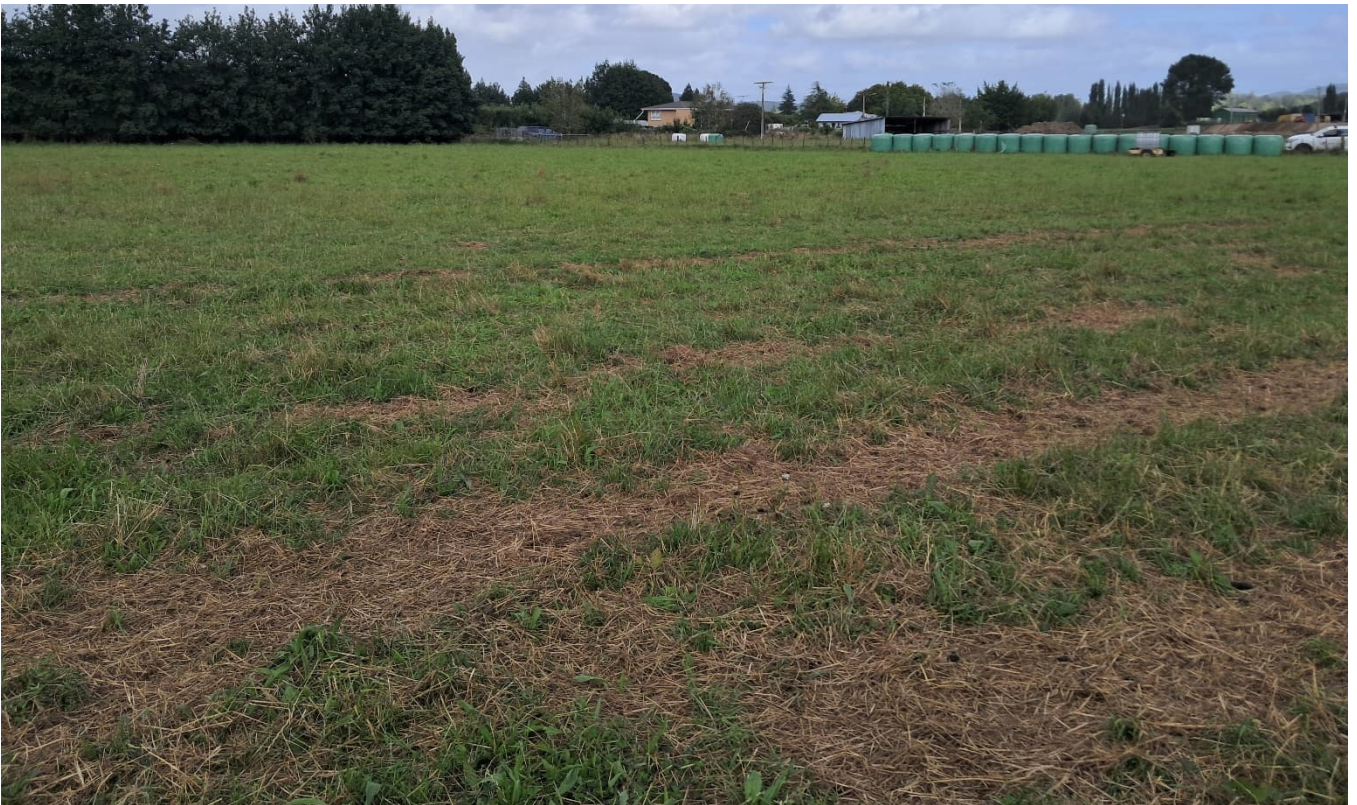
Figure 8. Section of proposed alignment used for pasture.

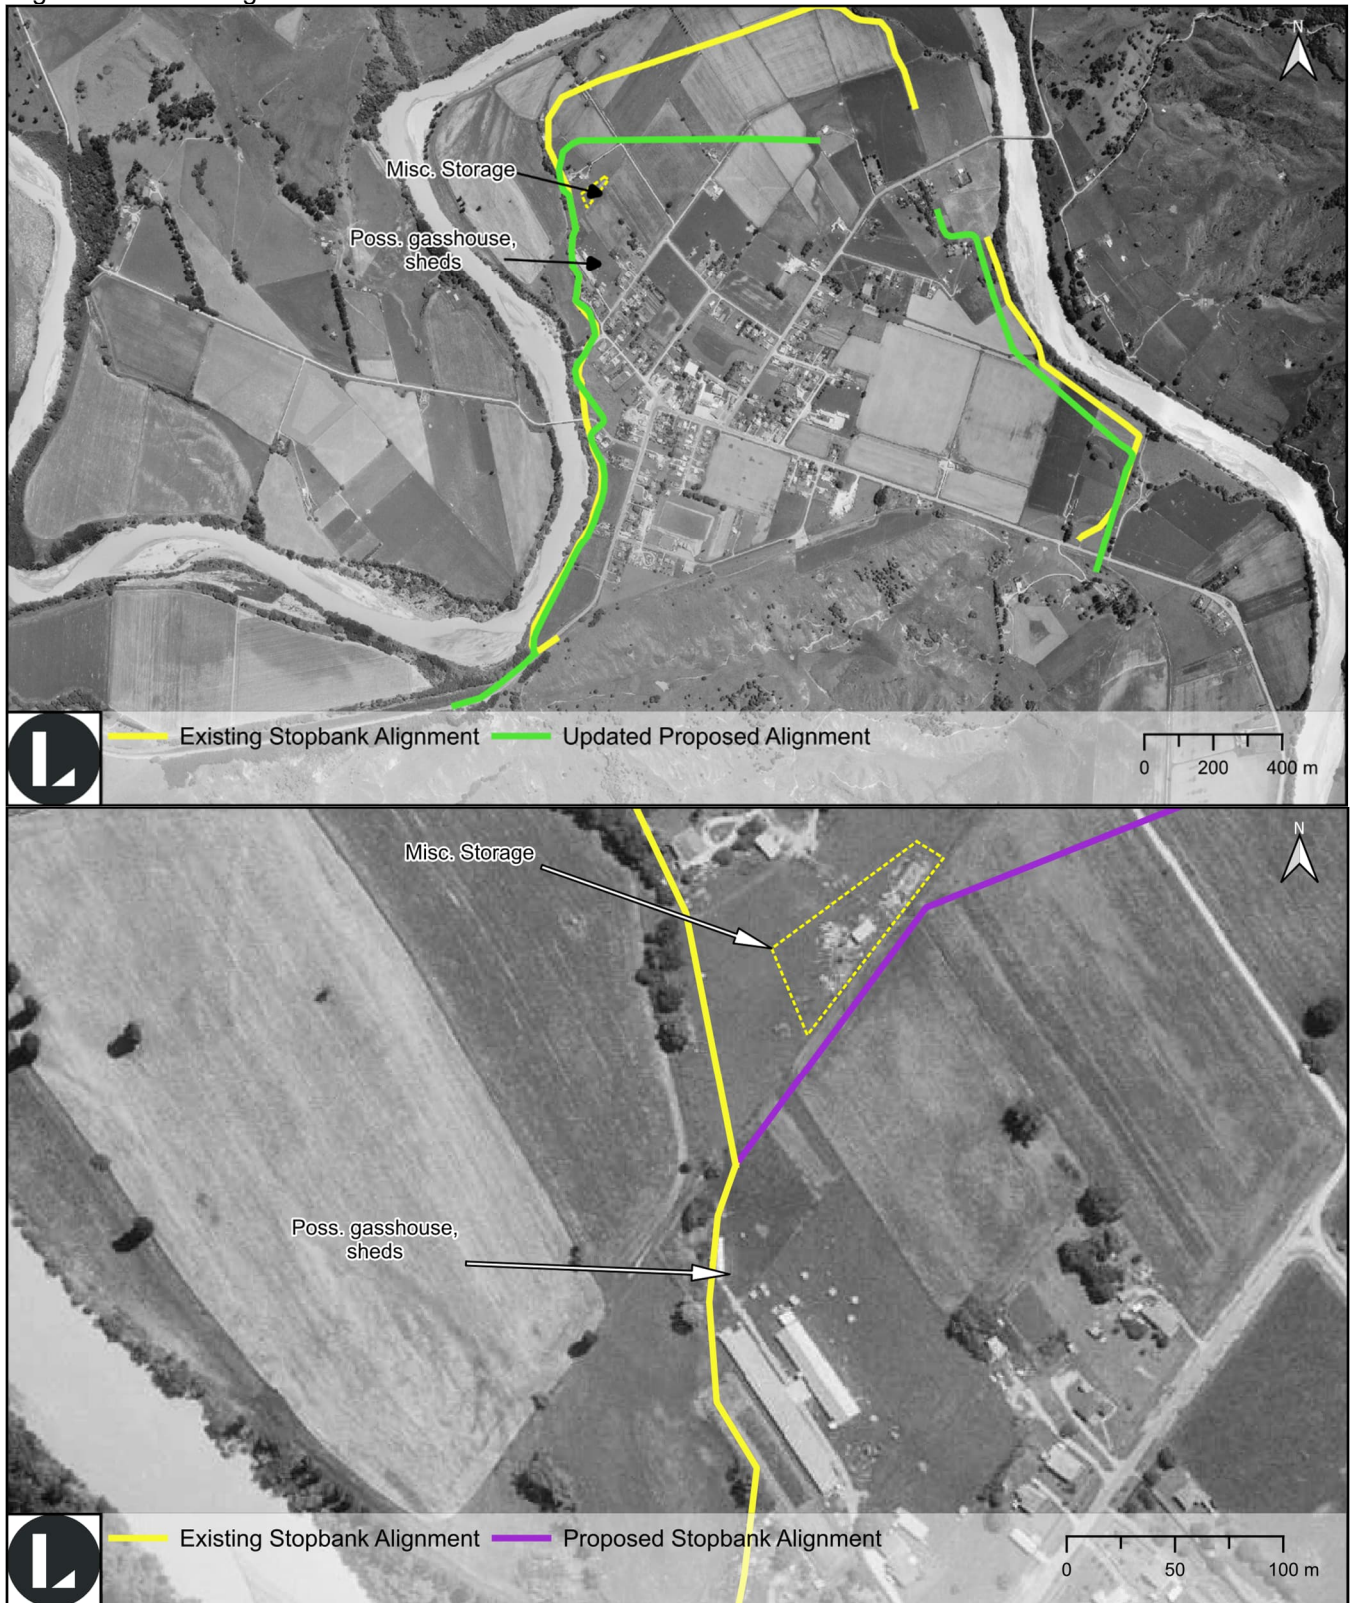
**1974:** Miscellaneous storage, possibly timber, is present adjacent to the proposed alignment. A series of large sheds or glasshouses have been constructed to the west adjacent to the proposed alignment. The remaining proposed alignment is unchanged.

Figure 8. Aerial imagery 1974. Full (top) and Zoomed-in (bottom) aeriels. Sourced from Retrolenz.nz and licensed by LINZ (annotated image).

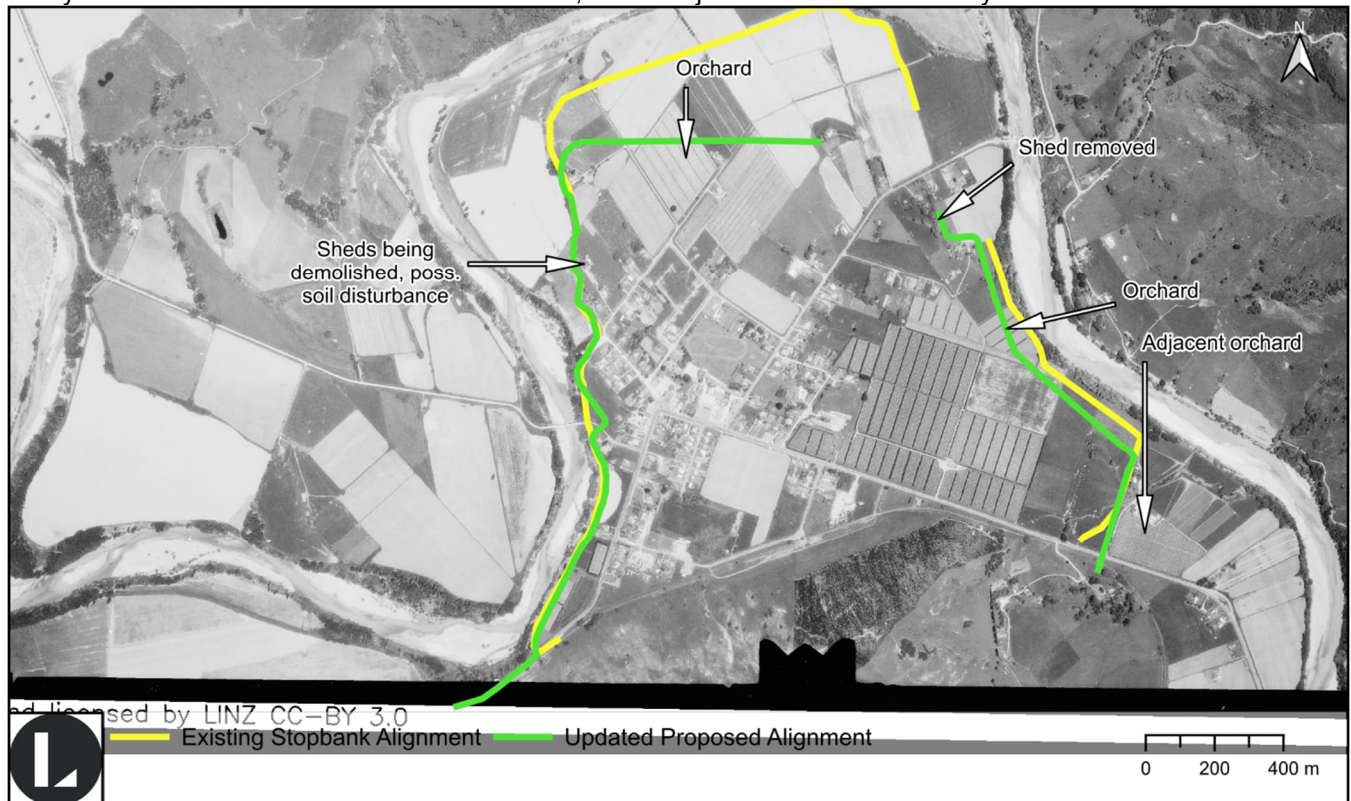
**1982:** Sheds / glasshouses along the NW proposed alignment are being removed. The alignment crosses several newly established orchards in the north and east, and is adjacent to another recently established orchard in the SE.

Figure 9. Aerial imagery 1982. Sourced from Retrolenz.nz and licensed by LINZ (annotated image).

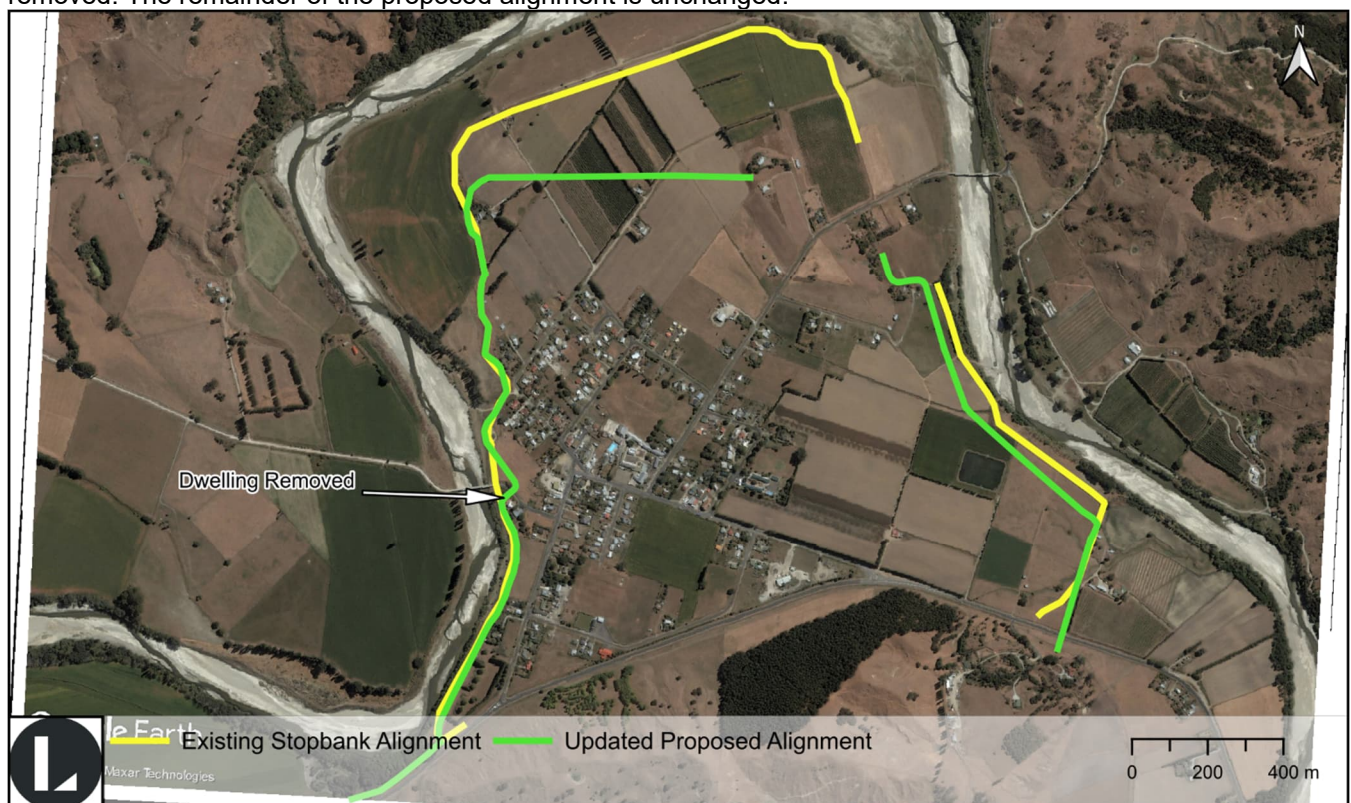
**2003:** The existing stopbank has been constructed. A dwelling close to the Rangatira Road bridge has been removed. The remainder of the proposed alignment is unchanged.

Figure 10. Aerial imagery 2003. Sourced from Google Earth (annotated image).

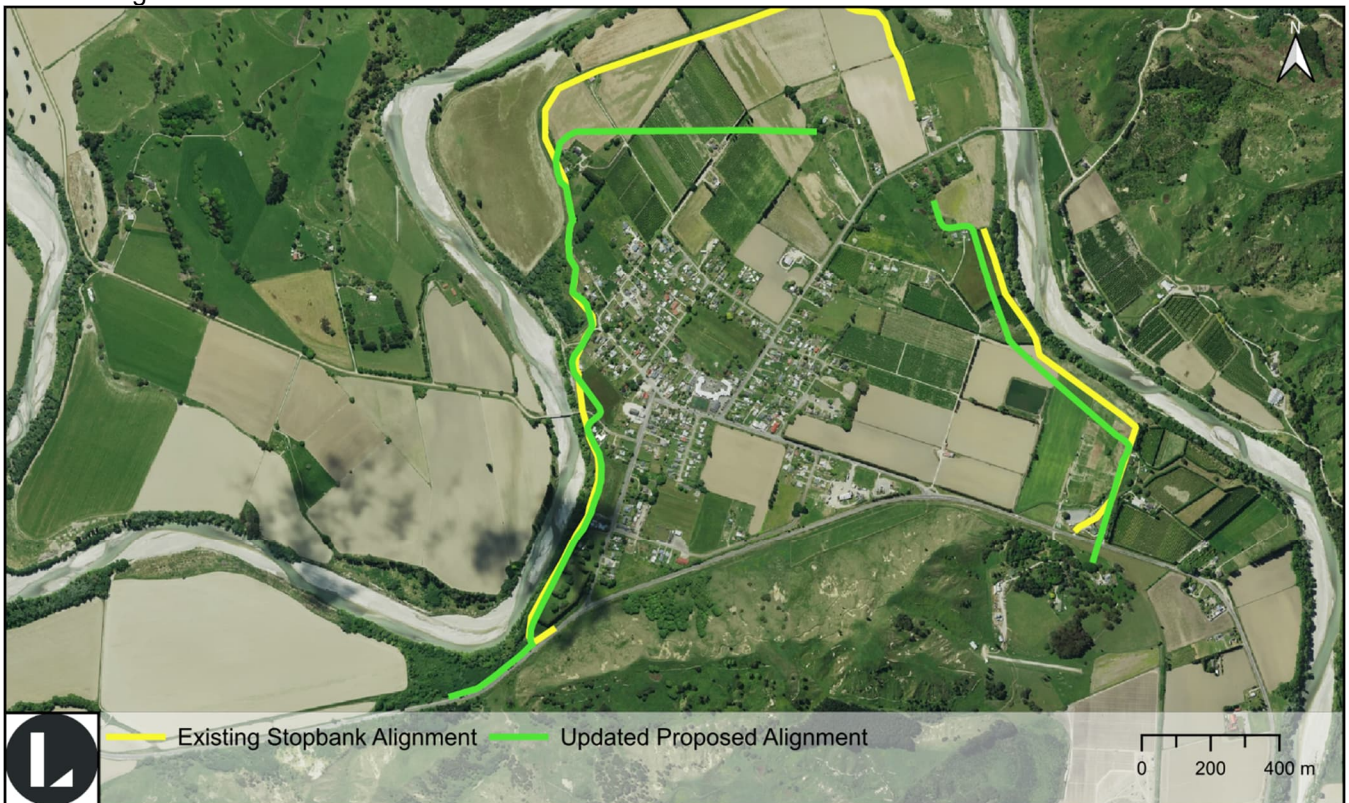
**2024:** The majority of the proposed alignment remains unchanged. The proposed alignment crosses a small area of silt storage to the north.

Figure 13. Aerial imagery 2024. Sourced from Tairawhiti Maps<sup>2</sup>.
