Analysis of landslide events in the Wakaroa and Makiri Forests, and adjacent areas

This report forms two parts. Firstly it provides a spatial analysis of the number and distribution of landslides within the study area, and secondly an analysis of the types of failures and the mechanisms driving the failures.

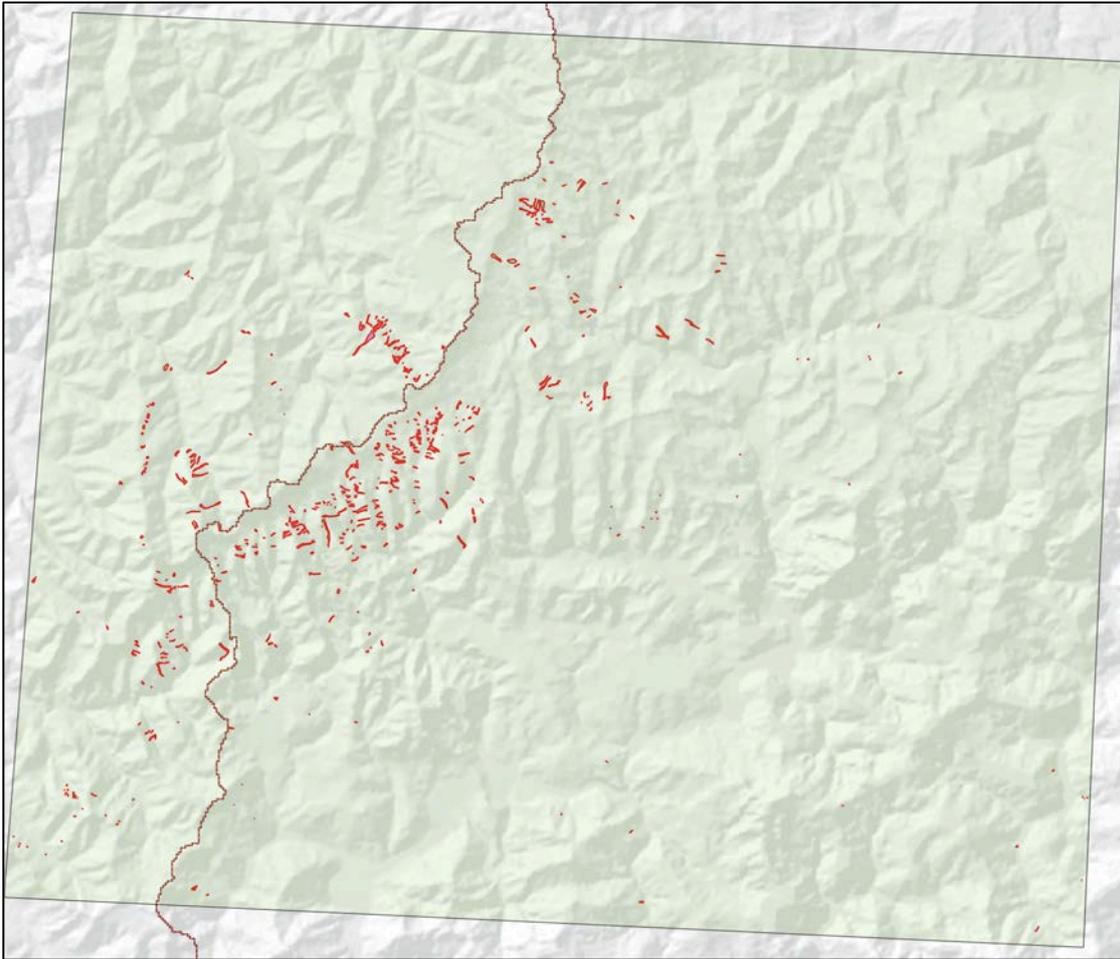
The majority of the landslides occurred at the crest of the Waimata catchment with the majority occurring on the Waimata side of a the crest and somewhat less on the western side in the upper Waipaoa Catchment (**Figure Twelve**). The relationship between landslide distribution and the 24 hour rainfall for the 11th to 12th June is shown in **Figure Thirteen** which shows that the more landslides occurred in the 50mm rainfall band than occurred in the 100mm rainfall band (see Cave 2018b).

Figure Twelve. *Spatial distribution of landslides within the study area. The boundary between the Waimata (east) and Waipaoa catchment (west). See Appendix One.*

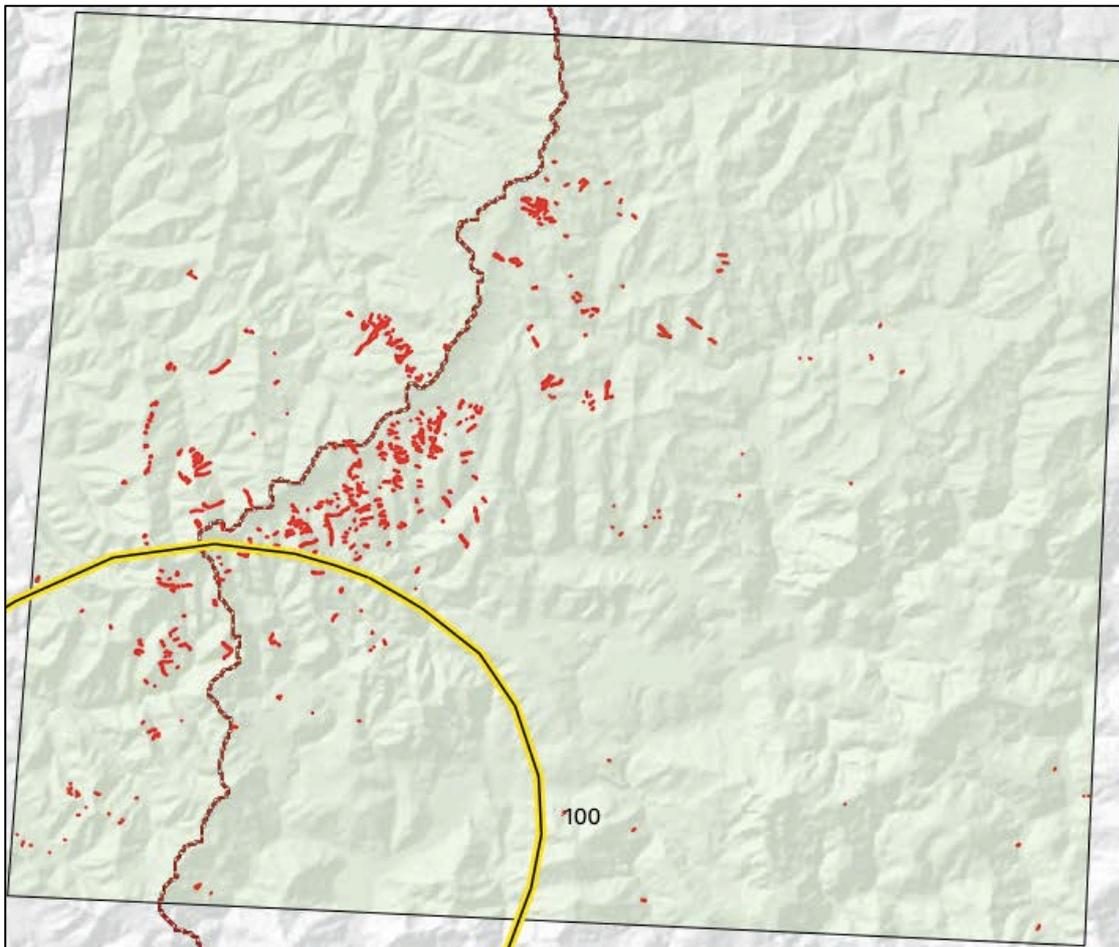
Figure Thirteen. The study area showing landslide distribution relative to the 100mm isoheyt.

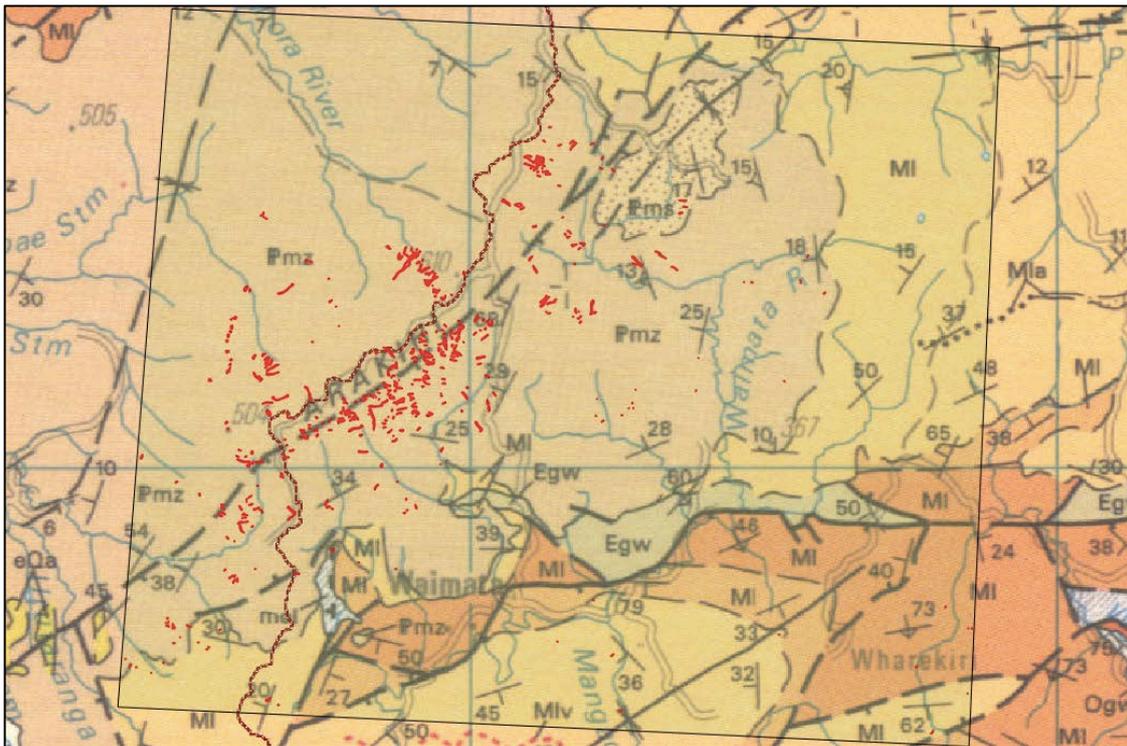
The relationship between the landslide distribution and geology is shown in **Figure Fourteen** below. This indicates that the majority of landslides were underlain by undifferentiated fossiliferous north-west dipping mudstones and sandstones of early Pliocene Age. Additionally, the majority occur along the Arakihi fault, although this is not known to be an active feature.

Figure Fourteen. Distribution of landslides and underlying geology.

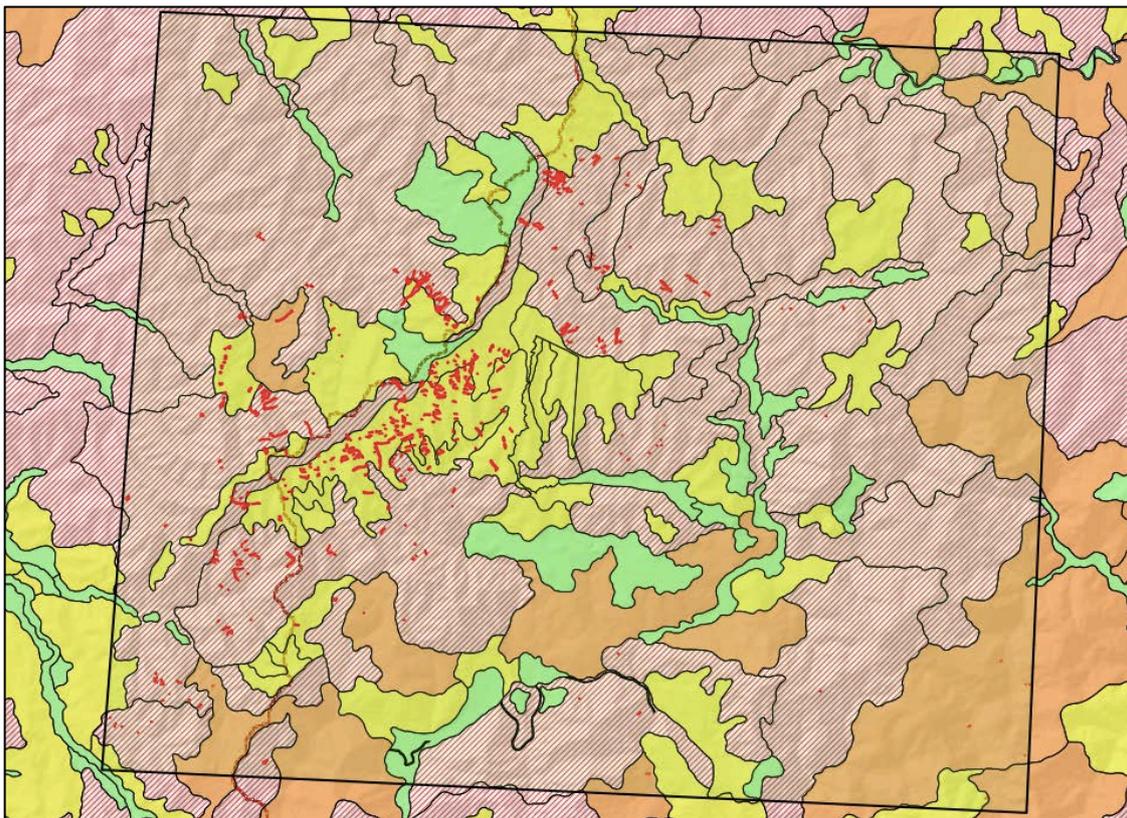
These 4 classes are shown in **Figure Fifteen** below. Not surprisingly, a large number of landslides occurred on red zone land which has a very high erosion susceptibility, but more significantly, a larger number have occurred on yellow zone land which has moderate erosion susceptibility or where streams had their heads on yellow zoned land.

Figure Fifteen. Distribution of landslides according to NES-PF red (very high erosion susceptibility), orange, yellow and green (Low erosion susceptibility) zones.

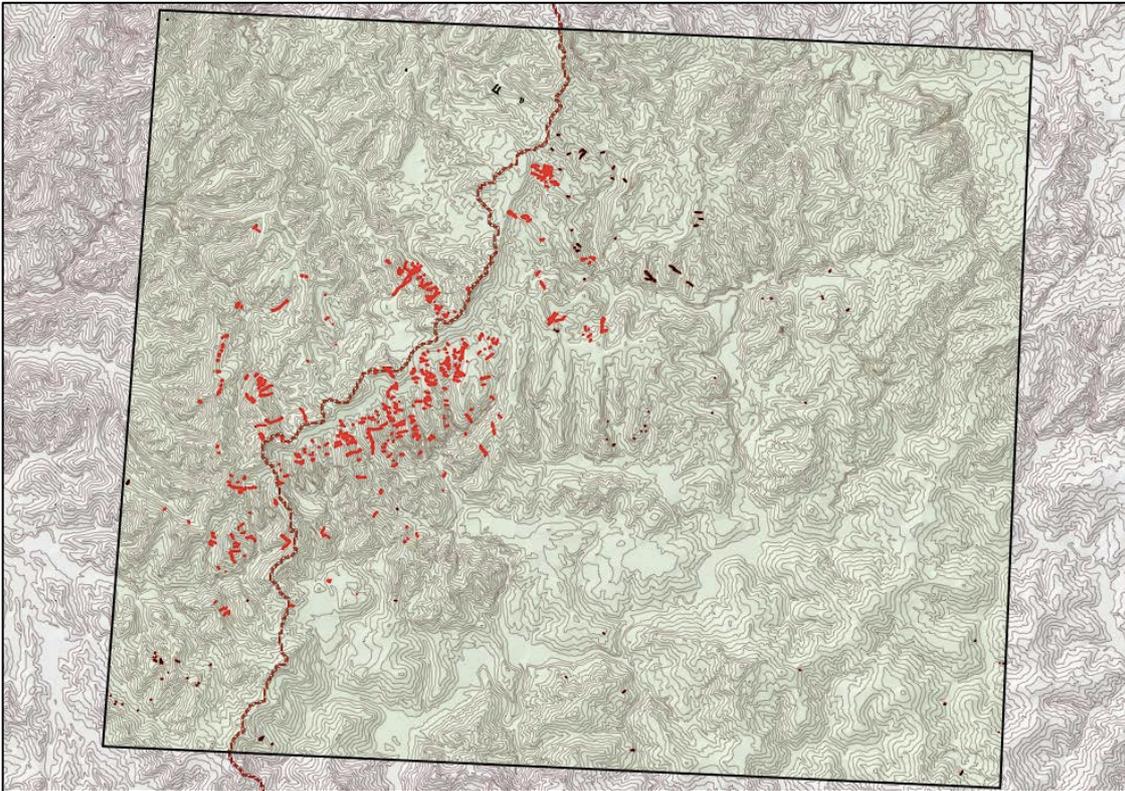
Comparing landslide distribution with topography suggests that a greater proportion of slope failures occurred on north-east to east facing slopes rather than on south or west facing slopes. For the Makiri Forest the majority of landslides originate at the boundary of the yellow and red zones and occur on north-east slopes. For the Wakaroa Forest around 75% of landslides are on north-east to east facing slopes (**Figures Sixteen and Seventeen**).

Figure Sixteen. Landslide distribution compared with topography.

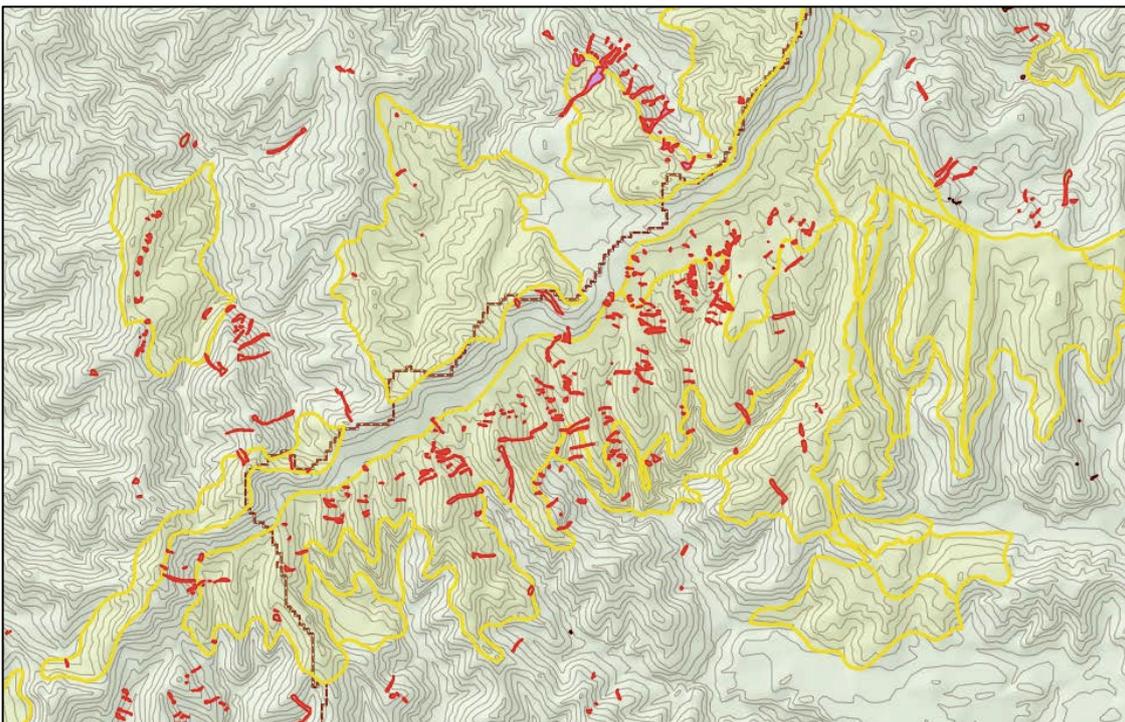
Figure Seventeen. Detail of the area of greatest Landslide density compared with topography within the yellow zone. For the Makiri Forest the majority of landslides originate at the boundary of the yellow and red zones and occur on north-east slopes. For the Wakaroa Forest around 75% of landslides are on north-east to east facing slopes.

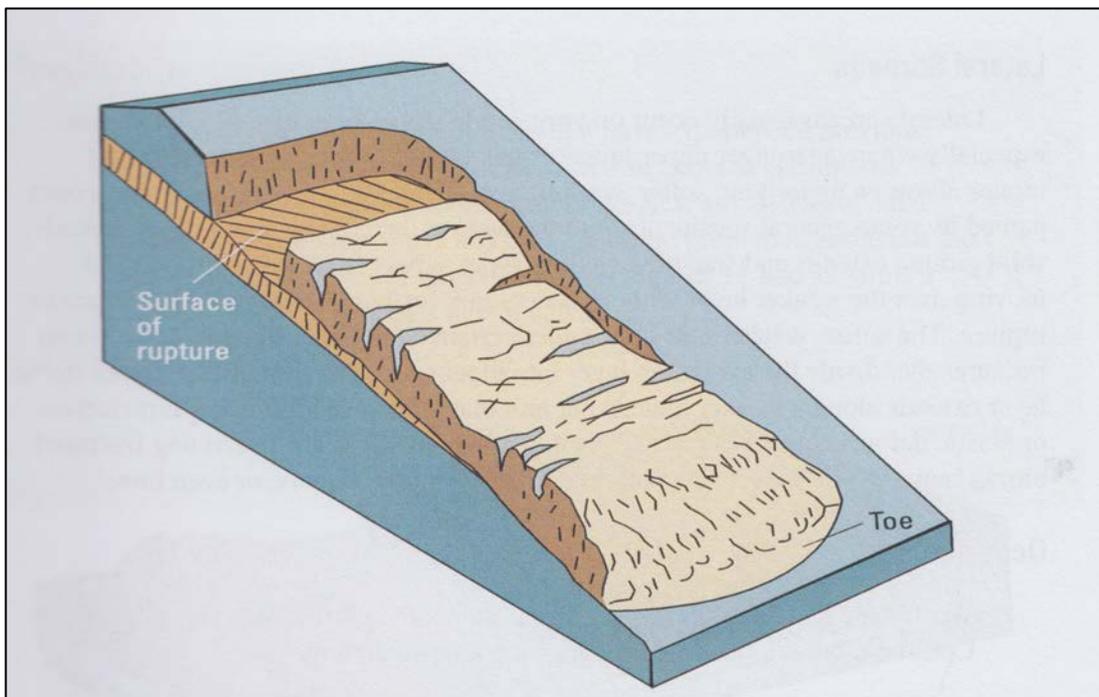
Figure Nineteen. Translational debris/earth slide. These are landslides that move along a planar surface with little or no rotational movement or backward tilting. Such landslides can move over significant distances if the rupture surface is sufficiently steep. Such landslides commonly fail along geological discontinuities such as faults, joints, bedding planes or dip surfaces, or along the contact between rock and soil.

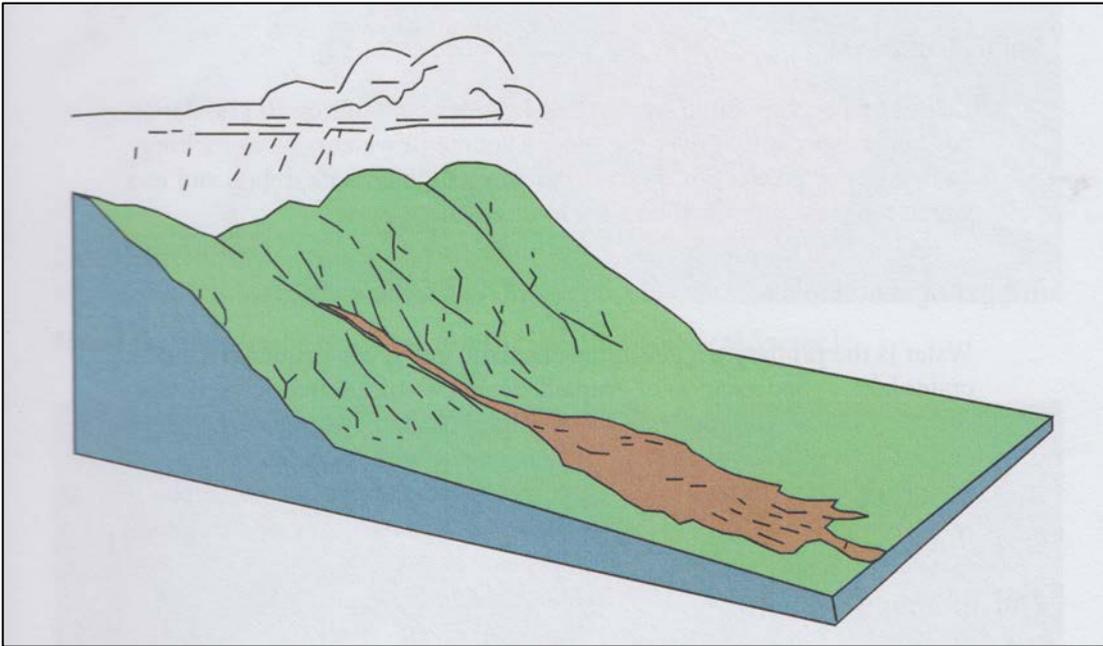
Figure Twenty. Debris Flow. These are landslides that are characterised by rapid mass movement in which loose soil, rock and sometimes organic material combine with water to form a slurry that flows downhill. Occasionally, as a translational landslide gains velocity and the internal mass loses cohesion or gains water, it may evolve into a debris flow.

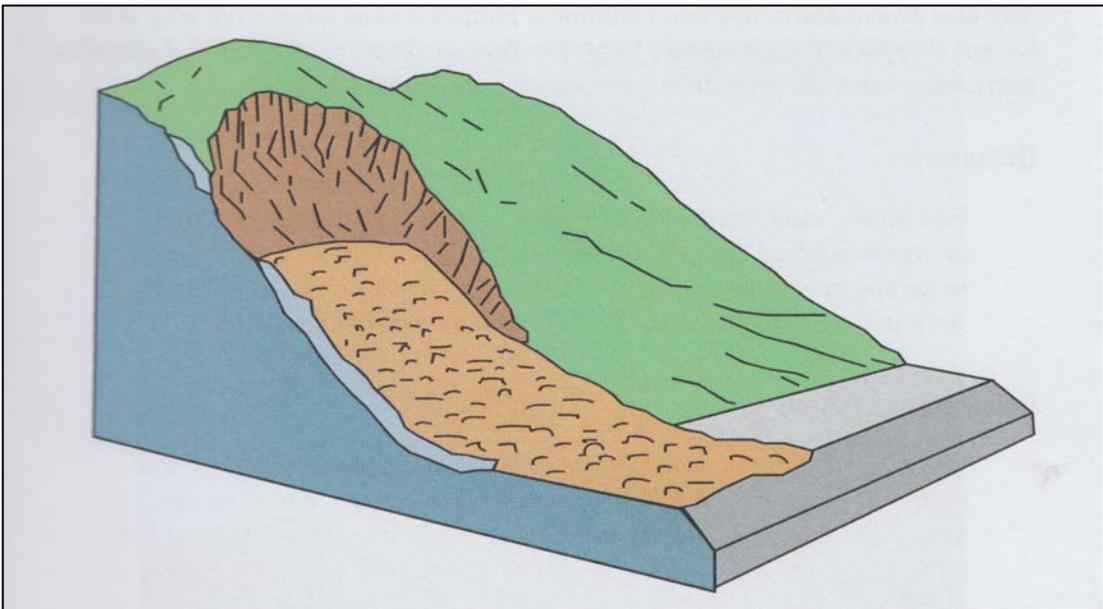
Figure Twenty One. Debris falls or avalanches. These are typically large scale landslides that move rapidly and behave similarly to debris flows but can carry large sized material.
