Hikurangi Forest Farms Wakaroa Forest, Upper Waimata 3 July 2018

Compliance visit to assess whether or not an investigation is required

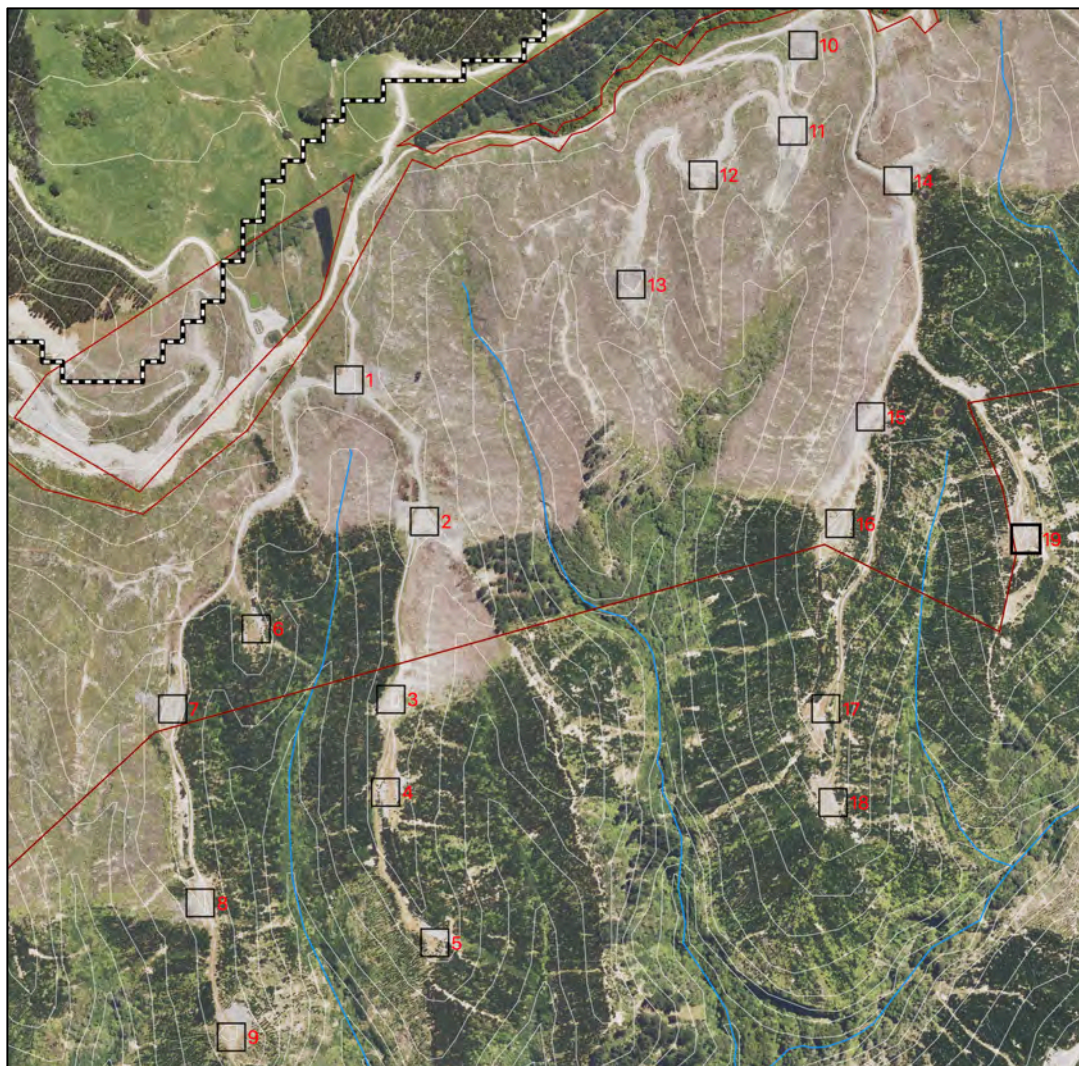
Figure One. Aerial photograph of Hikurangi Forest Farms Wakaroa Forest showing Duncan road at top left and the forestry spur roads and sites to the south.

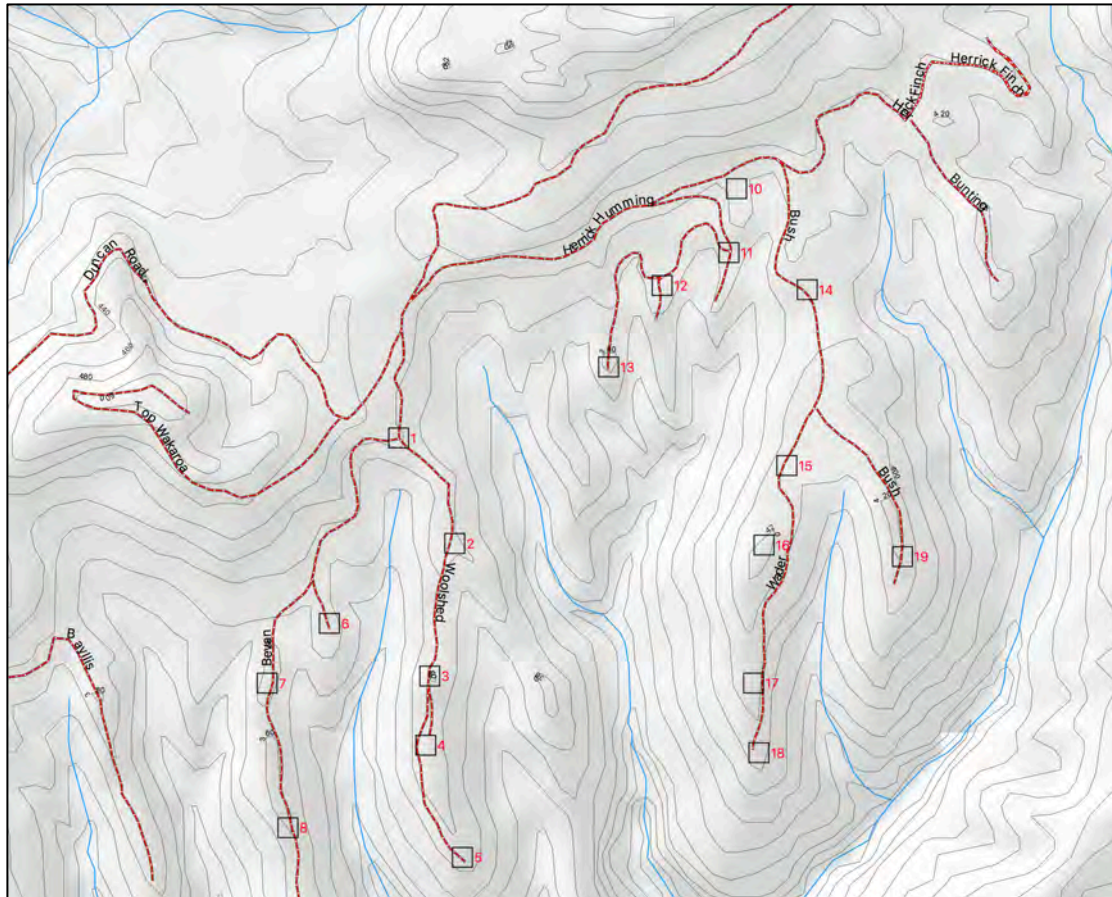
Figure Two. Road names and skid numbers assigned for sites south of Duncan Road.

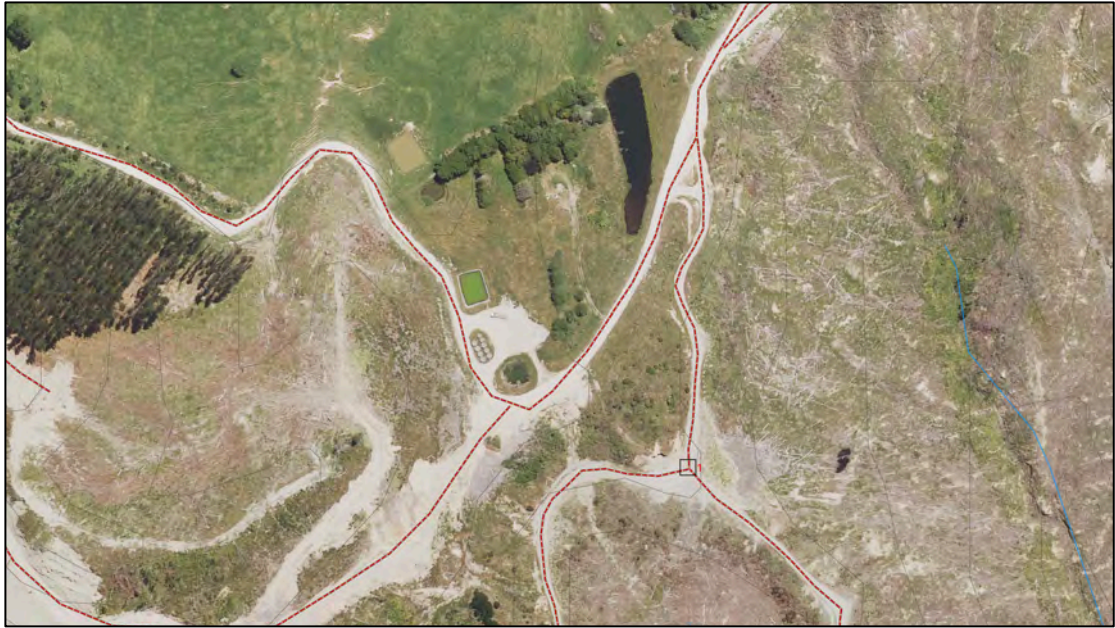
Figure Three. Location of Site One.

Site One is located around 220m south of Duncan road on the intersection of Bevan and Woolshed Roads (**Figure Three**). The site condition based on GDC's newly acquired (summer 2017-18 aerial imagery) shows that slash and woody debris has been shed into the basins to both the east and south over time. To the east of the site is a water storage pond. To the west, a slope failure from Duncan Road to Bottom Road is Figured as Figure 27 by Cave *et al* (2017) and noted as a landing failure and a road edge collapse.

Additional failures of this Duncan Road site are evident and it is clear from comparing Figure 27 (ibid) and the observations from this inspection that no effort had been made to remediate the causes of the original failure. This is despite this and other sites being discussed at a workshop held on 28 August 2017 and the full report being made available to all forestry companies in November 2017.

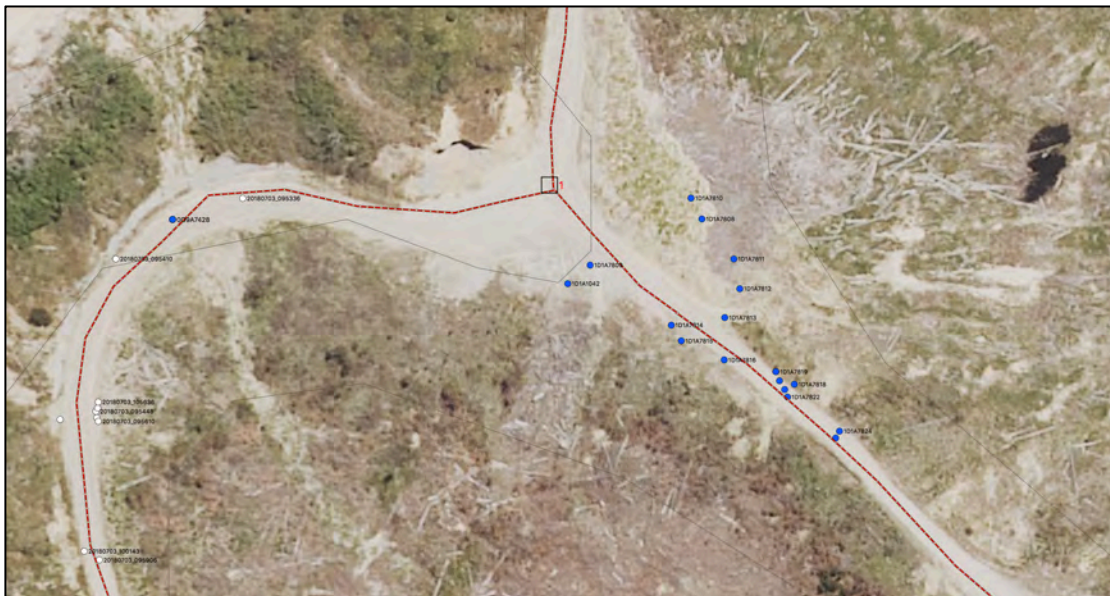
Figure Six. Aerial image of Site One showing the photo locations.

The site is relatively benign in that there are basins both east and west that could capture woody material lost from the skid site. None-the-less, despite the sites' location at the top of the Waimata Catchment, the area experienced a large number of failures that were largely triggered at roadways or skid sites. The reliance of natural basins below skid sites to stop the migration of woody debris downstream into vulnerable catchments is not a good strategy since debris flows are capable of being mobilised beyond such basins and that certainly occurred in this event. A series of photographs were taken to demonstrate the nature of the site and are located on **Figure Six**.

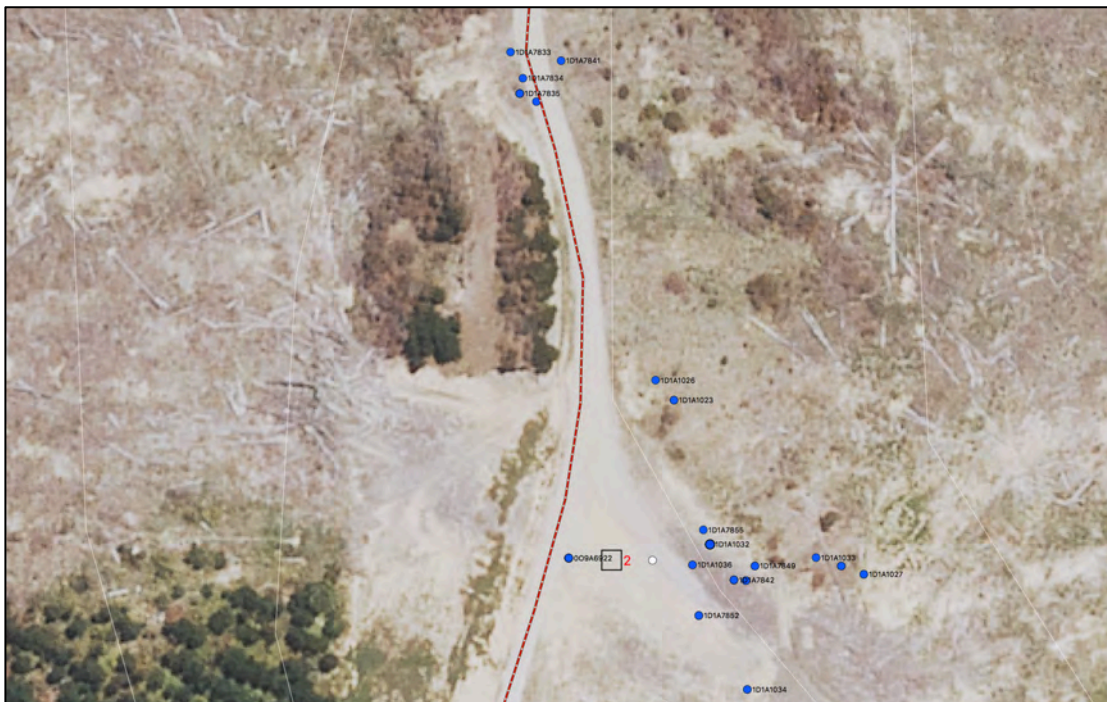
Figure Nineteen. View of Site Two showing photograph locations.

Site Two is around 500m south east of Site One and is located on a short spur leading off Woolshed Road. The site has a significant failure on the eastern side where a large pile of woody debris sits on the edge of the skid site (**Figures Nineteen & Twenty**).

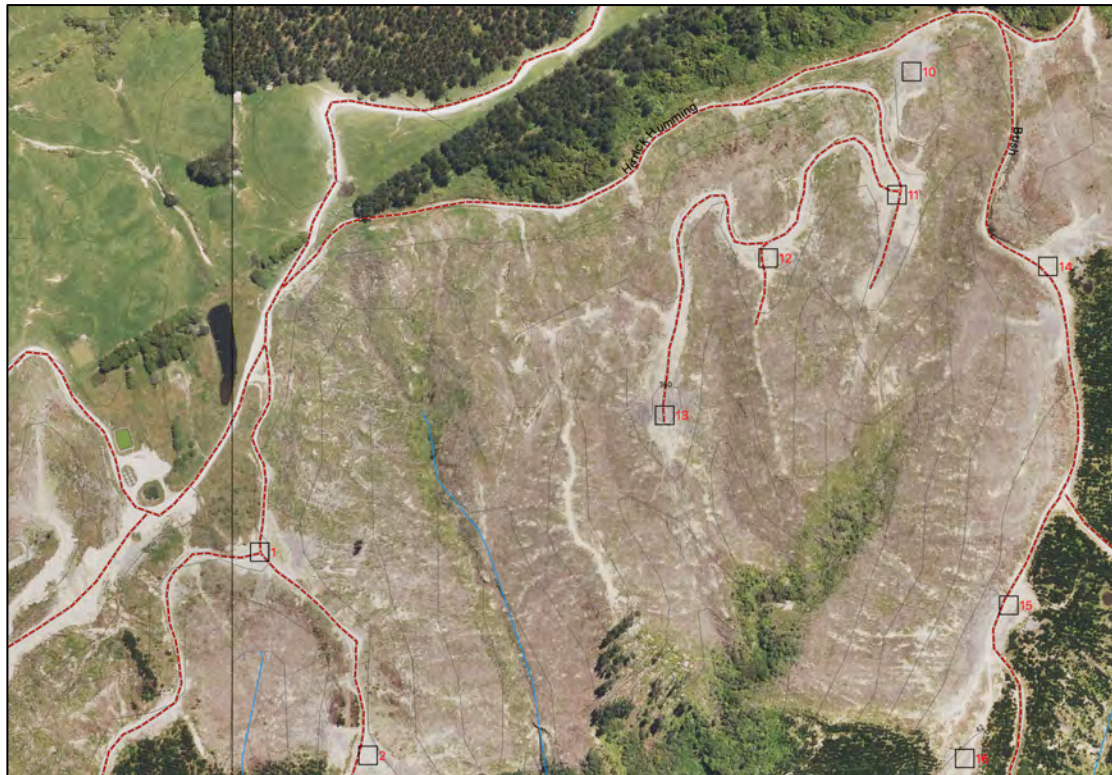
Figure Thirty Seven. Location of Site Eleven.

Site Eleven is located on a spur from Herrick Humming Road some 770m east of Site One (**Figure Thirty Seven**) and was selected as significant slope failures could be observed from those western sites from Woolshed Road (**Figure Thirty Eight**). It had been planned to start at Site Thirteen and work back to Site Twelve but while transiting to Site Thirteen it was observed that a significant failure had occurred at Site Eleven so that became the initial site to be assessed.
