# Assessment of the 20<sup>th</sup> June 2021 Weather Event

# **Assessment of the 20<sup>th</sup> June 2021 Weather Event, v.2.2**

**Dr M. P. Cave  
Principal Scientist  
Gisborne District Council  
August 2021**

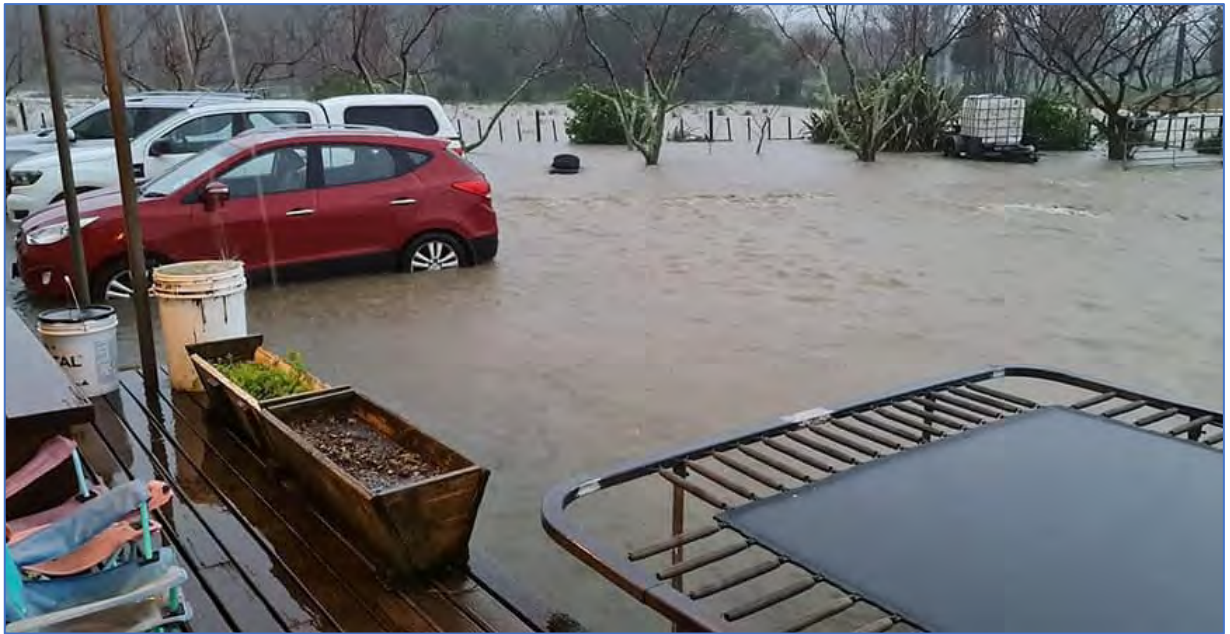
*Figure Eight. Flooding at Ruatoria. Manu Caddie facebook feed.*

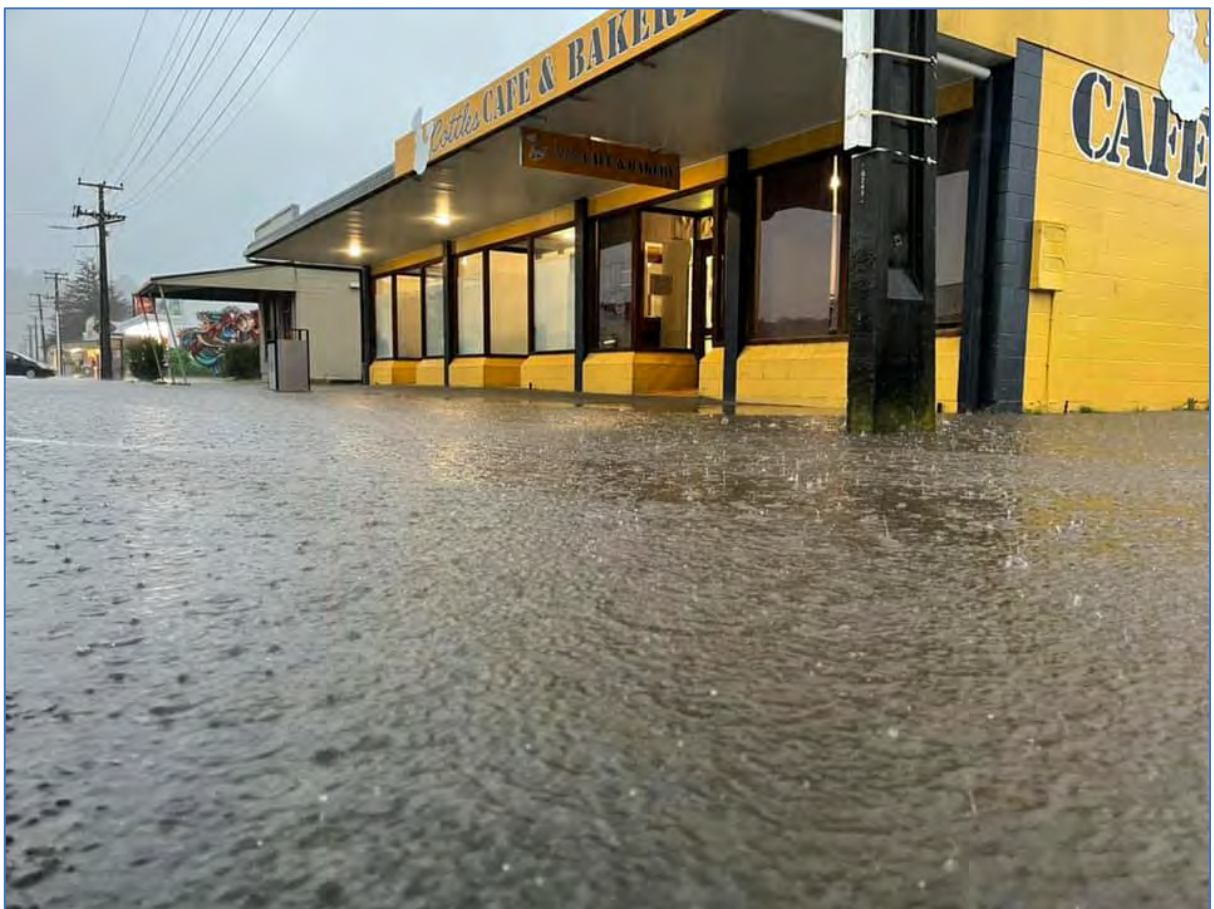
*Figure Nine. Flooding at Tolaga Bay (Uawa Live Facebook post).*

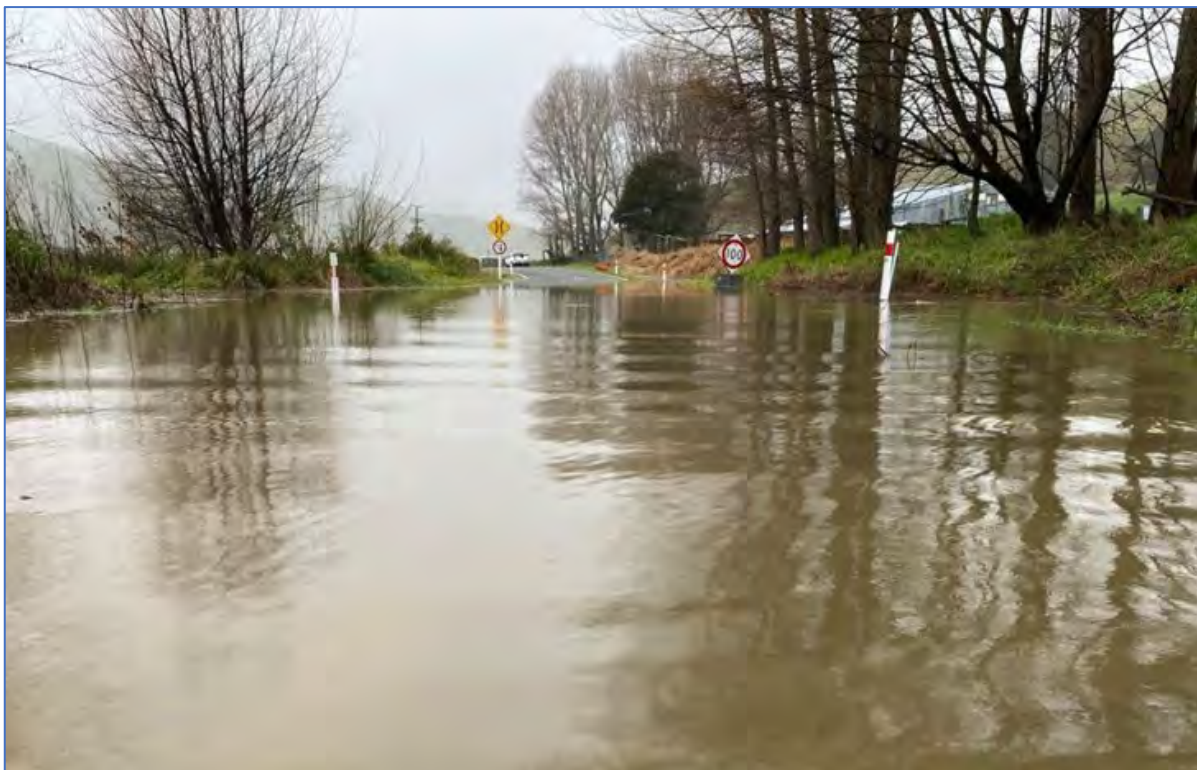
**Figure Ten.** *Flooding on the road to Anaura east of the junction with State Highway 35.*

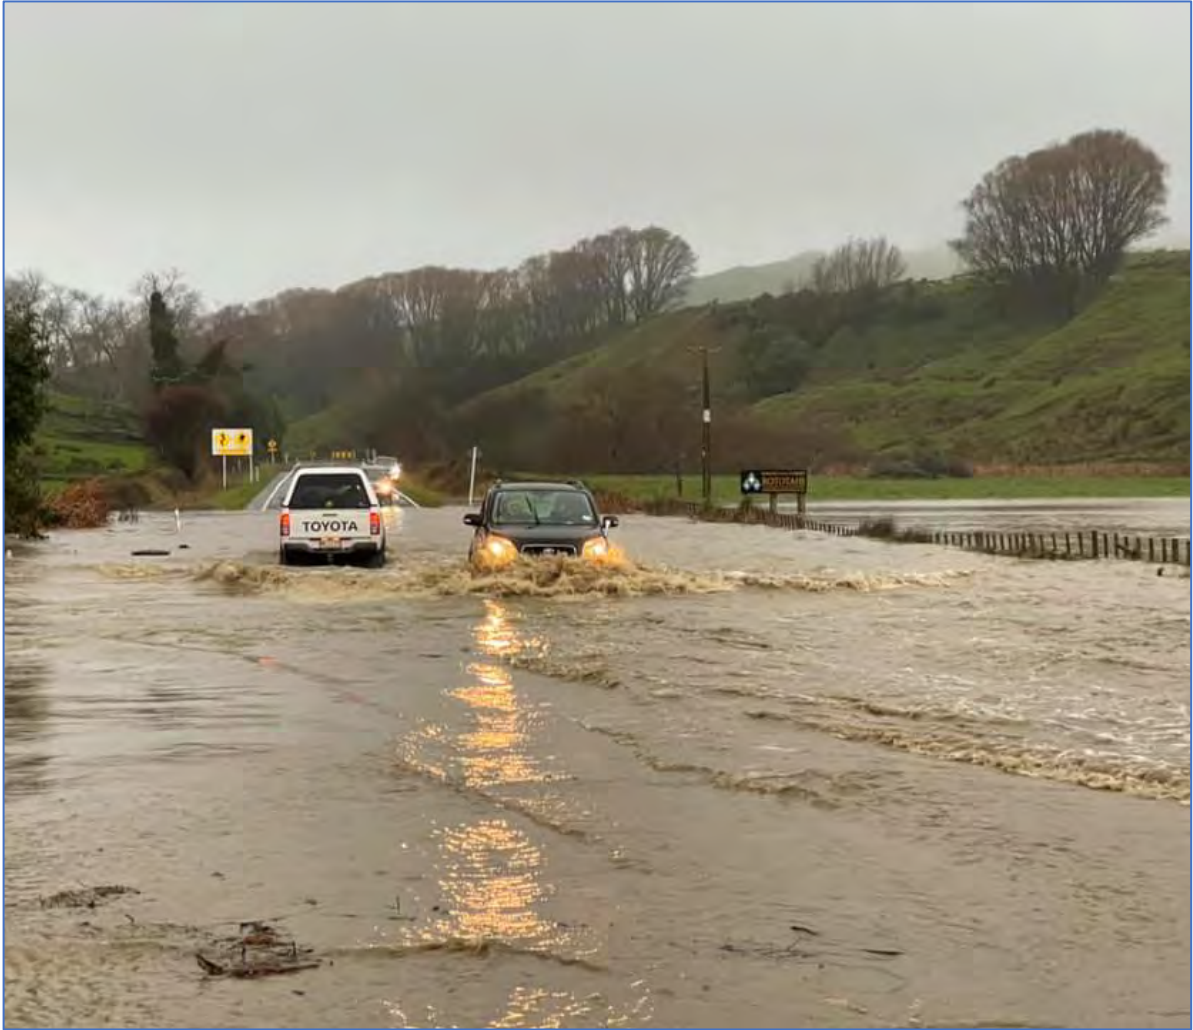
**Figure Fourteen.** Flooding on State Highway 35 south of Tolaga Bay.

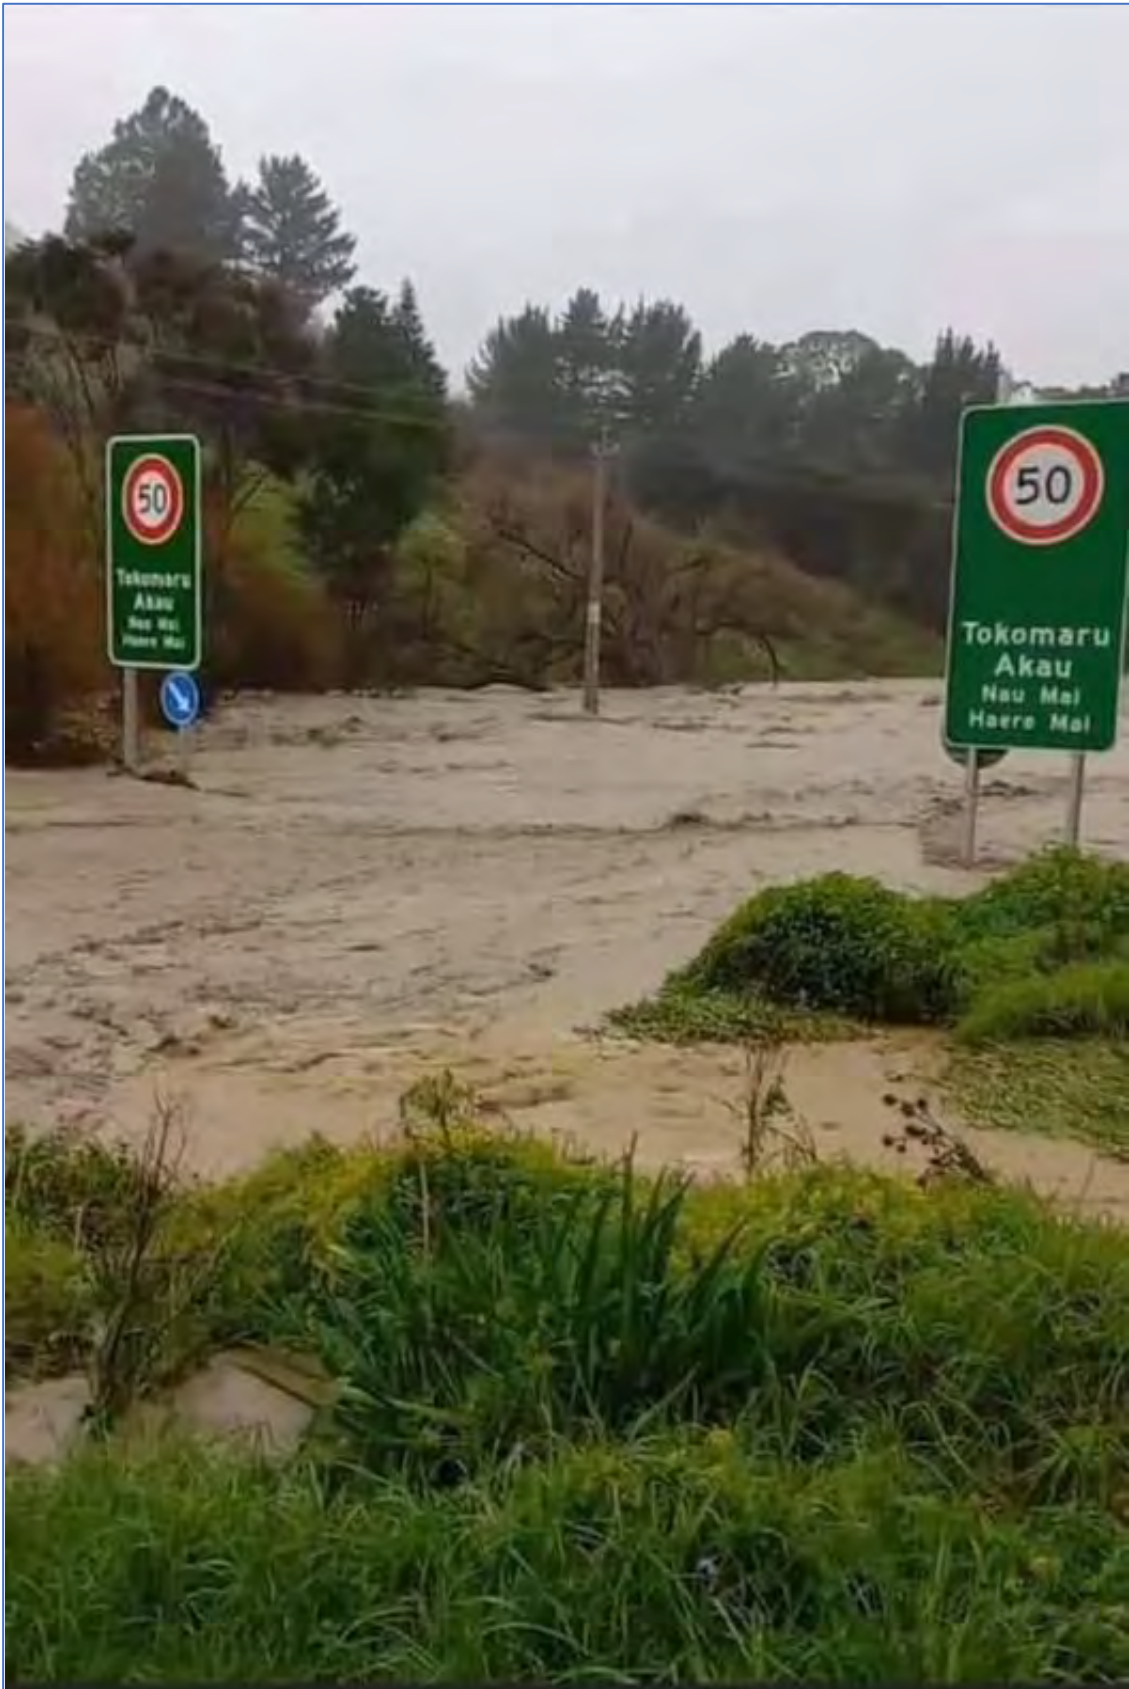
**Figure Fifteen.** Photograph hosted on the Uawa Live Facebook page credited to Kuipo Saulala and described as taken at approximately 8am showing the approach to Tokomaru Bay.

The flooding was particularly dramatic as the images and video of State Highway 35 at the southern approach to Tokomaru Bay attest (see **Figures Fifteen, Sixteen and Seventeen** above). The reports from the local residents point to flooding being evident from 7 to 7:15 AM and reaching a peak by 8:30 to 8:50 AM before rapidly receding. The combination of a very short (1.5 hour) very heavy rainfall event very closely coinciding with a flood duration points to flash flood conditions.

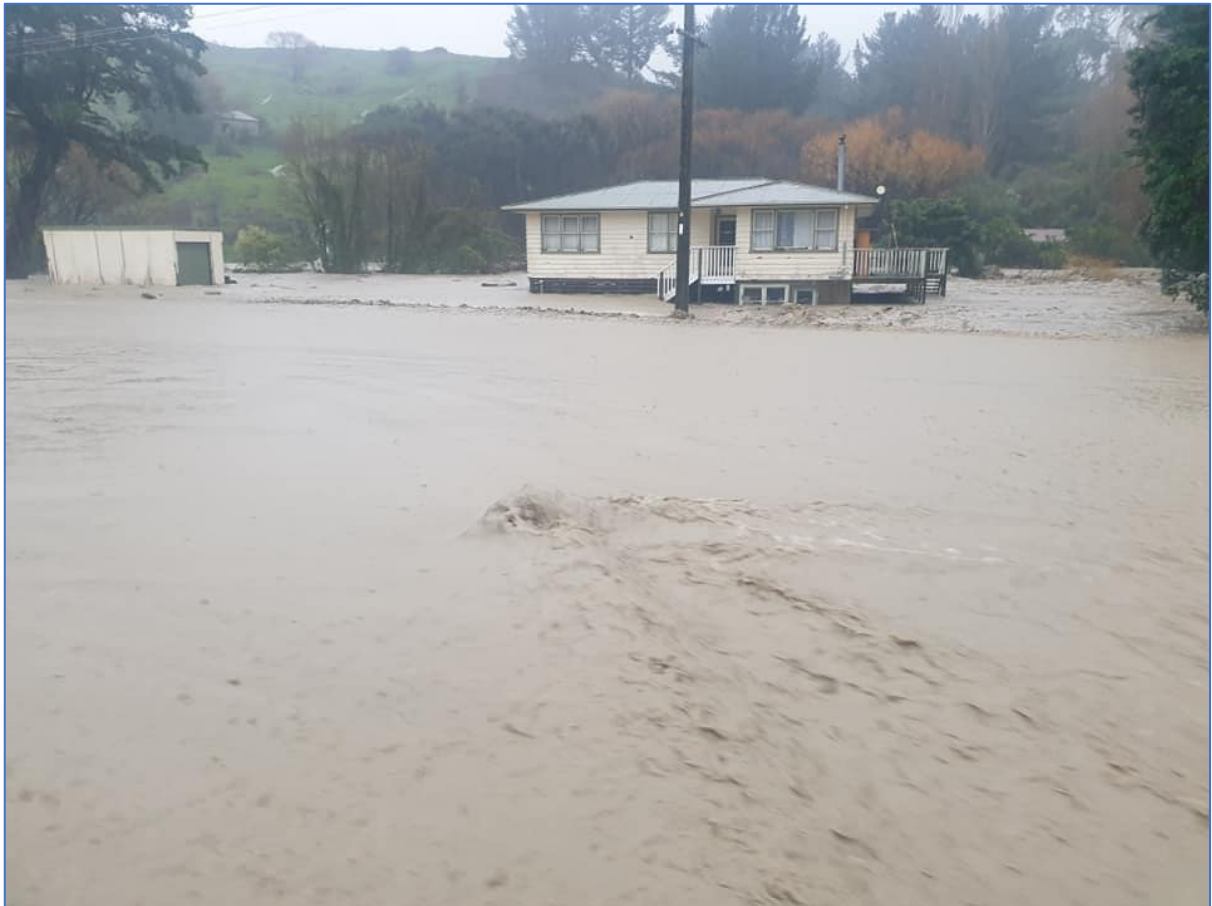
**Figure Sixteen.** Photograph posted to Facebook at 8:45 AM. Image taken from number 3552 Waiapu Road by Hoana Forrester with the image taken around 8:15 AM based on the comments.

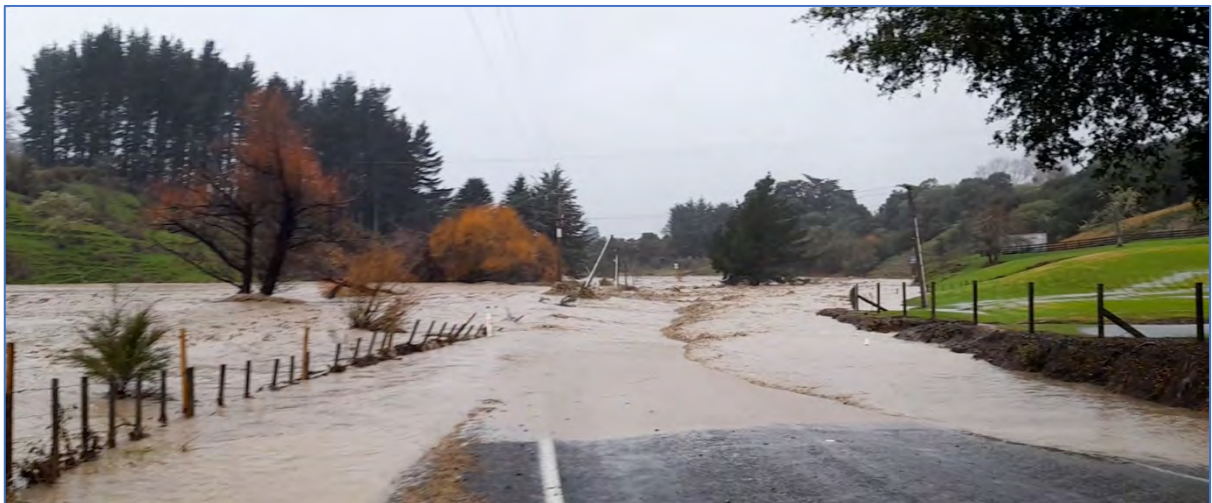
**Figure Seventeen.** Screenshot from a video posted at 8:46 AM by Tianna Rongonui showing what is estimated as close to the maximum extent of the flood.

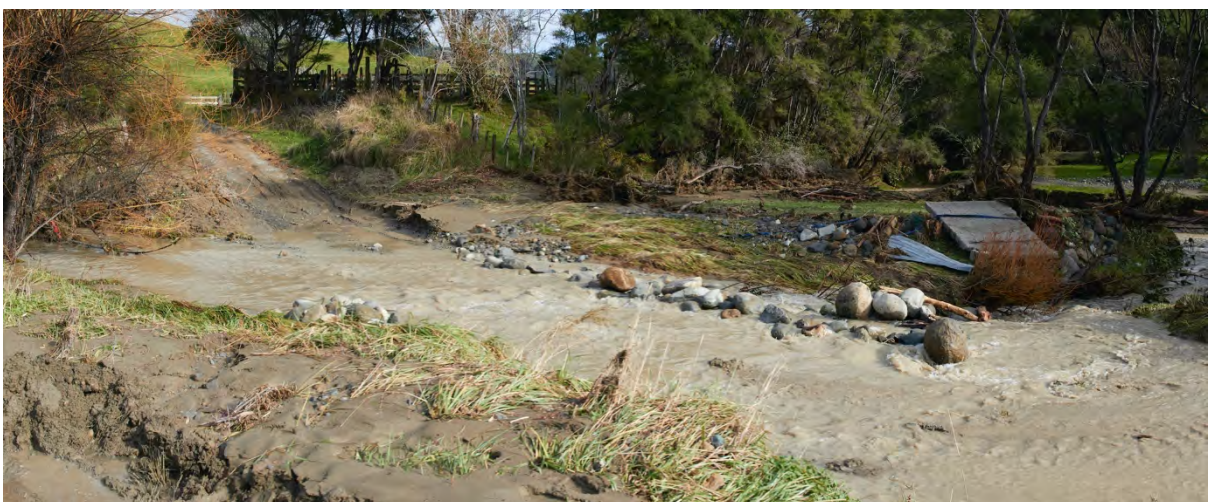
Approximately 650m up Kaiawha Road a ford provides access to the road end farmhouse but was blocked by up to 60cm of silt deposition. The silt deposition height was approximately 1m above river level and there was a considerable amount of debris scattered on the river bank downstream of the ford. The force of the flood appears to have been strong enough to move large boulders. (**Figure Thirty Six**).

**Figure Thirty Six.** Photograph of the ford 650m upstream of the bridge on State Highway 35 showing the depth of silt deposition (bottom left), the height of the flood spread based on the debris layer and the mobilised boulders on the ford path.

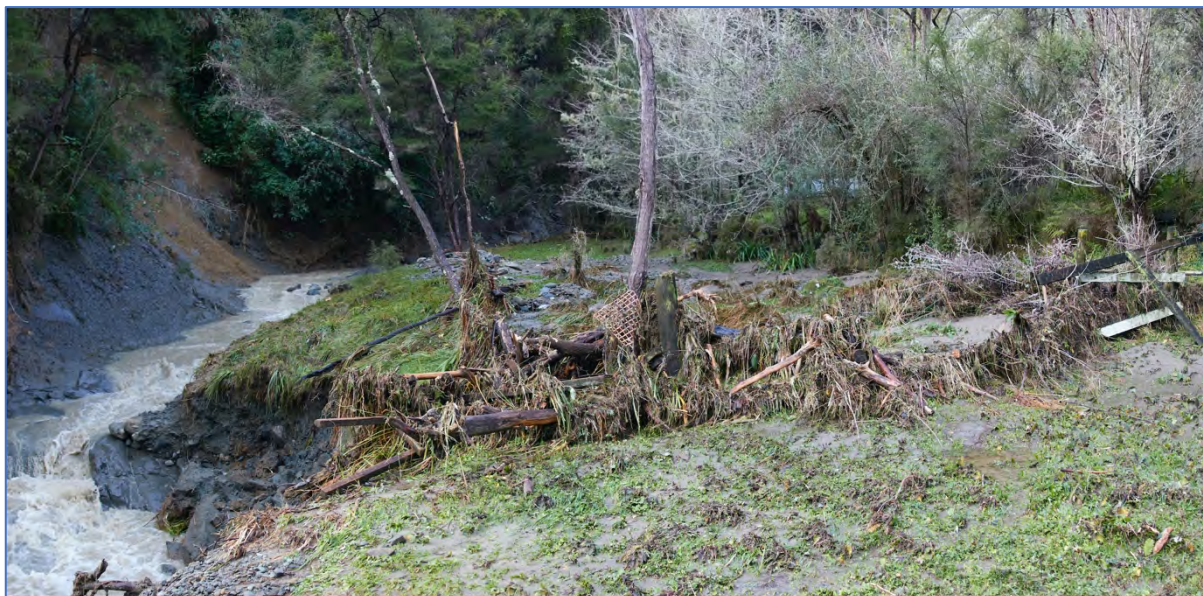
Further upstream the extent of the flooding was even more obvious with debris at approximately 2m above river level (**Figure Thirty Seven**) and the flood spread reaching all the way across the valley floor (**Figure Thirty Eight**) while in slightly raised parts of the valley the edge of the flood was marked by a debris line of small woody debris (**Figure Thirty Nine**). Further upstream there was evident of overground flow (**Figure Forty**).

**Figure Thirty Seven.** Photograph upstream of the ford on Kaiawha Road showing the extent of flooding upstream of the ford on the Kaiawha Road.

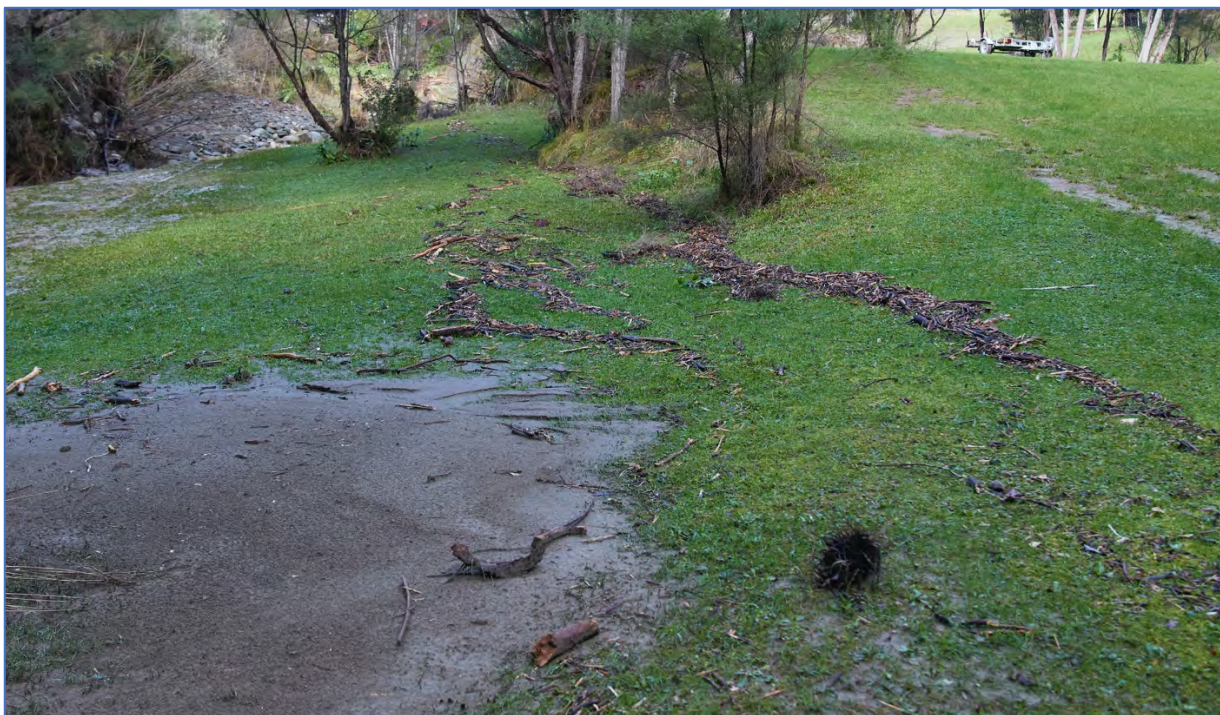
**Figure Thirty Nine.** Photograph upstream of the ford on Kaiawha Road showing the edge of the flood spread against higher ground.

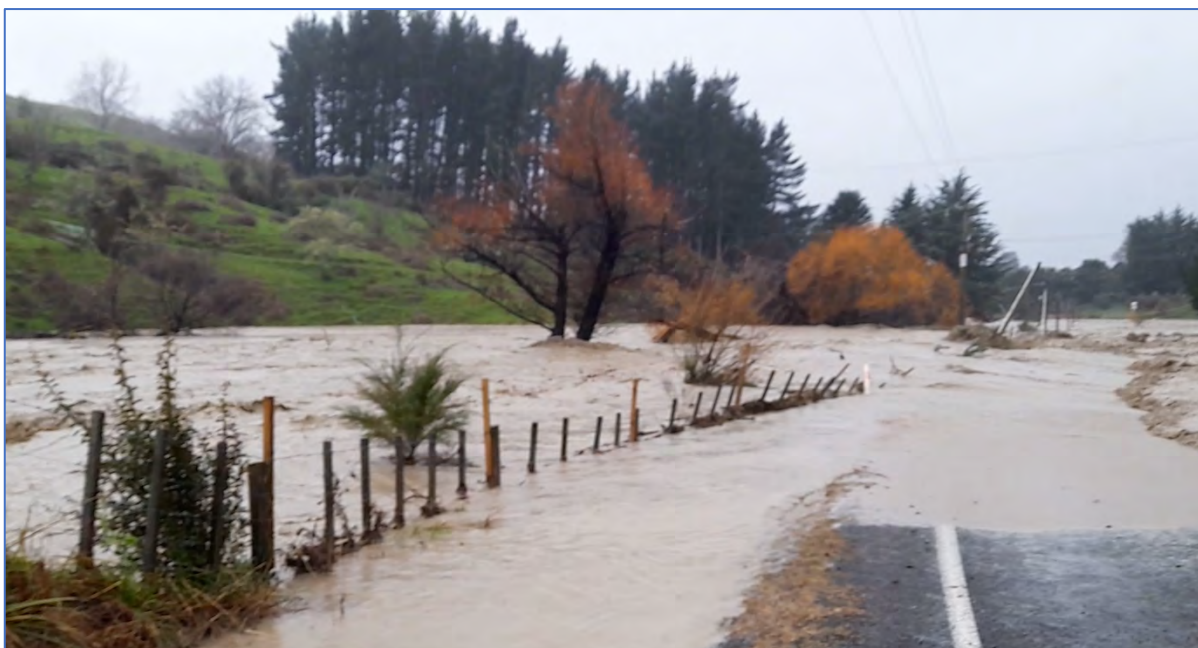
Video footage provided by Tianna Rongonui (cf. **Figure Seventeen** p.12) gave an good indication of maximum flood spread and enabled the drone mapping to be calibrated. It also help show that the willow in the middle of Waitotu Stream had a negligible effect on flood spread (**Figure Forty Two**). This is also evident from the mapped flood for this area (**Figure Forty Three**) which showed that it had a width of almost eighty metres while the river bed occupied by the willow was only eight metres wide.

**Figure Forty Two.** Video still provided by Tianna Rongonui showing the flood spread and with the large willow in the river in the background. As can be seen the flood spread was considerable wider than the normal river banks at point and had occupied the entire flood plain.

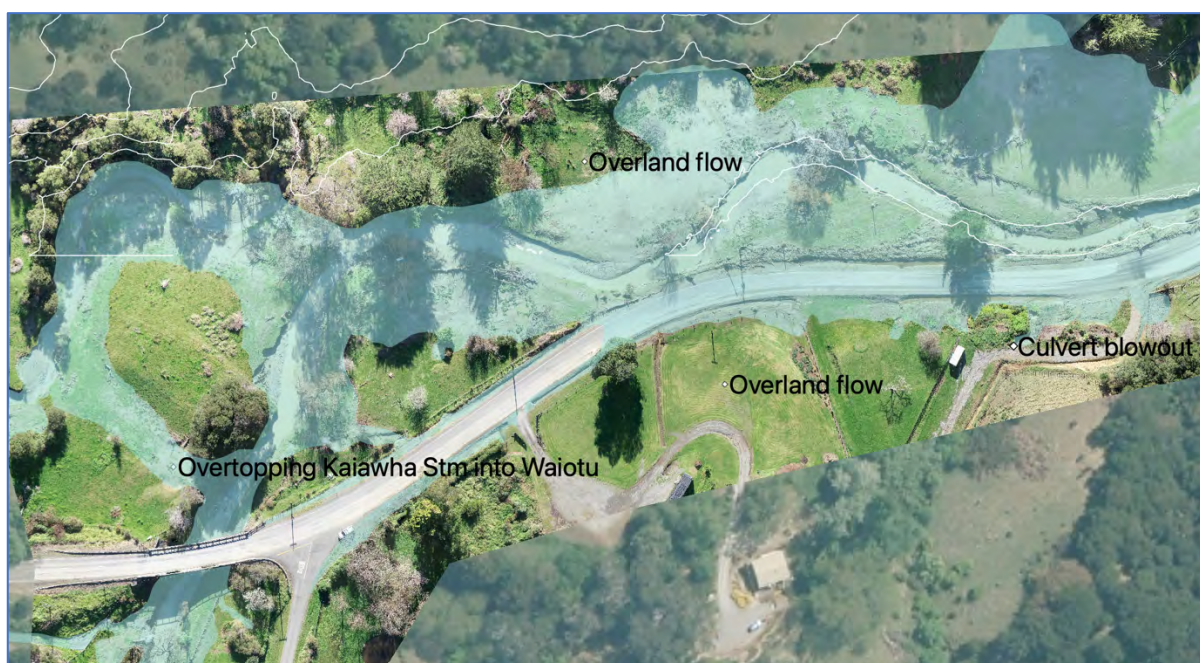
**Figure Forty Three.** Mapped flood spread in the Waitotu below Kaiawha Stream showing that the willow occupying the river channel occupied only a small part of the flood spread.

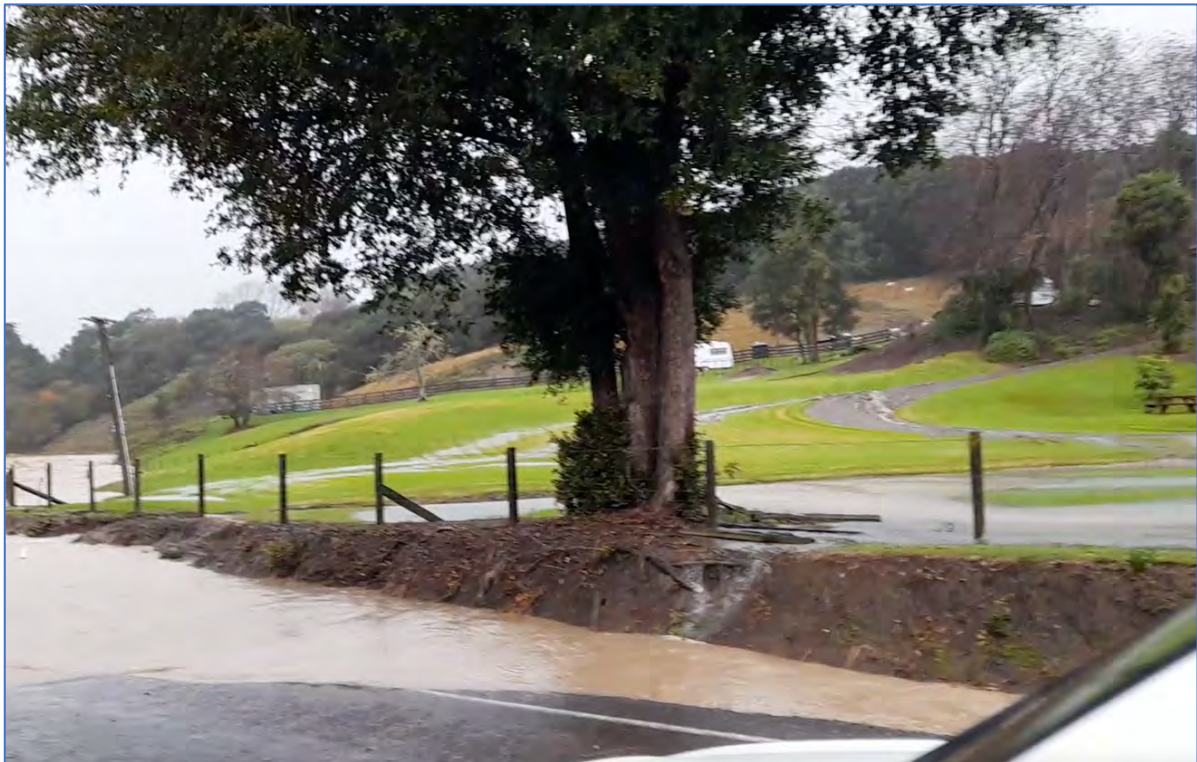
**Figure Forty Four** below which is also a still from Tianna Rongonui’s video shows the extent of the flood spread on the true right and the contribution of overland flow from adjacent properties.

***Figure Forty Four.** Still from the video provided by Tianna Rongonui showing the flood spread on the state highway approach to Tokomaru Bay with the flood spread contribution from adjacent properties.*

The role that overland flow had in this storm is evident in **Figure Forty Four** and **Forty Five** and it is considered that this overland flow was a significant exacerbating factor particularly in the vicinity of the School (**Figure Forty Six**), at Café 35 (**Figure Forty Seven**) and the Playgrounds (**Figure Forty Eight**). The force of the flood waters within the Kaiawha/Waiotu catchments is graphically illustrated in **Figure Forty Nine** which shows the scoured out true left abutment of the footbridge at the mouth of Waiotu Stream.

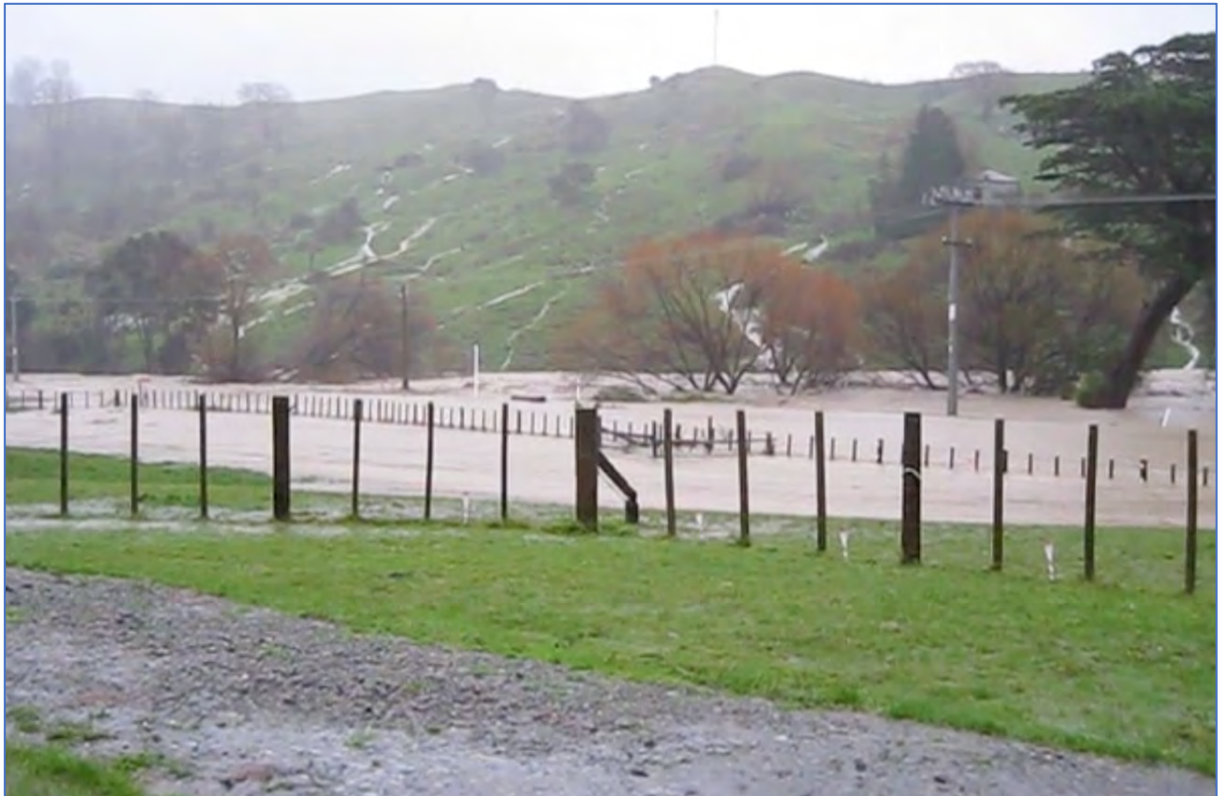
The video footage from 3552 Waiapu Road State Highway 35 (**Figure Forty Five**) is also helpful as it graphically demonstrates the significant degree of overland flow during the storm. This calibration is useful because post-event on the ground mapping and the drone footage cannot readily differentiate between flood spread and overland flow.

**Figure Forty Five.** Video screenshot from No. 3552 Waiapu Road State Highway 35 showing the flood extent over the paddock and the considerable volume of overland flow on the hillside opposite.

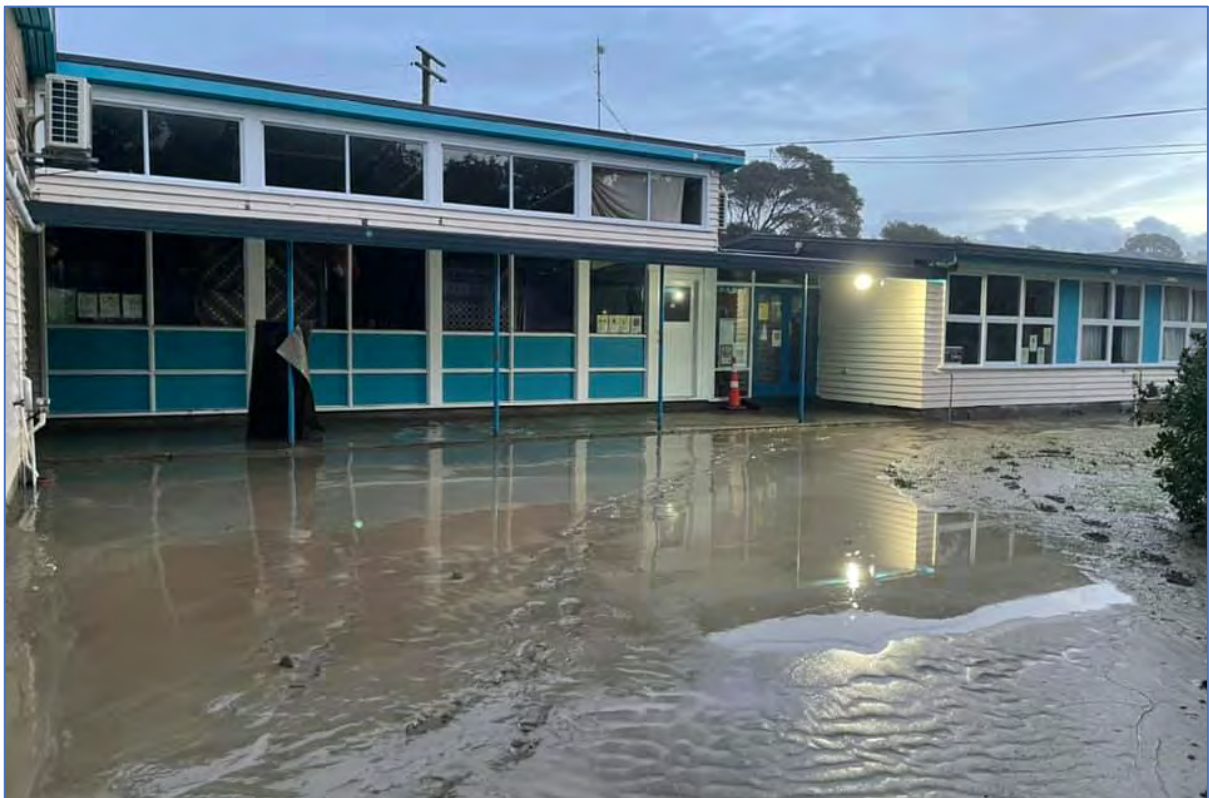
**Figure Forty Six.** Flooding and silt deposition at Hatea-A-Rangi School, Tokomaru Bay.

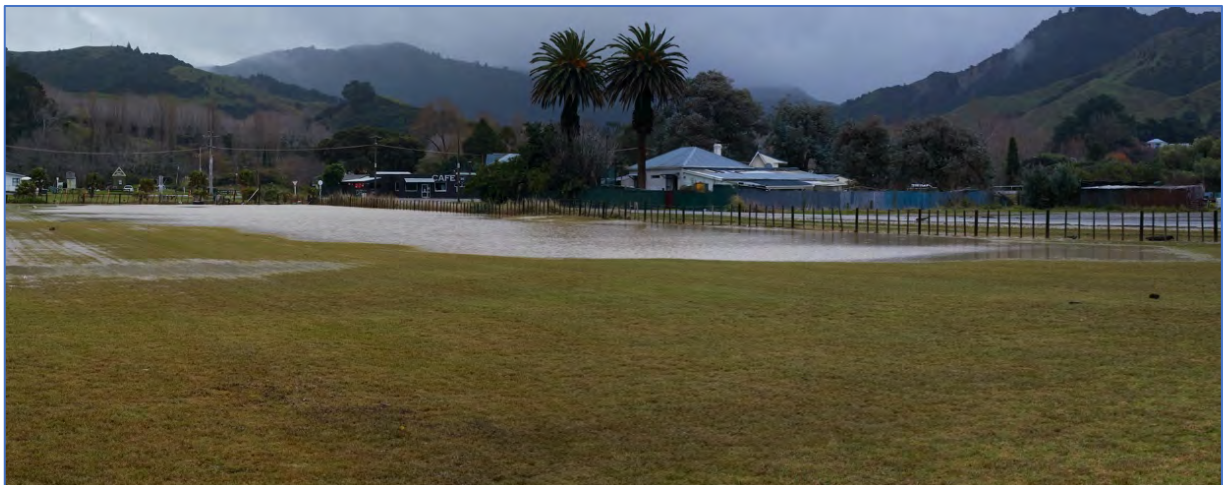
**Figure Forty Eight.** Flood water ponded at the north end of the Hatea-a-rangi Memorial Park.

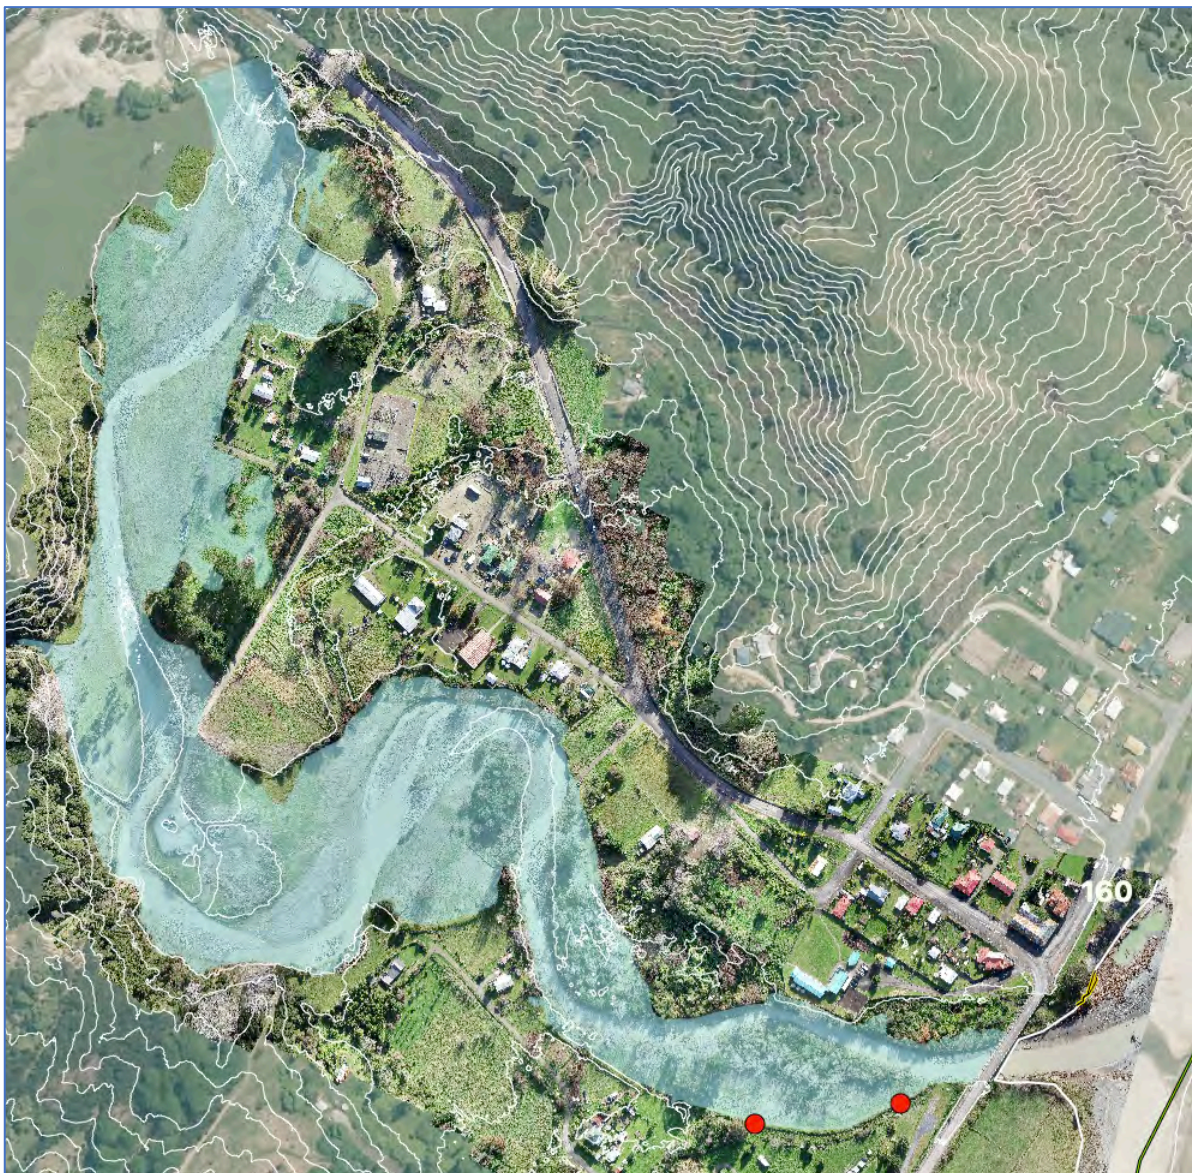
affected by storm surge during the event. As **Figure Fifty Five** indicates the Mangahauini River was largely confined to its bed during the flood. There was flood spread into a low lying area on the true left immediately downstream of where the “Marotiri” tributary joined the Mangahauini, on the true left above the transfer station and across the transfer station itself. Some further inundation on the true left bank occurred east of Toa Street but otherwise no break out occurred.

**Figure Fifty Five.** View of the river generated flood spread for the Mangahauini River from upstream of the “Marotiri” tributary to the bridge over the Mangahauini at the river mouth. The two sites where overtopping occurred are shown as red dots. The mouth itself below the bridge has been excluded from the flood spread as it is assessed that this area was dominated by storm surge during the storm. The location of the rain gauge is shown bottom right.

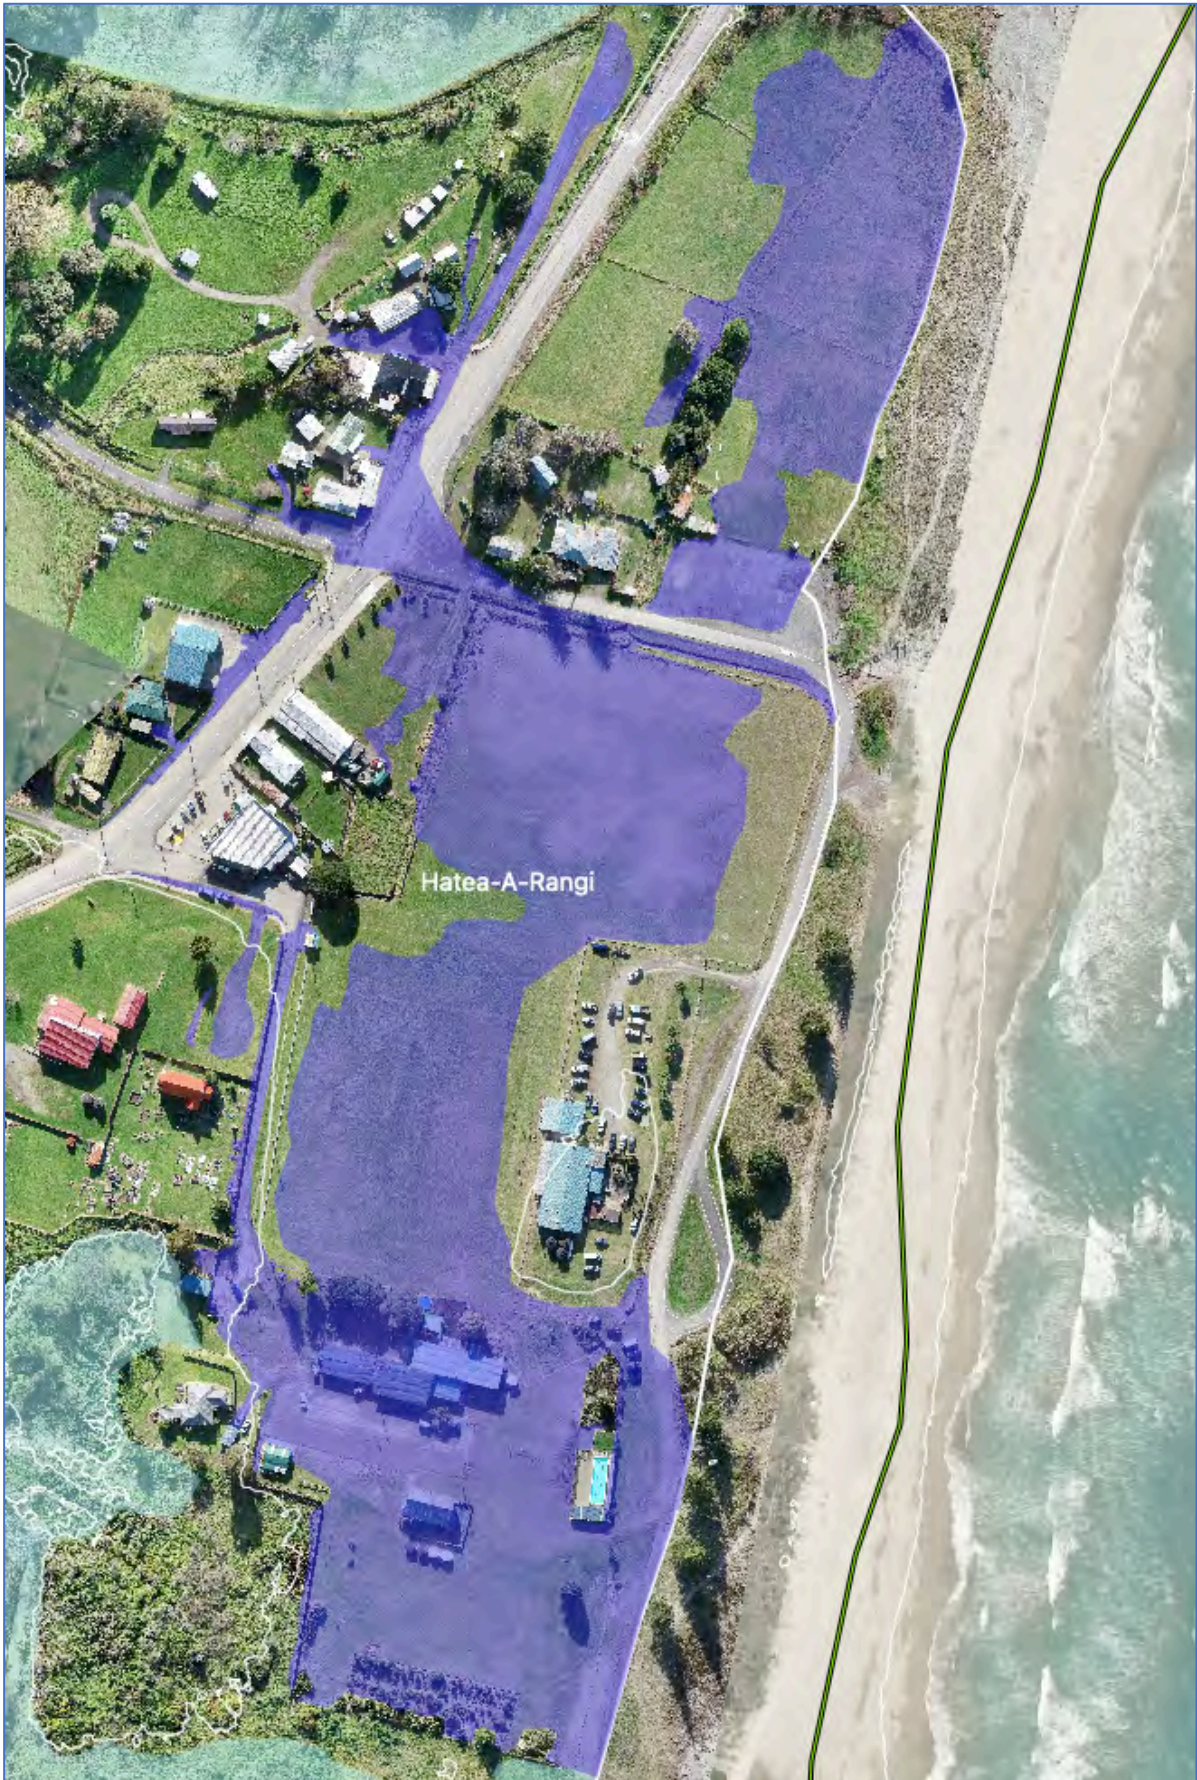
**Figure Sixty.** Hatea-A-Rangi indicative main ponding area, Tokomaru Bay. The area east of the white line was subject to storm surge.

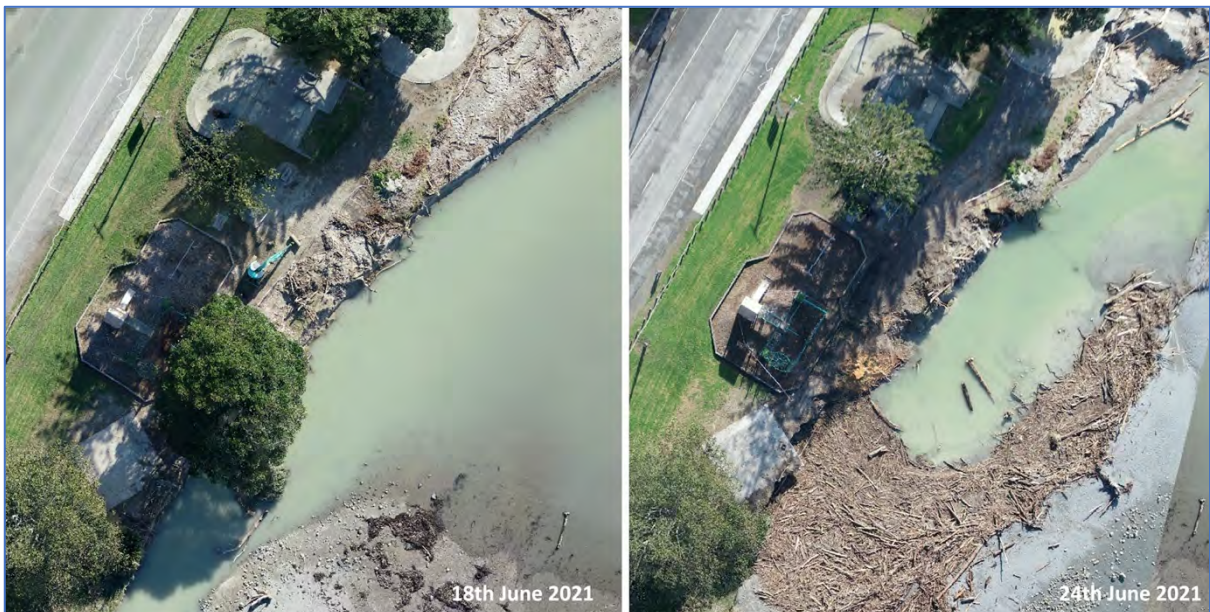
The most obvious damage occurred at the reserve at the mouth of the Mangahauini River which had previously been damaged by storm surge and assessed as being highly vulnerable (Cave 2019a, 2019b). This area also experienced significant erosion as a result of storm surge in May 2021 but the 20<sup>th</sup> of June storm surge was more significant with the surge extending 25m in from the bank edge pre-event. Coincidentally, the area was drone mapped on the 18<sup>th</sup> of June 2021 to assess the damage from the May

**Figure Sixty Nine.** Comparison between the Tokomaru Reserve and playground drone orthomapping dated 18<sup>th</sup> June and 24<sup>th</sup> of June 2021. Note the removed tree, the overhanging concrete pad bottom left and the erosion at the turn around bay.

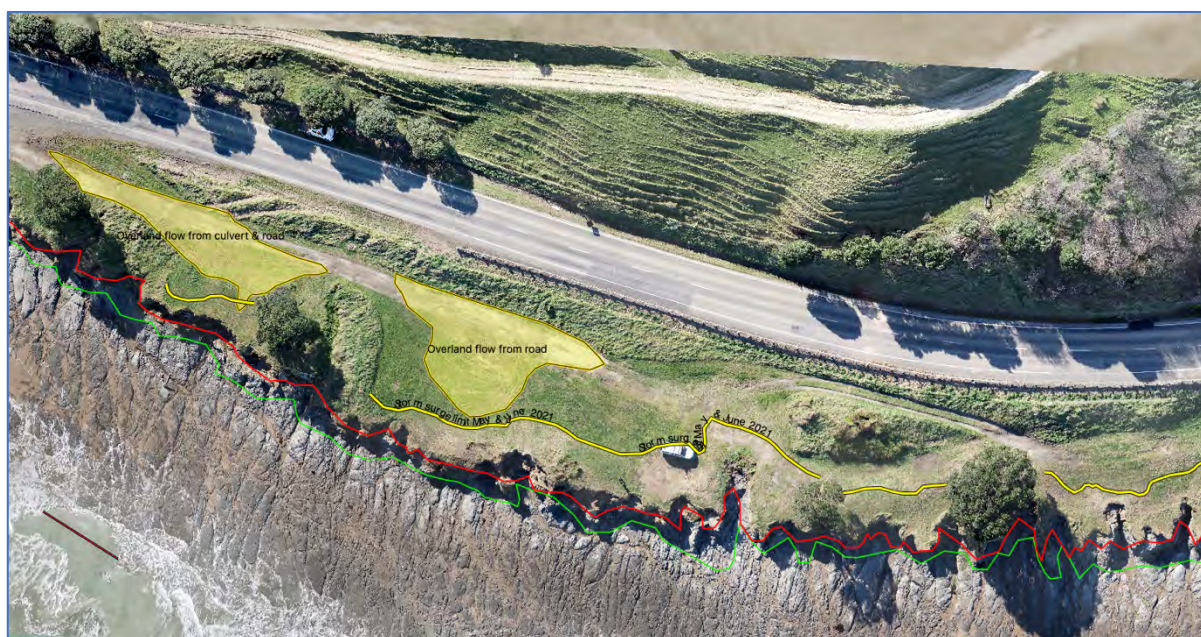
Monitoring for erosion of the freedom camping zone<sup>12</sup> between Pouawa and Turihaua was initiated in September 2020 and an initial report prepared in November 2020 (Cave 2020). A drone flight was undertaken in August 2021 and the limits for the May and June storm surge mapped on the ground is shown below on the drone orthomap in **Figure Seventy**. Evidence of storm surge was indicated by salt burnt grass, flattened vegetation and rocks and woody debris thrown up onto the top of the beach terrace (**Figure Seventy One**). Some erosion of top soil and grass on top of the wave cut platform was observed for both the May and June storm surges.

**Figure Seventy.** Drone map of Turihaua Point showing the top of the bank from the 2018 aerial imagery (red), the June 2016 bank (green), the areas affected by overland flow and inundation in June 2021 (yellow area) and the storm surge limits for May and June 2021 (yellow line).
