# Assessment of the 20<sup>th</sup> June 2021 Weather Event

# **Assessment of the 20<sup>th</sup> June 2021 Weather Event, v.2.2**

**Dr M. P. Cave  
Principal Scientist  
Gisborne District Council  
August 2021**

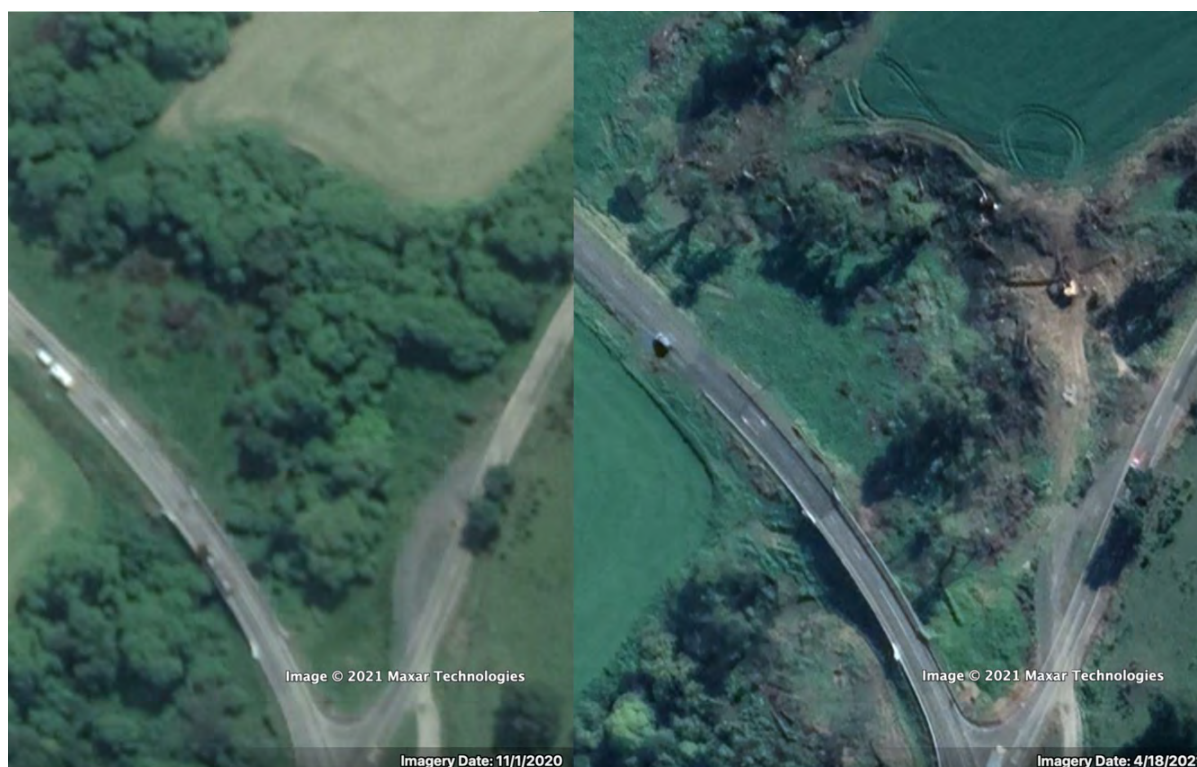
At the State Highway 35 bridge over Mahanga Stream at Kopuatarakihi Road, however, significant volumes of willow wood was observed being eroded from piles of cut willow that was being stored on the banks of Mahanga Stream (*c.f* **Figure Eleven** page 8). A ten minute observation period was used to assess the quantity of material mobilising and several videos and photographs taken. It was not possible to do individual log counts as the material being mobilised were clumps which because the willow had not been de-limbed, incorporated multiple trees. From Mahanga Stream the woody debris was observed catching up on trees downstream but then being released and discharging into the Hikuwai River. Later on the 20<sup>th</sup> June 2021, willow woody debris was observed in the Hikuwai river at the Paroa Road bridge and then at the State Highway 35 bridge across the Uawa at Tolaga bay. Based on the assessment on the day, Mahanga stream location is the only likely source of the new willow on the Uawa beaches.

**Figure Seventy Five.** Screenshots of satellite imagery dated 1<sup>st</sup> November 2020 (left) and 18<sup>th</sup> April 2021 for the Mahanga Stream (right) where it crosses State Highway 35 showing the active clearance of willow during April 2021.

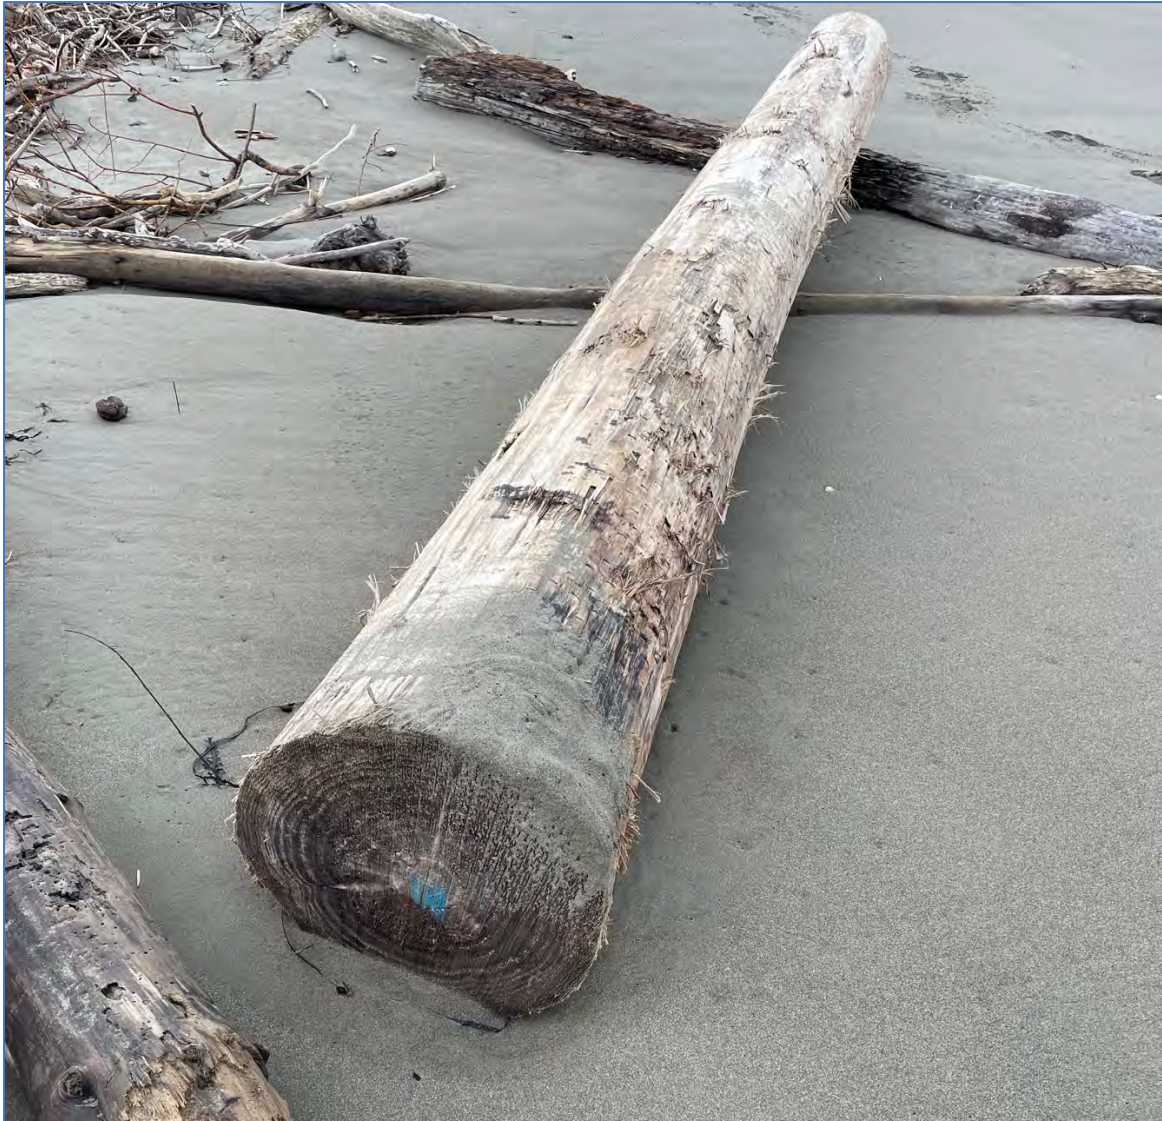
On the day of the event a fresh cut pine log was found on the beach. The log had blue identifier paint on one end, obvious waratah marks and clean cut ends (**Figure Seventy Six**). Such fresh identifiable logs are not typically found on the beaches but several were identified on the beach in 2017 following Cyclone Cook.

Logs are more typically what are known as long-resident logs. That is, logs that have spent some time in the catchment and as a result of transport have abraded ends. A log this fresh indicates that had been graded and stored on a landing or skid site in preparation for transport to the port or a log yard. It could have come from any operator currently or very recently harvesting within the Uawa catchment. As it has not been treated it cannot have been lost off a ship. I am unaware of any self-reported skid failures within the catchment.

*Figure Seventy Six. A fresh pine log on north Tolaga Bay Beach 20<sup>th</sup> June 2021.*
