# Downstream Impacts of sediment and woody debris Inundation in the Mangaheia sub-catchment Uawa Catchment during the Queens Birthday Storm 2018

Dr Murry Cave  
Principal Scientist  
Gisborne District Council  
v.3.2 October 2022

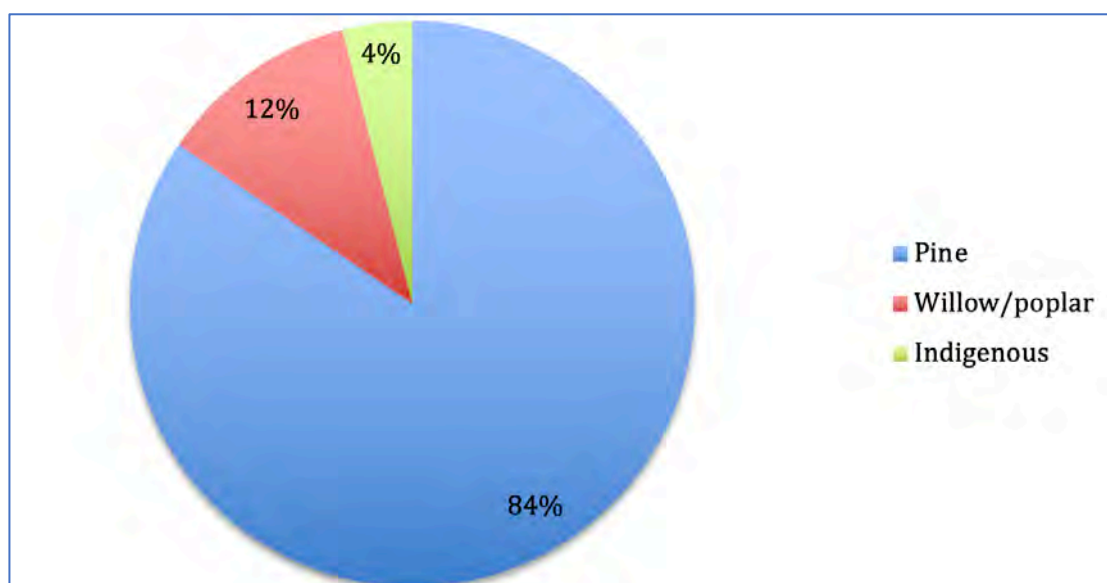
**Figure Three.** Aggregate woody debris composition 2018 Queens Birthday storm, Uawa catchment.

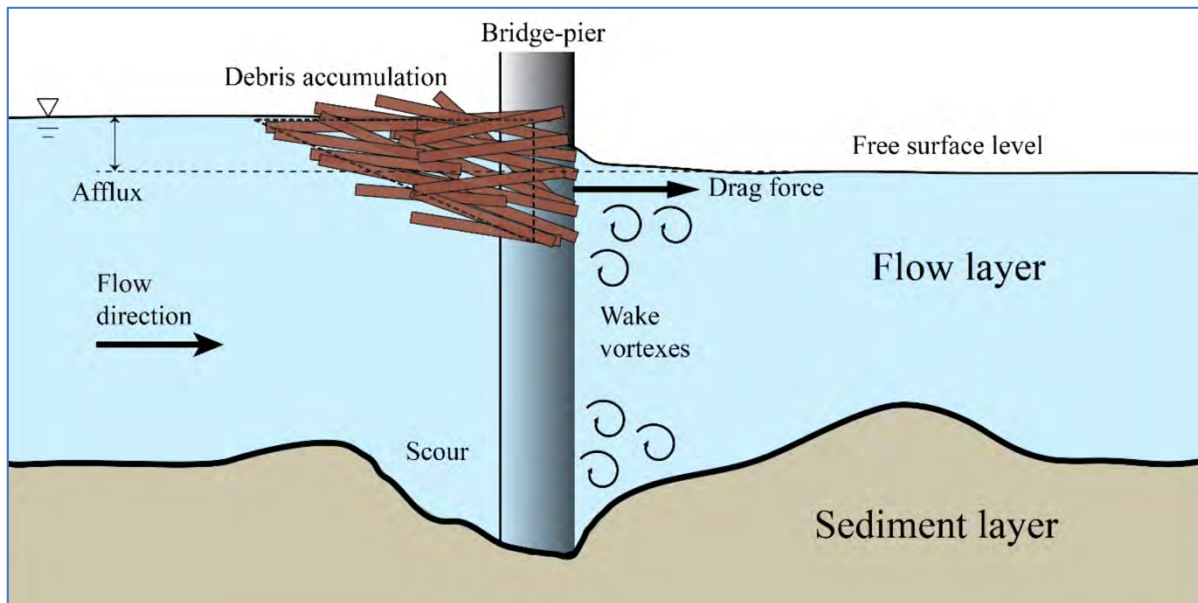
**Figure Eighteen.** Diagram showing the impact of woody debris jams against bridges (From Cantero-Chinchilla, et. al (2018) Assessing the effects of debris accumulations against river bridges. A key element is the afflux that results which exacerbates flooding upstream.
