CIVIL DEFENCE EMERGENCY MANAGEMENT GROUP

DATE: Wednesday 11 May 2022

Civil Defence Emergency Management

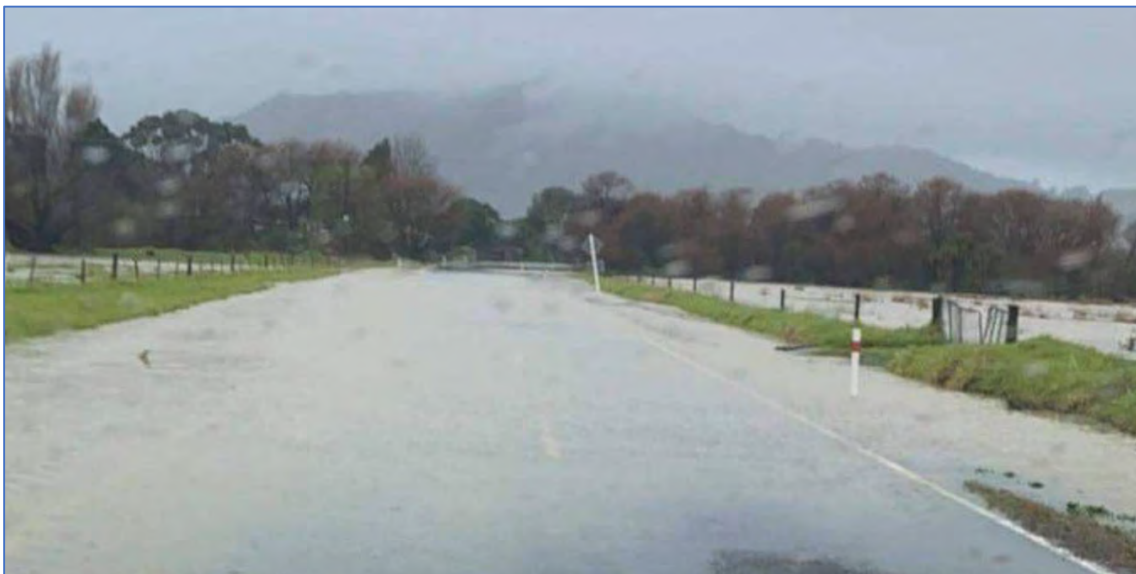
Figure Seven. Flooding on the road north of Te Araroa (Tairawhiti Civil Defence.. check source better quality image).

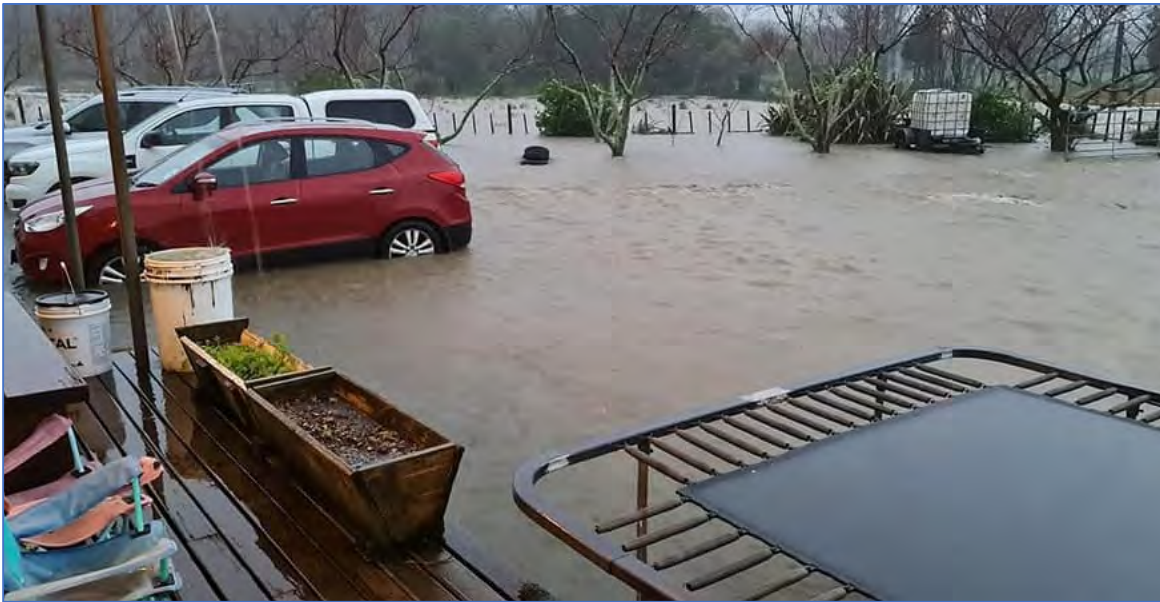
Figure Eight. Flooding at Ruatoria. Manu Caddy facebook feed.

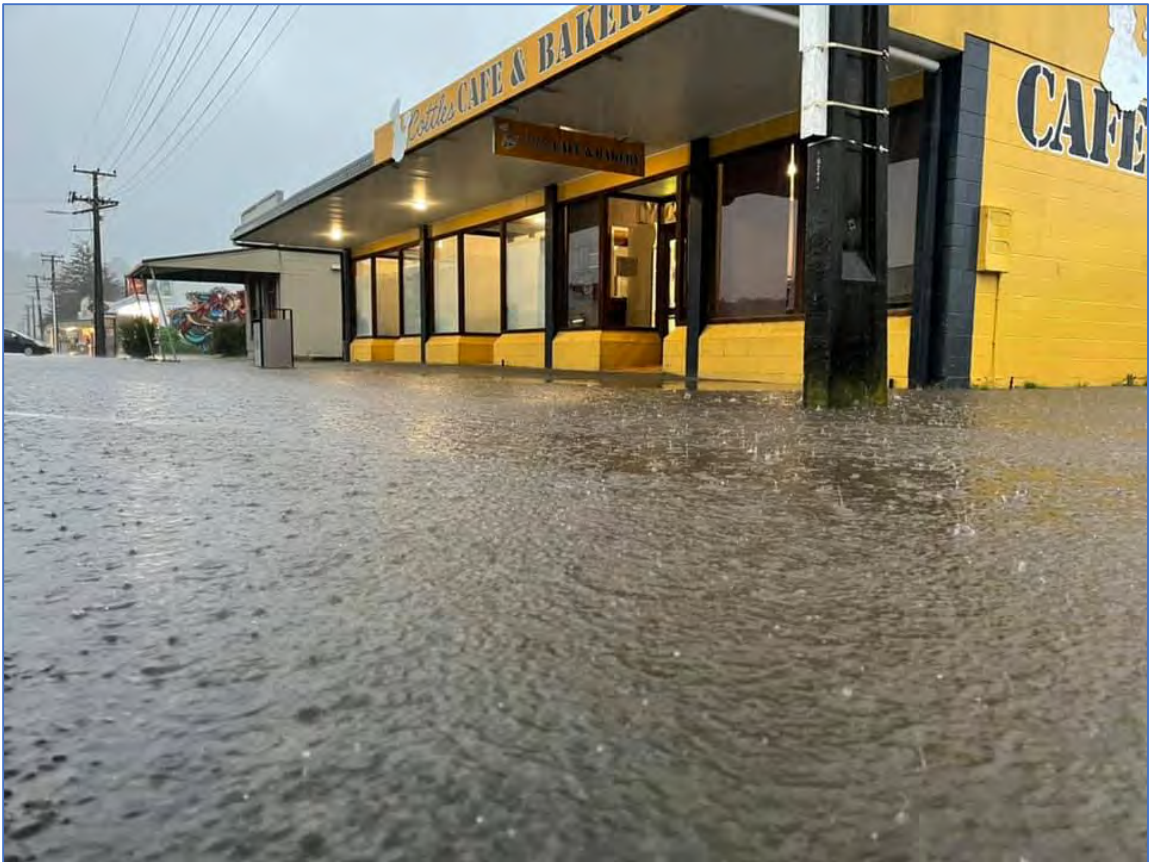
Figure Nine. Flooding at Tolaga Bay (Uawa Live Facebook post).

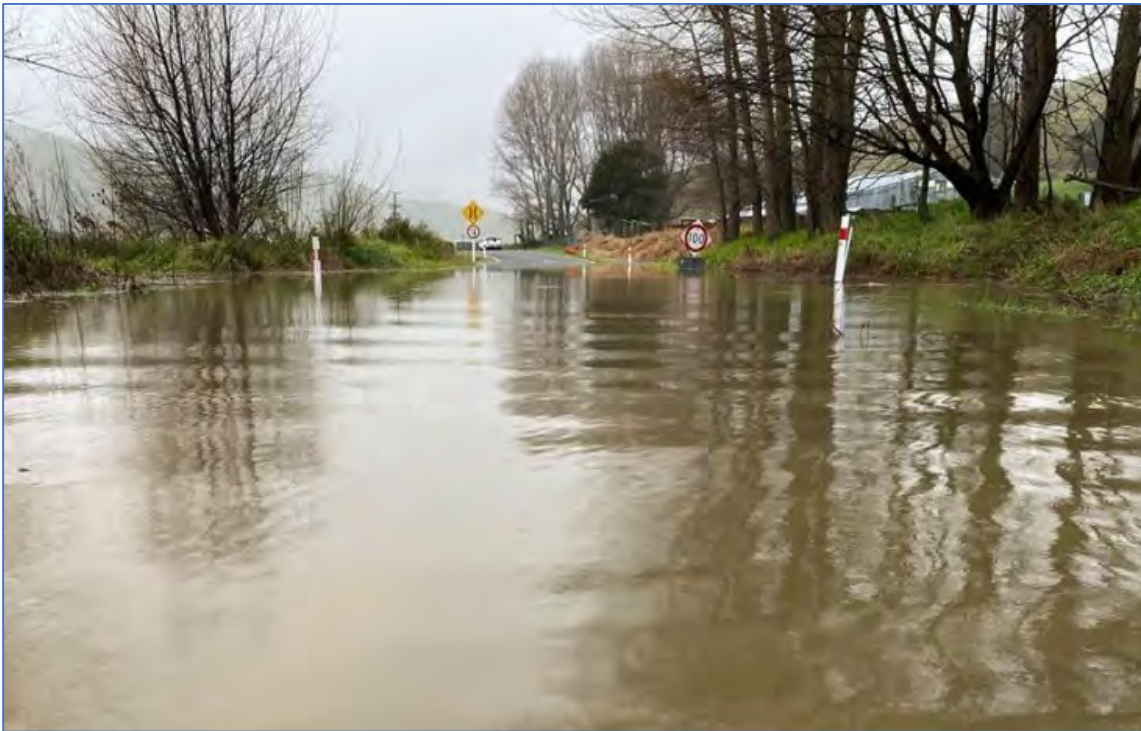
Figure Ten. *Flooding on the road to Anaura east of the junction with State Highway 35.*

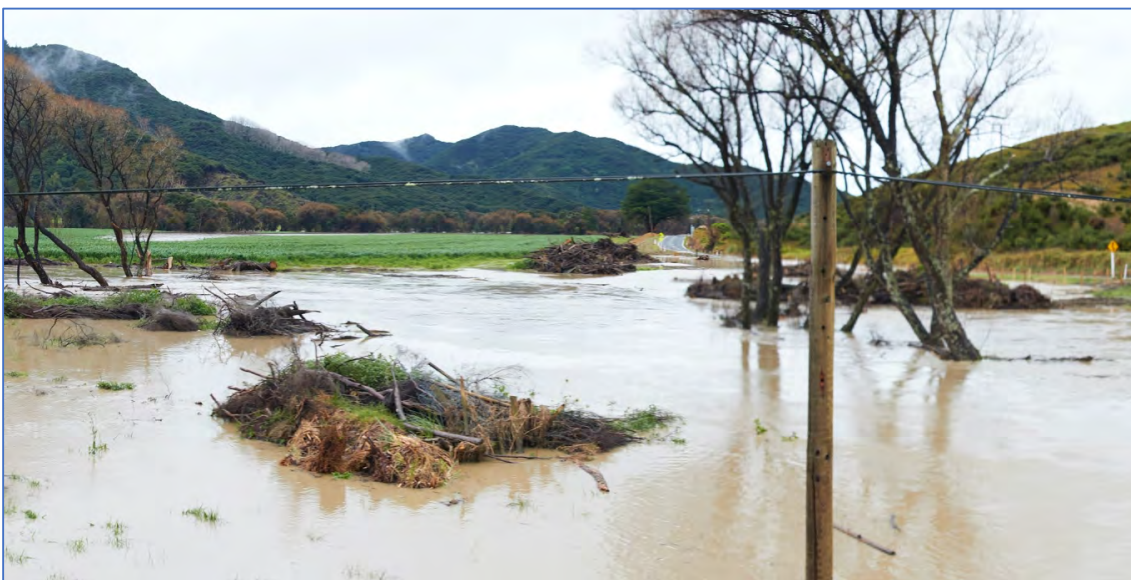
At Tolaga Bay², the storm surge scoured the top of the north and south beaches and remobilised pine logs. An additional contribution of fresh willow debris on the north beach suggests that the willow piles observed being mobilised at the Anaura Bay turn-off migrated to the beach (**Figure Thirteen**).

Figure Eleven. *Willow piles being eroded upstream of State Highway 35 Bridge, Mahanga Stream.*

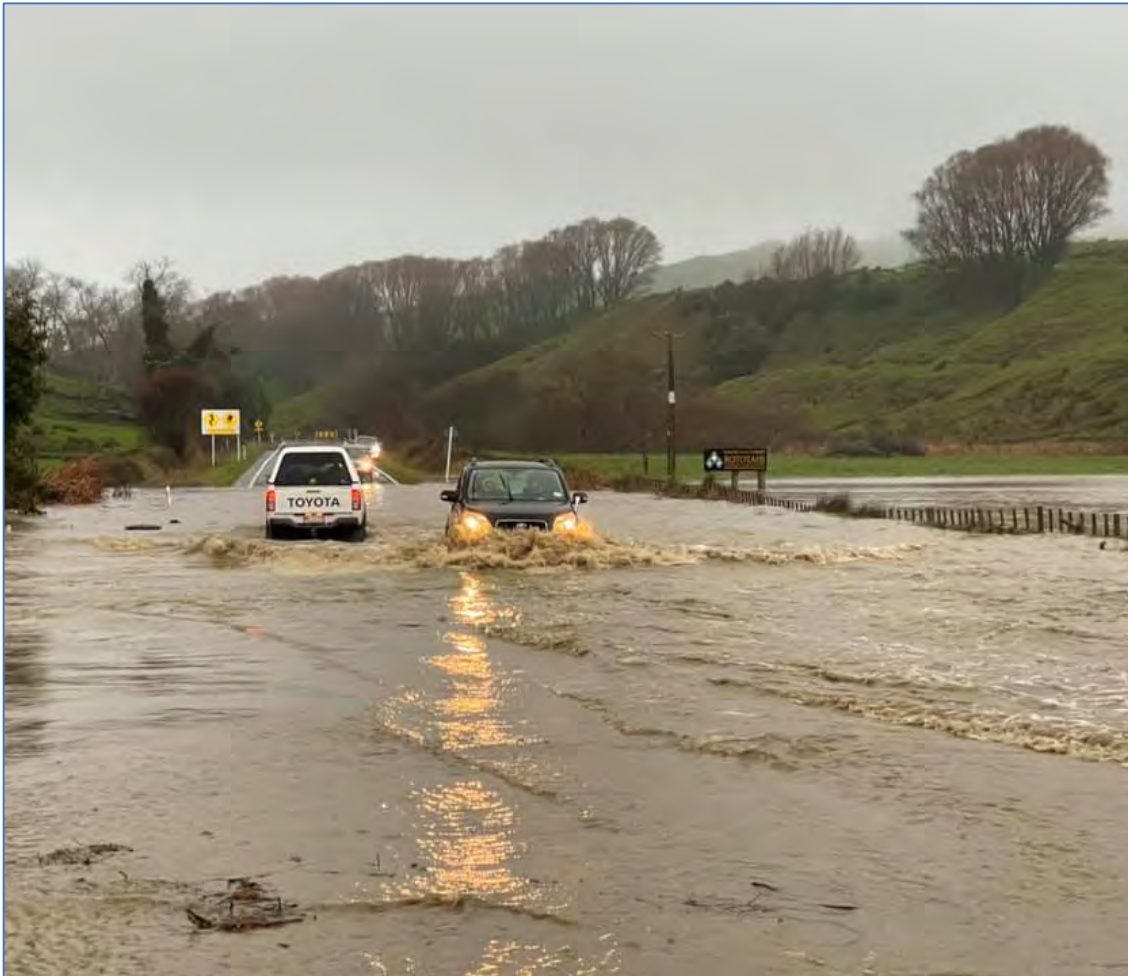
Figure Fourteen. Flooding on State Highway 35 south of Tolaga Bay.

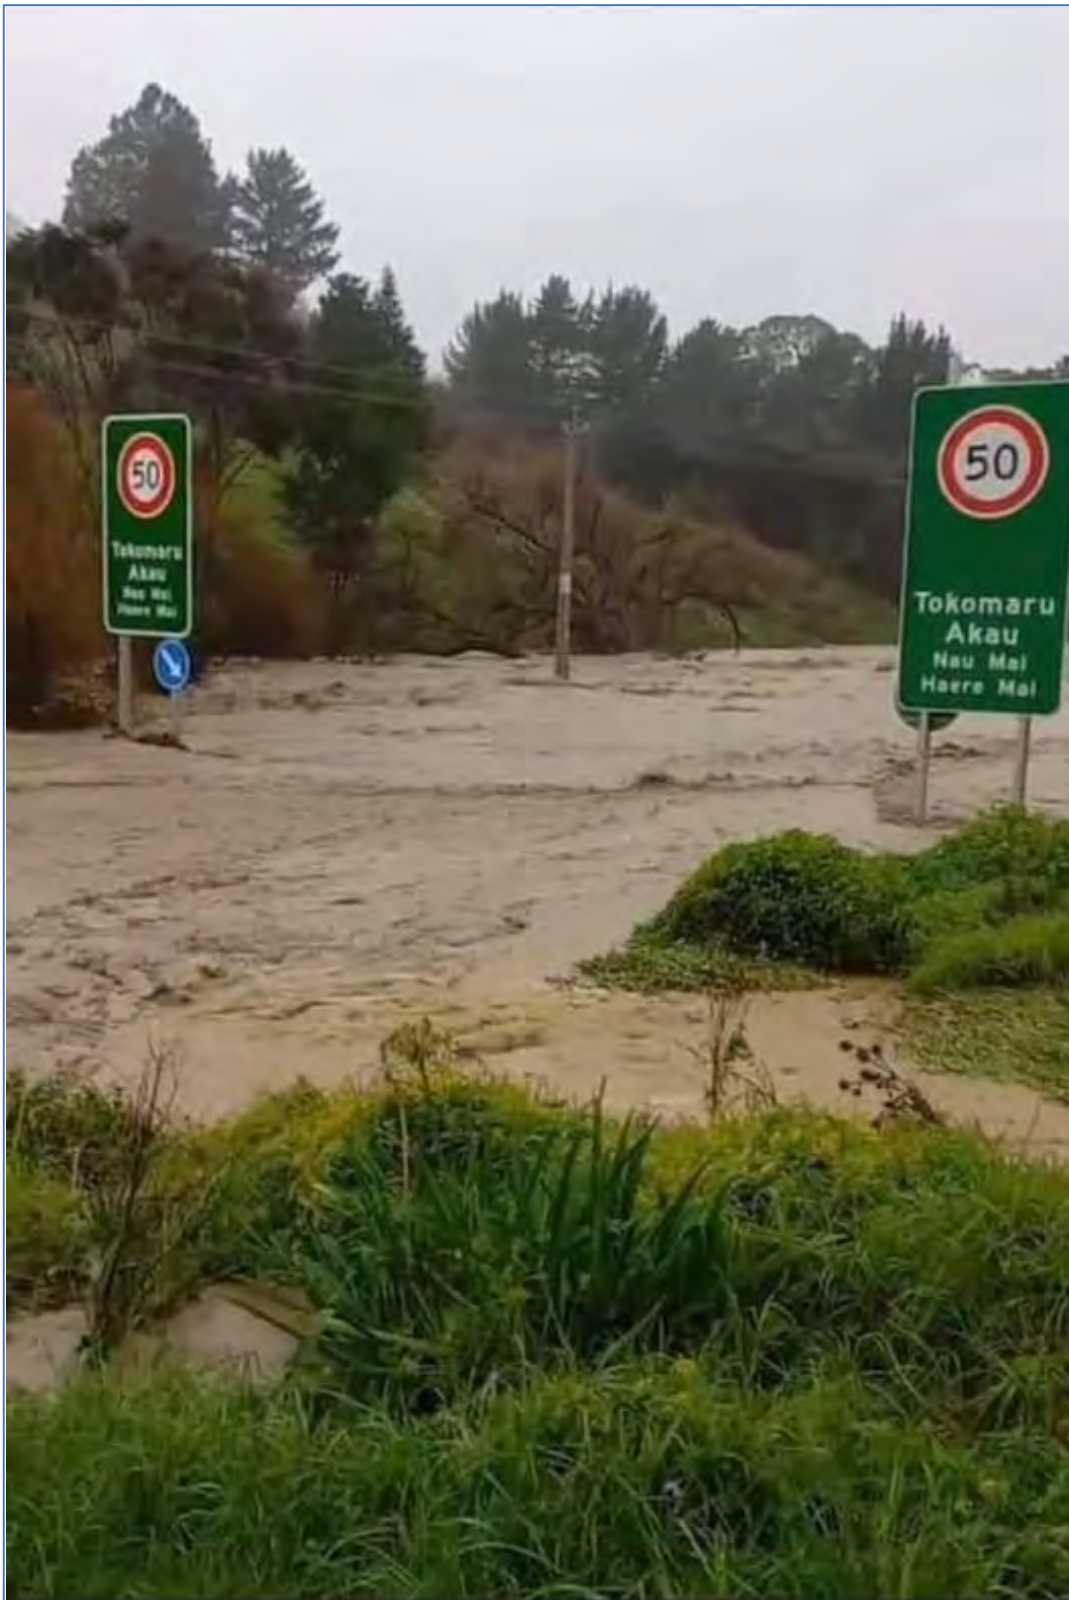
One resident in Toa Street reported flooding around their house about 7 AM or soon thereafter while at 3552 Waiapu Road sheets of water were reported running down the property from the hill behind at 7:15 AM and the road was flooding. At 8 AM photographs and video started appearing on Facebook showing the flood at full height (**Figures Fifteen, Sixteen and Seventeen**).

Figure Fifteen. Photograph hosted on the Uawa Live Facebook page credited to Kuipo Saulala and described as taken at approximately 8am.

The flooding was particularly dramatic as the images and video of State Highway 35 at the southern approach to Tokomaru Bay attest (see **Figures Fifteen, Sixteen and Seventeen** above). The reports from the local residents point to flooding being evident from 7 to 7:15 AM and reaching a peak by 8:30 to 8:50 AM before rapidly receding. The combination of a very short (1.5 hour) very heavy rainfall event very closely coinciding with a flood duration points to flash flood conditions.

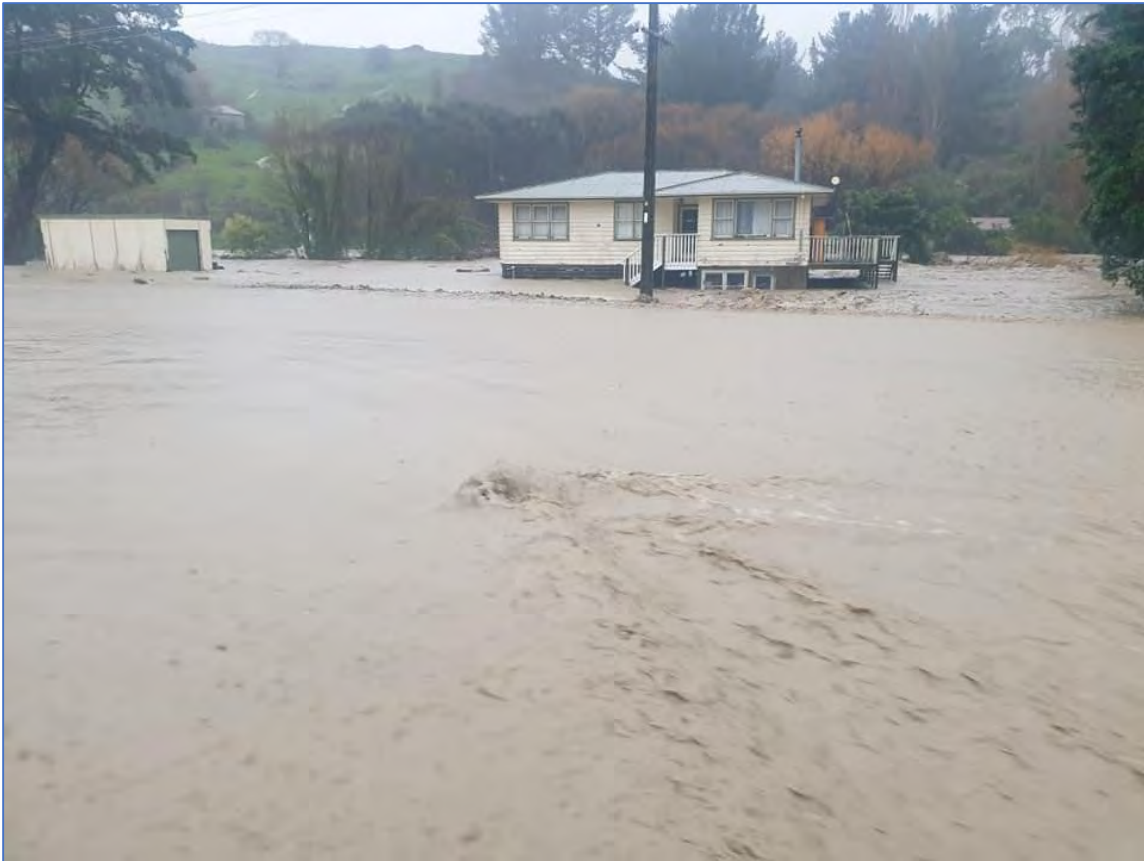
Figure Sixteen. Photograph posted to Facebook at 8:45 AM. Image taken from number 3552 Waiapu Road by Hoana Forrester with the image taken around 8:15 AM based on the comments.

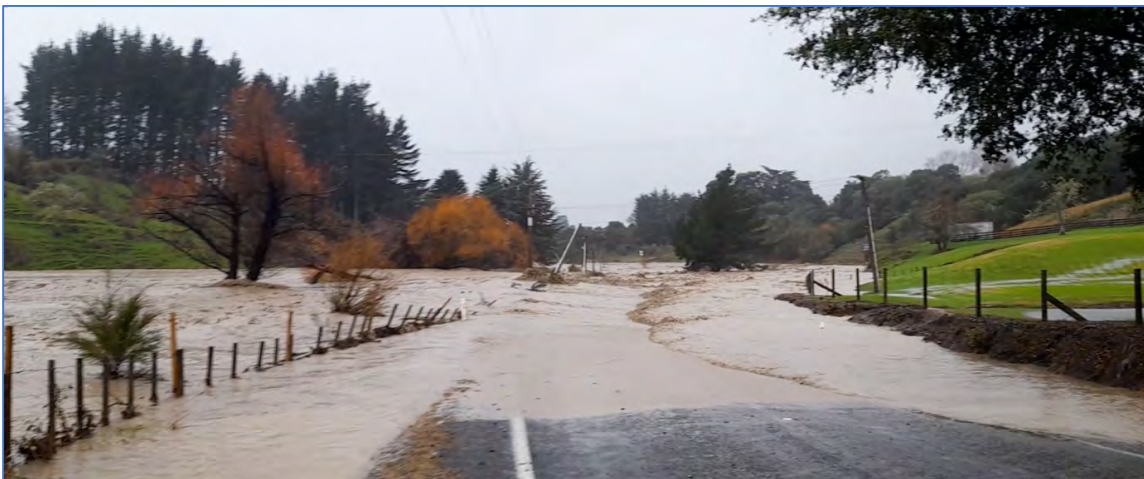
Figure Seventeen. Screenshot from a video posted at 8:46 AM by Tianna Rongonui showing what is estimated as close to the maximum extent of the flood.

Based on the information available (facebook posts and interviews), it appears that while there was heavy rain over night, rainfall intensity increased significantly from around 6 AM and flooding in Tokomaru was evident by 7 AM to 7:15 AM and reached a peak between 8:30 to 8:50 AM. The floods receded rapidly and the road became

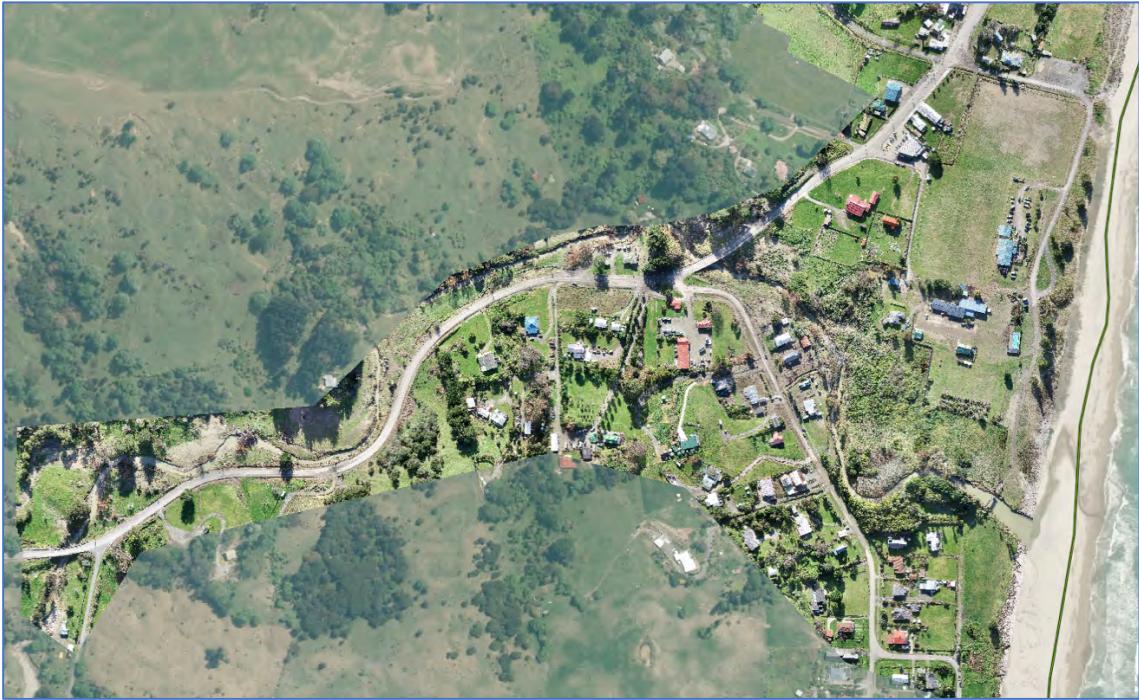
Figure Thirty One. Drone orthomosaic for the Kaiawha and Waitu Streams flown on the 23rd June 2021.

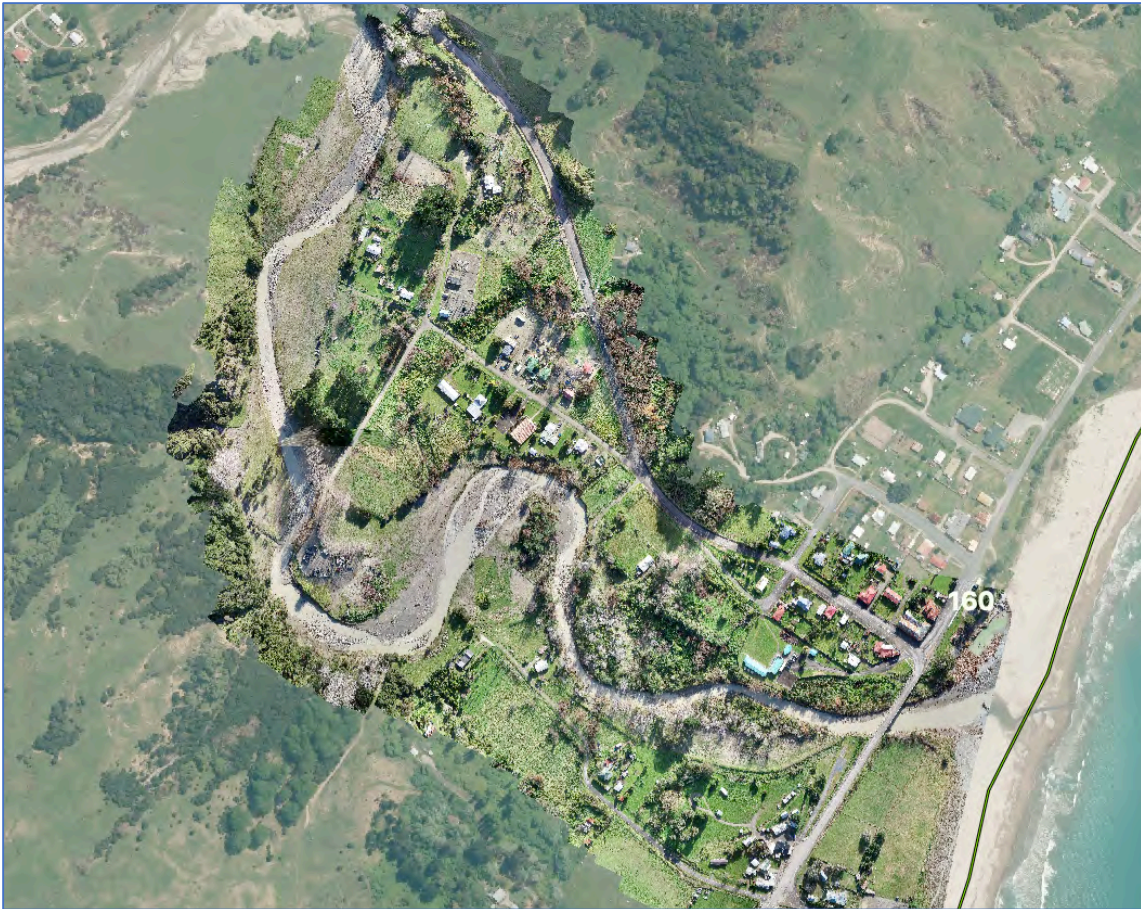
Figure Thirty Two. Drone orthomosaic for Mangahauini Stream flown on the 23rd June 2021. The 160 annotation at] the right of the image indicates the location of the Sanders rain gauge site.

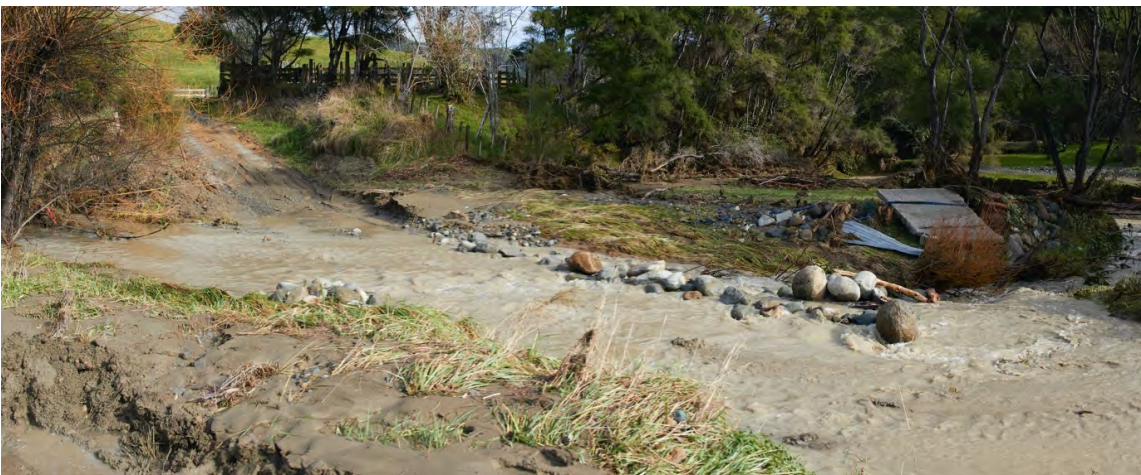
Approximately 650m up Kaiawha Road a ford provides access to the road end farmhouse but was blocked by up to 60cm of silt deposition. The silt deposition height was approximately 1m above river level and there was a considerable amount of debris scattered on the river bank downstream of the ford. The force of the flood appears to have been strong enough to move large boulders. (**Figure Thirty Six**).

Figure Thirty Six. Photograph of the ford 650m upstream of the bridge on State Highway 35 showing the depth of silt deposition (bottom left), the height of the flood spread based on the debris layer and the mobilised boulders on the ford path.

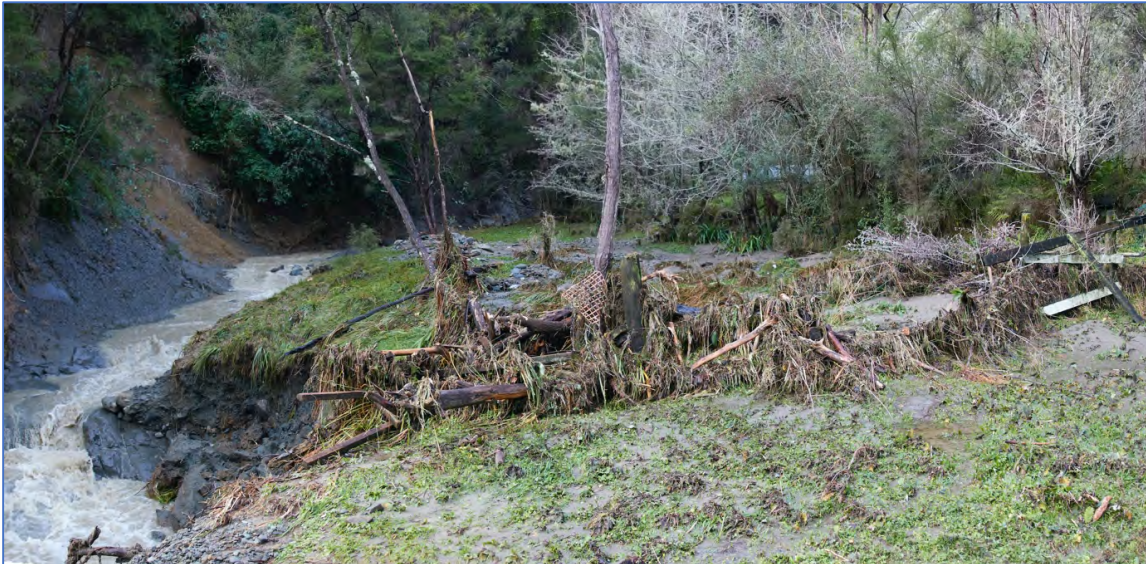
Further upstream the extent of the flooding was even more obvious with debris at approximately 2m above river level (**Figure Thirty Seven**) and the flood spread reaching all the way across the valley floor (**Figure Thirty Eight**) while in slightly raised parts of the valley the edge of the flood was marked by a debris line of small woody debris (**Figure Thirty Nine**). Further upstream there was evident of overground flow (**Figure Forty**).

Figure Thirty Seven. Photograph upstream of the ford on Kaiawha Road showing the extent of flooding upstream of the ford on the Kaiawha Road.

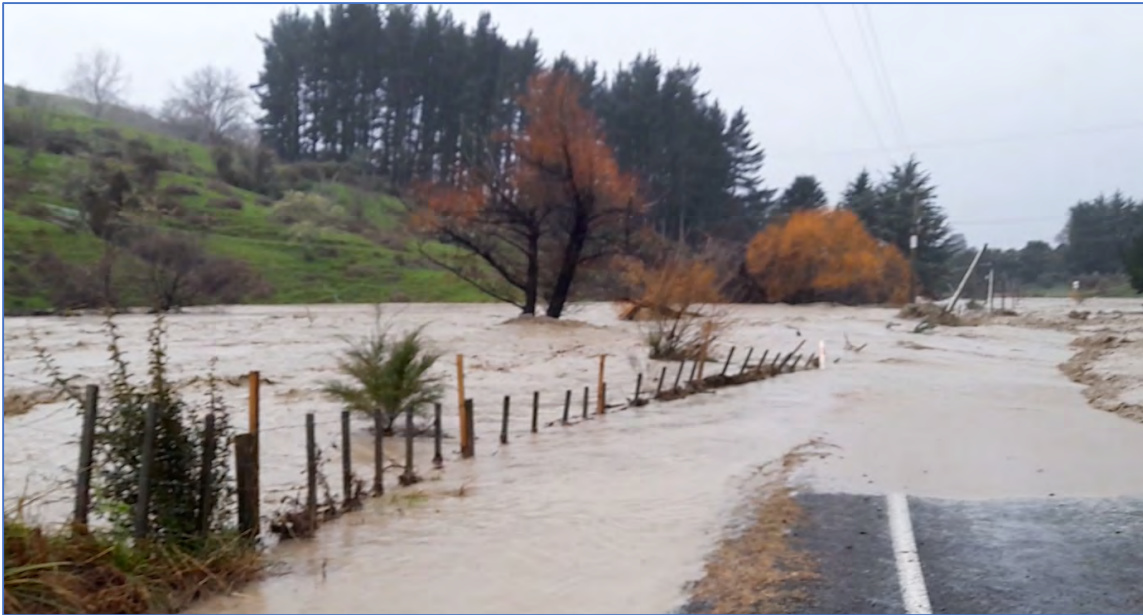
Video footage provided by Tianna Rongonui (cf. **Figure Seventeen** p.12) gave an good indication of maximum flood spread and enabled the drone mapping to be calibrated. It also help show that the willow in the middle of Waitotu Stream had a negligible effect on flood spread (**Figure Forty Two**). This is also evident from the mapped flood for this area (**Figure Forty Three**) which showed that it had a width of almost eighty metres while the river bed occupied by the willow was only eight metres wide.

Figure Forty Two. Video still provided by Tianna Rongonui showing the flood spread and with the large willow in the river in the background. As can be seen the flood spread was considerable wider than the normal river banks at point and had occupied the entire flood plain.

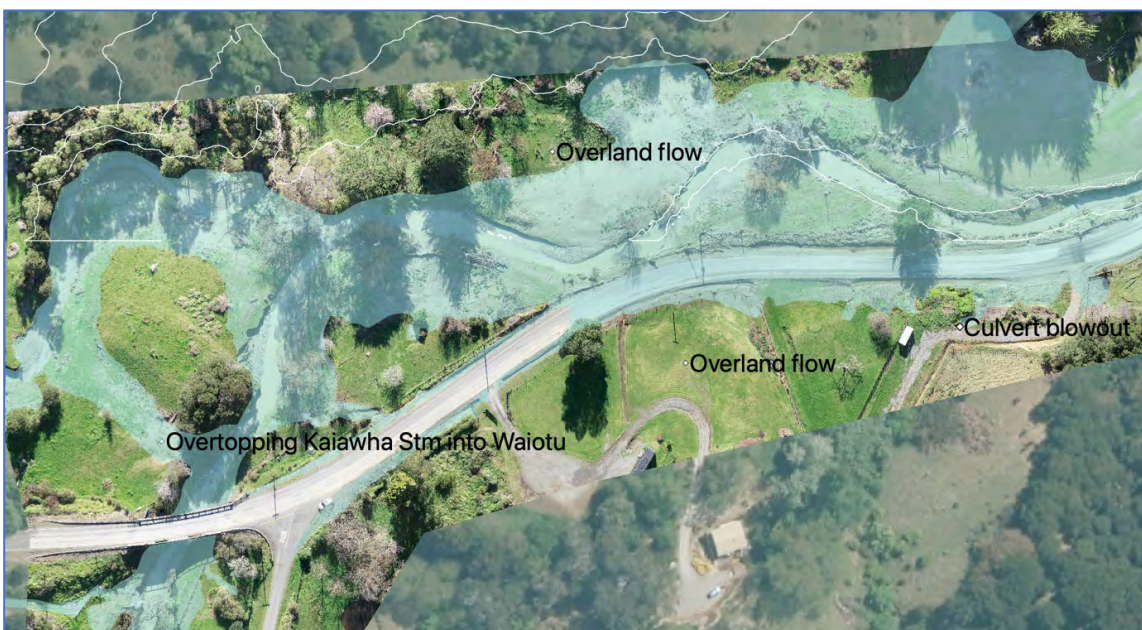
Figure Forty Three. Mapped flood spread in the Waitotu below Kaiawha Stream showing that the willow occupying the river channel occupied only a small part of the flood spread.

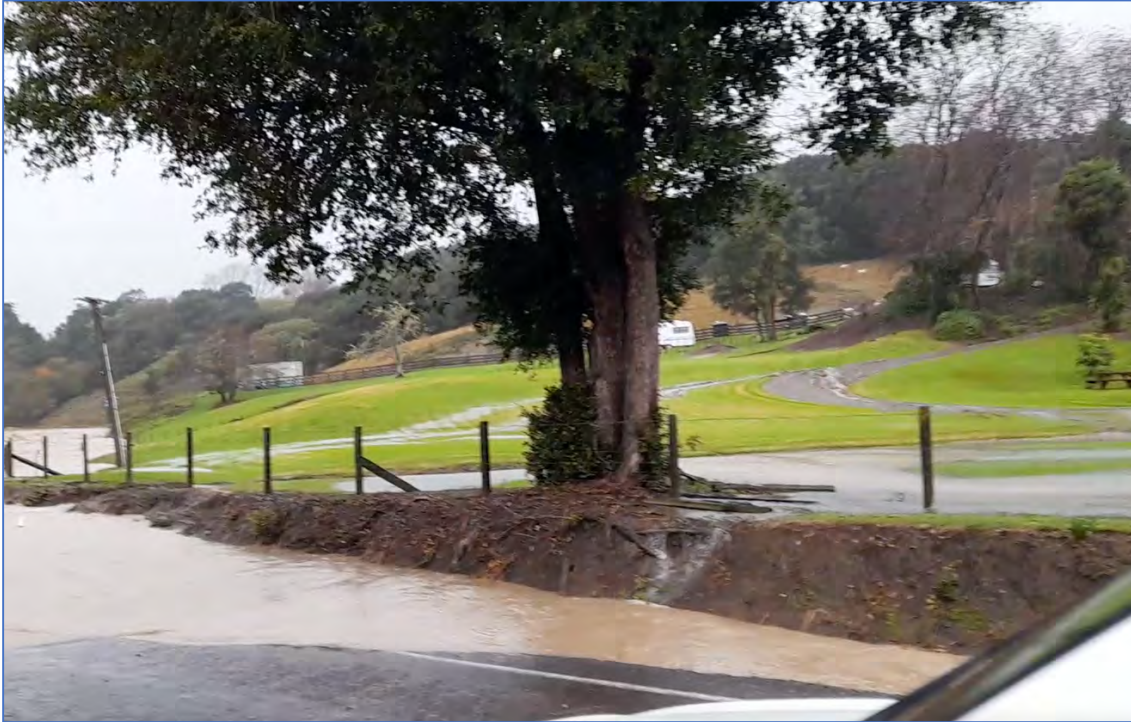
Figure Forty Four below which is also a still from Tianna Rongonui's video shows the extent of the flood spread on the true right and the contribution of overland flow from adjacent properties.

Figure Forty Four. Still from the video provided by Tianna Rongonui showing the flood spread on the state highway approach to Tokomaru Bay with the flood spread contribution from adjacent properties.

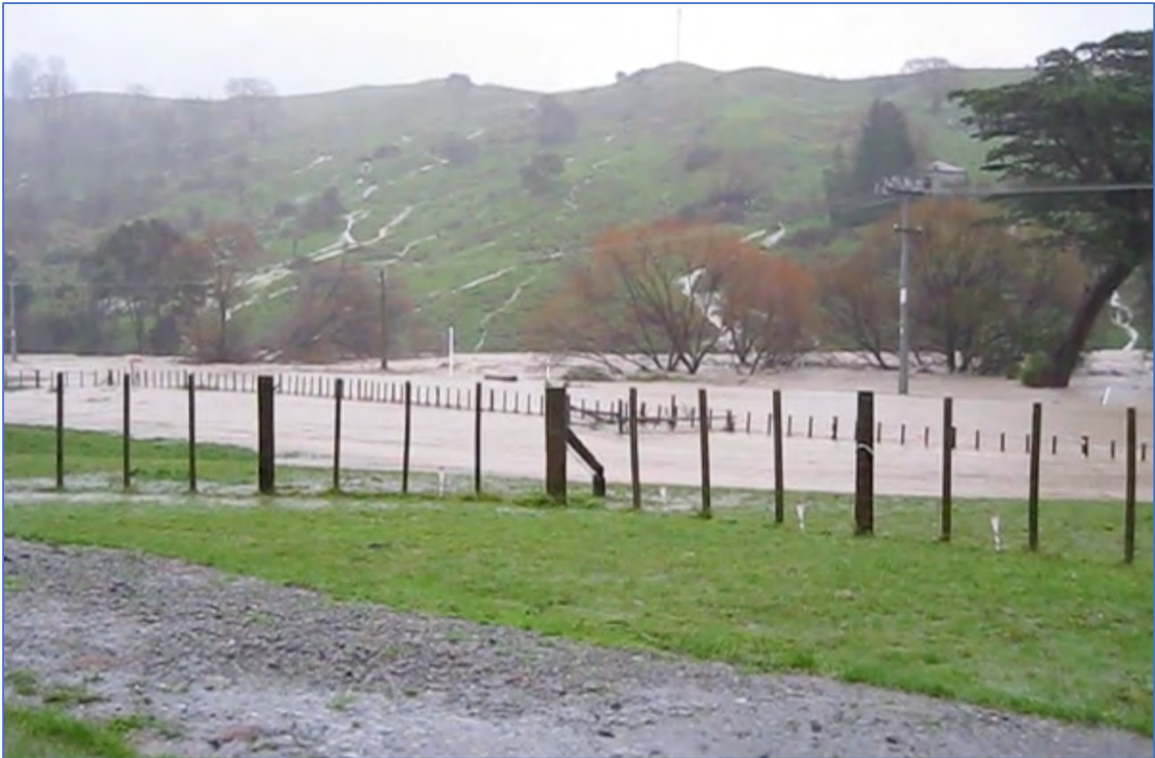
The video footage from 3552 Waiapu Road State Highway 35 (**Figure Forty Five**) is helpful as it graphically demonstrates the significant degree of overland flow during the storm. This calibration is useful because post-event on the ground mapping and the drone footage cannot readily differentiate between flood spread and overland flow.

Figure Forty Five. Video screenshot from No. 3552 Waiapu Road State Highway 35 showing the flood extent over the paddock and the considerable volume of overland flow on the hillside opposite.

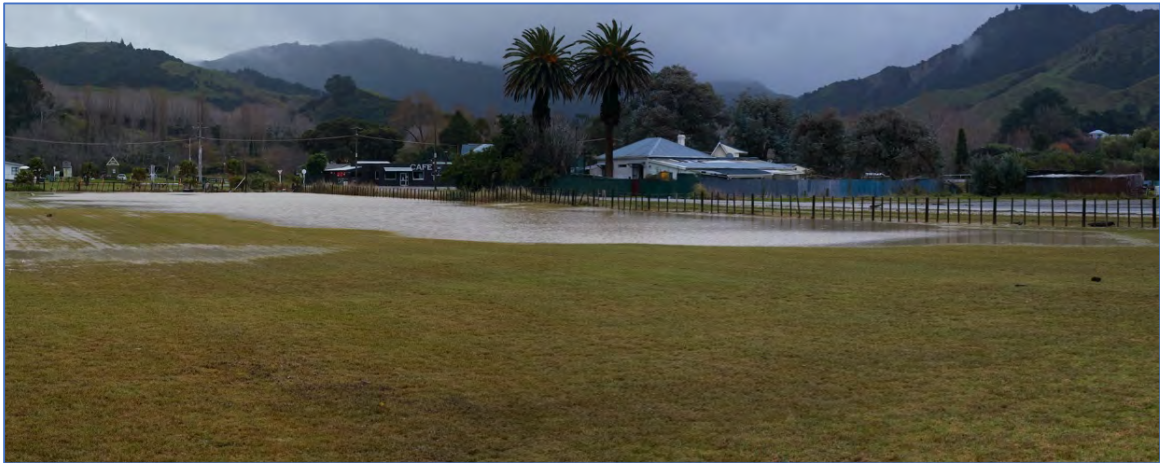
Figure Forty Eight. Flood water ponded at the north end of the Hatea-a-rangi Memorial Park.

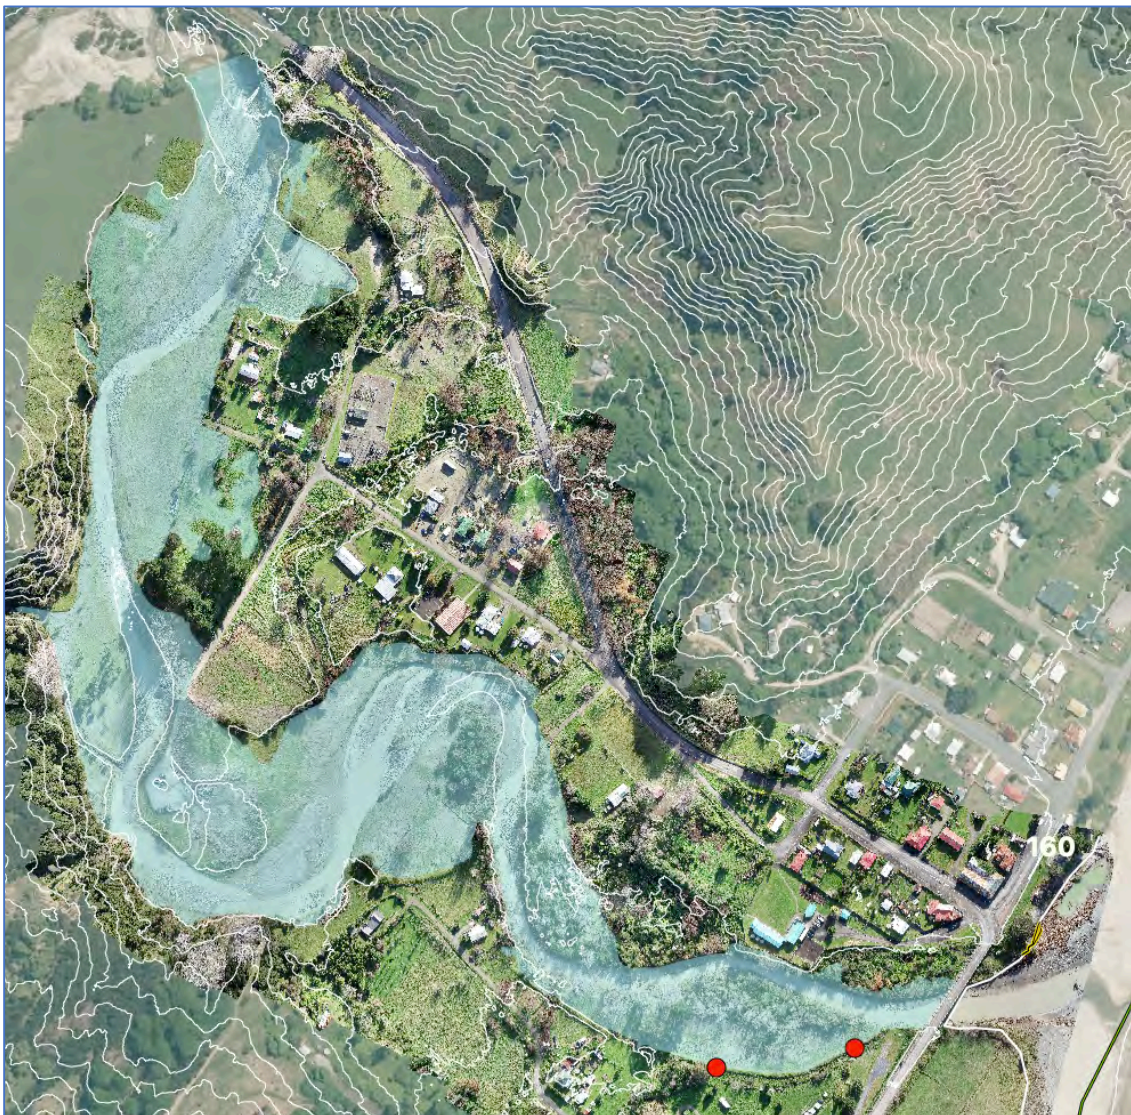
affected by storm surge during the event. As **Figure Fifty Five** indicates the Mangahauini River was largely confined to its bed during the flood. There was flood spread into a low lying area on the true left immediately downstream of where the “Marotiri” tributary joined the Mangahauini, on the true left above the transfer station and across the transfer station itself. Some further inundation on the true left bank occurred east of Toa Street but otherwise no break out occurred.

Figure Fifty Five. View of the river generated flood spread for the Mangahauini River from upstream of the “Marotiri” tributary to the bridge over the Mangahauini at the river mouth. The two sites where overtopping occurred are shown as red dots. The mouth itself below the bridge has been excluded from the flood spread as it is assessed that this area was dominated by storm surge during the storm. The location of the rain gauge is shown bottom right.

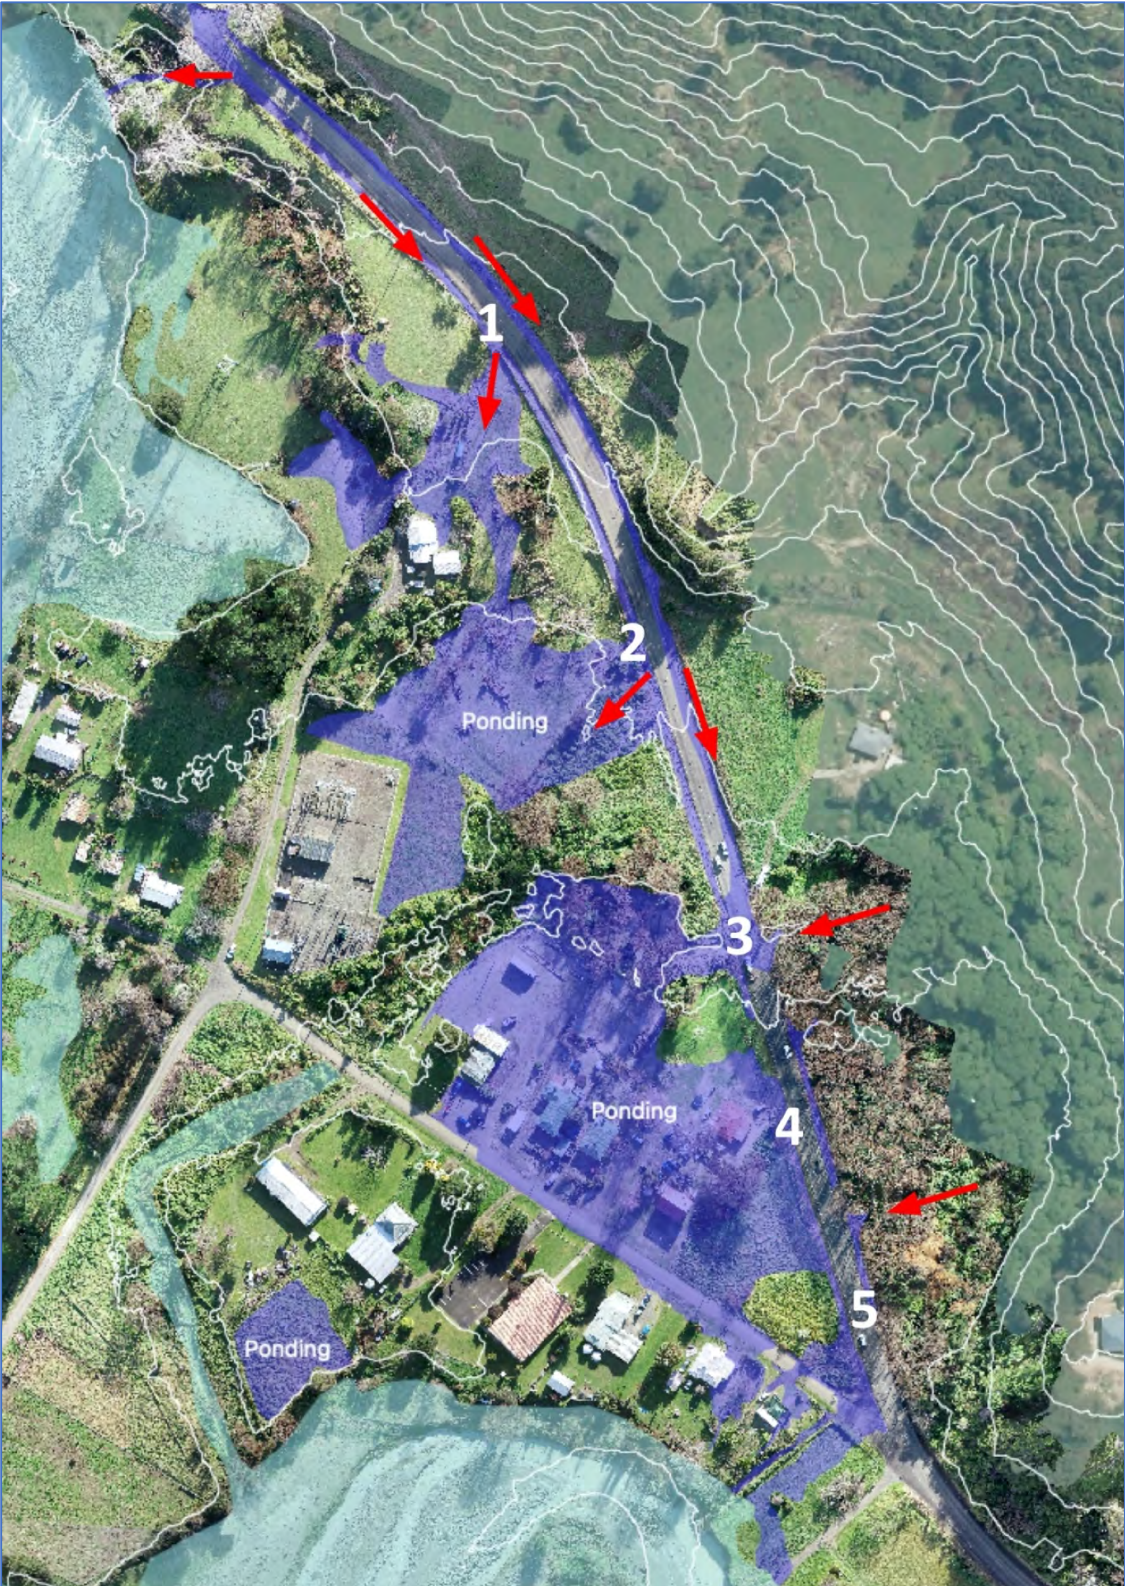
Overland flow off State Highway 35 was the primary cause the flooding at Toa Street rather than flooding from Mangahauini River. The *indicative*⁷ flood spread resulting from the overland flow is shown in **Figure Fifty Nine** below. While the blocked culvert in the “Marotiri” tributary could have had a impact on the inundation at Toa Street it would not have been the only source of flooding. Indeed it has already been noted that some of the discharge from “Marotiri” tributary above the blocked culvert would have re-entered the creek immediately downstream. Still more of the flood from the “Marotiri” tributary appears to have discharged from the water table at two points before reaching Toa Street (c.f **Figure Fifty Nine**).

Figure Fifty Nine. Overland flow from SH 35 discharging above the house upstream of the substation (Point 1), the substation (Point 2), and ponding in the vicinity of Toa Street (Points 3-5).

⁹ It is noted that a significant portion of the flow from the blocked culvert may have exited the road surface before Toa Street having a more significant affect at locations 1 and 2 in **Figure Fifty Nine** than at Toa Street itself.

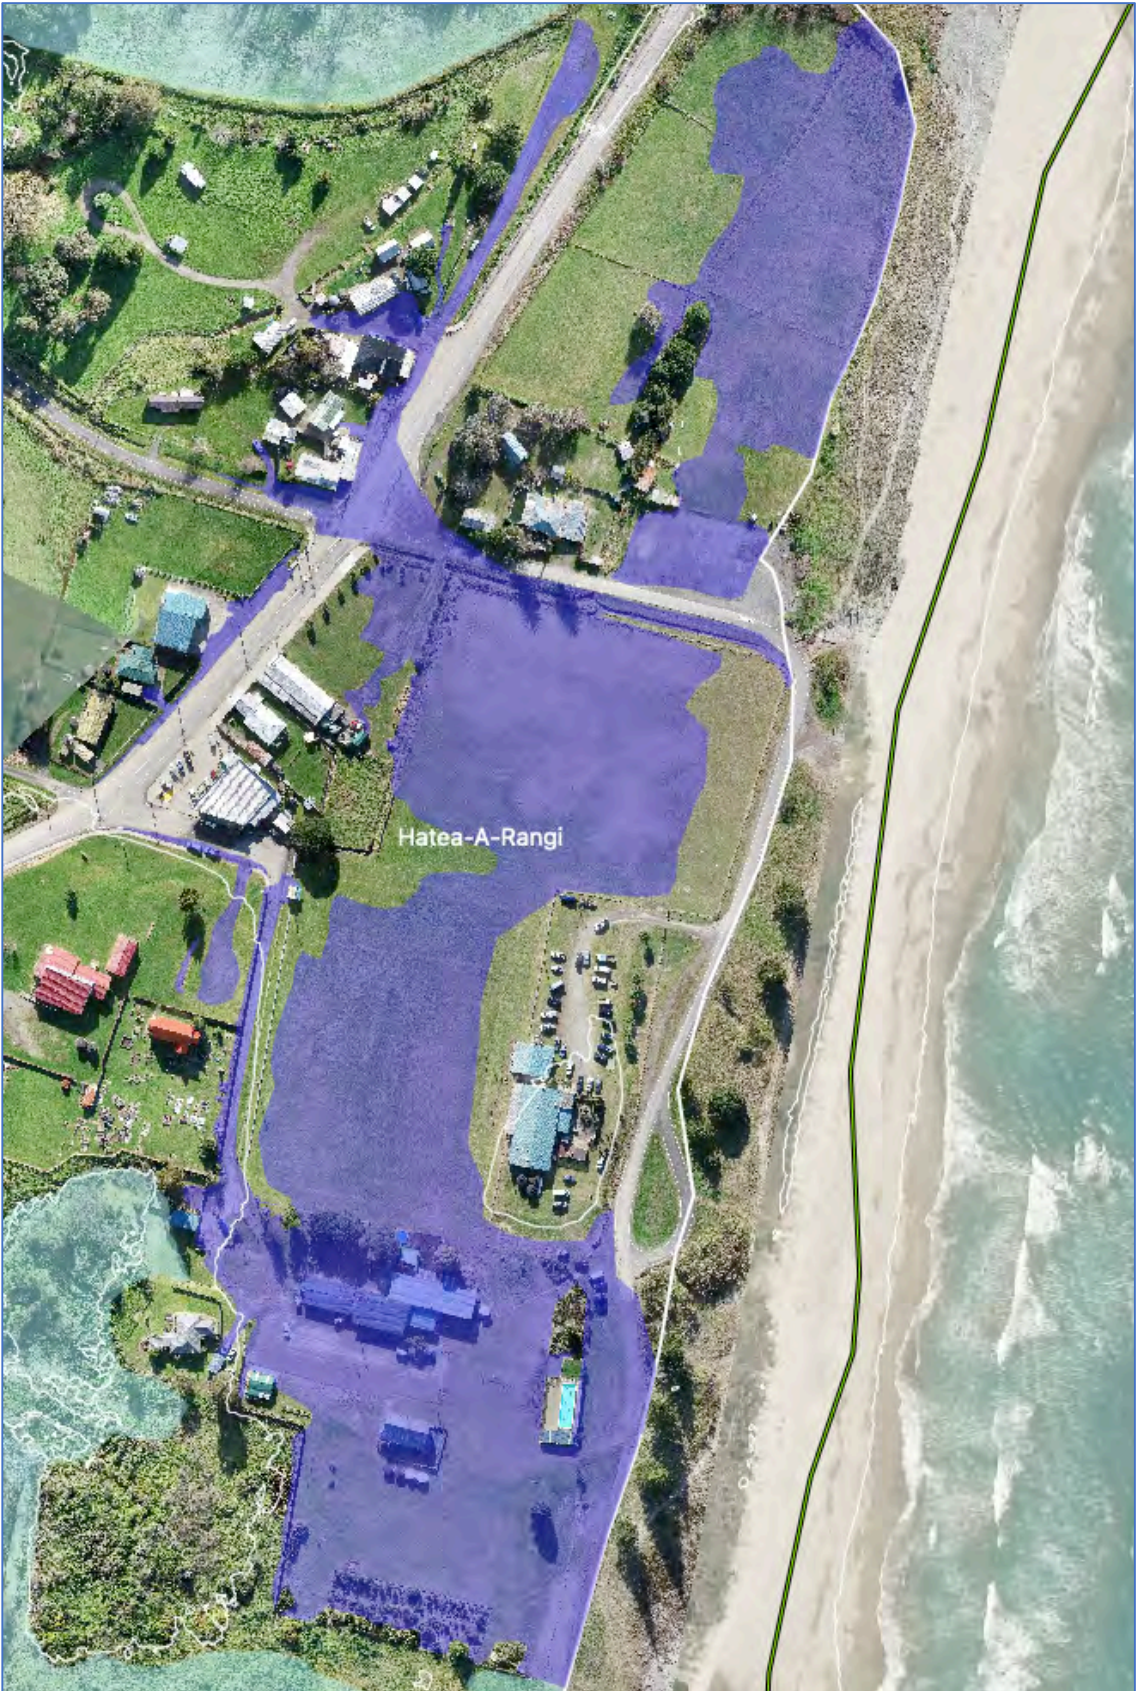
Figure Sixty. Hatea-A-Rangi indicative main ponding area, Tokomaru Bay. The area east of the white line was subject to storm surge.

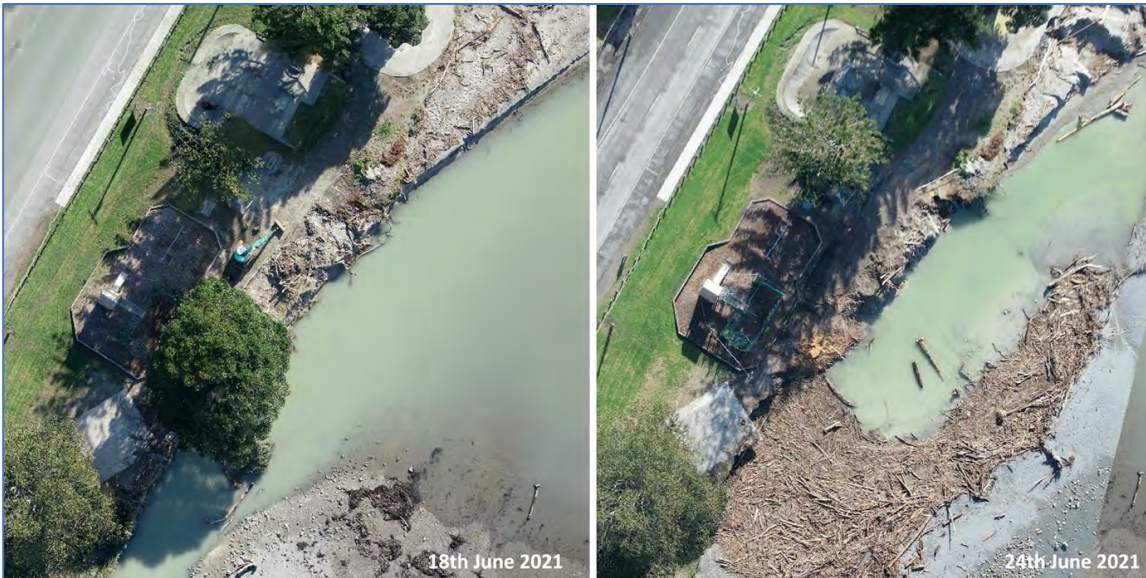
The most obvious damage occurred at the reserve at the mouth of the Mangahauini River which had previously been damaged by storm surge and assessed as being highly vulnerable (Cave 2019a, 2019b). This area also experienced significant erosion as a result of storm surge in May 2021 but the 20th of June storm surge was more significant with the surge extending 25m in from the bank edge pre-event. Coincidentally, the area was drone mapped on the 18th of June 2021 to assess the damage from the May

Figure Sixty Nine. Comparison between the Tokomaru Reserve and playground drone orthomapping dated 18th June and 24th of June 2021. Note the removed tree, the overhanging concrete pad bottom left and the erosion at the turn around bay.
