CIVIL DEFENCE EMERGENCY MANAGEMENT GROUP

DATE: Wednesday 11 May 2022

Civil Defence Emergency Management

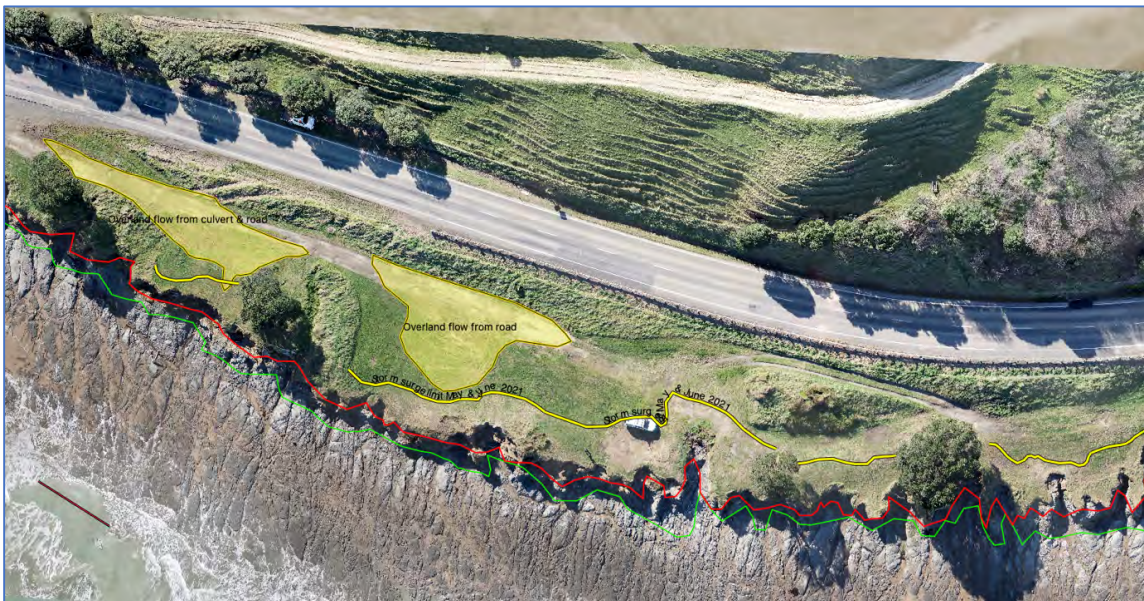
Monitoring for erosion of the freedom camping zone¹² between Pouawa and Turihaua was initiated in September 2020 and an initial report prepared in November 2020 (Cave 2020). A drone flight was undertaken in August 2021 and the limits for the May and June storm surge mapped on the ground is shown below on the drone orthomap in **Figure Seventy**. Evidence of storm surge was indicated by salt burnt grass, flattened vegetation and rocks and woody debris thrown up onto the top of the beach terrace (**Figure Seventy One**). Some erosion of top soil and grass on top of the wave cut platform was observed for both the May and June storm surges.

Figure Seventy. Drone map of Turihaua Point showing the top of the bank from the 2018 aerial imagery (red), the June 2016 bank (green), the areas affected by overland flow and inundation in June 2021 (yellow area) and the storm surge limits for May and June 2021 (yellow line).

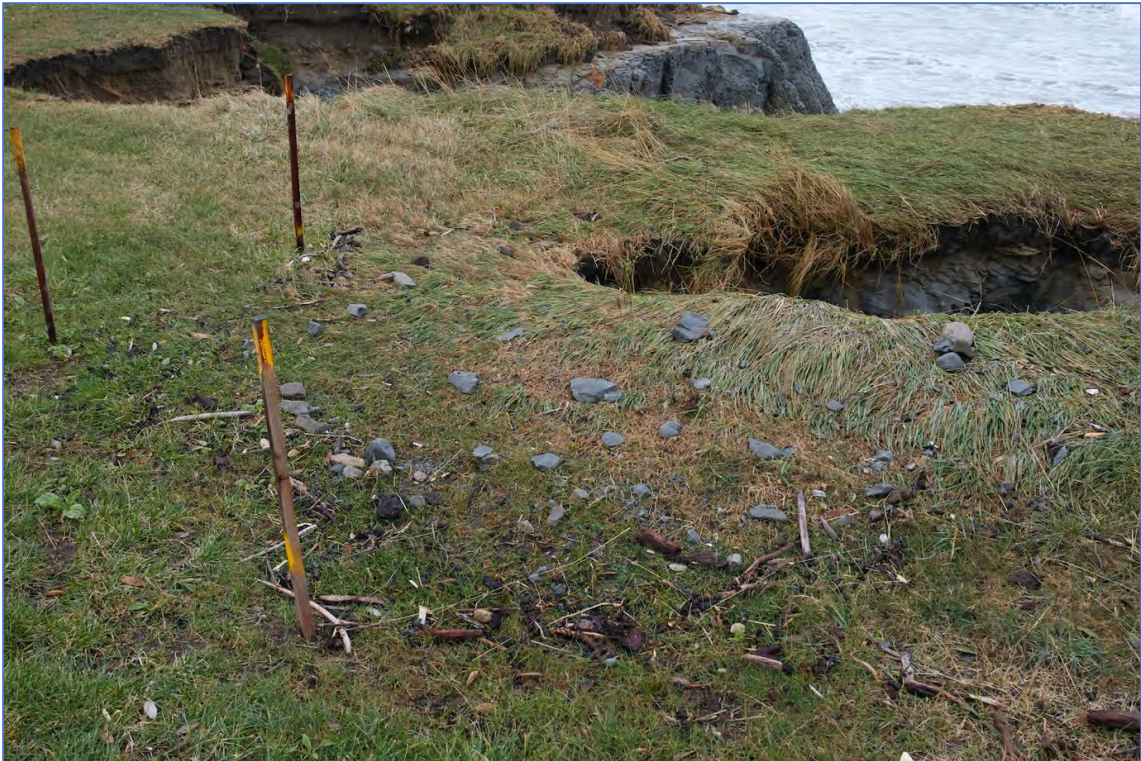
Figure Seventy One. Photograph taken 30th June 2021 showing the debris thrown up during the 20th June storm surge.

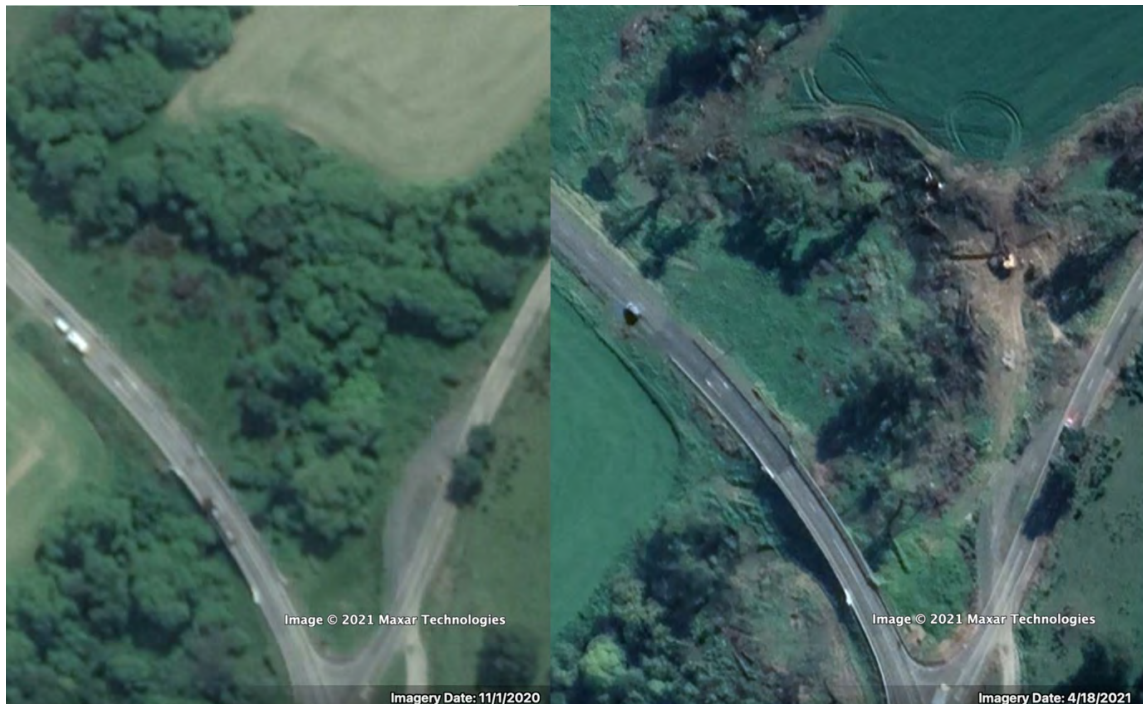
with the vegetation clearance and the placement of the willow piles on the banks of the stream within the flood plan has resulted in the discharge of sediment and wood waste into Mahanga Stream. From there it has entered the Hikuwai and then made its way downstream.

Figure Seventy Six. Screenshots of satellite imagery dated 1st November 2020 (left) and 18th April 2021 for the Mahanga Stream (right) where it crosses State Highway 35 showing the active clearance of willow during April 2021.
