Estimates of Log Volumes on Tolaga, Kaiaua and Anaura Beaches

Summary

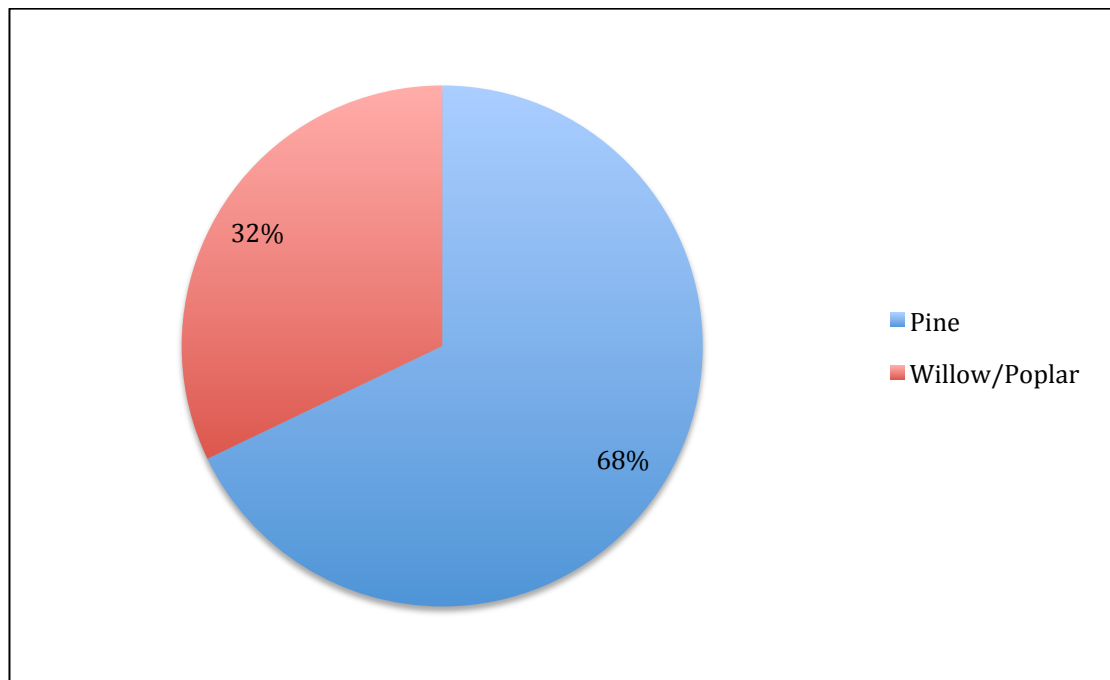
Work undertaken by counting all woody material within three 10m^2 plots after Ex-Cyclone Cook demonstrated that the woody debris excluding dross (small disaggregated material) was dominated by pine (68%) with the remainder willow or poplar (32%) (**Figure Four**). That work also showed that the pine material comprised cut pine (19%), fresh cut pine (2%) long resident process logs (67%), and “windthrow” (12%) (**Figure Five**).

Figure Four. Composition of woody debris ex-Cyclone Cook event.

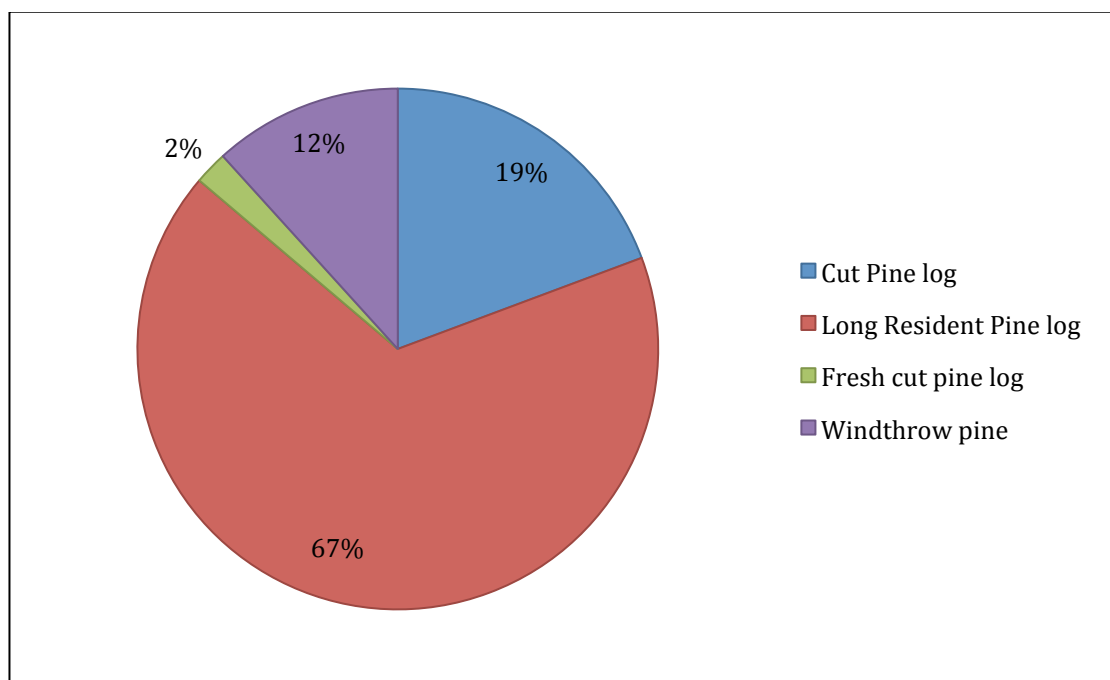
Figure Five. Types of Pine ex-Cyclone Cook event

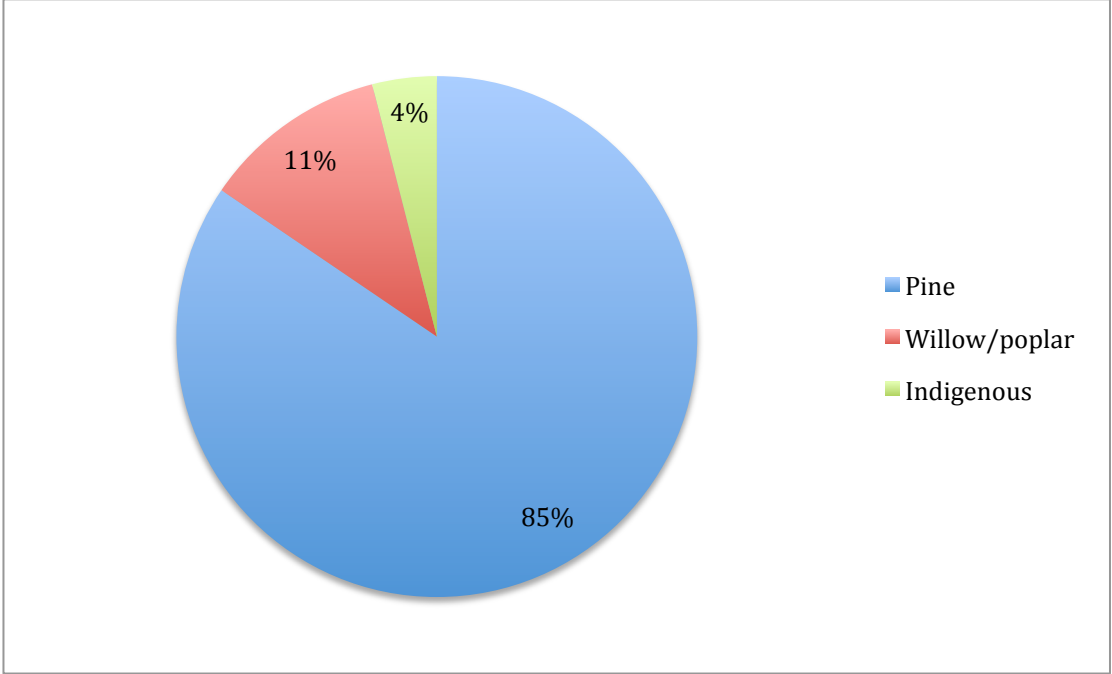
It was not possible to re-occupy the plots used in 2017 as material within these areas had been highly modified during clean up that happened immediately post the Queens Birthday storm. One 10m² plot was counted in the area immediately south of Tolaga Bay wharf. This showed that the Queens Birthday event was largely comparable to ex-Cyclone Cook with 13% cut pine,

54% long resident pine logs and 17% “windthrow” pine, while willow and poplar comprised 11.5% and indigenous 4% (**Figure Six**). On an aggregate basis 84.5% was pine and when recalculated to total pine, cut pine comprised 16%, long resident logs 64% and “windthrow” pine 20% (**Figure Seven**).

Figure Six. Percentage of pine, willow and poplar and indigenous.

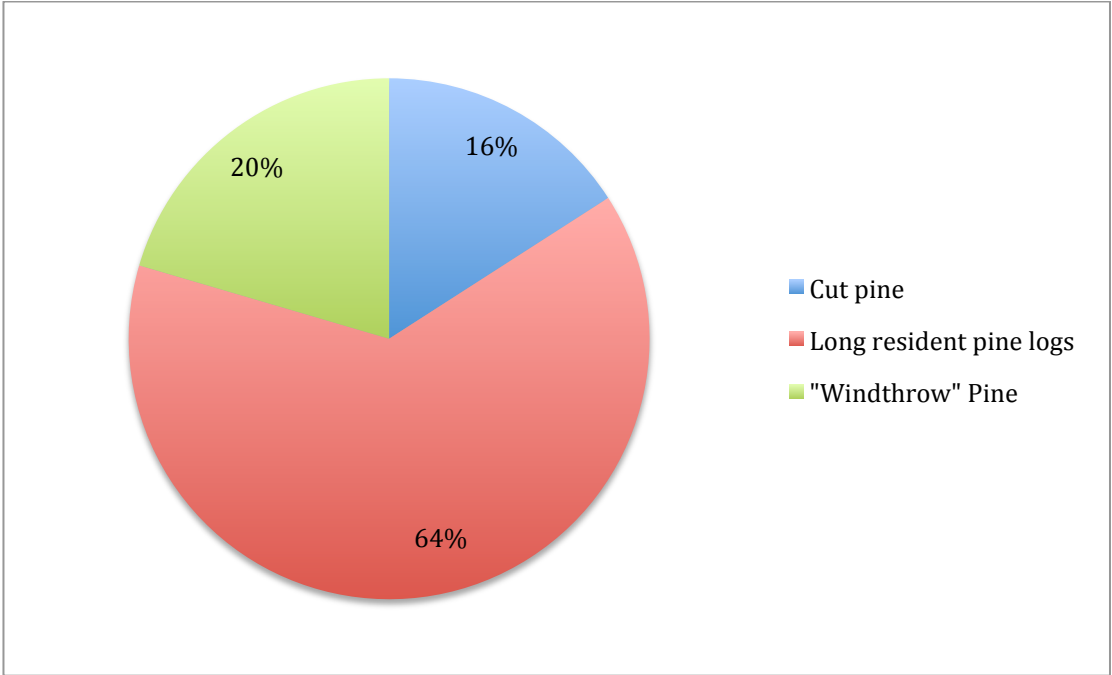
Figure Seven. Percentages of pine types.

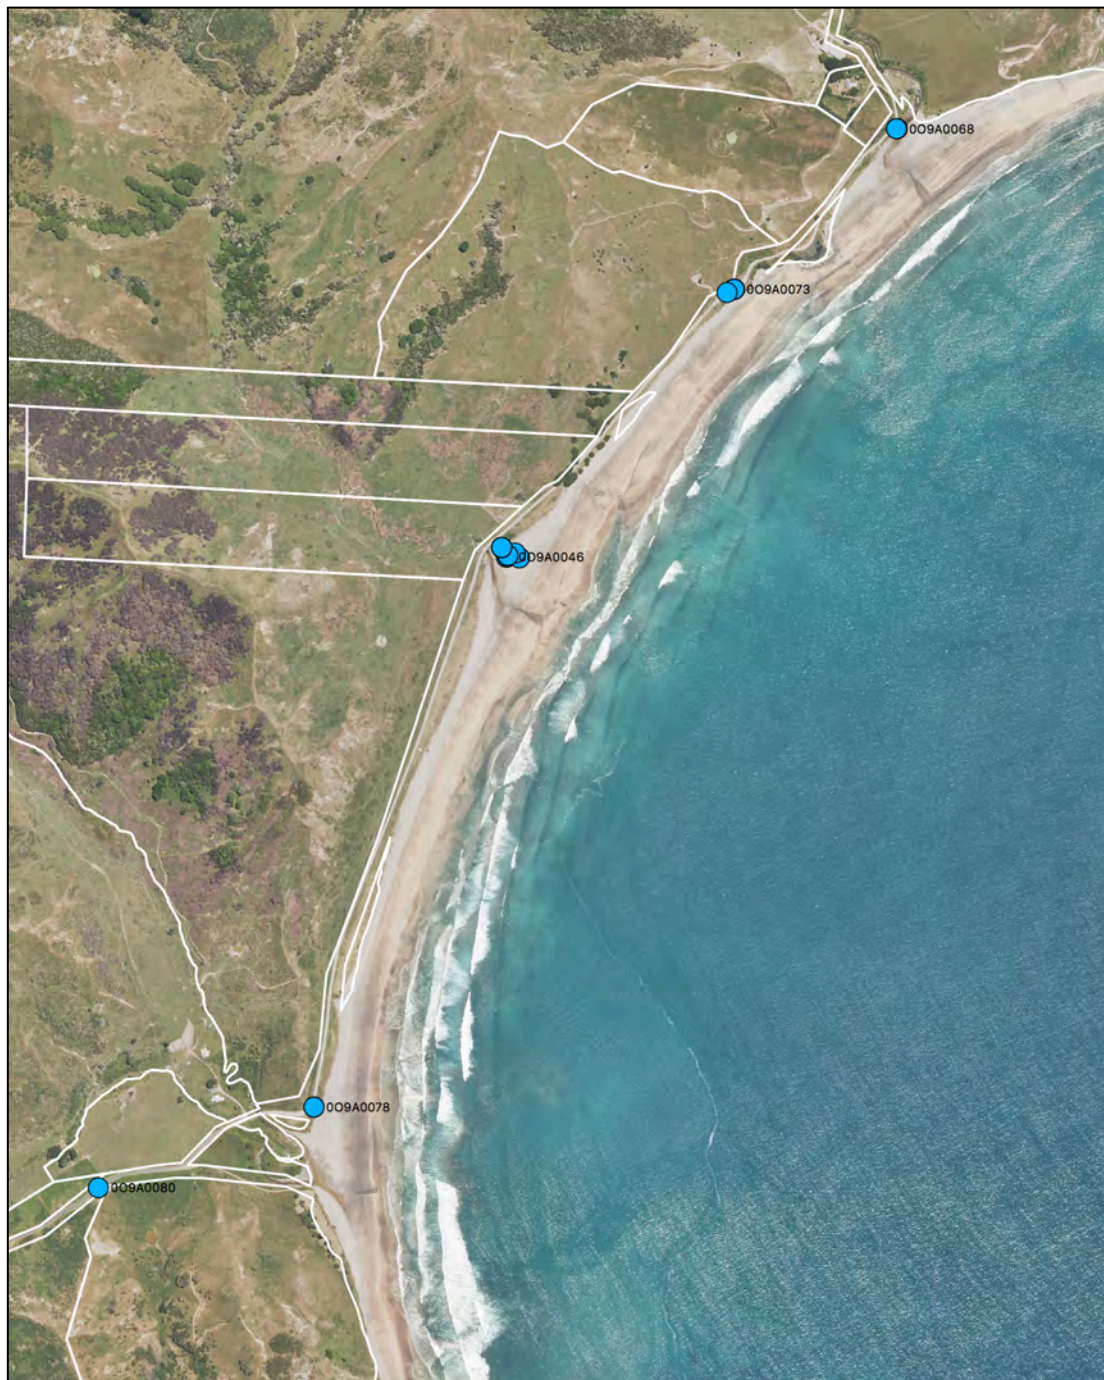
Kaiaua Beach was assessed by a drone overflight and an on the ground inspection. It is clear from the overflight and on the ground inspection that the overall volume of material is far less significant than at Tolaga Bay. The material is, however, collected at key points against headlands and in the mouths of creeks (**Figure Thirteen**). At the north end, pine logs are clustered around the creek and for about 100m to the north (**Figure Fourteen**). South of this creek there are some logs which concentrate towards the headland immediately south (**Figure Fifteen**).

Figure Thirteen. Kaiaua Beach showing locations where photographs of debris were taken. This coincides with debris locations except the southern images where the debris is further south.

It is envisaged that a digger with a small bucket and thumb loading to a tractor with a large caged trailer would be able to move the material to an adjacent rough paddock for burial within ½ to 1 day. There is poor access to the beach just south of the creek but a better option would be via the farm and the north side of the creek. Access to the paddock for burial would, of course, need to be negotiated.
