Post Restorative Justice Conference Assessment Gough property, Paroa Road

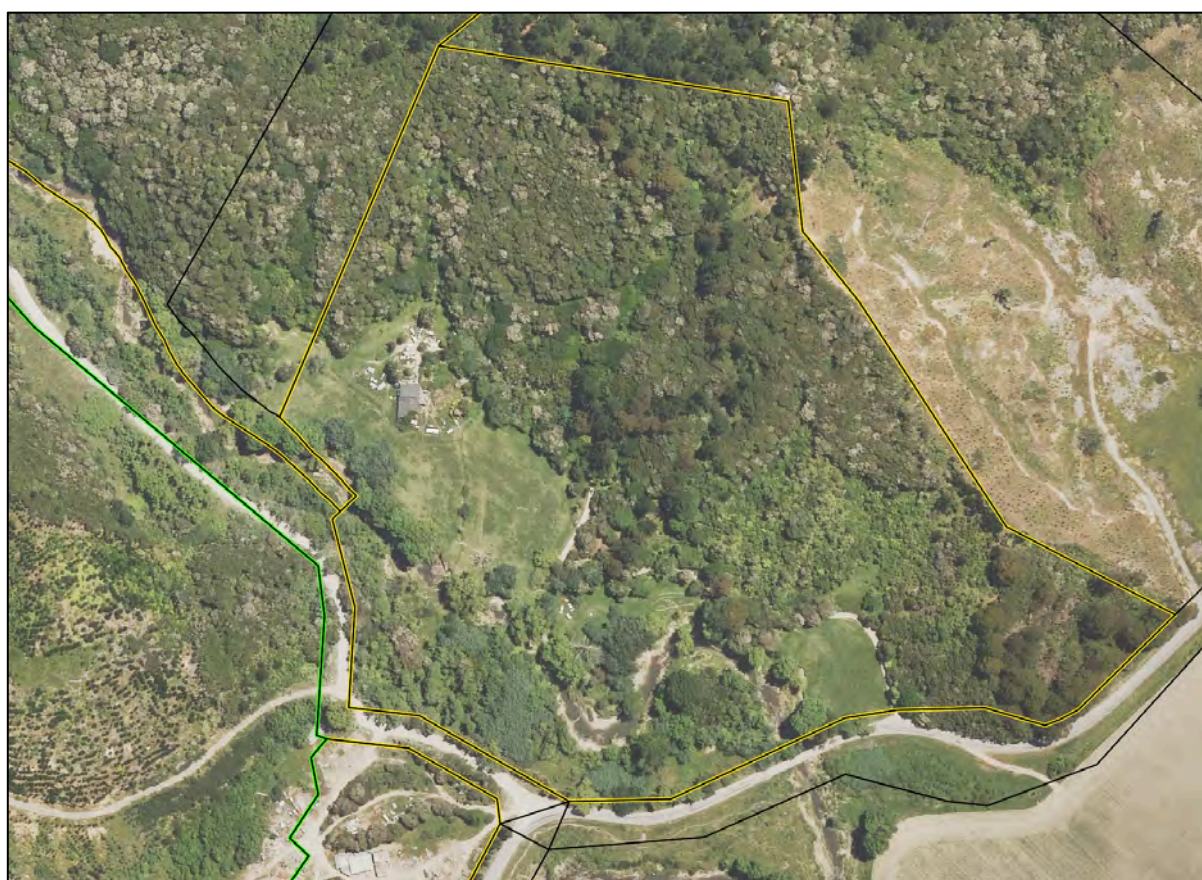
Figure One. The Gough property (outlined in yellow) situated north of Paroa Road and largely on the true left side of the Mangatokerau River (pre-event aerial imagery dated January 2018).

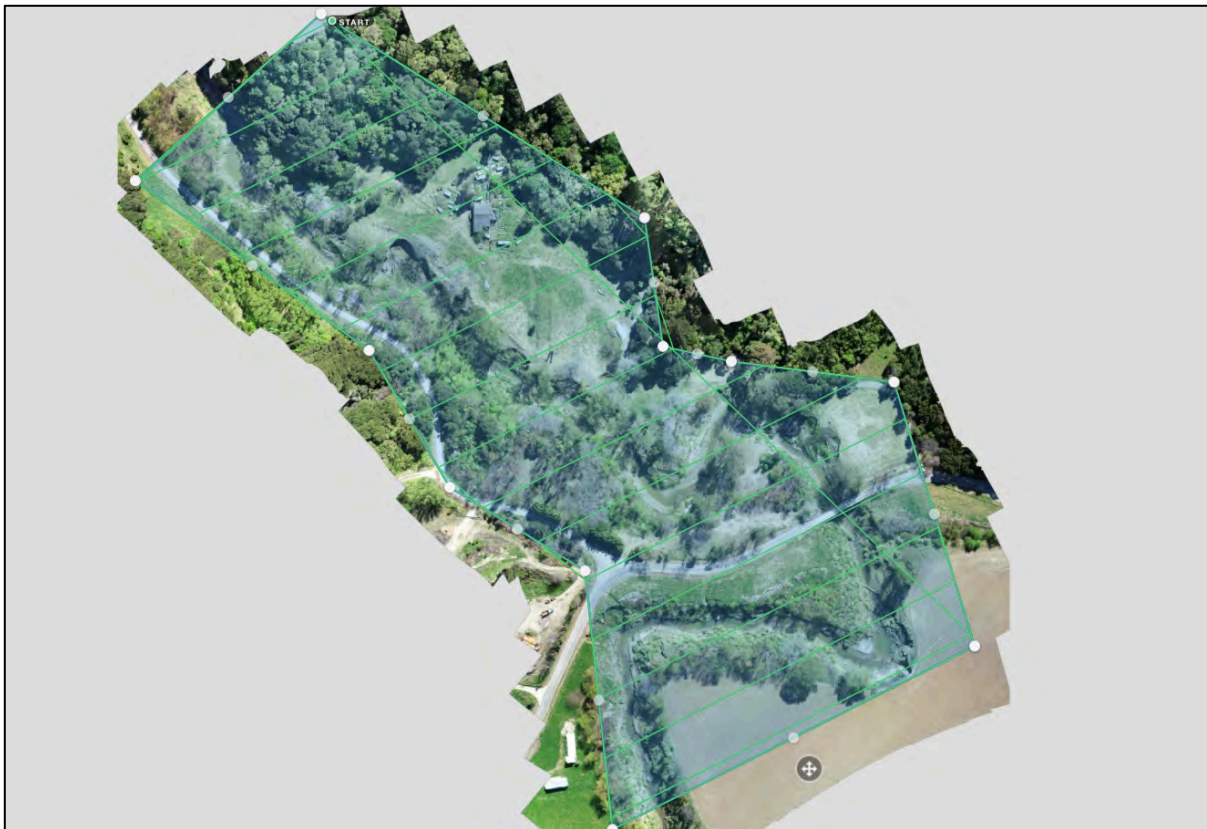
Figure Four. Flight path and coverage of the 27th of September 2019 orthomapping.

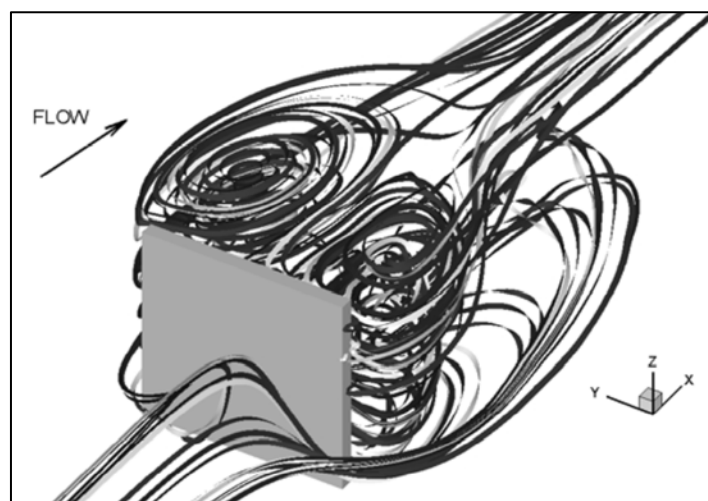
Figure Eight. *Example of a computer simulation of flow around a rectangular barrier in a flowing channel (Kirkil and Constantinescu 2009). As this shows the barrier converts laminar flow into turbulent flow characterised by eddies or vortices immediately downstream.*

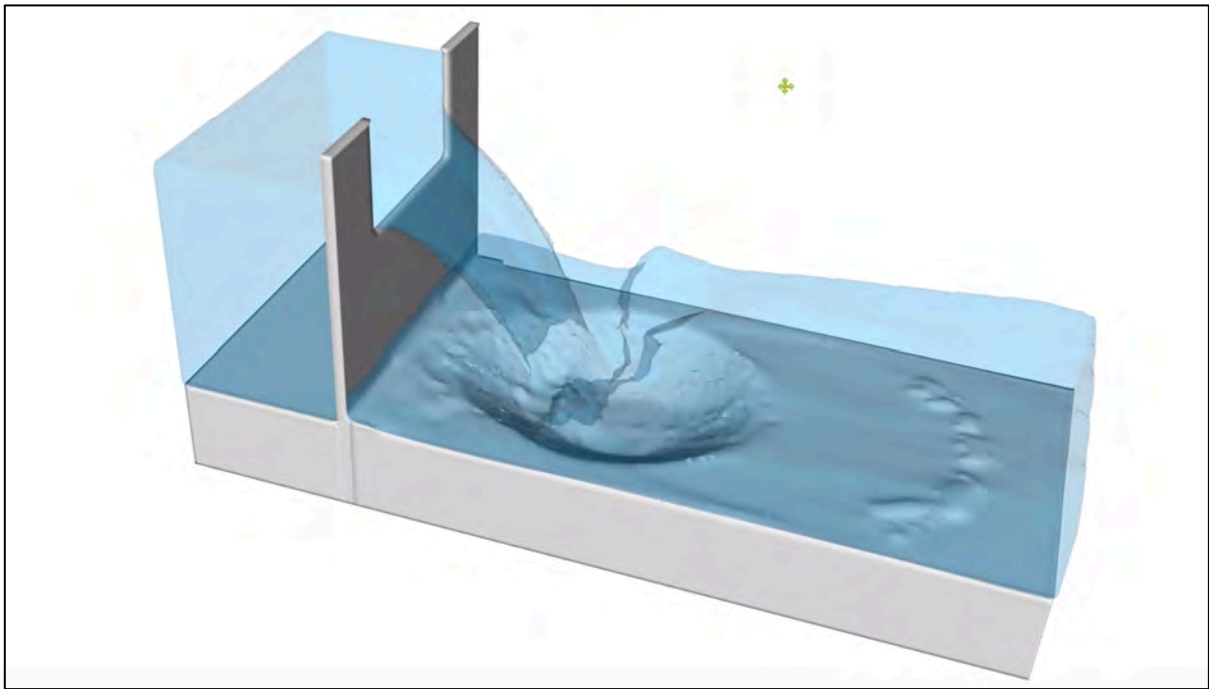
Figure Nine. Screenshot from a simulation of scour effects of flow through a notched weir.

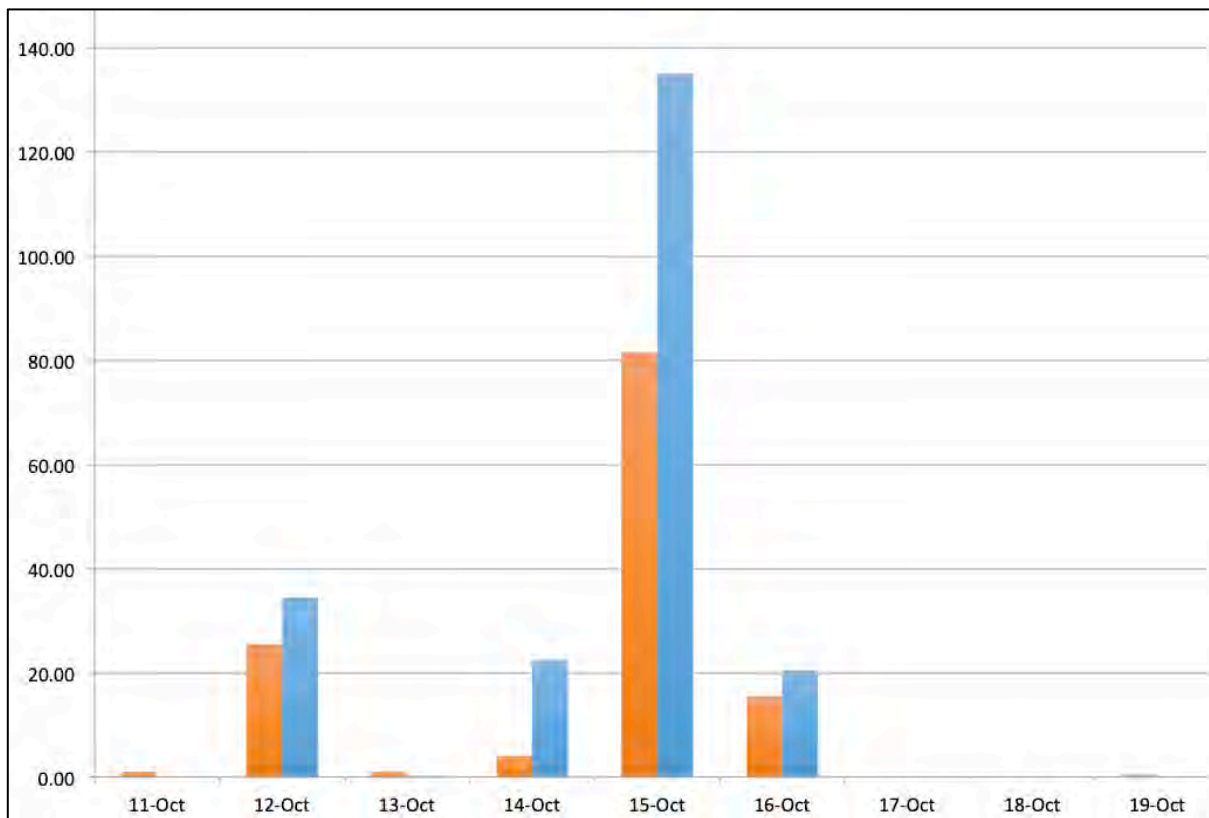
Long range weather forecasts on the 9th of October indicated the potential for a significant storm to hit the region in the following week. It was therefore decided to defer design of the remediation because of the possibility that the storm would result in floods that would flush out the log jam. The storm duly hit on the 15th of October and the rain accumulation at the closest rain gauge (Hikuwai at Willowflat) was 81.5mm on the 15th October. This is equivalent to an ARI of just under 2 years (**Figure Eleven**).

Peak flow in the Hikuwai River was 133 m³/sec (cumecs) at the Hikuwai at Willowflat rain gauge. There are no flow records for the Mangatokerau but a comparison of debris in photographs taken at the same site on the Gough property before and after the storm indicates that flood heights reached around 1.5 to 2m and did not overtop the river bank.

Figure Eleven. Rainfall accumulation for the Mangaheia and Willowbank (blue) and Hikuwai at Willowflat (orange) rain gauges.
