**Forestry Harvest Residues  
on slopes in Makiri Forest  
and in the Upper Waipaoa Catchment  
after the Storm of 11<sup>th</sup>-12<sup>th</sup> June 2018**

**M.P Cave  
Principal Scientist  
Gisborne District Council**

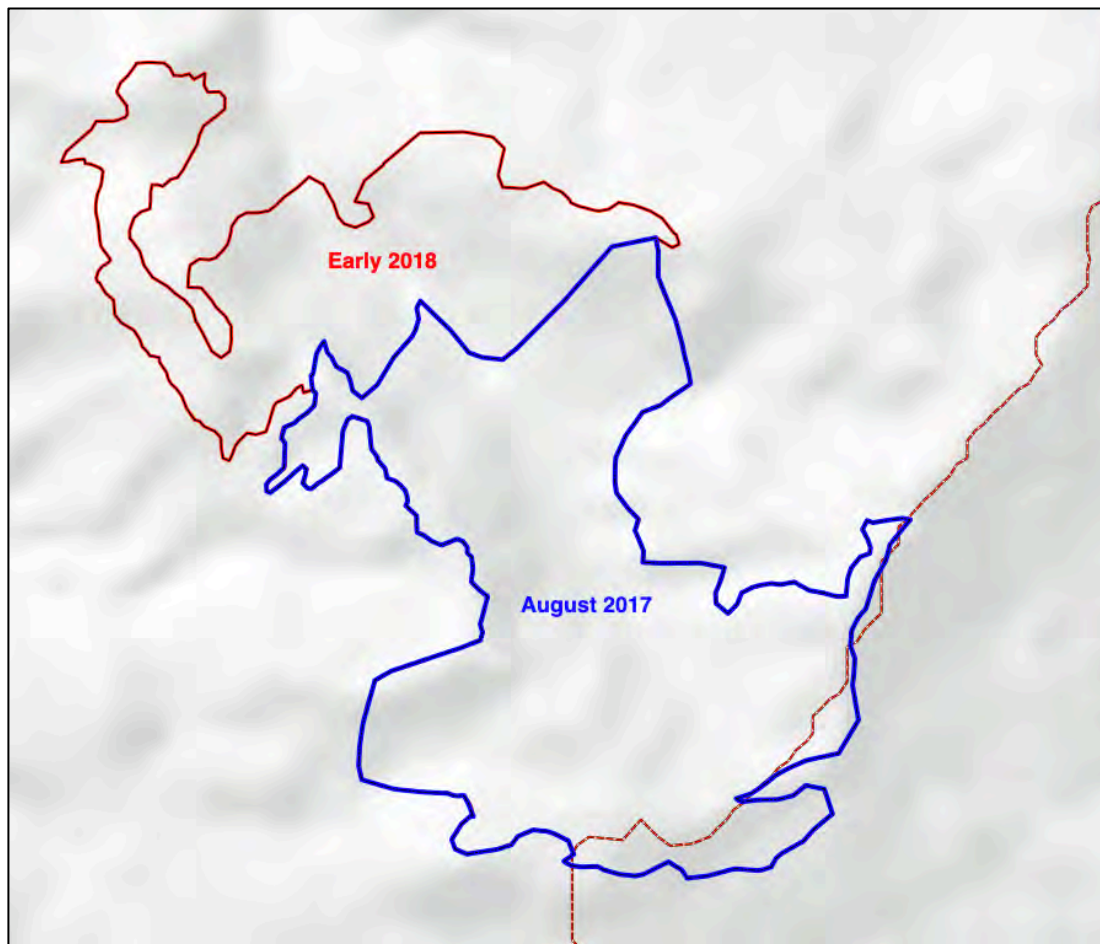
Harvesting in Makiri Forest was initiated in 2017 and by the 17<sup>th</sup> of August 2017 58.25 Ha of forest had been harvested. Harvesting activity ceased in early 2018 with a total of 87.1 Ha of harvest completed. Active harvesting and maintenance of the forest ceased in early 2018 due to a dispute between the forest owner and contractors (**Figure Four**).

**Figure Four.** Makiri Forest showing the areas harvested by August 2017 (58.25 Ha) and at the end of harvest in early 2018 (87.1 Ha).

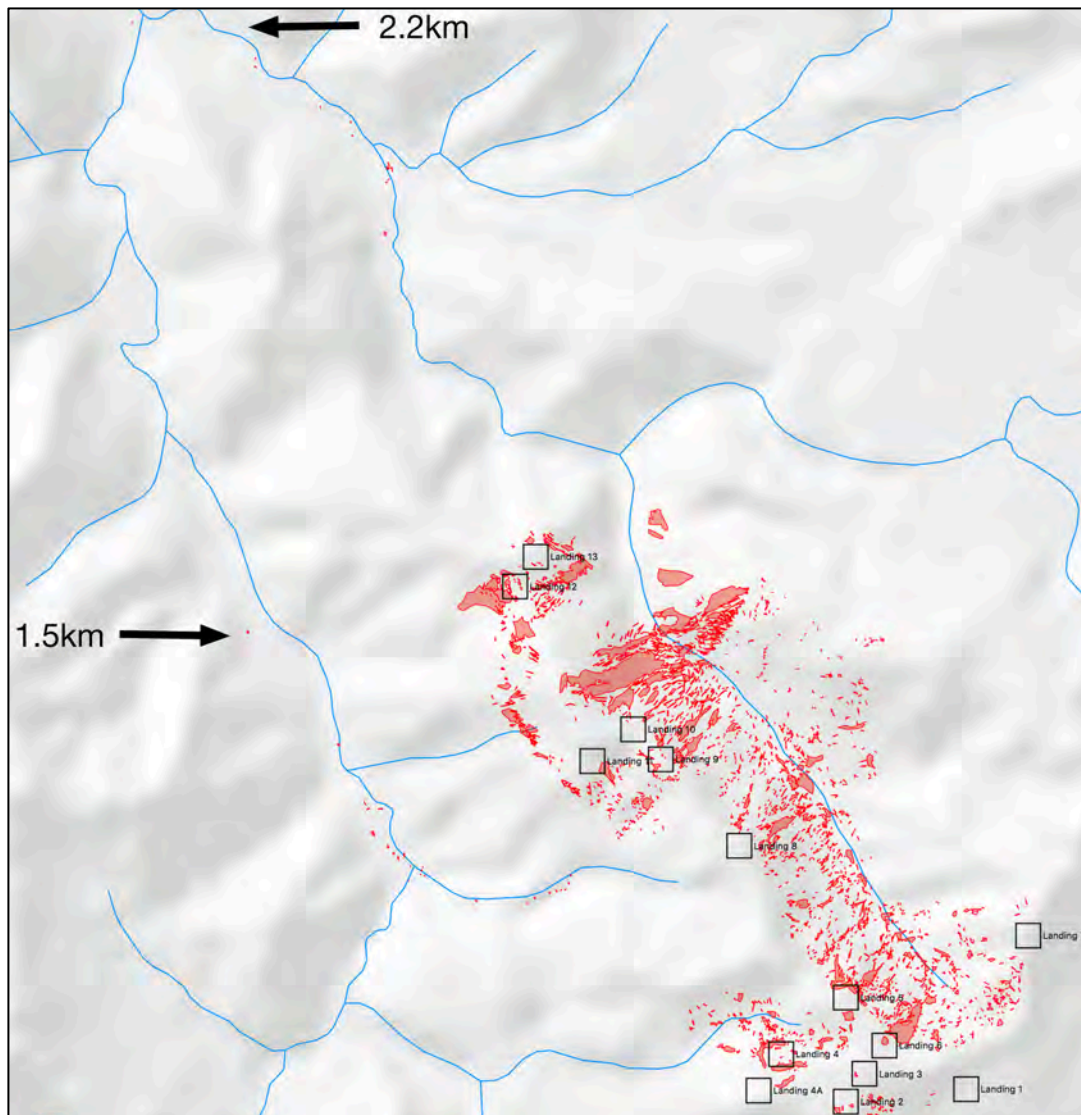
The Waihora River area below Makiri Forest is rugged and inaccessible until the valley widens out at Bruce Road, Kanakania. As such, the Council relies on landowners or contractors to report the presence of slash on their properties. In the case of Makiri, no downstream reports were received but once the high resolution satellite imagery was available, the harvest waste could be traced downstream. The harvest waste from Landing 9 (see **Figure 30** above) could be traced 1.5km down the true left branch of the Waihora while harvest waste from the north-east side of Makiri West Road could be traced 2.2km down the true right tributary of the Waihora River to its confluence with the main branch (**Figure Forty One**).

**Figure Forty One.** Map showing the distribution of harvest residues immediately downstream of Makiri Forest in the tributaries of the Waihora River.

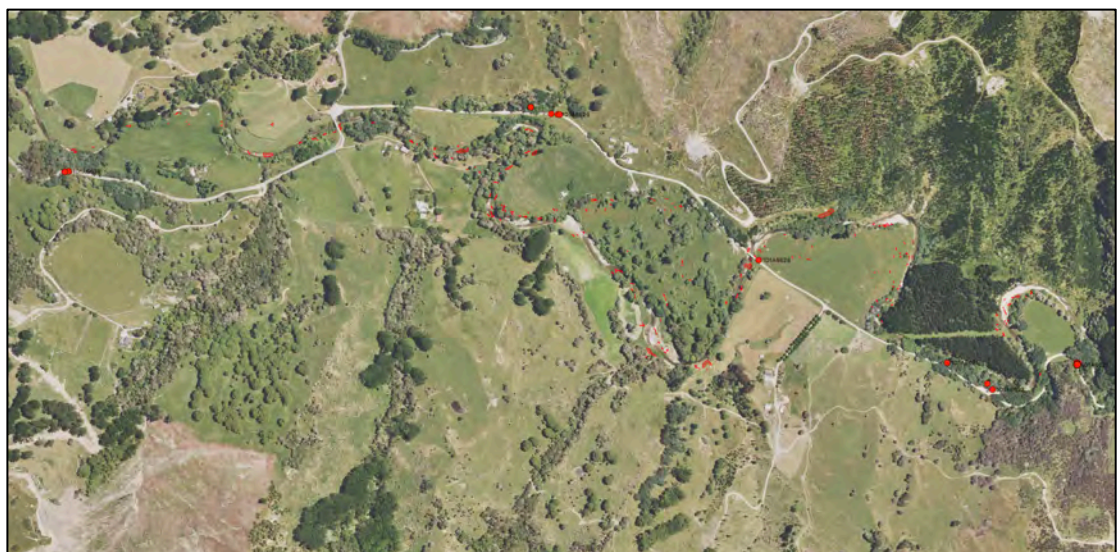
Following the identification of slash in the satellite imagery, the Kanakania-Bruce Road area was visited on the 7<sup>th</sup> of June 2019 and locations recorded on the satellite imagery verified (**Figure Forty Two**). This confirmed that slash had been washed downstream after the second Queens Birthday storm with a local landowner also reporting that at least 100 tonnes of slash had been caught up on river flats within the farm (Brian Milligan pers comm June 2019).

**Figure Forty Two.** Aerial image of Kanakania Bruce Road area showing slash plotted from the satellite imagery and the on the ground photograph locations.
