**IRBA**

**Geotechnical engineering  
aspects of forestry  
operations, Uawa catchment**

**for  
Gisborne District Council**

**Project 1273**

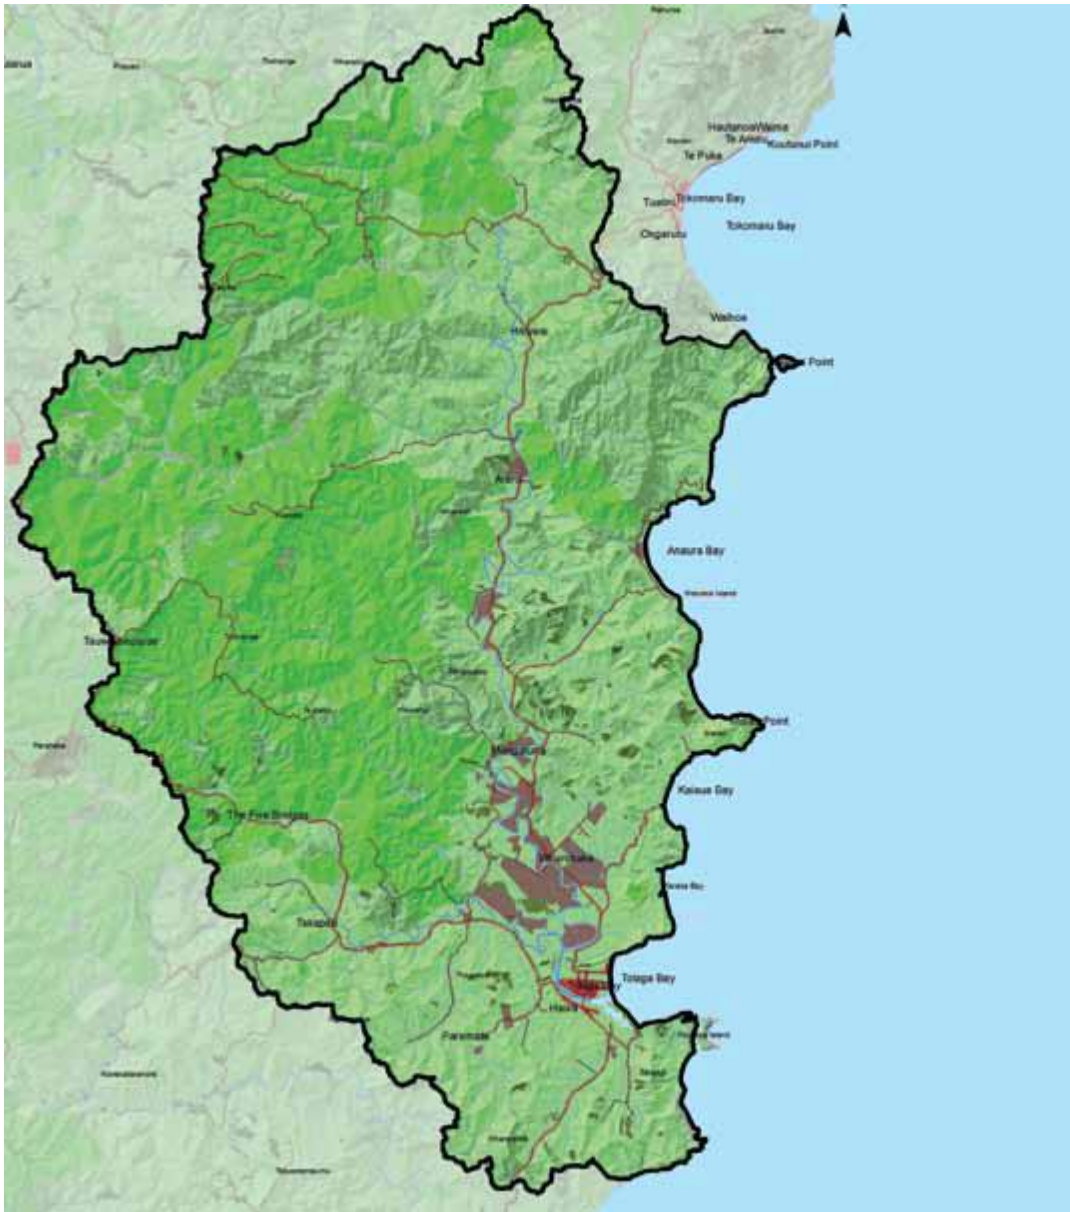
Figure 3 Uawa catchment land cover

Dark green – planted forest and shelterbelts
