Fresh Water Resources

Principal findings

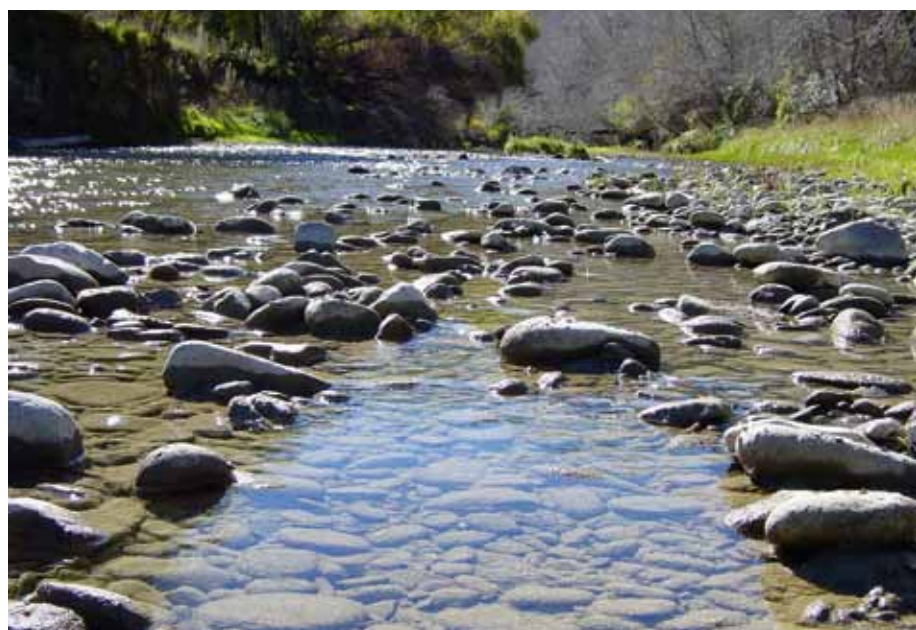
Above: River flows were very low, and very clear, over summer 2007 – 08.

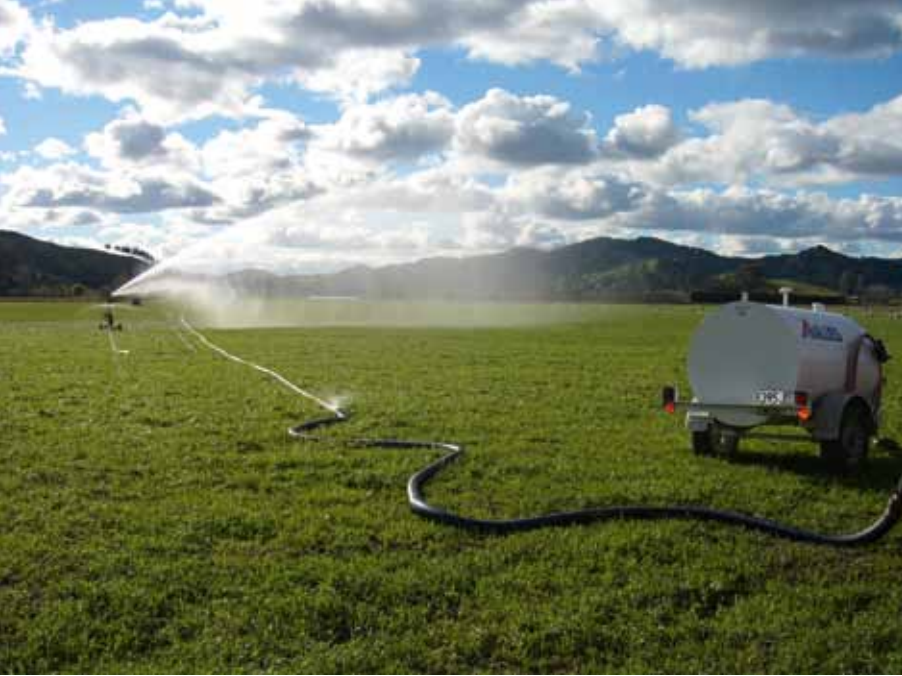
Above: Irrigation of pasture, seldom seen in Gisborne District, became a fairly common sight over the very dry summer of 2007 – 2008.

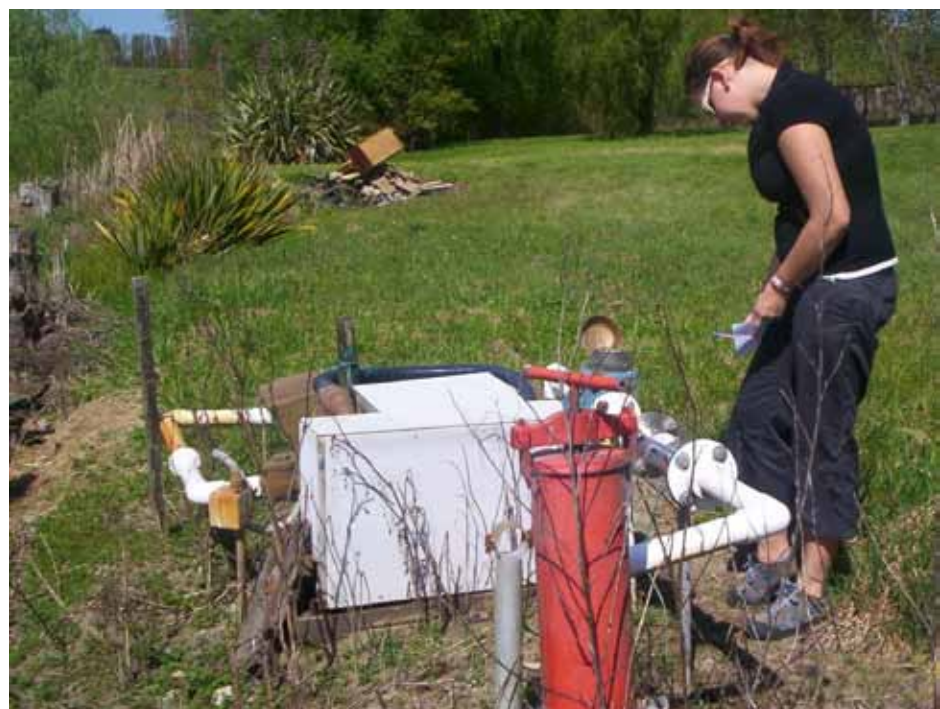
Above: GDC staff member taking a water-meter reading.

Gisborne District is in a unique situation to be able to conduct a study like this: every water-take in the District is metered, and users are required to provide returns to Council on a regular basis, stating exactly the volume of water they have used. This situation is a legacy of the 1980s kiwifruit boom, when it seemed water resources were becoming stretched. As a result, every permit holder was required to have a meter installed, and that requirement has continued to the present day.

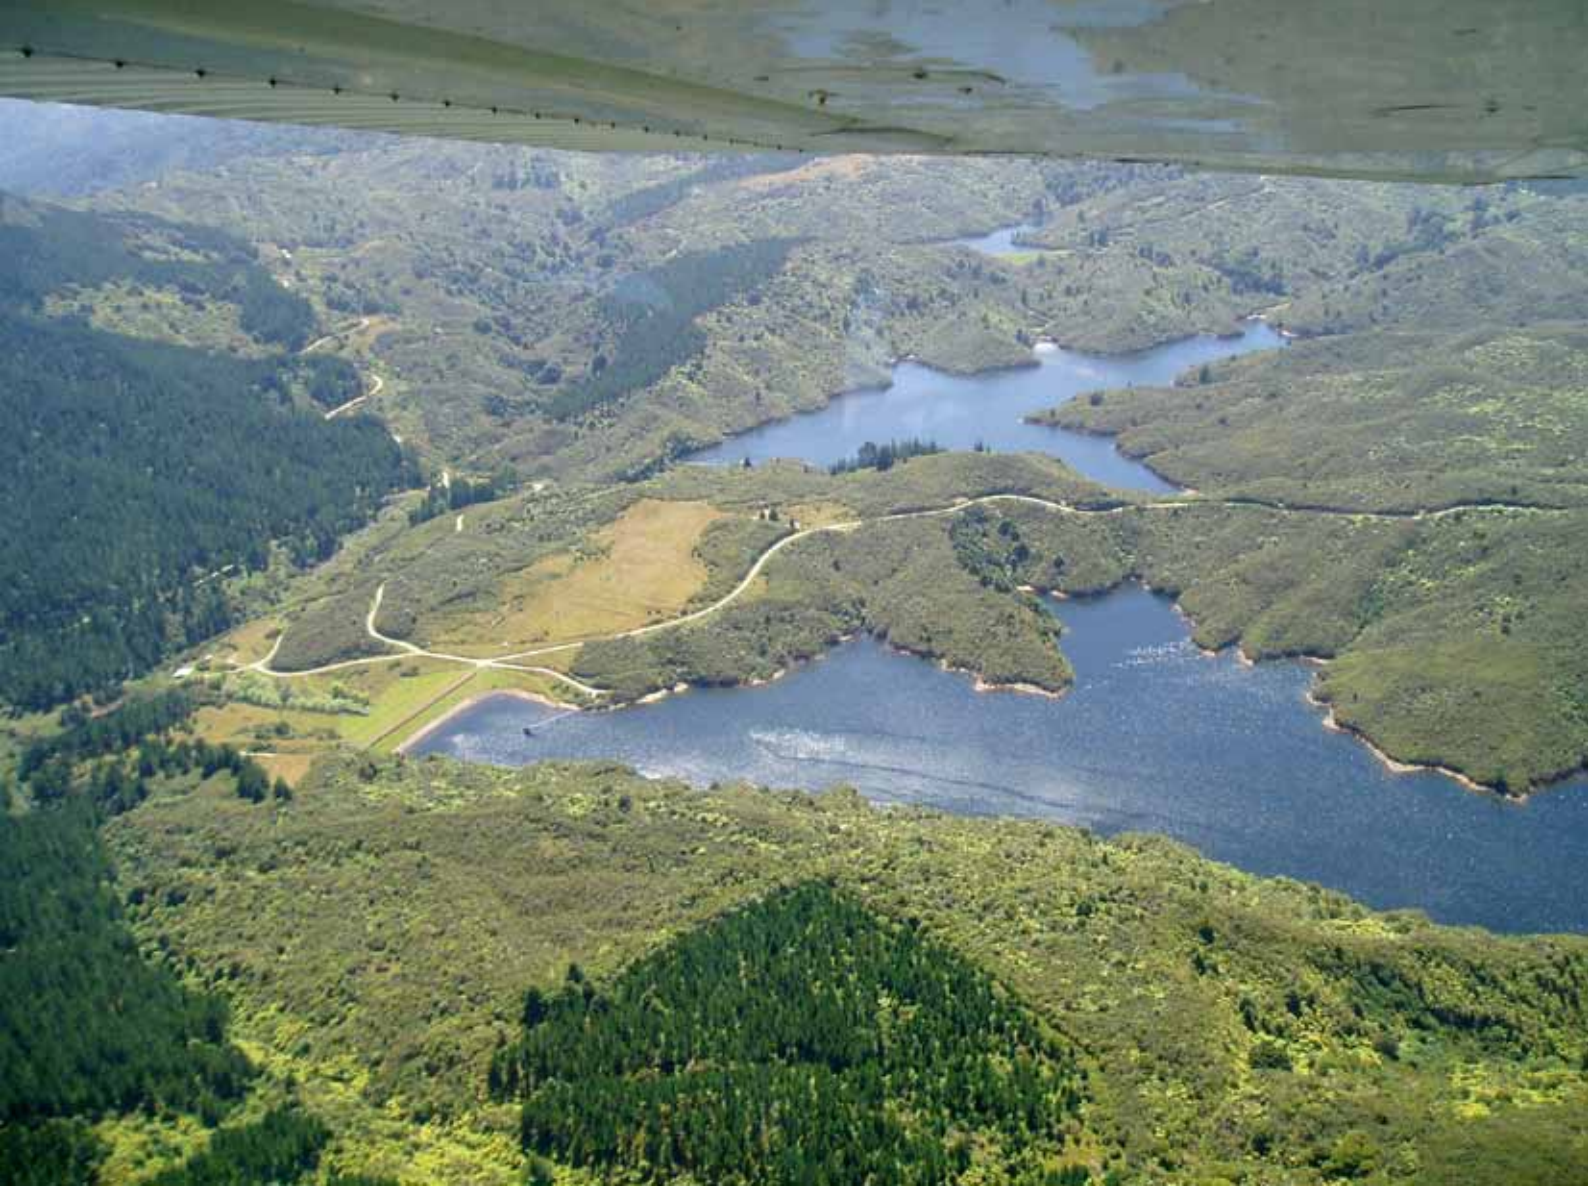
Above: Mangapoike Dams from the air.

In the 1940s the Council of the day purchased 450 hectares of land at Mangapoike and constructed 3

dams: the Sang Dam (347,568m³) that gravity feeds into the Clapcott and Williams Dams (1,121,365m³ and 2,291,864m³ respectively). Raw water is also sourced from the 1,100 hectare Te Arai bush catchment. Nearly all of Gisborne’s water supply is being treated at the Waingake treatment plant.

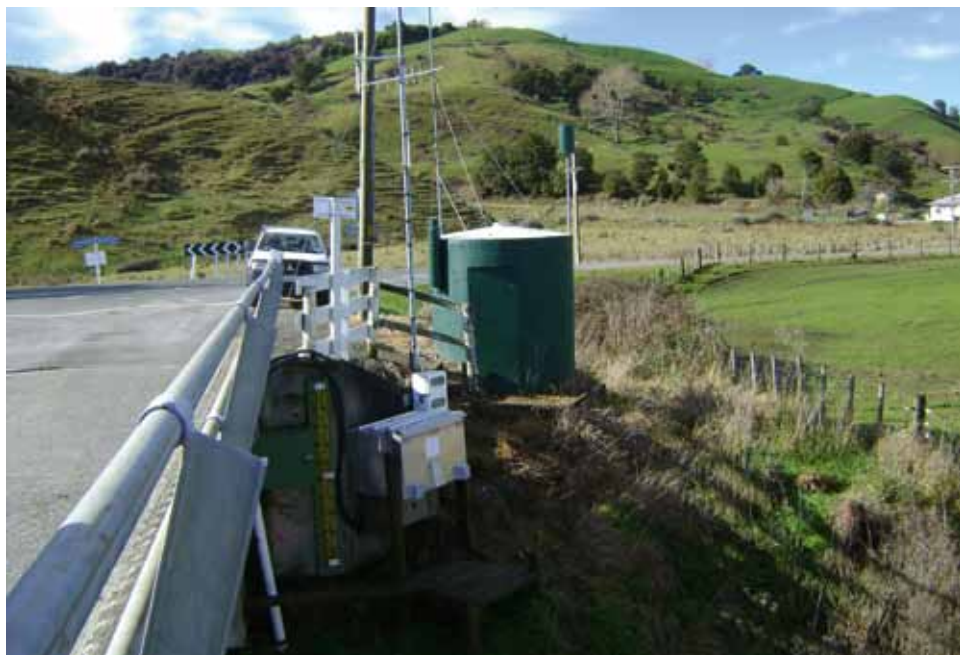
Above: Kanakanaia telemetry station, which records data on the Waipaoa River.

The job is done by forty-two automated telemetry stations, that record some or all of the following information at key locations: rainfall, water levels, water flows, temperature, wind direction, wind speed, and humidity.

The telemetry stations automatically send the data via UHF radio to the software system Hydrotel, operated by staff at the Gisborne District Council, enabling staff to view the latest values for all the telemetry stations in the District at the click of a computer mouse.

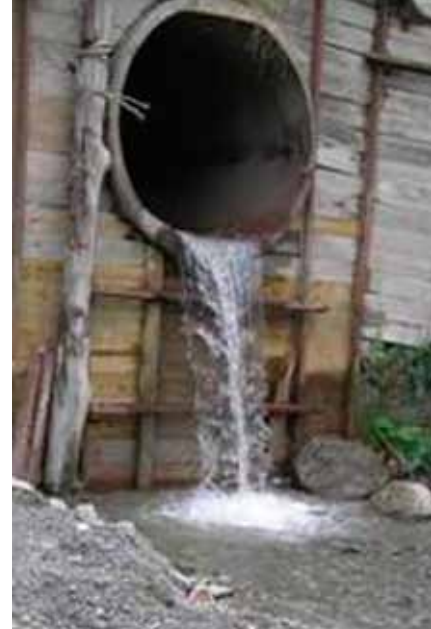
Above: Culverts with a 'drop' such as this prevent fish passage.

These tiny migrating fish are able to conquer some incredible physical obstacles, such as rapids, natural waterfalls, and even land for short distances. However many fish need low-speed zones and wetted margins at the water's edge which climbing species can traverse. Just a single, impassable man-made barrier in their path, debris build up around structures and floodgates, concentrated too-fast water, thinly-spread too-

shallow water, or a culvert that's too long and dark, can prevent fish from completing their lifecycles leading to catastrophic decline in fish populations.

In 2008 the Department of Conservation surveyed all in-stream structures on public roads and some on private property within the Waipaoa Catchment. There were 169 in-stream structures that would impede or prevent fish passage, 81% of them culverts, 17% fords and 2% were combined types of structure. DoC staff determined that around 16% of fish habitat within the Waipaoa Catchment was unavailable to fish due to these barriers.
