BEFORE AN INDEPENDENT HEARINGS COMMISSIONER

IN THE MATTER a resource consent application and an objection to a decision of the Gisborne District Council by Simon Cave concerning a revetment wall at the toe of the cliff below 4, 6 and 8 Tuahine Crescent, Wainui Beach

**STATEMENT OF EVIDENCE OF SAMUEL CASEY MORGAN
FOR SIMON CAVE**

COASTAL PROCESSES

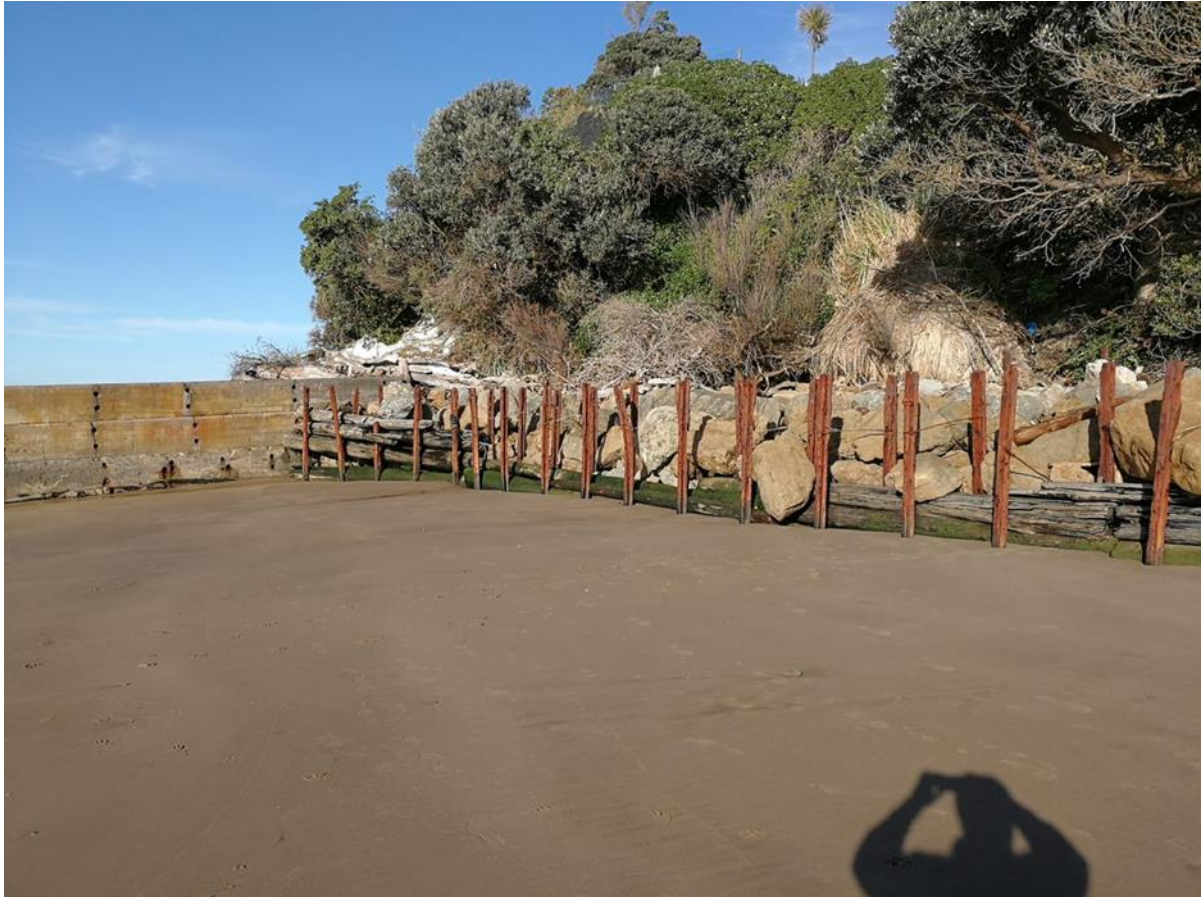
- 6.1** The structure currently is considered to have deteriorated from what was initially constructed and documented in prior consenting processes. Figure 1 below shows the present state of the structure with only the lower logs acting to retain the rocks remaining. Displaced rocks and deformed railway irons are also noted. Based on discussions with the applicant a number of logs have been displaced and the rock material weathered and settled from its original condition.

Figure 1: The existing structure in 2018.

- 5.1** The existing structure is a hybrid solution utilising railway irons as a toe control to retain a rip-rap rock wall established against the toe of the cliff. The rip-rap rock serves to dissipate the incoming wave energy. However, this existing structure has now deteriorated to a stage where the railway irons can no longer be relied upon to maintain the stability of the rip-rap rock wall.

- 6.3** However, continued deterioration of the structure can be expected, and should the existing structure fail it is anticipated that the existing rock contained behind the railway irons would migrate on to and eventually cover the beach away from the toe of the cliff.
