## Appendix One

### Images from helicopter flight

### **Managatokerau Stream Traverse Images**

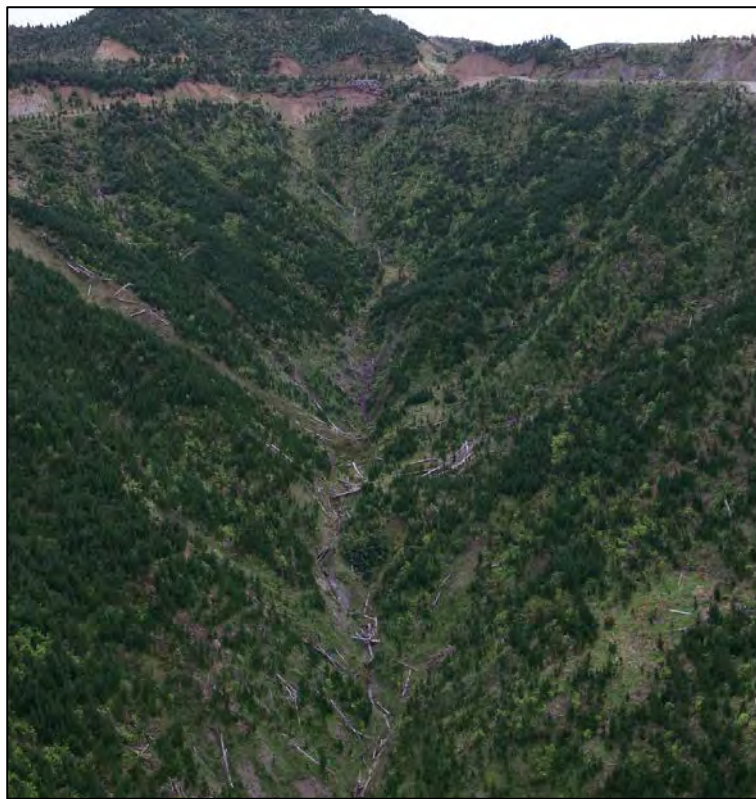
Image 1D1A0563 Waimanu Forest, Slash in gullies, sidecasting .

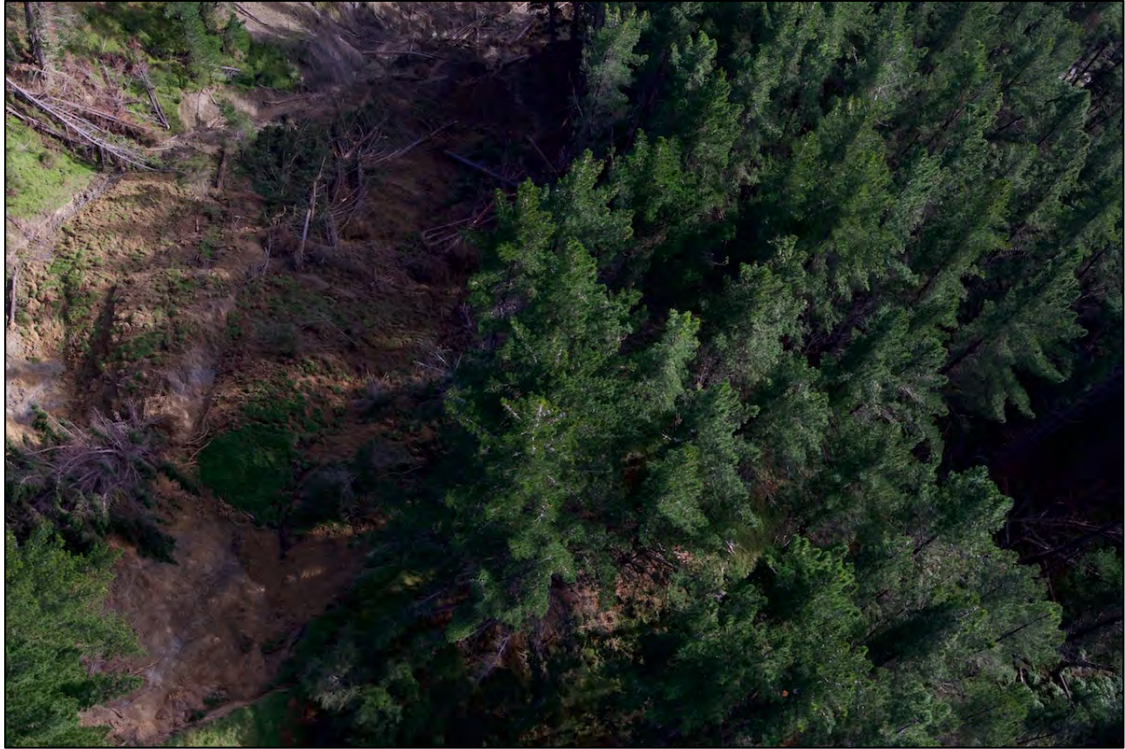
Image 1D1A0809. Doonholm Slip Tauwhareparae Road.

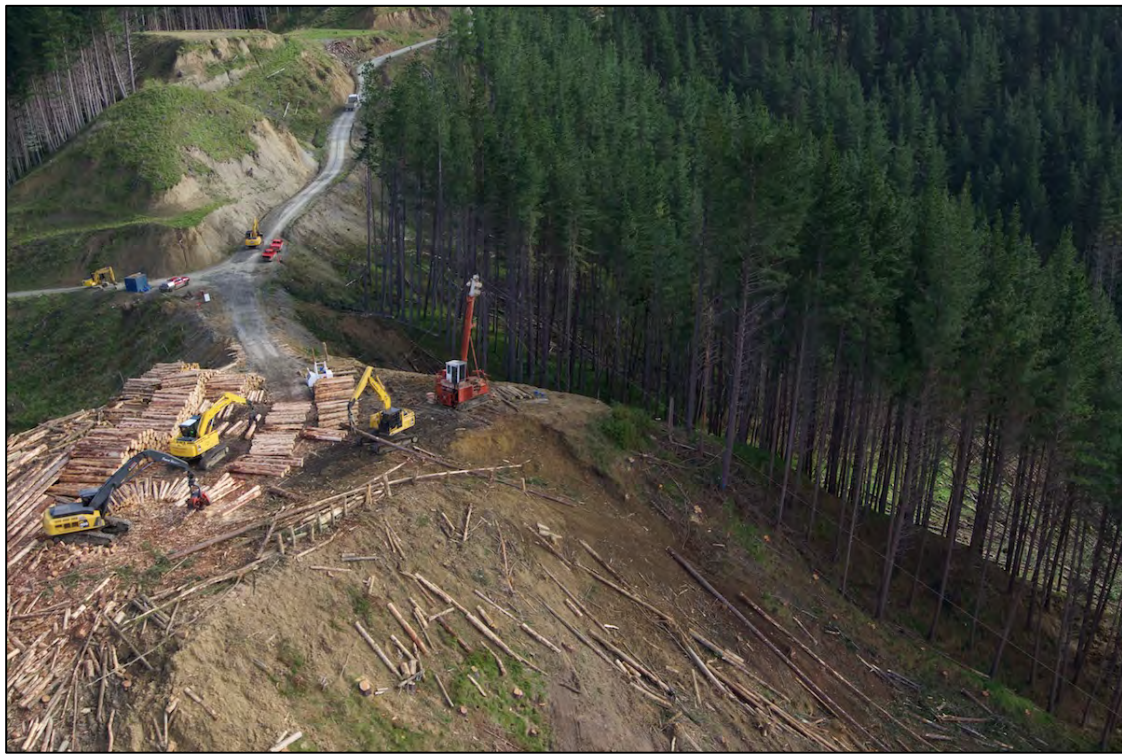
Image 1D1A0981. Operational landing, Mangatoitoi Stream, Tauwhareparae Road.

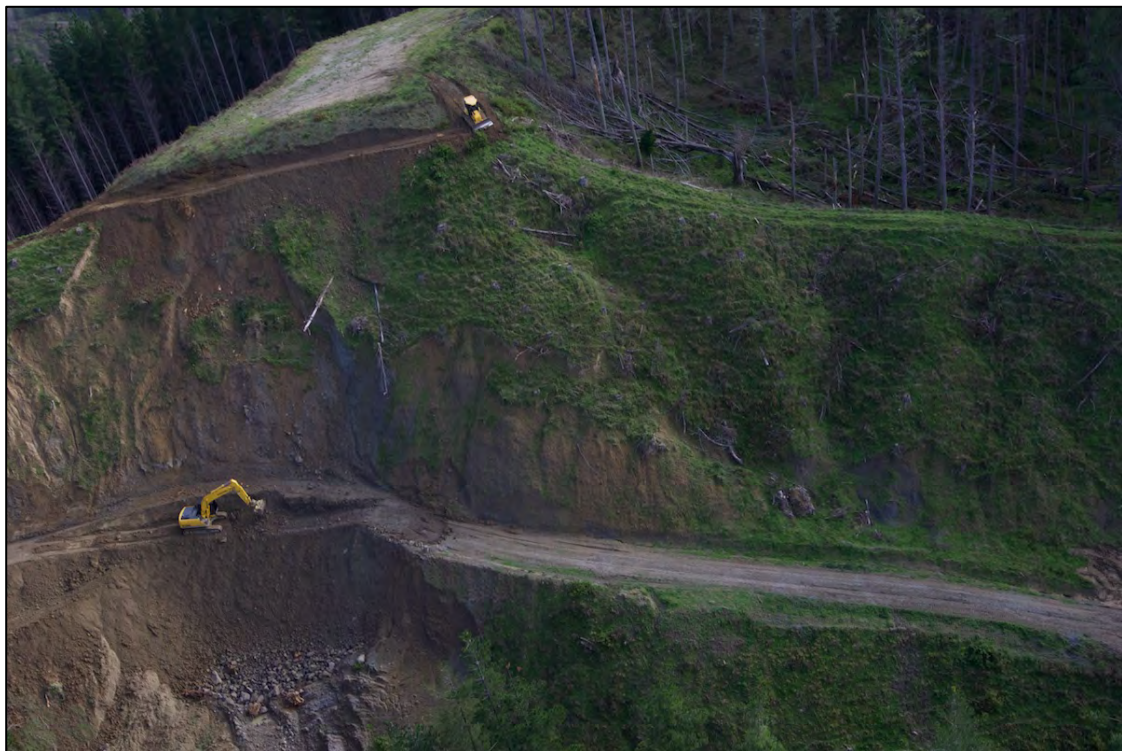
Image 1D1A0983. Forestry roadworks and slip clearing between Mangateao and Mangatoitoi streams, Tauwhareparae Road.

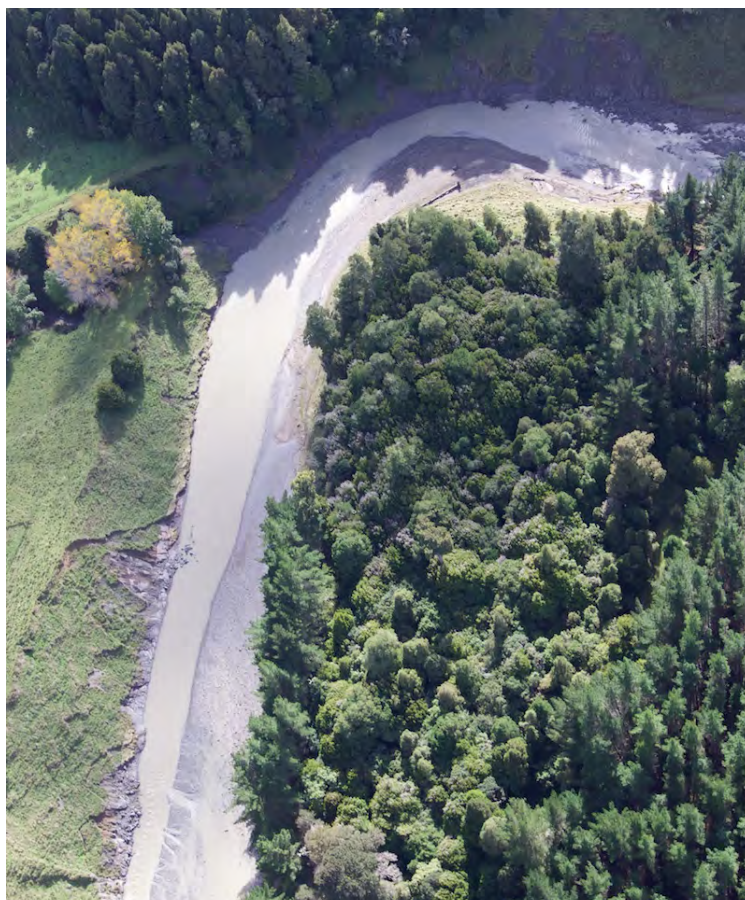
Image 1D1A1650. Mata River upstream of Whakoau Stream showing flood heights.

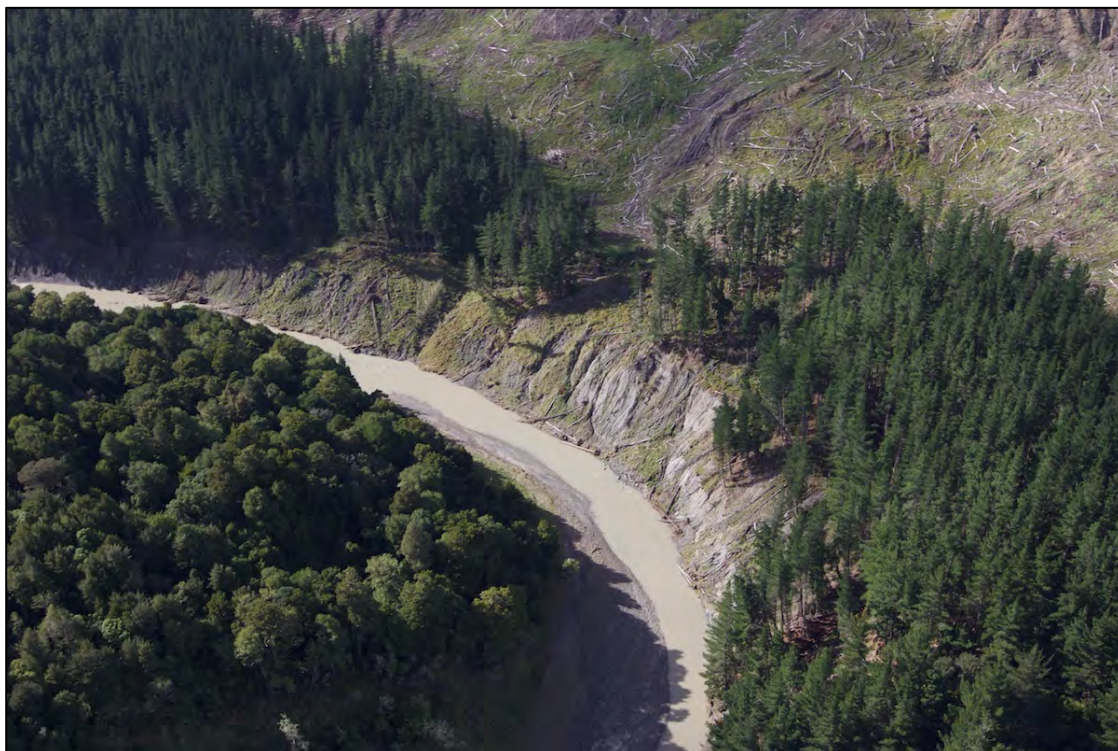
Image 1D1A1655. Mata River upstream of Whakoau showing buffer of trees left above steep bluffs on true right bank.

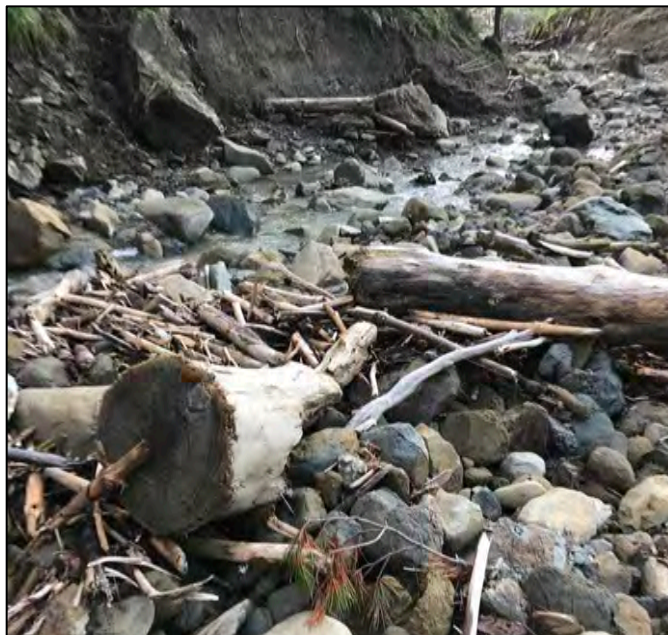
Photo of cut butt end, small dross and pine log. Base of Waterfall Creek, above road.

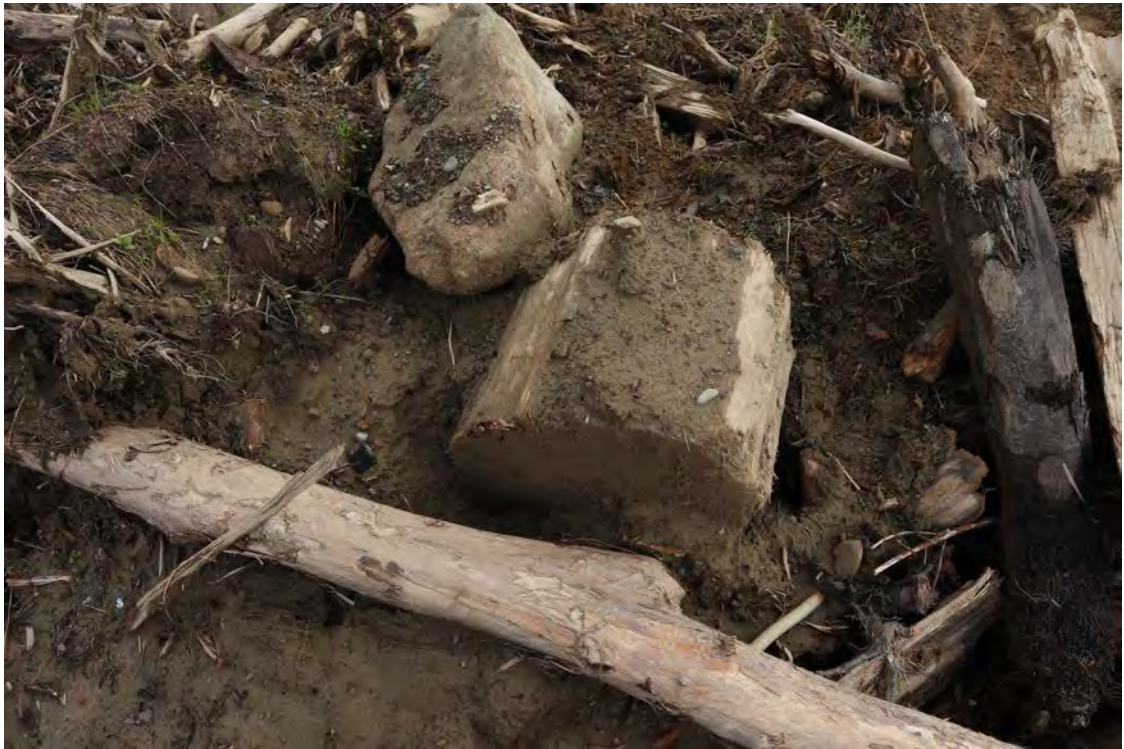
Cut butt end clean up area below road in Waterfall Creek.

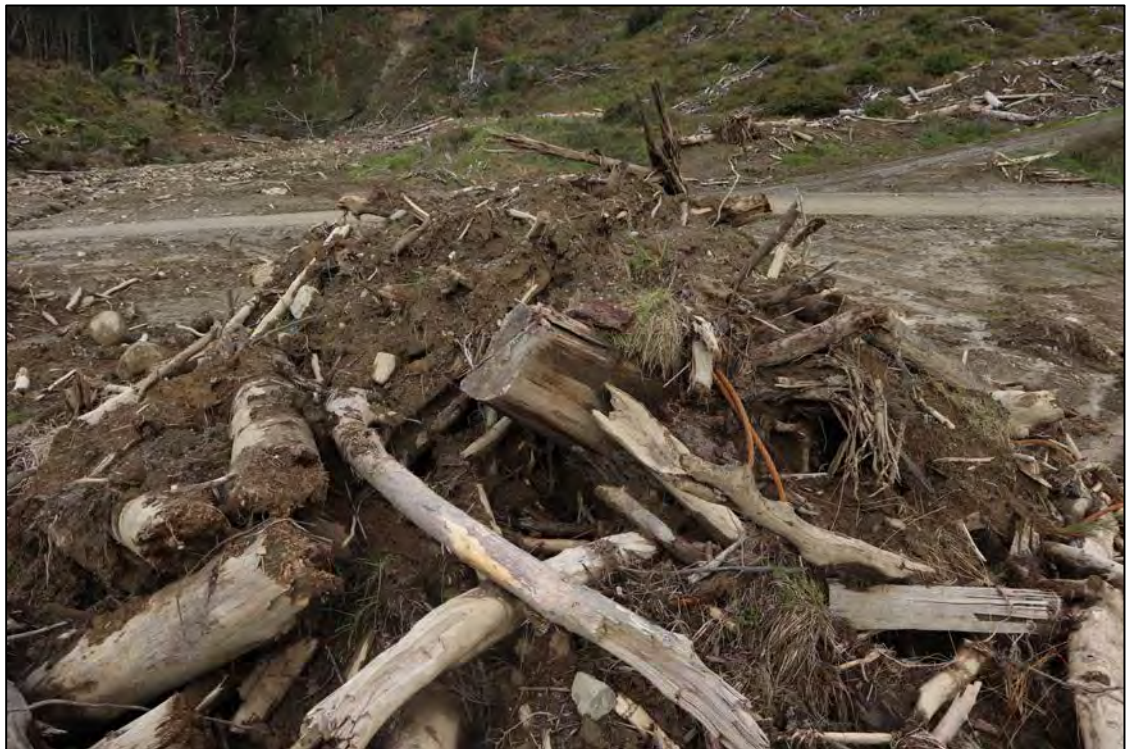
Log pile in clean up area below road at Waterfall Creek showing cut and broken logs.

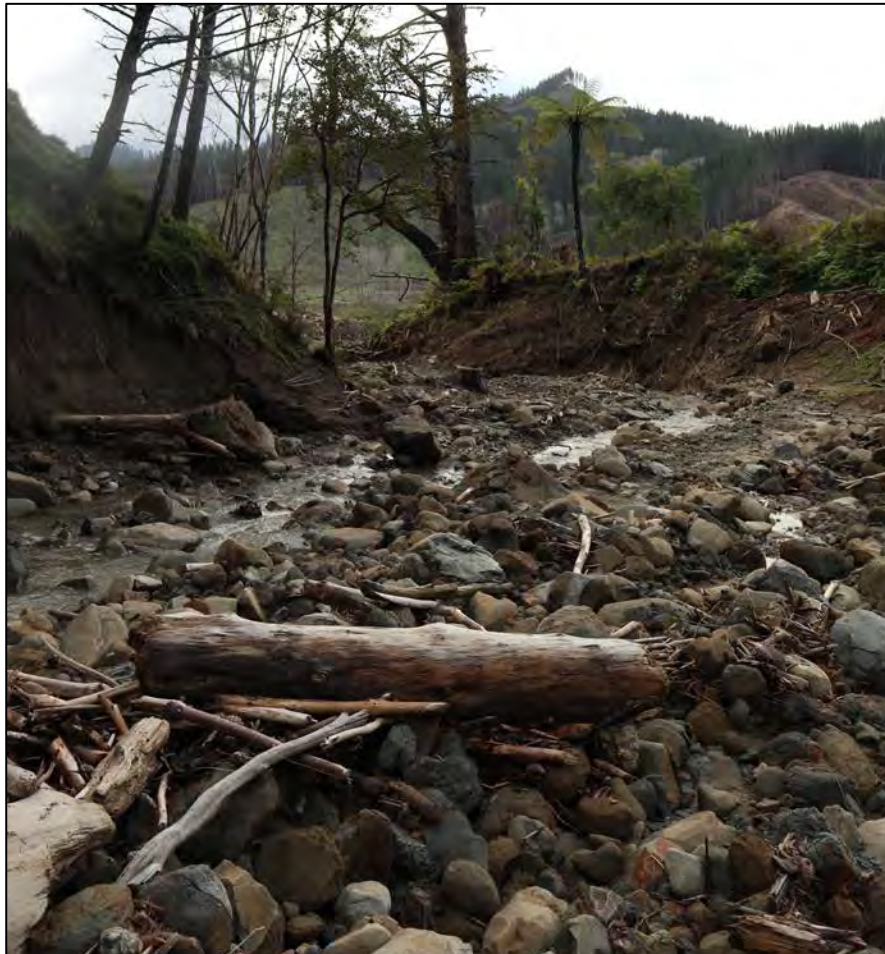
View of base of Waterfall Creek above road showing abraded end log, some dross and debris flow trim lines.

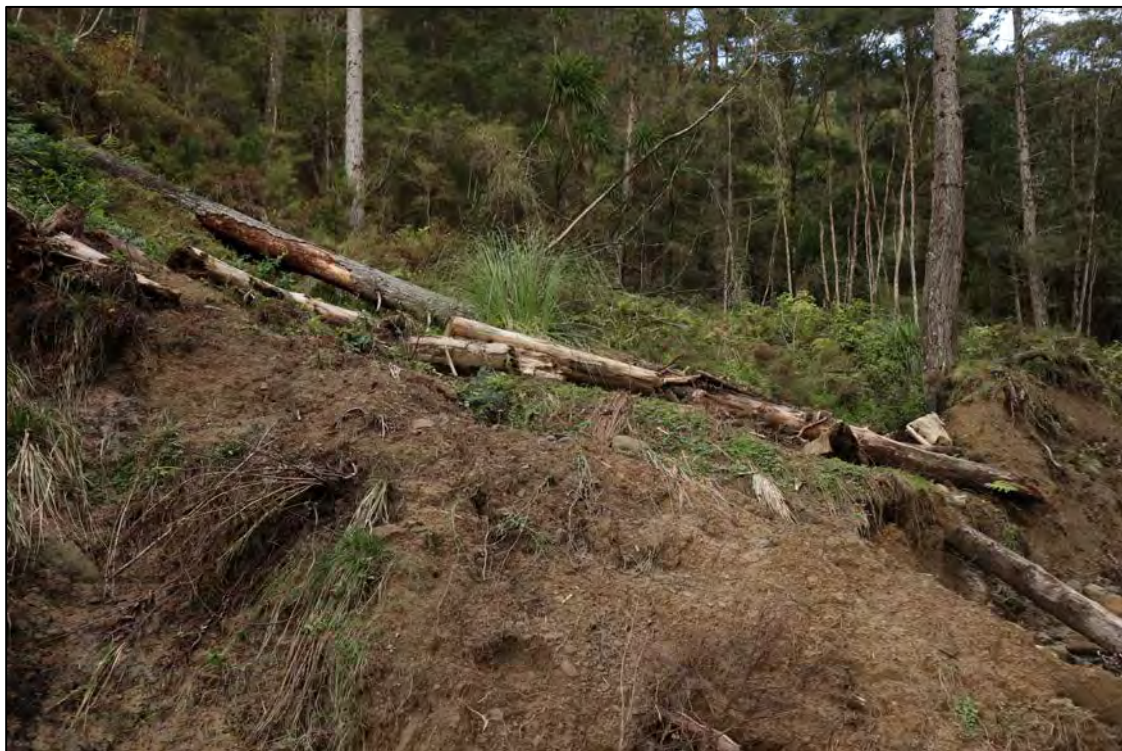
Logs on true left bank of Waterfall Creek showing height of debris flow.

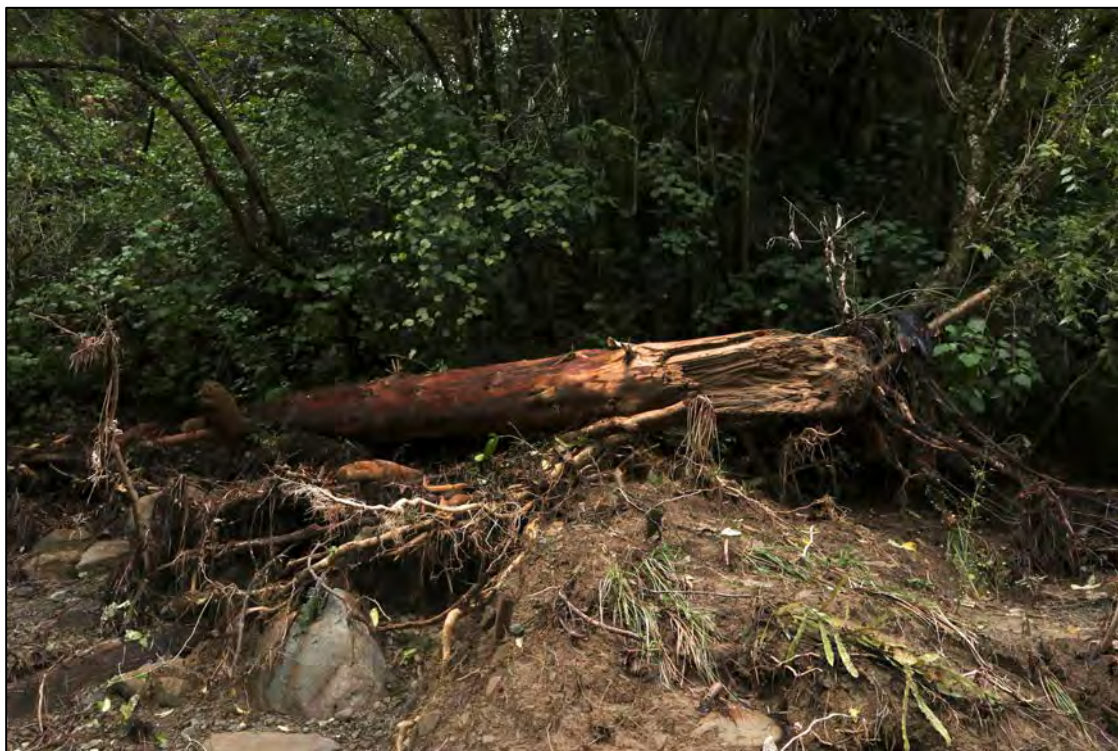
Pine log at debris flow height. Waterfall Creek

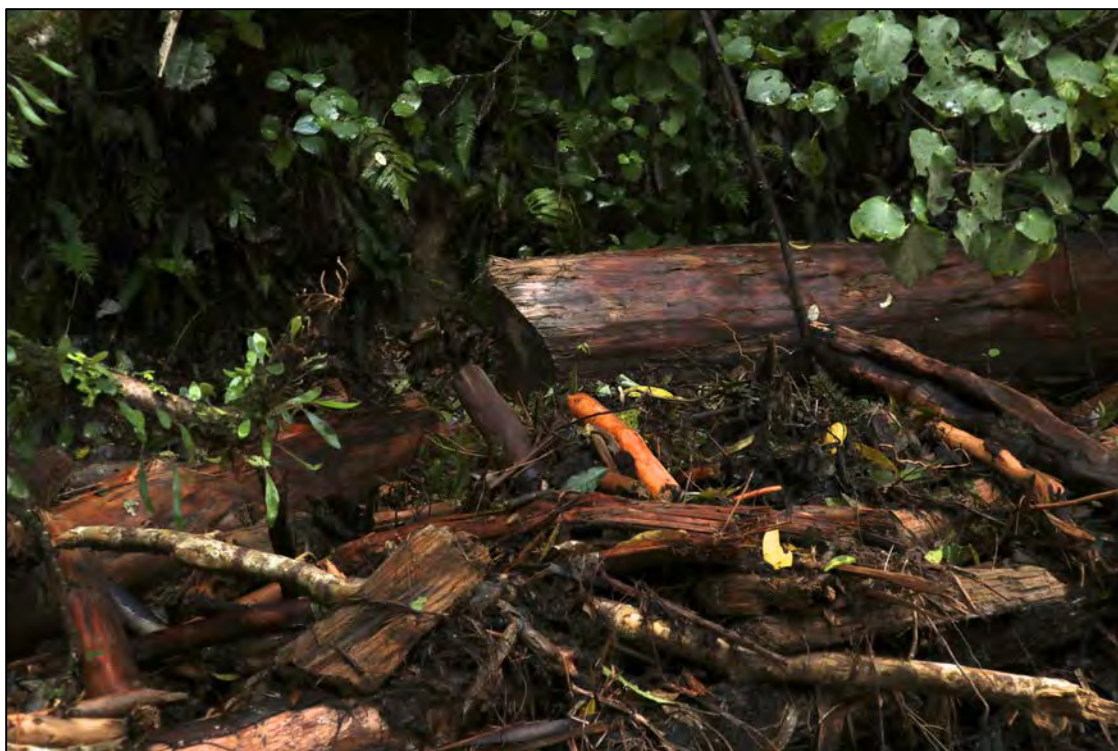
Cut pine log and dross. Waterfall Creek.

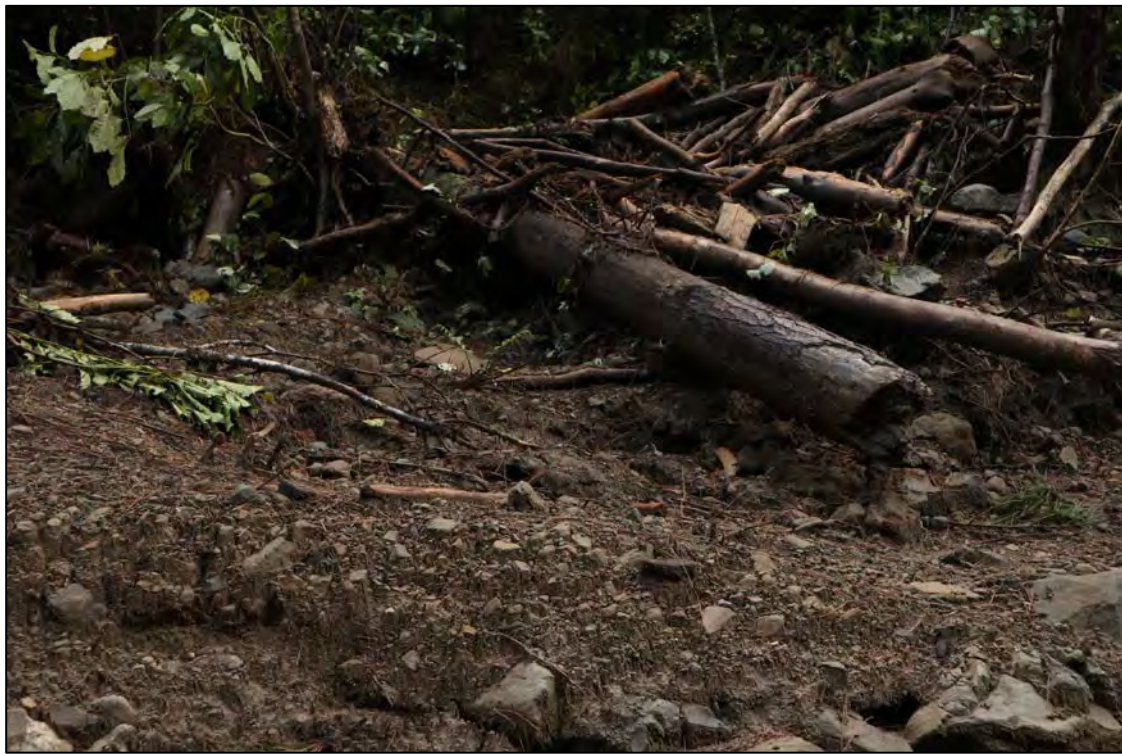
Pine log with bark still on and cut marks plus dross.

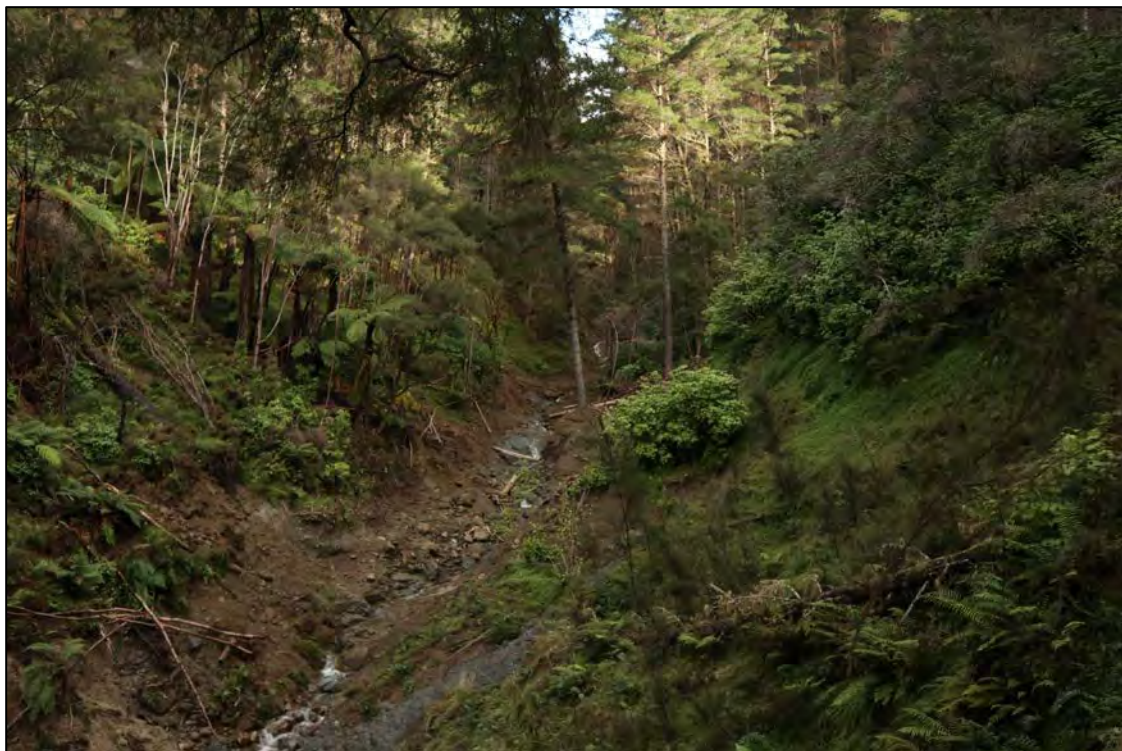
View looking down Waterfall Creek showing debris flow height.

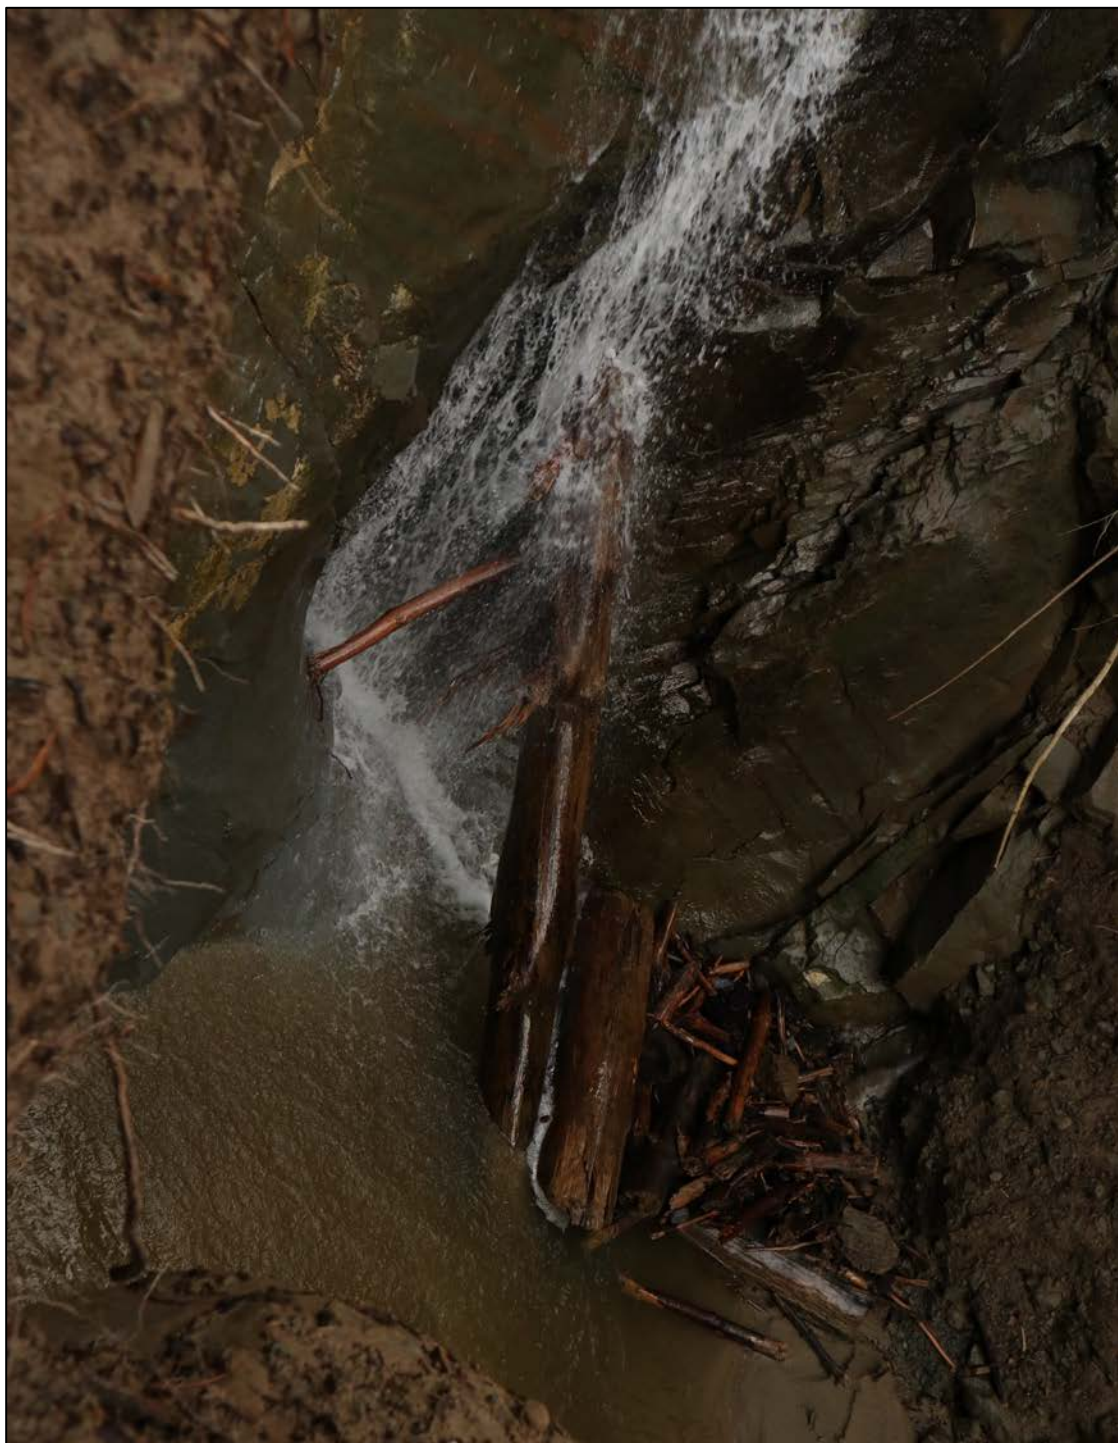
View looking down waterfall in Waterfall Creek showing pine logs and dross.

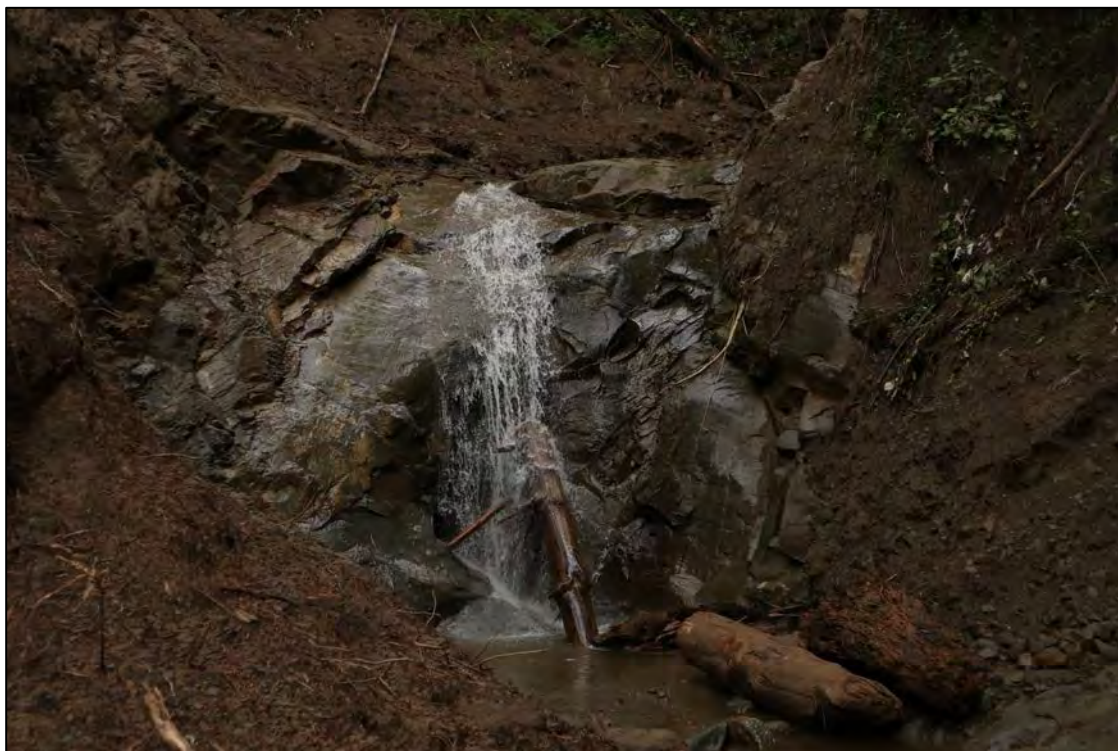
Waterfall in Waterfall Creek showing abraded pine logs.

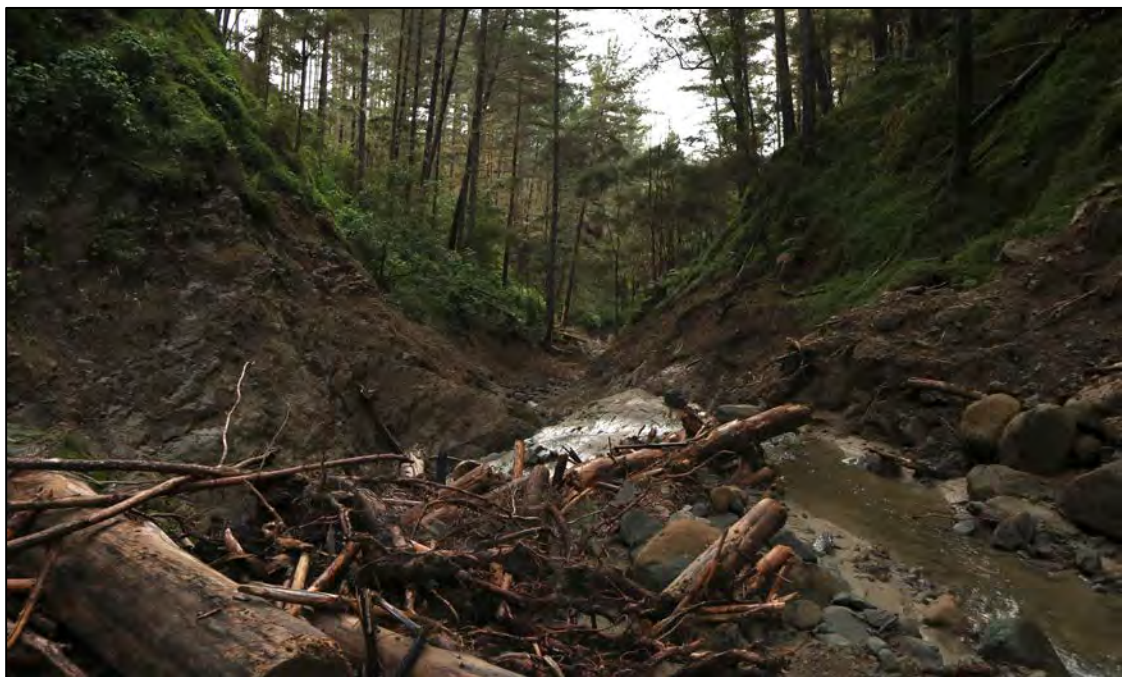
Cut log (bottom left) and dross in Waterfall Creek and debris flow trim lines.

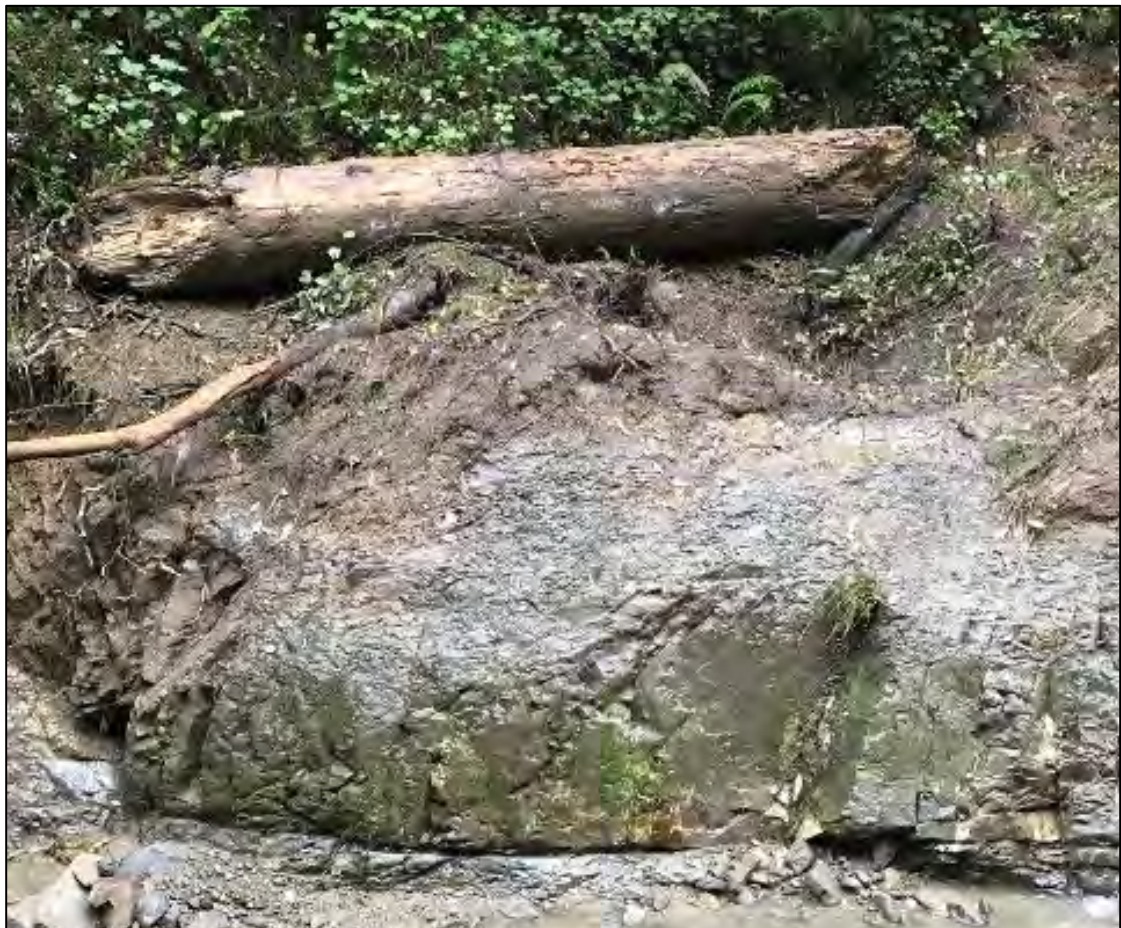
Low resolution GPS reference photo of abraded log, Waterfall Creek.

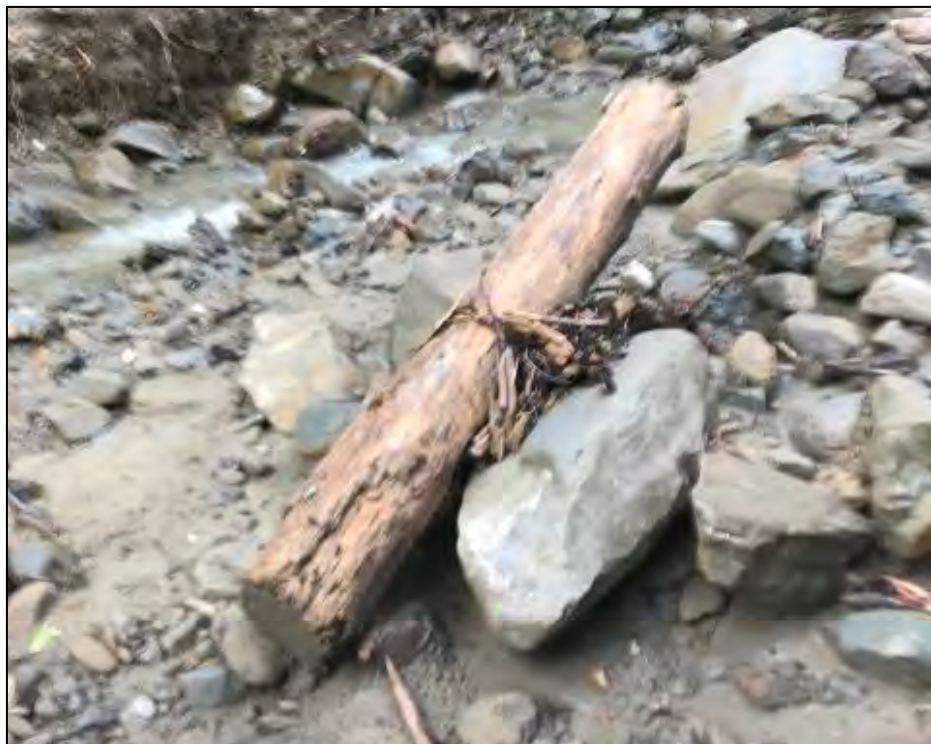
Low resolution GPS reference photo of abraded cut log, Waterfall Creek.

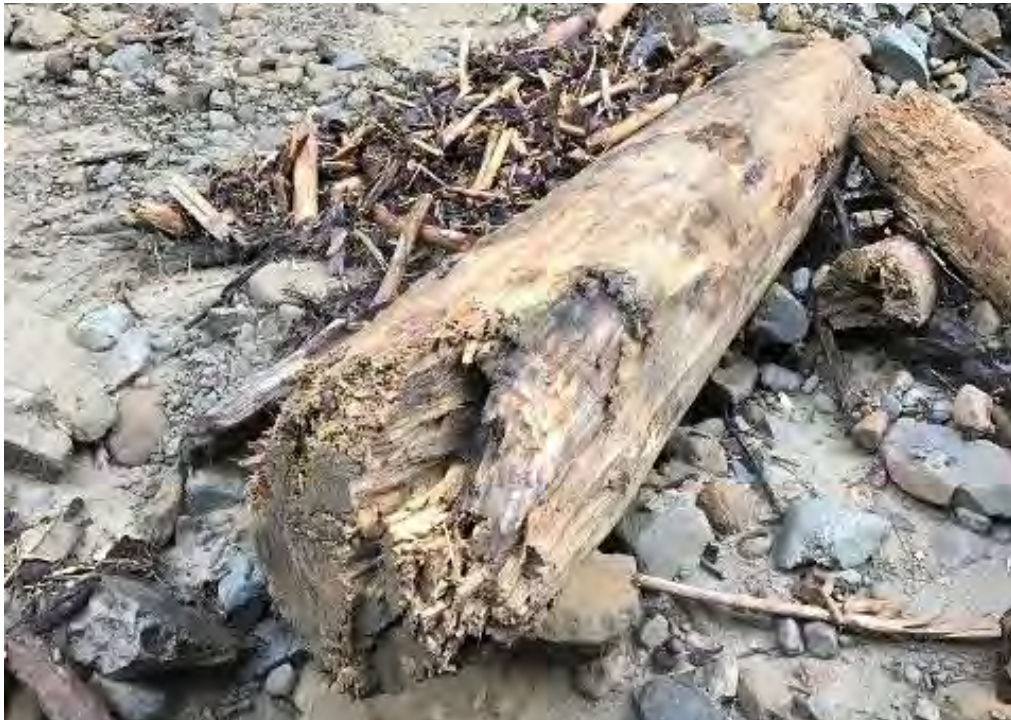
Low resolution GPS reference photo of abraded cut log plus dross , Waterfall Creek.

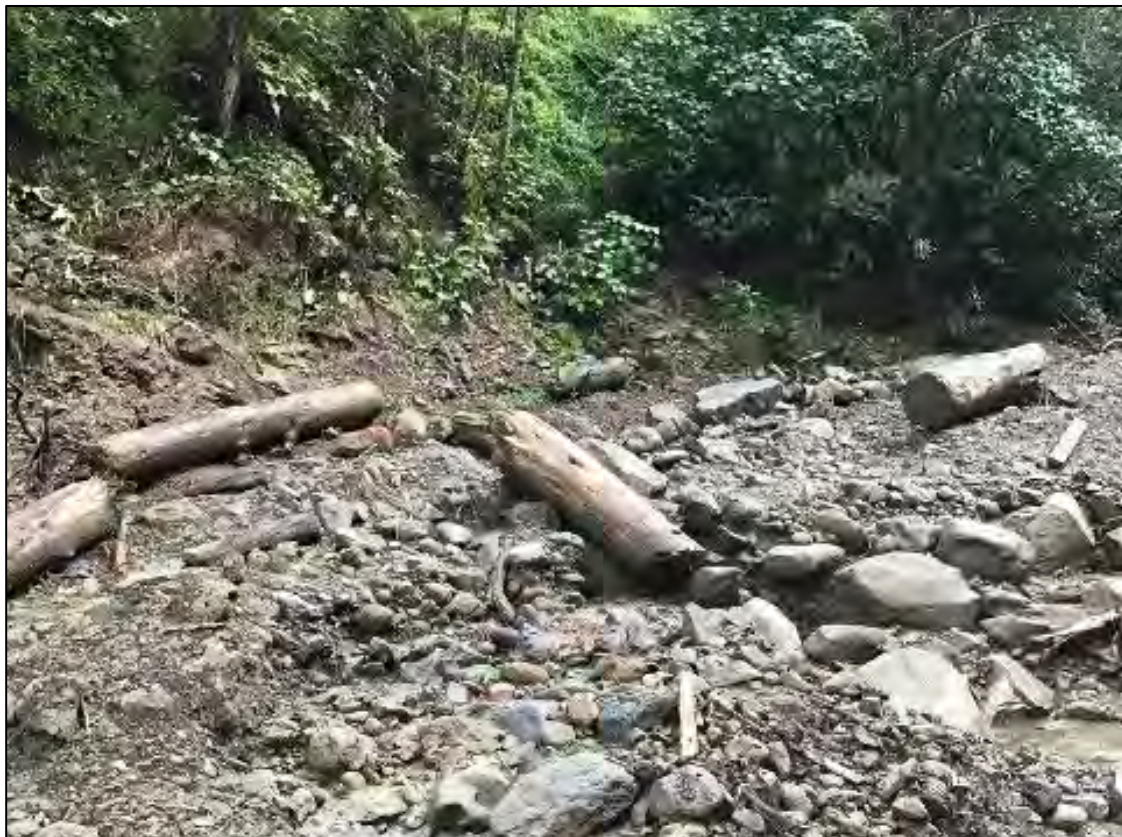
Low resolution GPS reference photo of abraded and cut logs, Waterfall Creek.

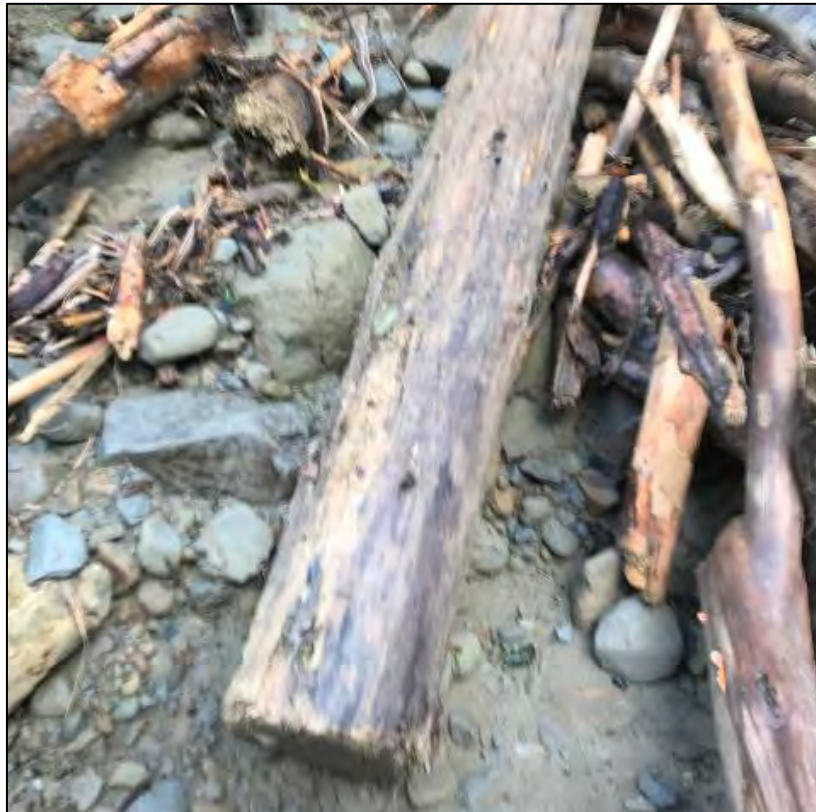
Low resolution GPS reference photo of cut log and dross , Waterfall Creek.

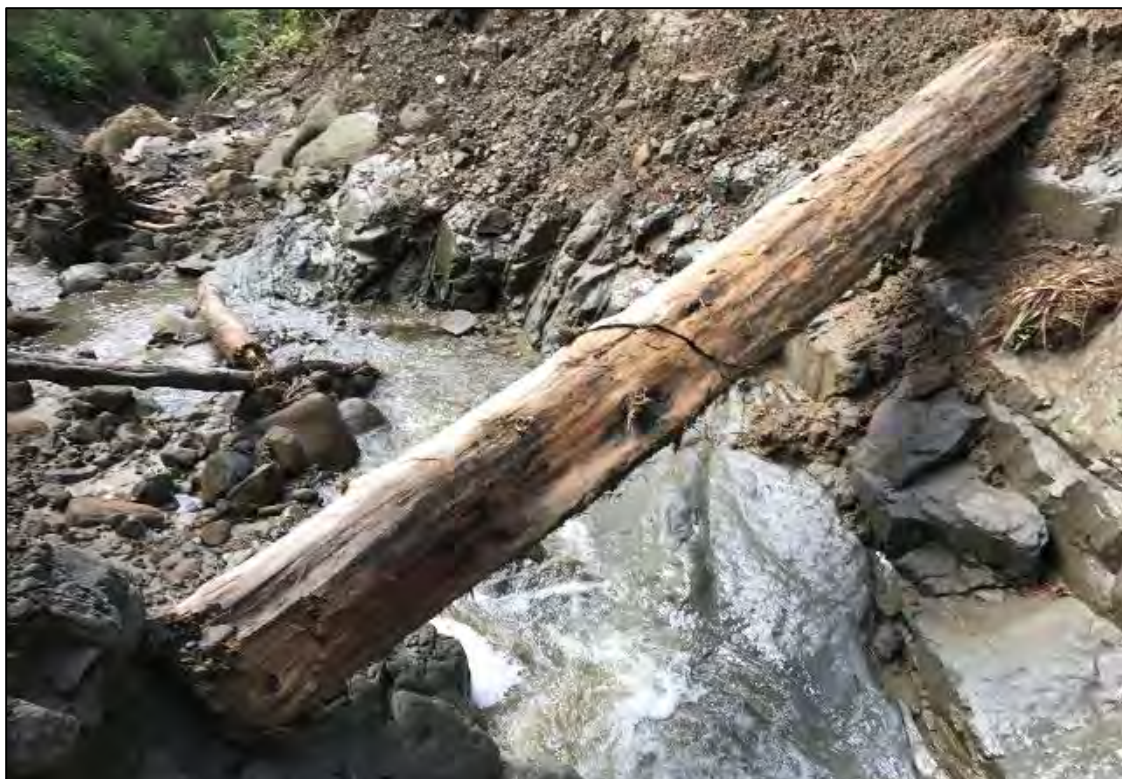
Abraded cut log Waterfall Creek.

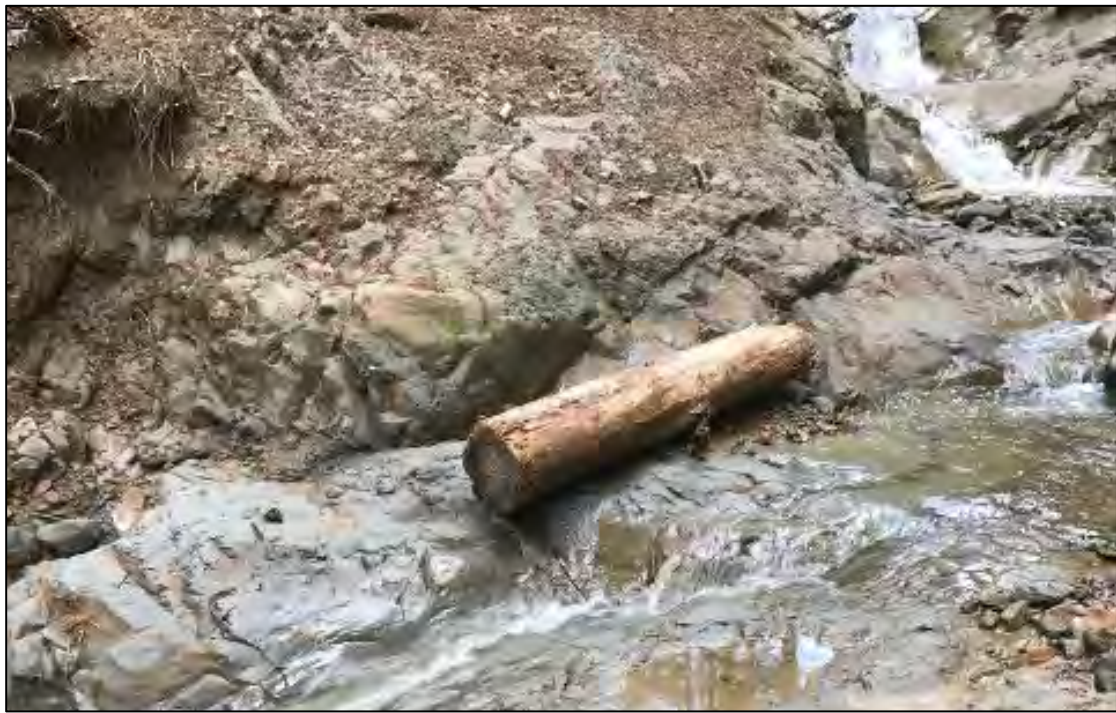
Cut Log Waterfall Creek.

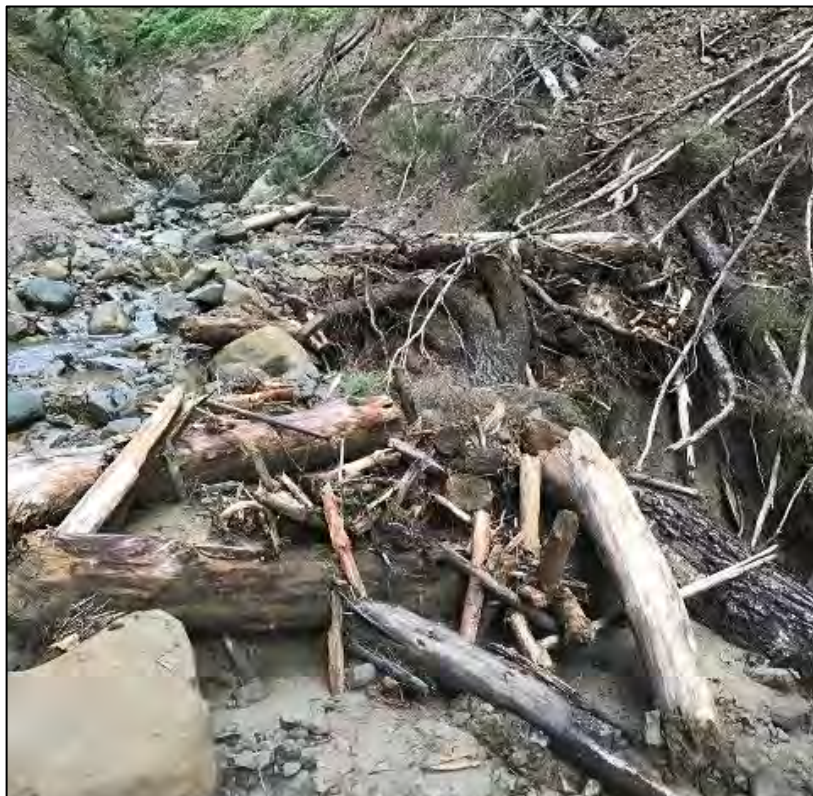
Low resolution GPS reference photo of abraded logs and dross , Waterfall Creek.

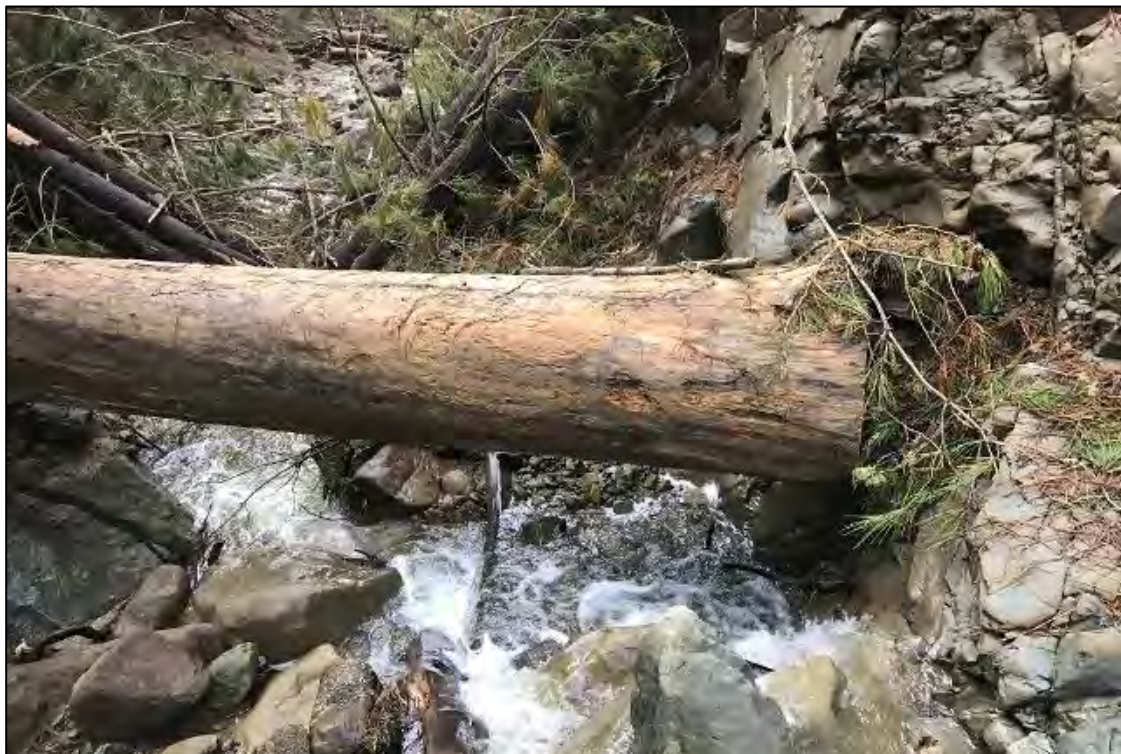
View of large cut log above fresh collapsed pine. Waterfall Creek.
