## Appendix One

### Images from helicopter flight

### **Managatokerau Stream Traverse Images**

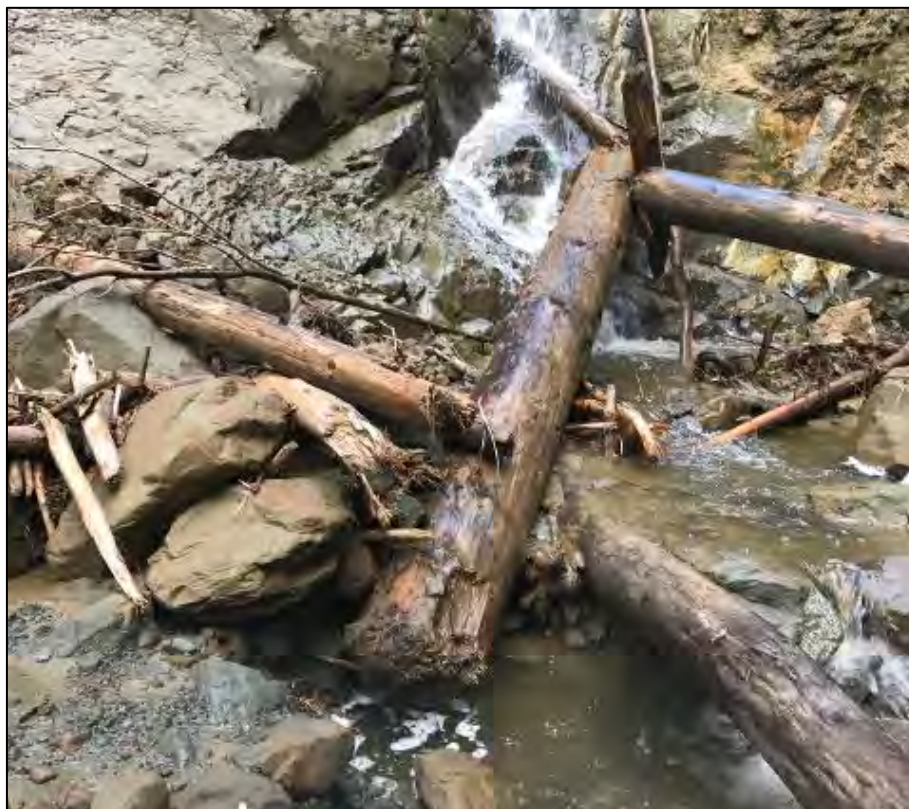
Low resolution GPS reference photo of abraded cut logs, and abraded logs Waterfall Creek.

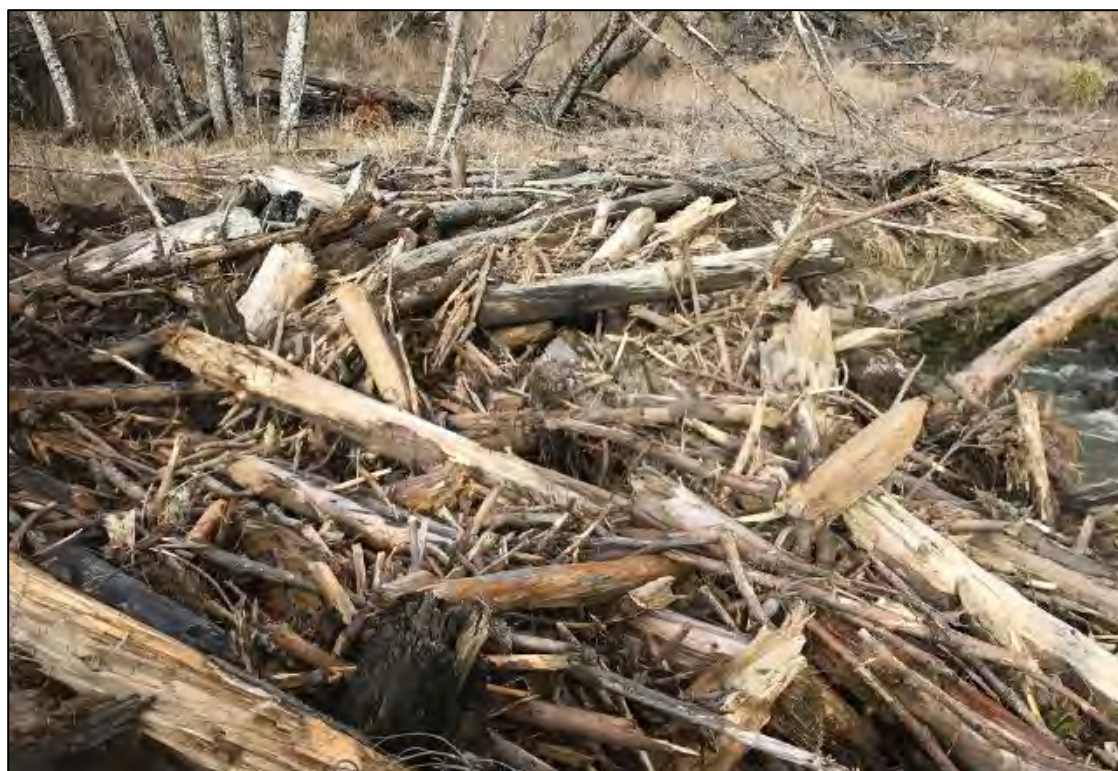
View of log jam caught above willow (cf Figure 94 of report) in Te Kokokahahi Stream, Mangatokerau Valley.

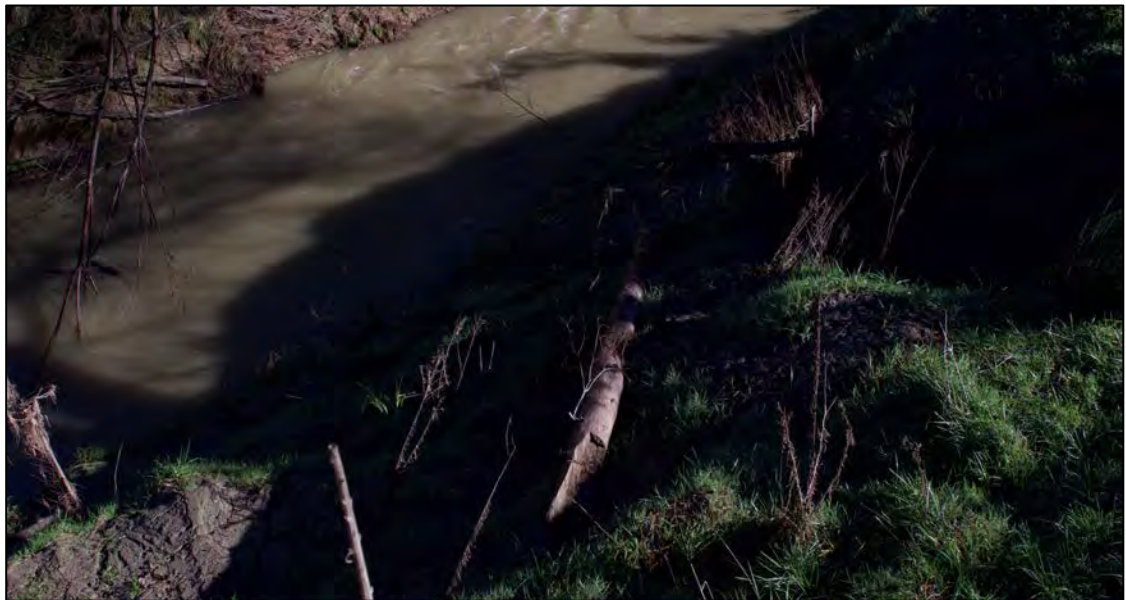
Image 1D1A3417. Pine log at Mangatokerau River Bridge; 11<sup>th</sup> July.

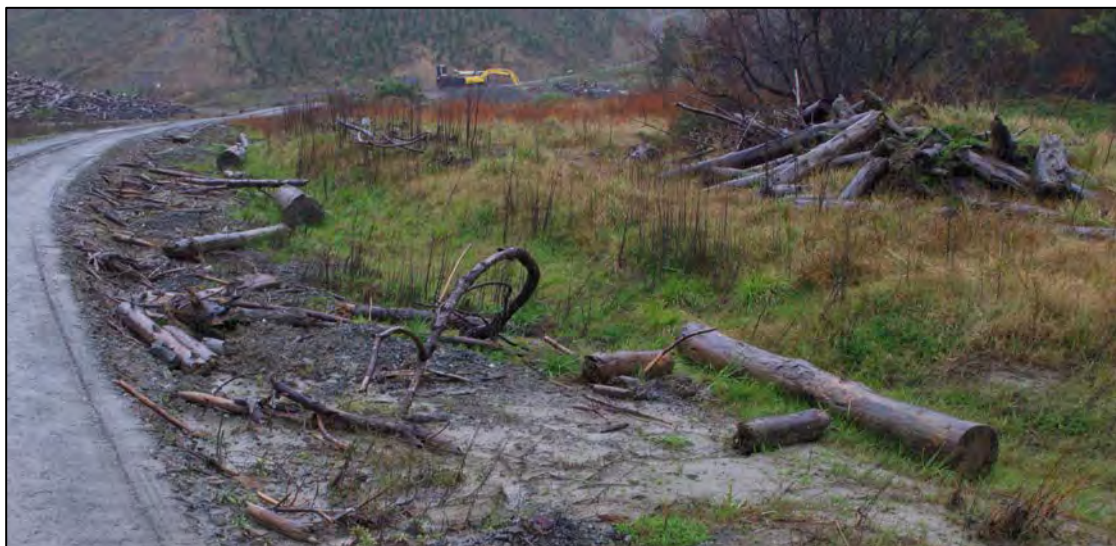
Image 1D1A3886. Cut pine logs and dross in the Mangatoitoi stream. The flood height in this area was above road level.

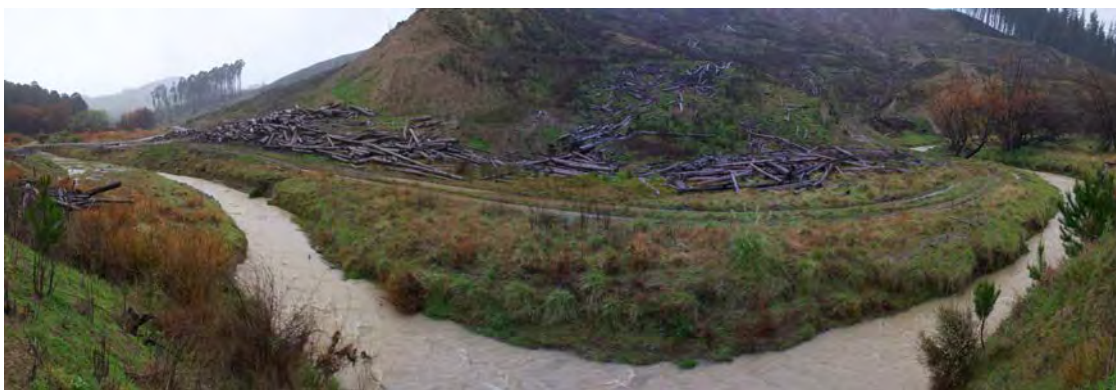
Wide angle panorama of Mangatoitoi Stream showing slash stowed at vulnerable height on edge of the flood plain (Images 1D1A3888 to 1D1A3896).

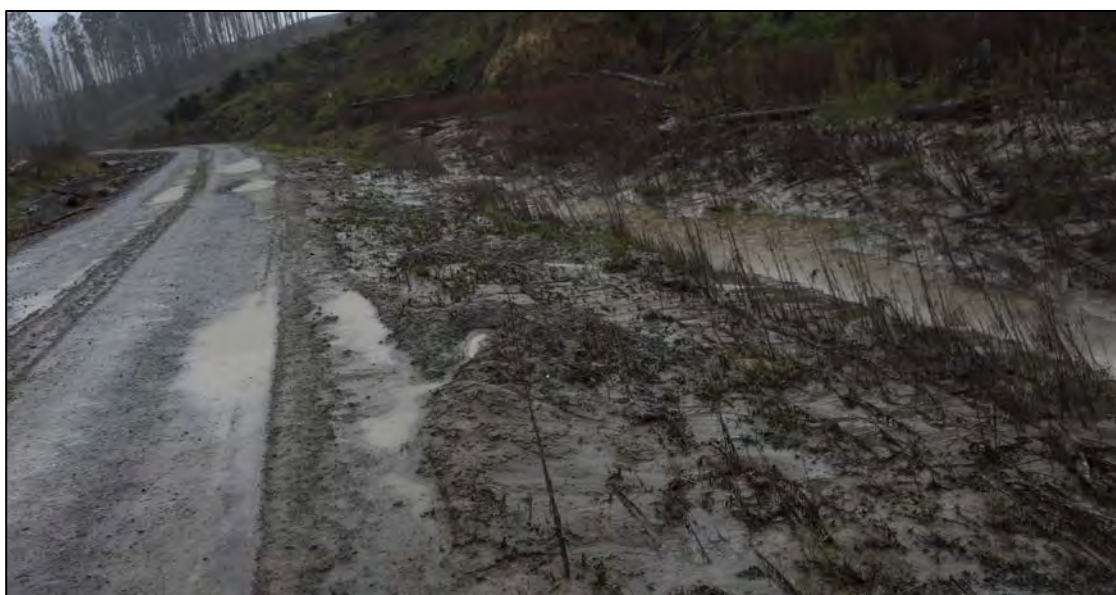
Image\_0116. Mangatoitoi forestry road showing silt deposition from flooding and scattered logs.

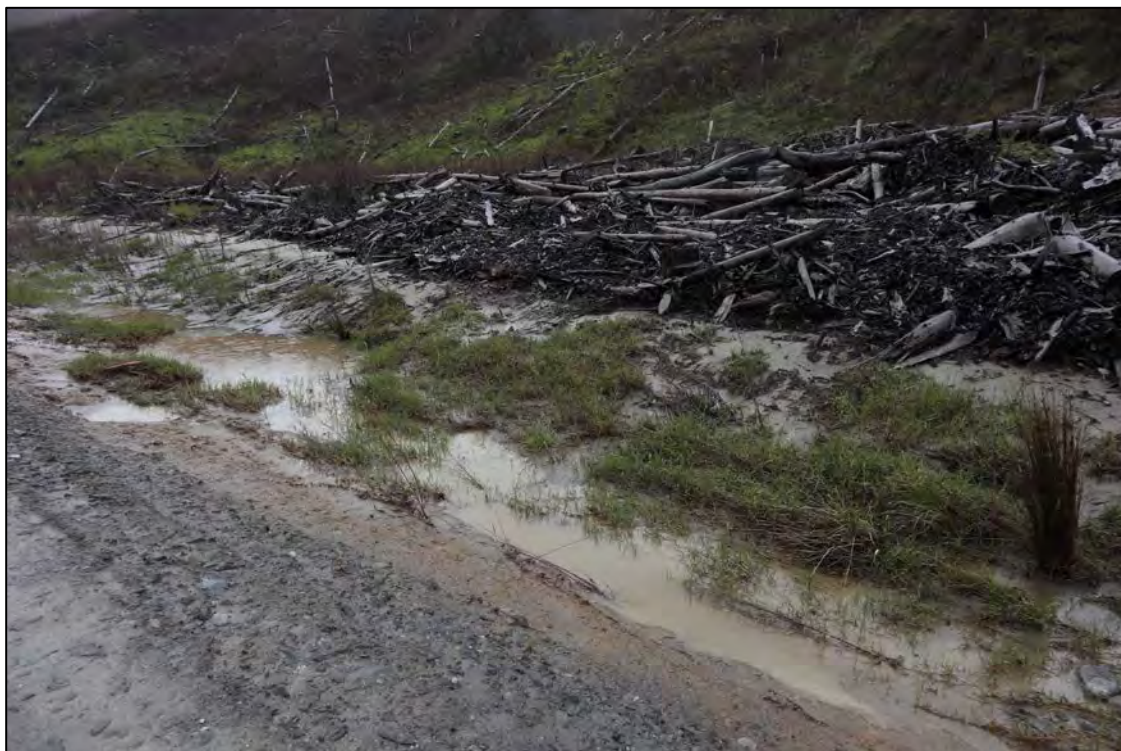
Image\_0107. View of flood trim line and slash pile at Magatoitoi forestry road.

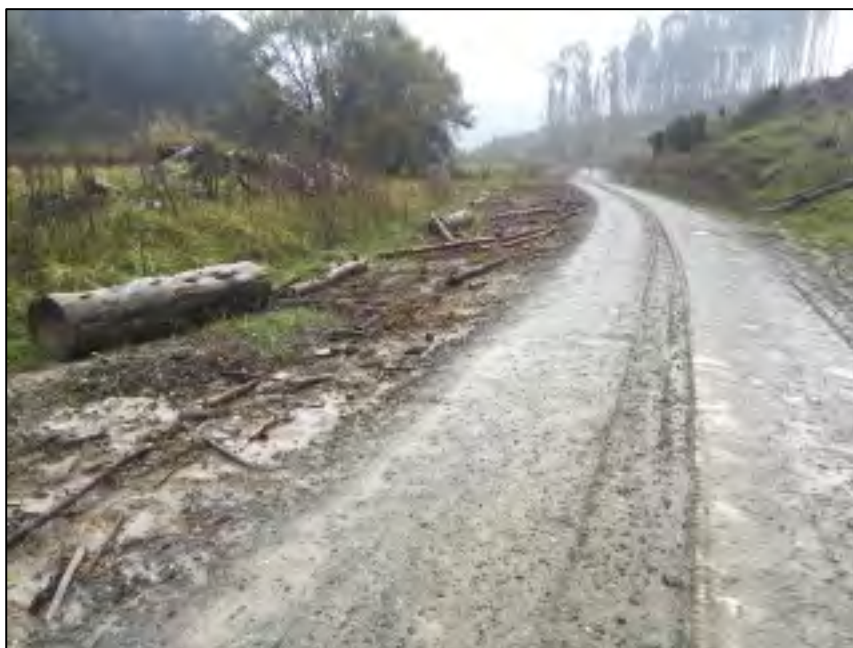
Low resolution GPS reference photo of cut logs on edge of Mangatoitoi forestry road.

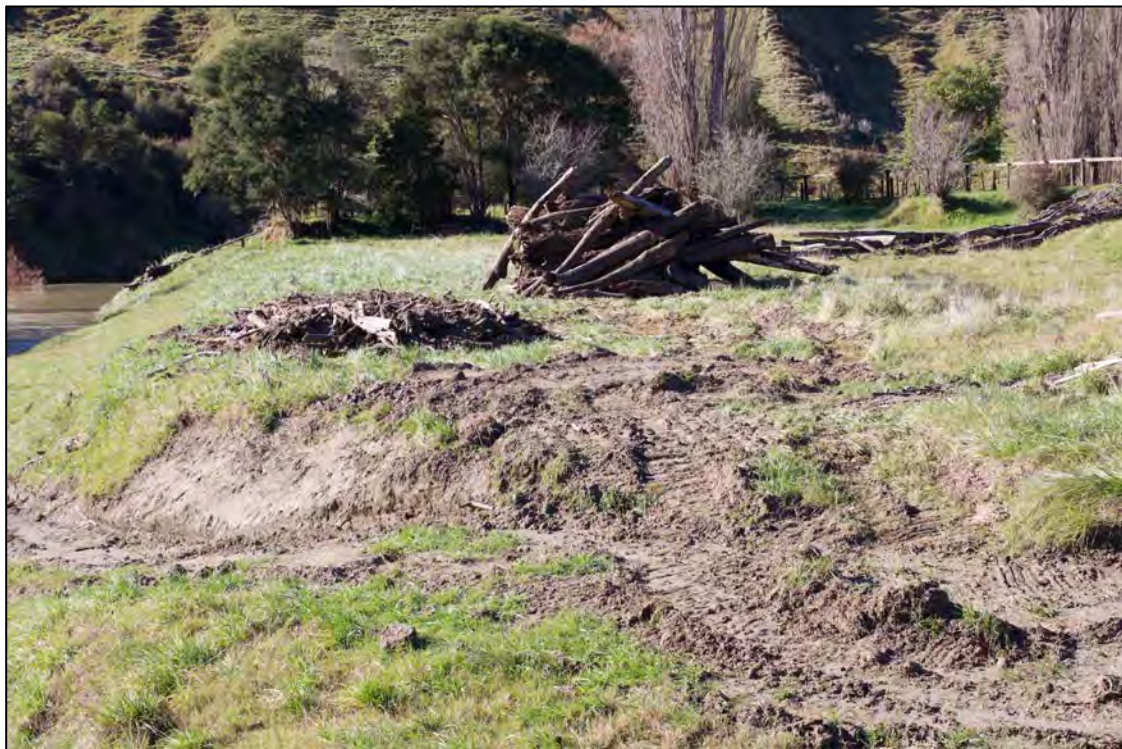
Image 1D1A3424. Lower slash pile Wigan Bridge post deconstruction.

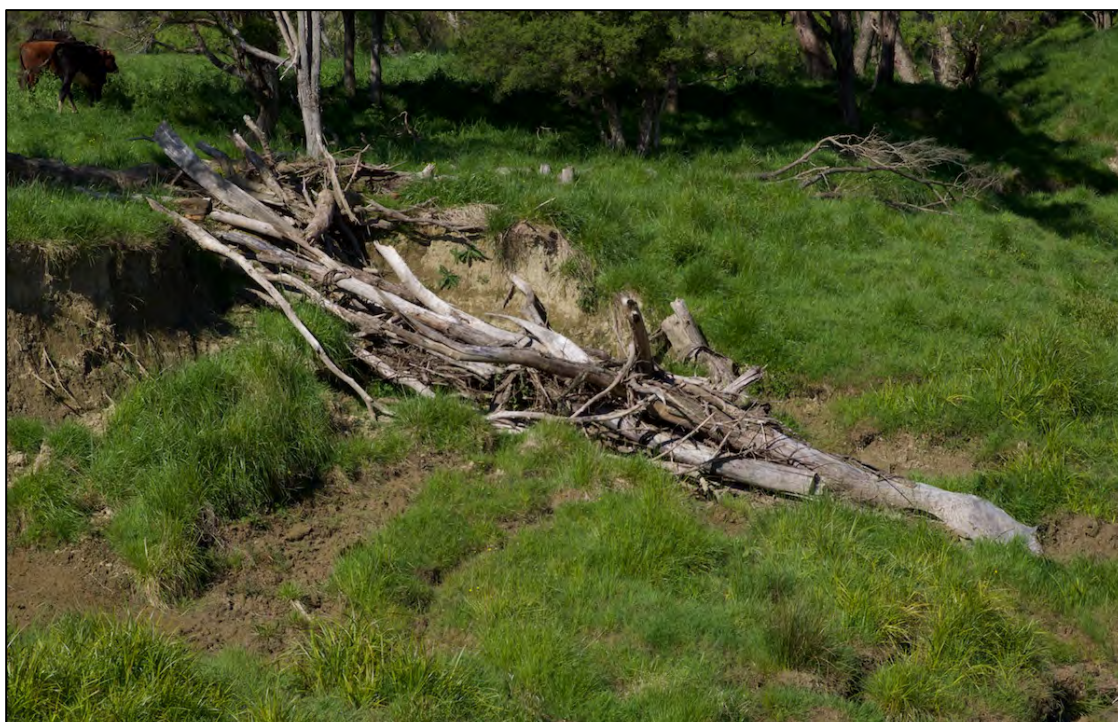
Image 1D1A4315. View of mix of willow and pine woody debris caught up on banks of Tapuae Stream downstream of Paroa Road bridge.

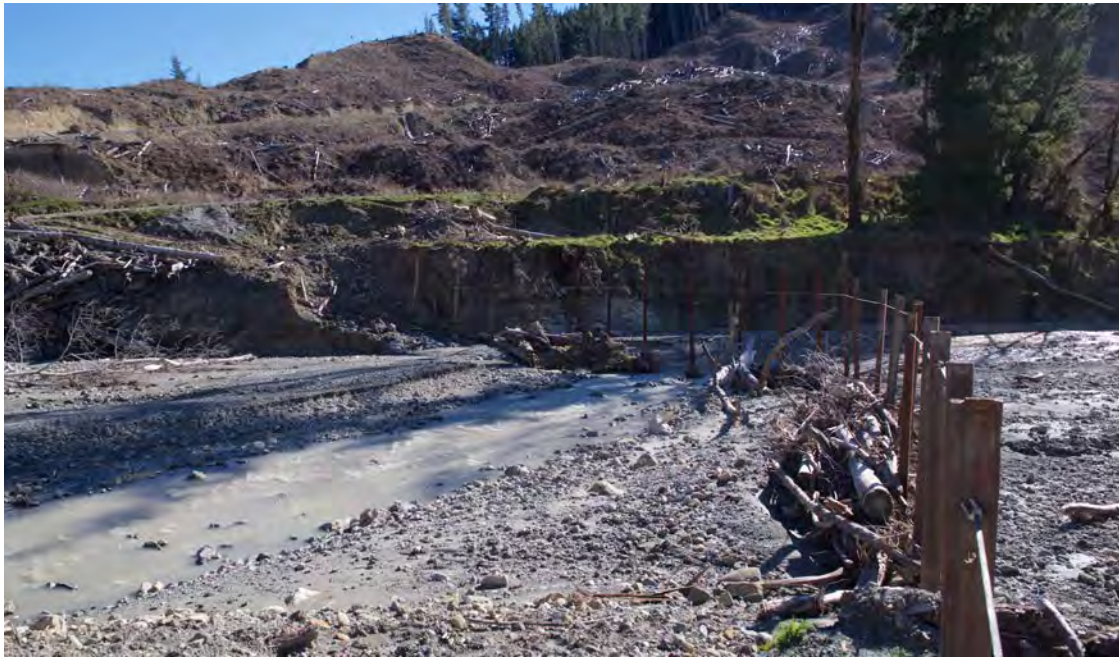
New slash catcher installed at Whakoau Stream showing new logs including cut logs caught against catcher

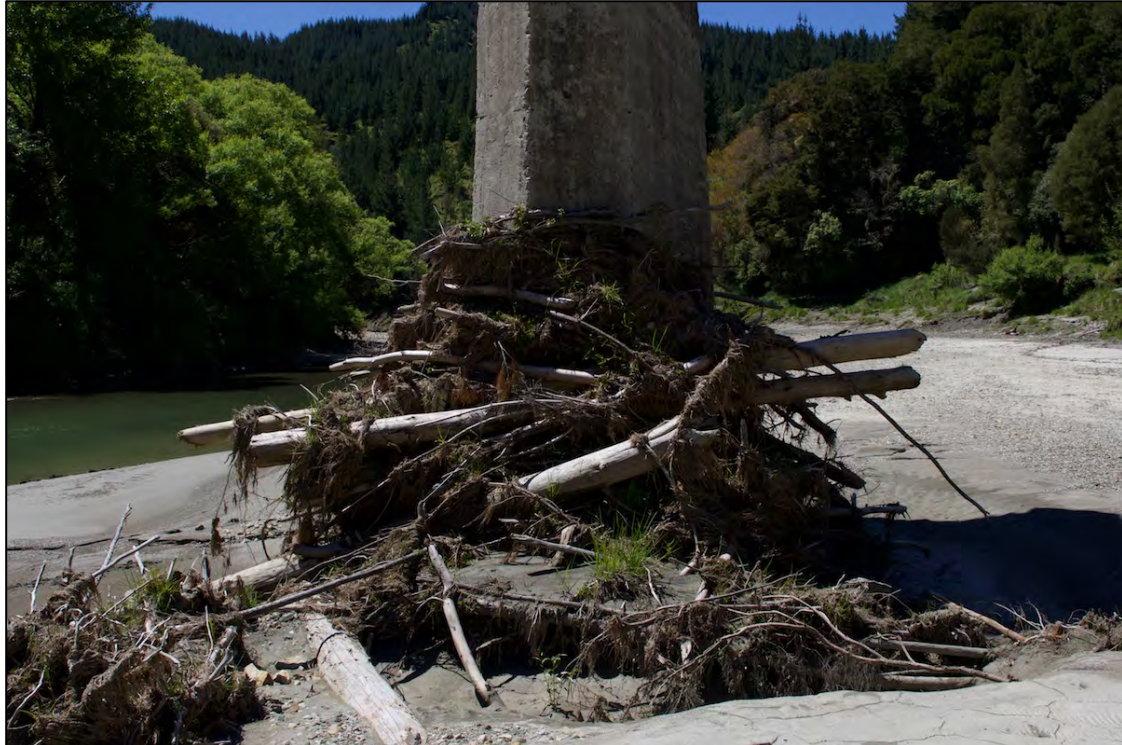
Image 1D1A4221. View of pine and cross woody debris caught up in old bridge pile Ihungia.

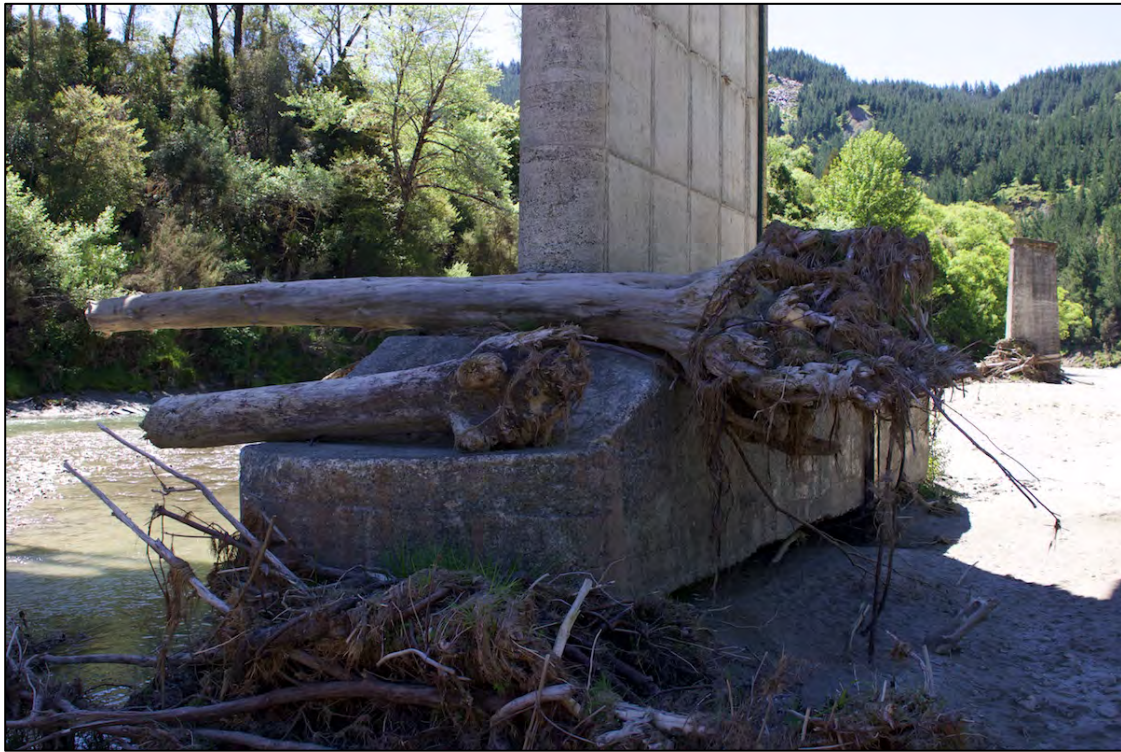
Image 1D1A4225. Windthrow pine logs caught up against Ihungia Bridge.

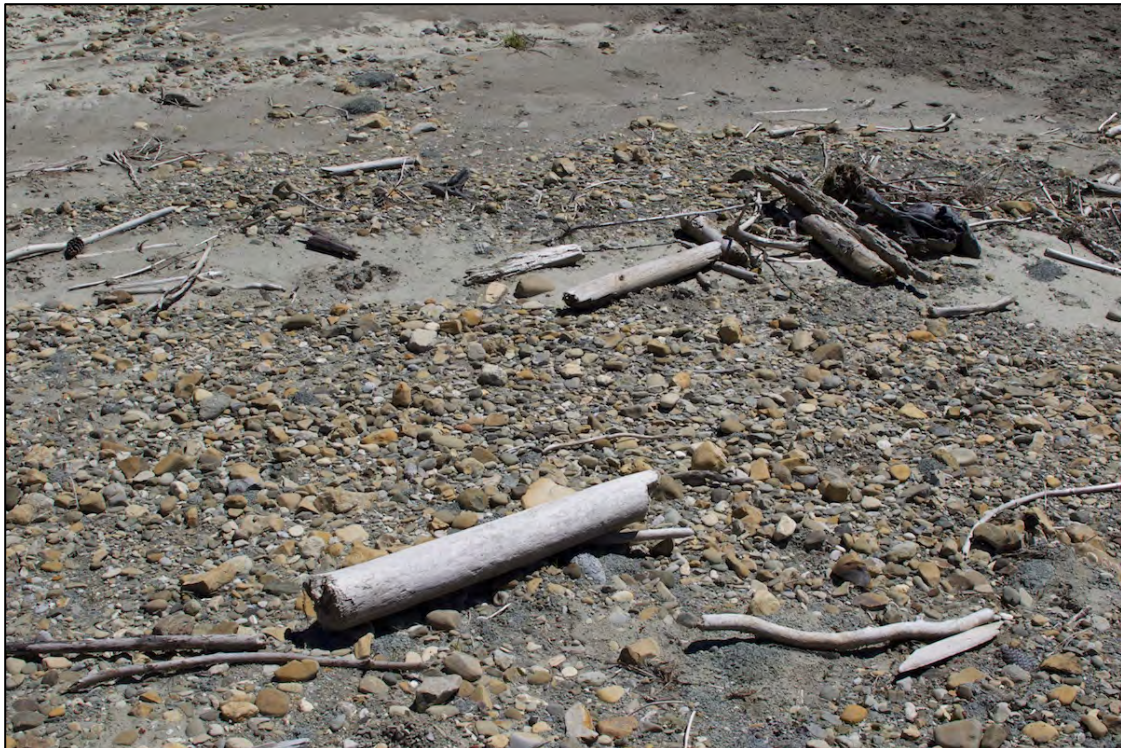
Image 1D1A4236. Scattered small pine logs on riverbed, Mata River.

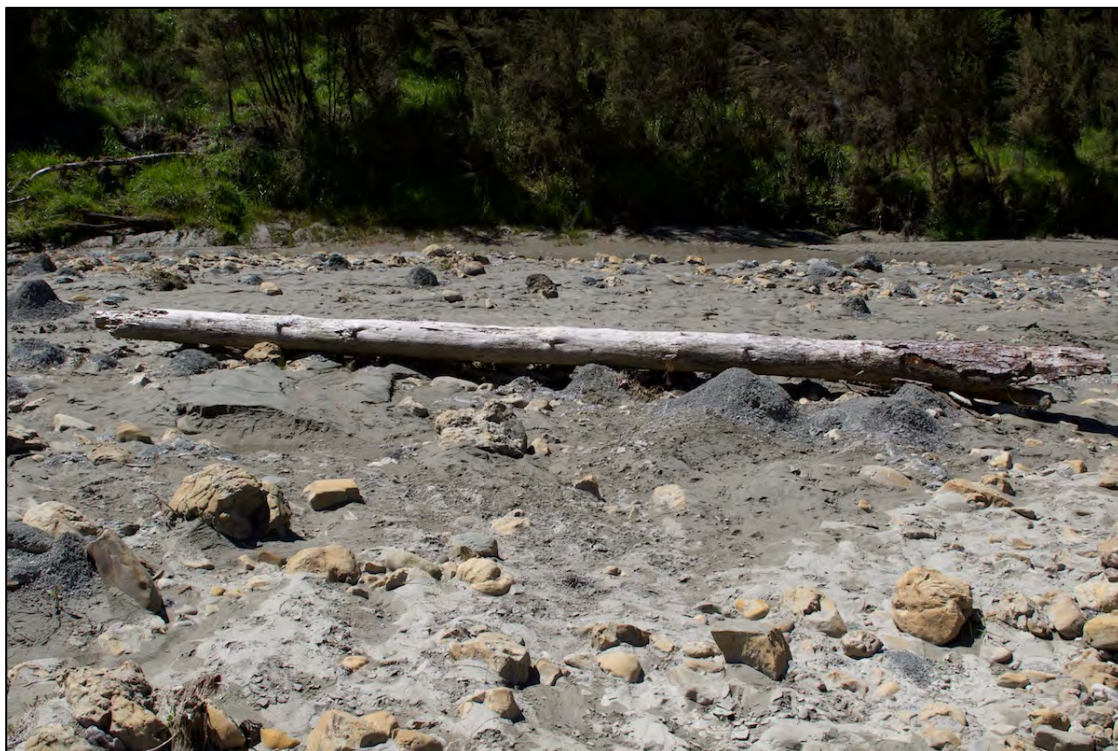
Image 1D1A4242. Pine log, Mata River.

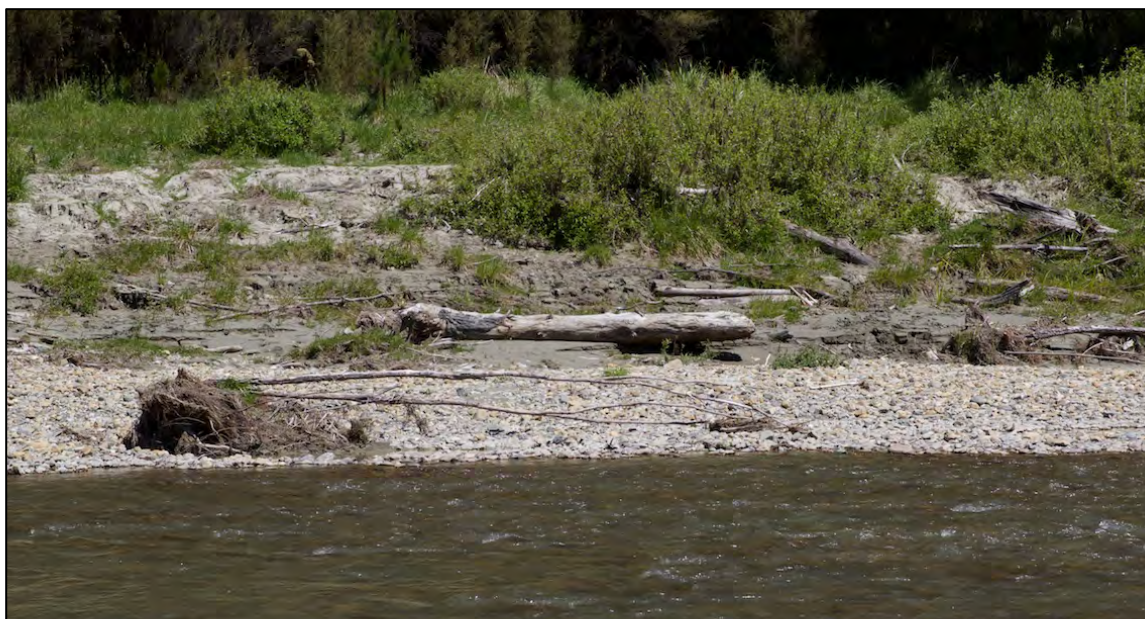
Image 1D1A4243. Abraded pine log and dross Mata River. Note flood height at top of bank.

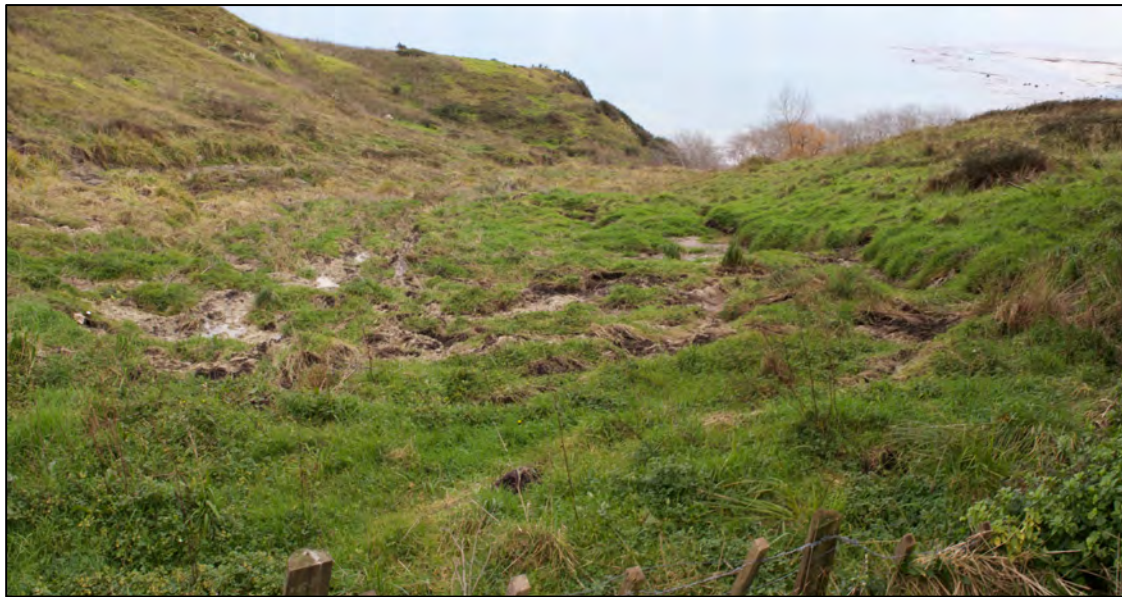
*Figure Three. View of the Wallis Road Landslide, Kaiti Hill. Note that the material has remained coherent and is sliding downslope.*

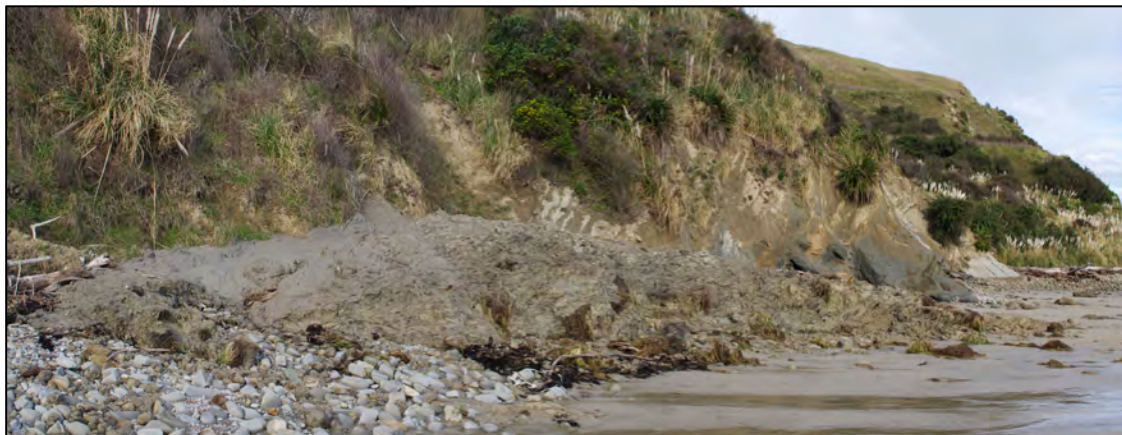
*Figure Four. Debris flow apron at the north end of Kaiti Beach.*
